Rail Accident Investigation Branch

Rail Accident Report

Near miss at Farnborough North footpath level crossing 19 May 2022

Report 04/2023
April 2023

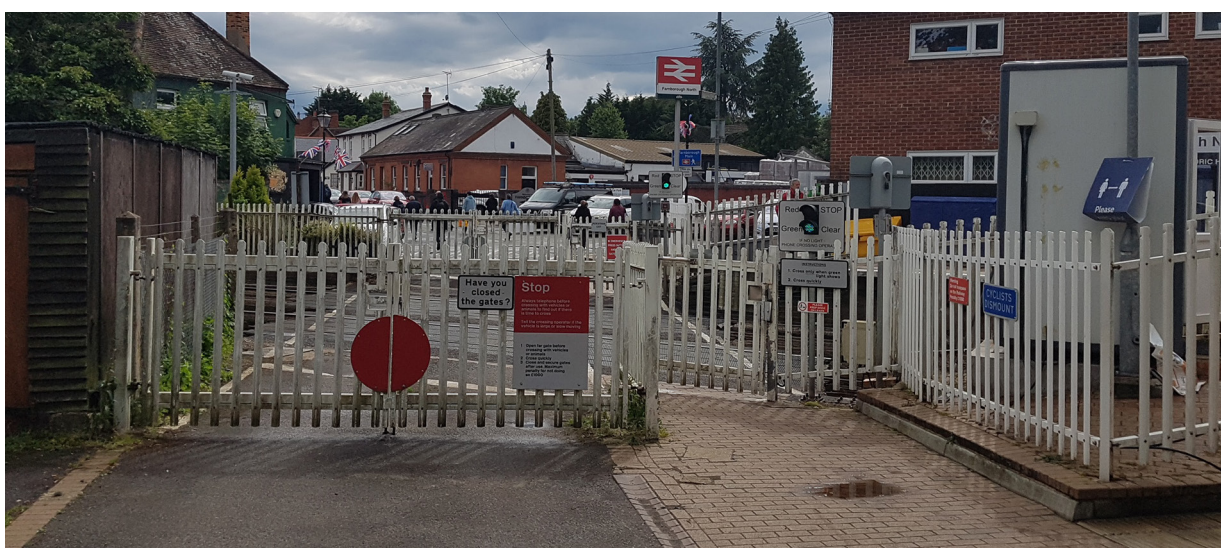
- 22 Signs at the crossing located underneath the miniature stop lights contain the following text (figures 4 and 5):
1. *Cross only when green light shows*

Figure 4: View looking west from near platform 1 showing user worked crossing (left), footpath crossing (centre) and side of crossing attendant's cabin (right).

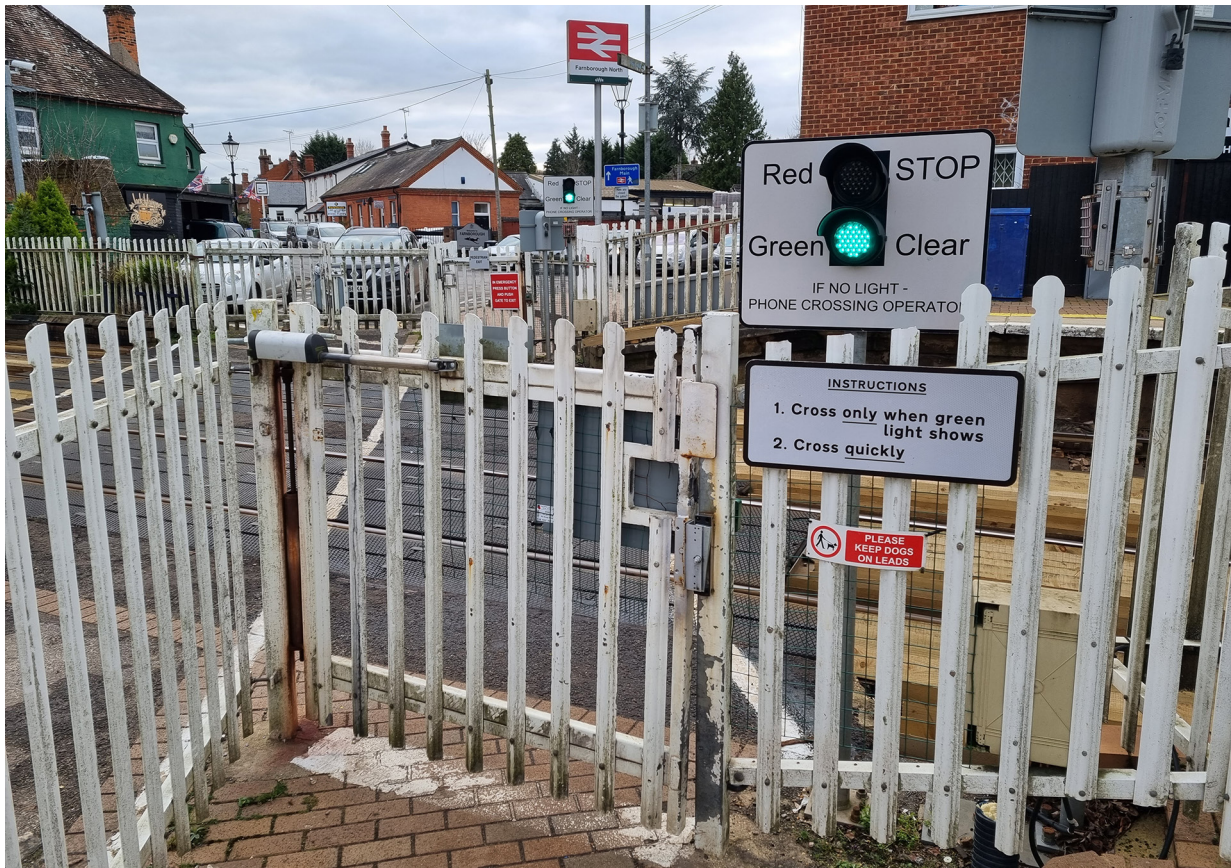
2. *Cross quickly*
- 23 Additional miniature stop lights were installed at the crossing in 2013. The new lights were fitted 'back-to-back' with the existing lights, presenting users with a warning light on both the near and far sides of the crossing. The enhancement was intended to reduce risk to users by providing redundancy and to allow users to check the status of the crossing while they are traversing it. The audible alarm was also installed at this time.

Figure 5: Footpath crossing gate near platform 1 with back-to-back miniature stop lights, visible on both sides of the railway.

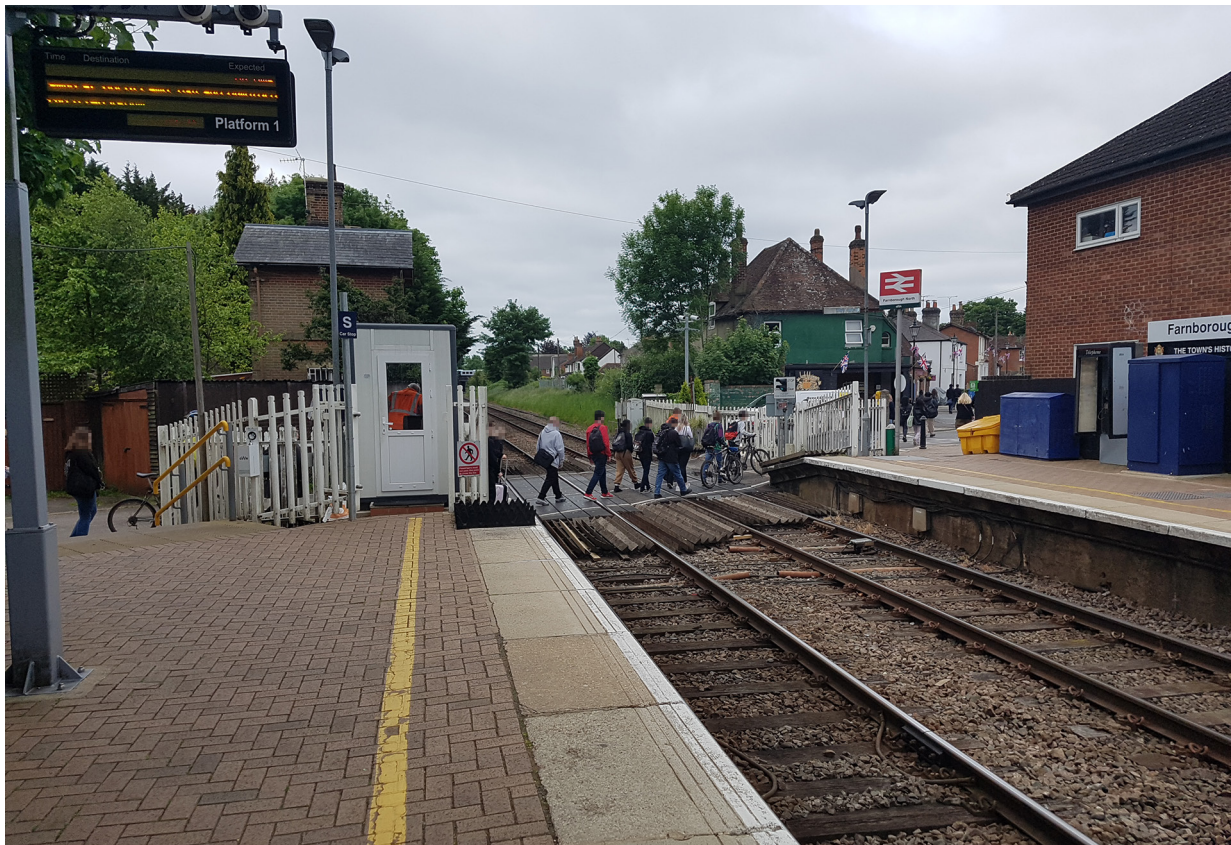
Figure 6: View looking south along platform 1 (not on the day of the incident) showing passenger information screen, crossing attendant's cabin and footpath crossing.

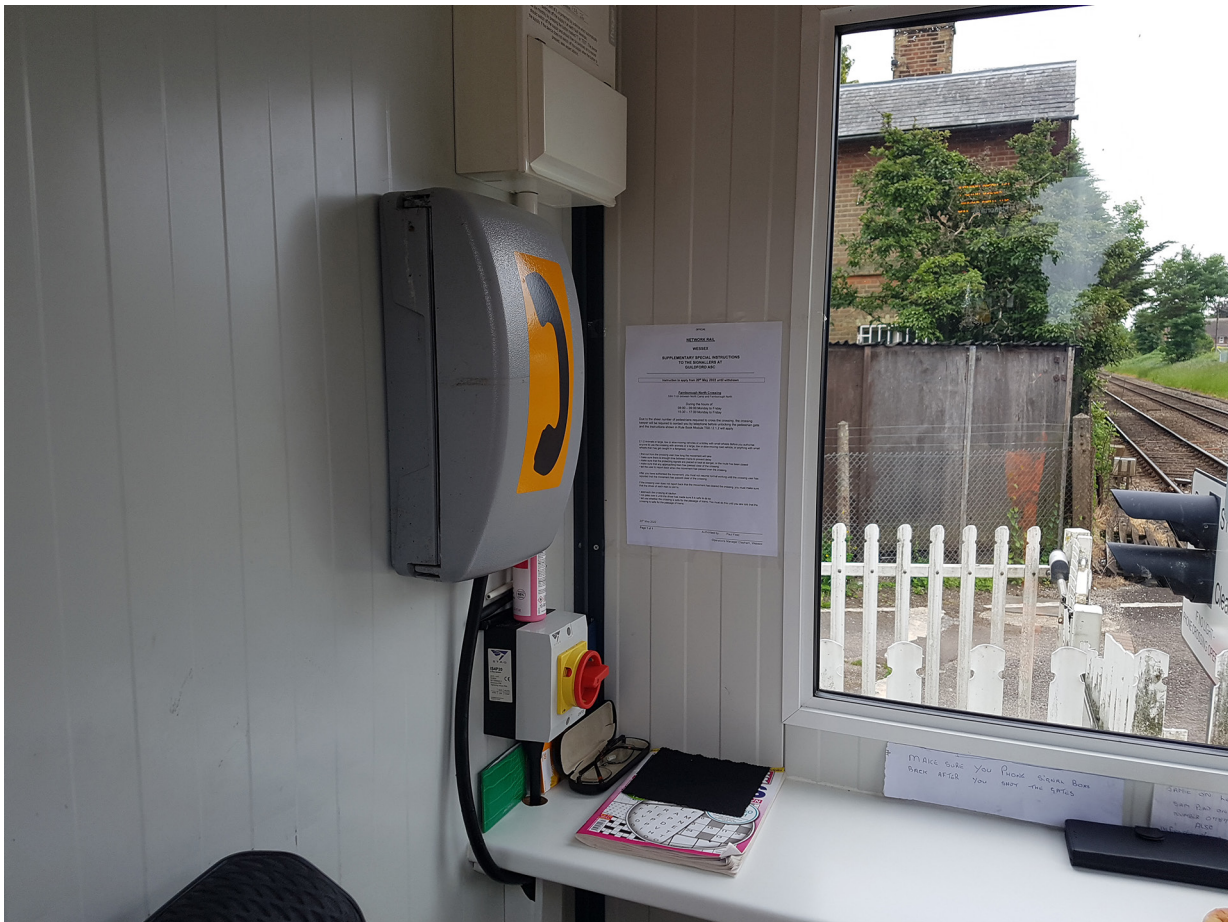
- 38 After the large group had started to use the crossing, train 1V38 was detected by the signalling system. The miniature stop lights changed from green to red and the audible alarm at the crossing started to sound. The crossing attendant responded within a few seconds by turning the switch in the attendant's cabin to lock the pedestrian gates (figure 7). This activates the electro-magnetic locks fitted to the gateposts.

Figure 7: Crossing attendant's cabin showing gate locking switch below the telephone (installed after the incident) with view of crossing and miniature stop light equipment.

- 39 Because crossing users were holding the gates open for the person following them, energising the locks had no effect on the flow of pedestrians (paragraph 24). The crossing attendant recognised the risk of users continuing to cross while the miniature stop lights and audible alarm were indicating the approach of a train and shouted a warning from the cabin window. This, however, had no effect and the flow of crossing users continued. The crossing attendant then left the cabin and directly intervened to close the gate, which prevented users entering the crossing from the platform 1 side at about the same time that train 1V38 came into view. The actions of the crossing attendant may have prevented a serious accident.

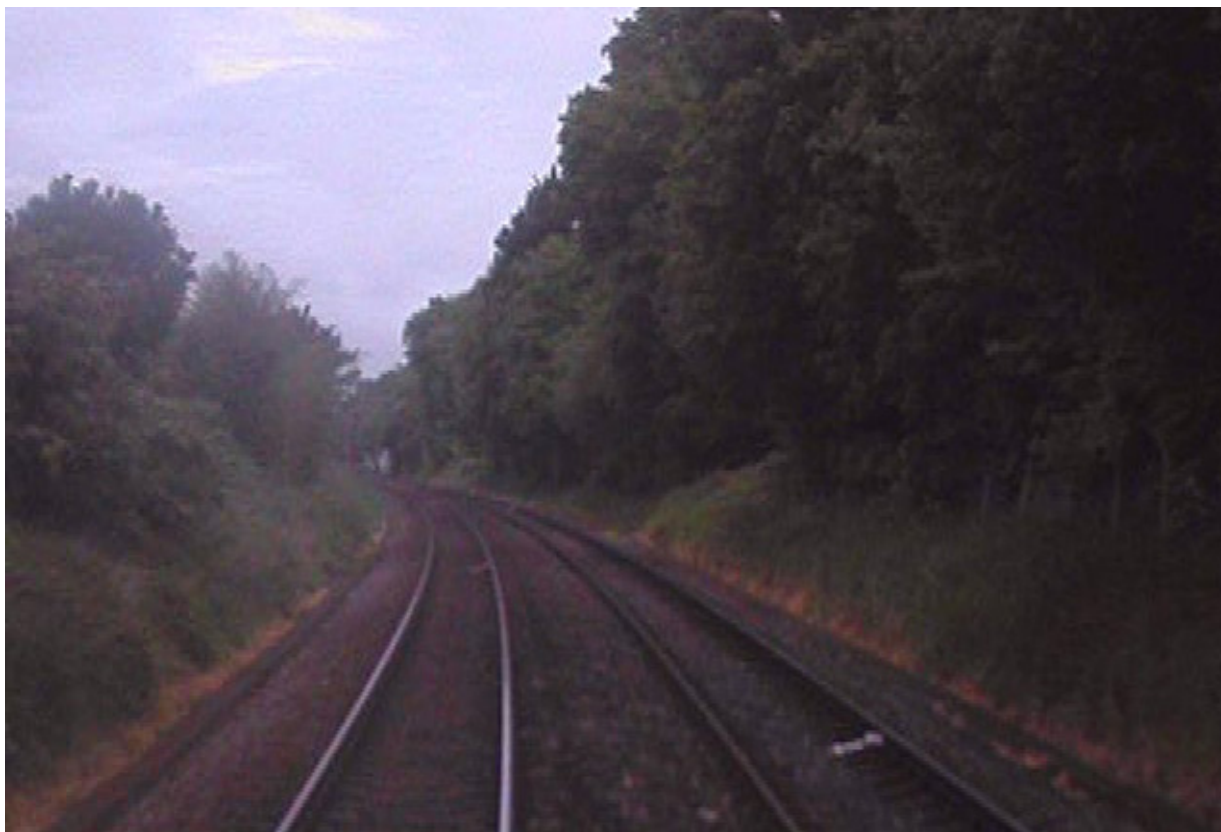
Figure 8: Forward-facing CCTV image from train 1V38 at 08:21:18 hrs. The crossing is 320 metres ahead and is just visible round a bend in the track.

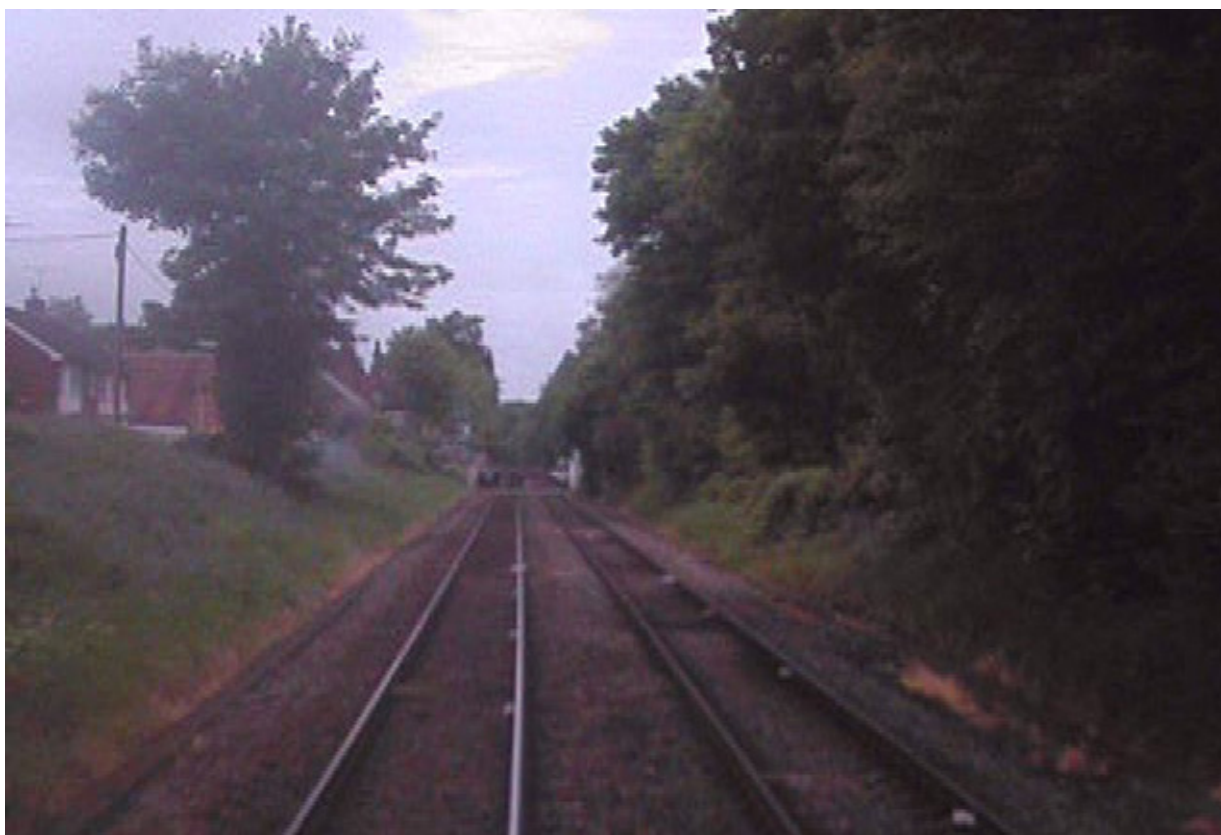
- 40 Train 1V38 approached Farnborough North on the down line at 69 mph (111 km/h). Forward-facing CCTV images show that the crossing was not visible until the train was about 320 metres away from it (figure 8). The driver observed a group of people on the crossing. Data from the on-train data recorder shows they quickly applied the emergency brake and sounded the horn continuously for the next 10 seconds. In a statement to their employer, the driver said, "The people slowly moved to the side of the track as I approached" (figure 9).

Figure 9: Forward-facing CCTV image from train 1V38 at 08:21:23 hrs. The crossing is 175 metres (8 seconds) ahead and pedestrians are visible.

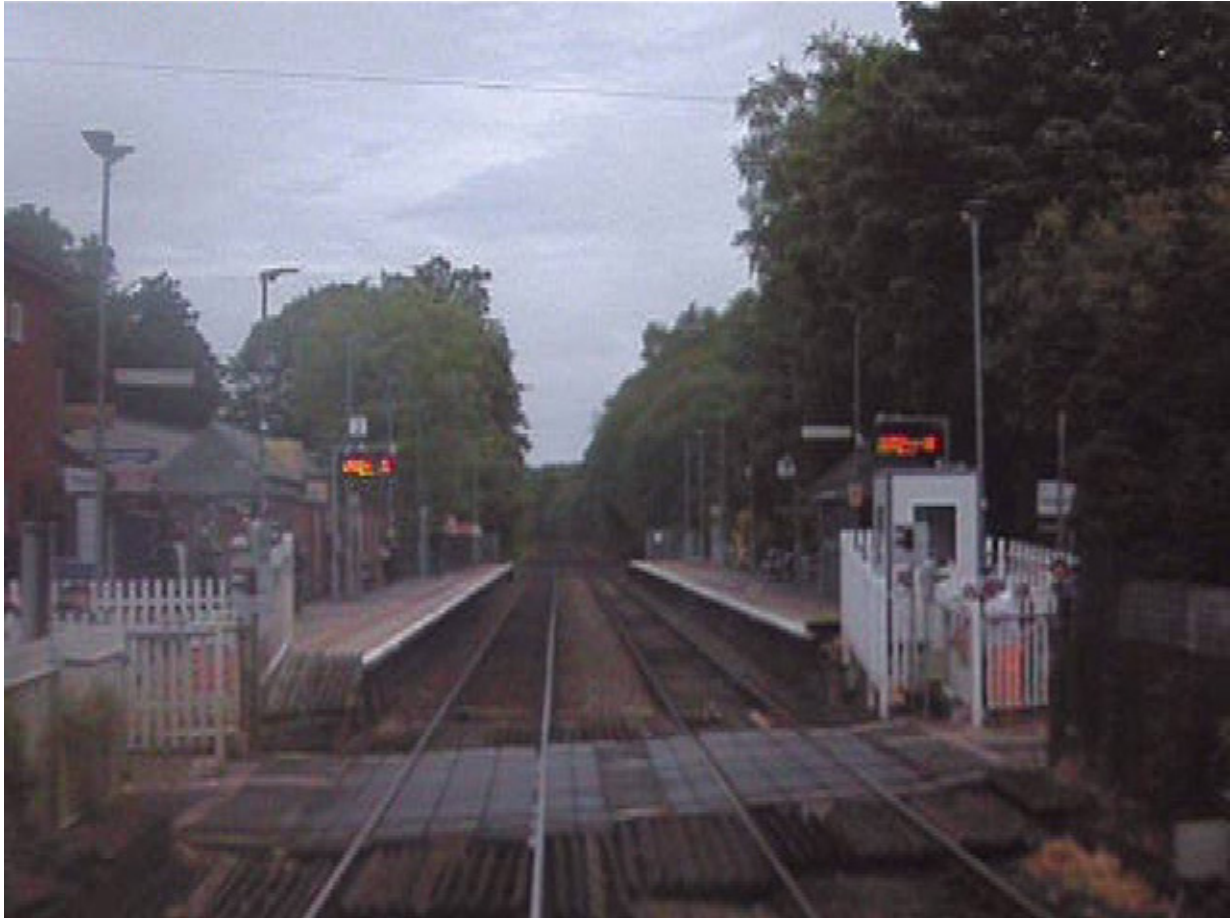
- 41 The users were clear of the crossing about six seconds before the train passed over it at 35 mph (56 km/h). The forward-facing CCTV equipment (figure 10) fitted to train 1V38 shows the crossing attendant standing behind the up-side gate with the remaining crossing users as the train passed.

Figure 10: Forward-facing CCTV image from train 1V38 at 08:21:30 hrs, one second before it passed over the crossing. The crossing attendant is visible (orange) behind the right-hand pedestrian gate.

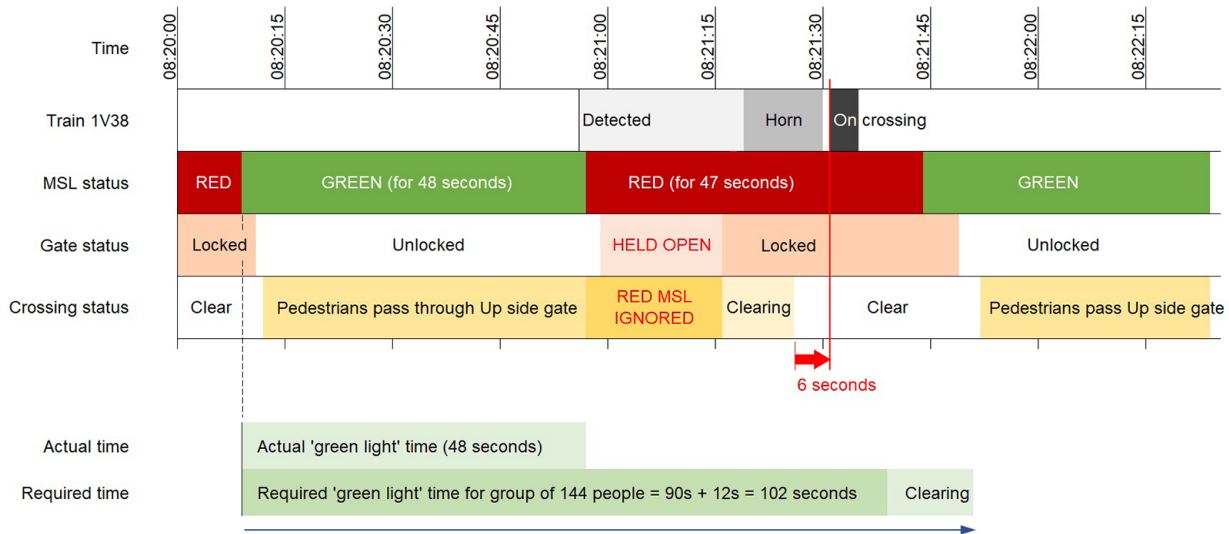
- 51 After displaying a green light for 48 seconds, the miniature stop lights changed to red and the audible warning started. If the flow of pedestrians had stopped immediately, then the earlier flow of pedestrians suggest that the crossing would have been completely clear about 12 seconds later, around 22 seconds before the train passed over the crossing. However, on 19 May, it actually took 28 seconds to clear the crossing after the lights and alarm activated because pedestrians continued to enter and use the crossing after this point in time, stopping only when the crossing attendant left their cabin and physically intervened to close the up-side gate. This reduced the time between the crossing being clear and the train passing to six seconds (figure 11).

Figure 11: Diagram showing sequence of events.

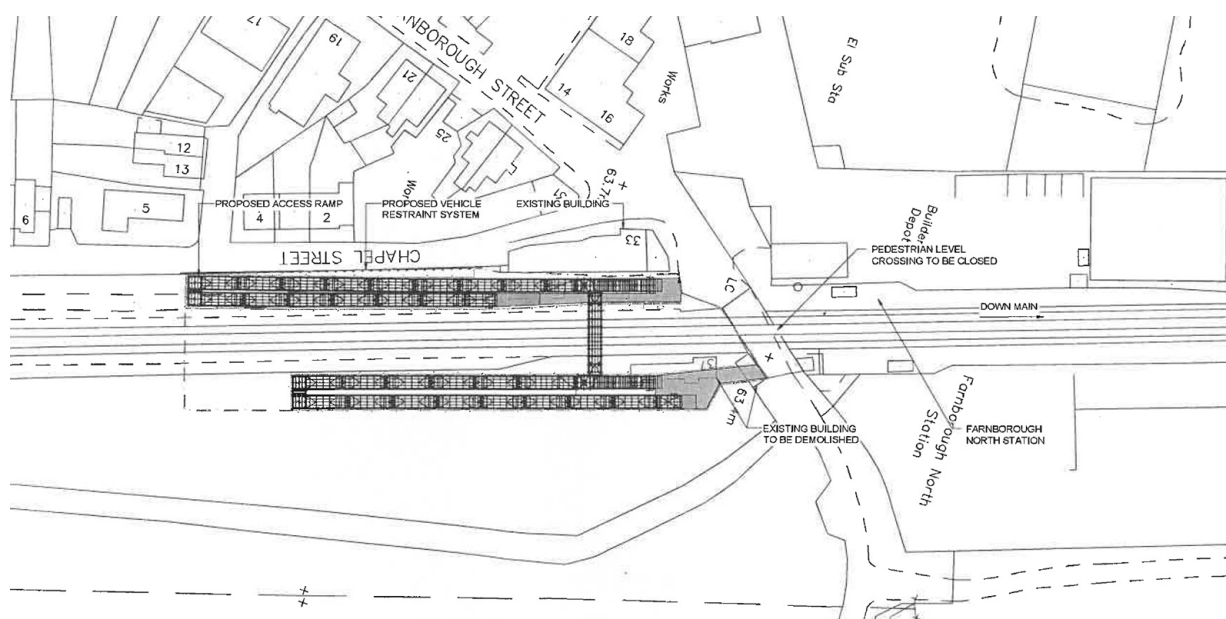
- 98 On 18 May 2018, Network Rail submitted a planning application for a stepped footbridge south of the crossing with ramps running south of the bridge (figure 13 and figure 14). The principal planning officer responded three days later stating that the application was invalid for a number of reasons. For example, the required ecological survey was not referenced in the application pack and not all the existing buildings to be demolished were shown. They requested further information before the application could be considered. However, Network Rail did not provide further information in response to the issues raised.

Figure 13: Diagram of proposed 2018 footbridge (extract from Network Rail drawing UA007617-20-01-ECV-DRG-ARC-104 revision P01 dated 09/03/18). Farnborough North station is on the right.

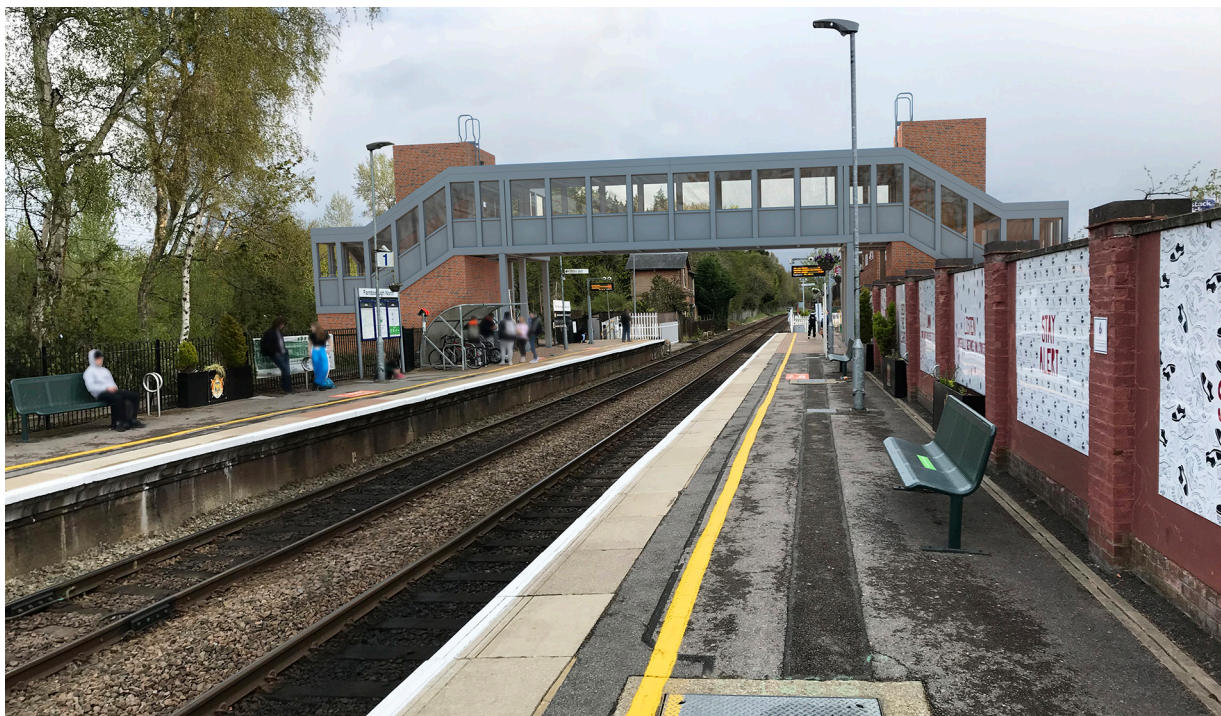
Figure 15: Visualisation of proposed 2024 footbridge with stairs and lifts (courtesy of Network Rail).
