Report on the investigation of
the capsizing of the recreational craft

Wheelyboat 123

with the loss of two lives
on Roadford Lake, Devon, England
on 8 June 2022

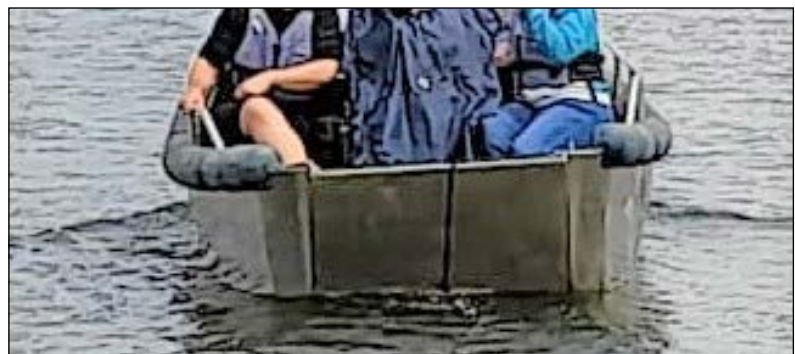
At about 1240, one of the carers ashore climbed into the boat and closed the bow ramp before climbing out again. The driver then started to manoeuvre *Wheelyboat 123* out on to the lake. The waterline of the loaded boat was now above the lower threshold of the bow ramp (**Figure 3**). As the boat left the shore, one of the carers noticed that water was entering the boat around the edges of the bow ramp and told the driver. The driver turned the boat and headed back to shore. To stop the water coming in, the instructor directed the carer on the starboard side to turn the winch handle to tighten the rope holding the bow ramp shut. The carer jumped out of the boat and tightened the bow ramp closure before climbing back in and returning to their seat. The instructor then asked the two carers to swap sides in an attempt to correct a heel to starboard. Satisfied that the water had stopped entering the boat, the driver recommenced the trip around the lake. The water that had entered the boat was not removed and the boat was now heeling slightly to port.

Figure 3: Bow ramp threshold below the waterline

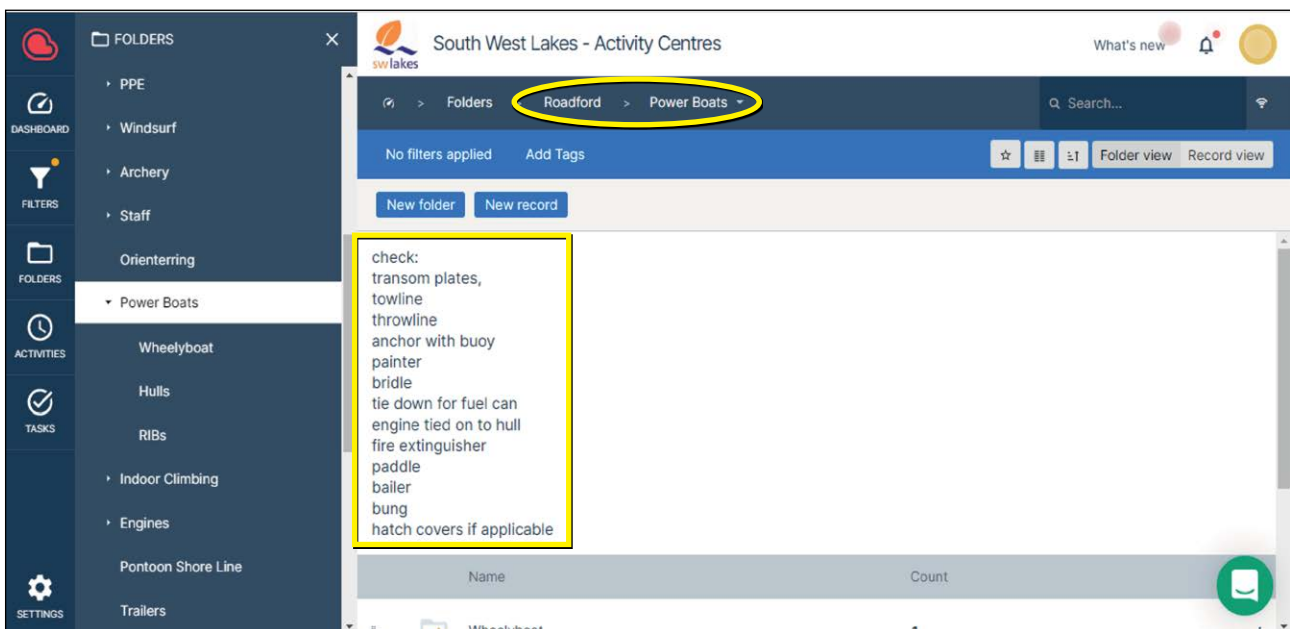
Following its investigation WBT sent an email to the activity centre in November 2016 instructing monthly inspection for water ingress of the *Wheelyboat 123* buoyancy tanks. This email also contained an electronic copy of the revised owner's manual. The activity centre's planned maintenance tasks were not updated to reflect this requirement and the investigation found no evidence that staff conducting monthly inspections were aware of the revised maintenance requirements. At the time of the investigation the activity centre was unable to locate either the original owner's manual or the updated version issued in October 2016, both having been mislaid at some point before the accident. None of the activity centre's management team or instructors had specific responsibility for the care, maintenance, or operation of *Wheelyboat 123*.

Figure 12: Roadford Lake Activity Centre maintenance system tasks

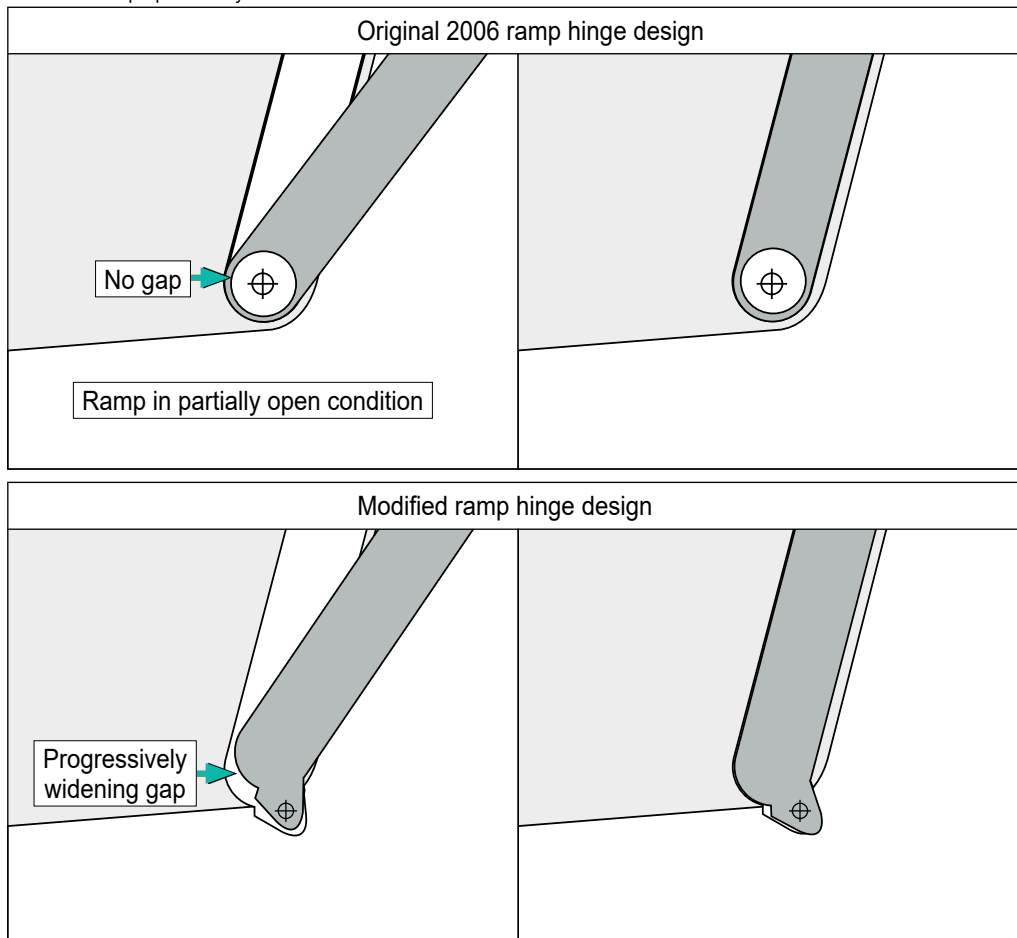
The original hinge arrangement kept the bottom edge of the bow ramp on a fixed axis of rotation, the modified hinge arrangement now allowed the bottom of the bow ramp to move away from the lower seal as the bow ramp was lowered (**Figure 14**). A transition plate was fitted to the bow door to cover the gap between the bow door and the deck of the boat when the bow ramp was lowered. The bow ramp seal liner was not replaced.

Figure 14: Modified hinge arrangement

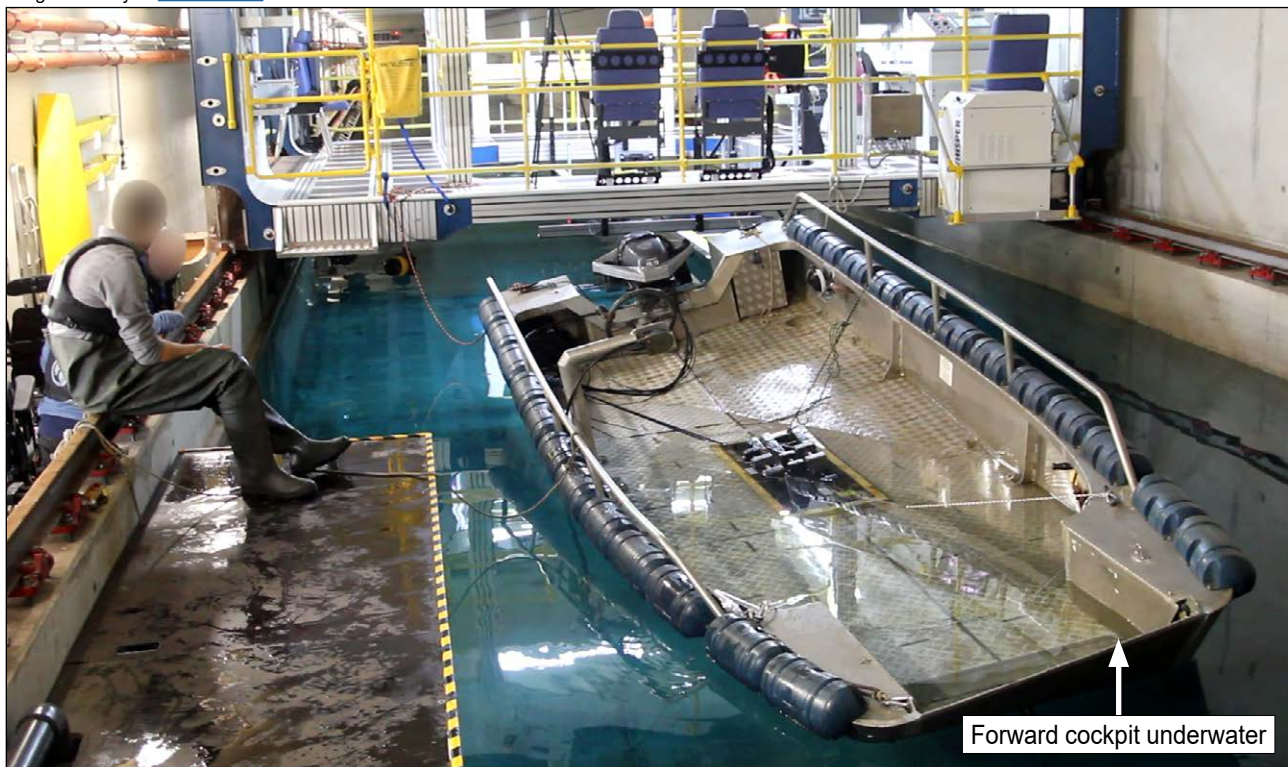
The offset load test was calculated numerically using the results from the lightship assessment. *Wheelyboat 123* failed the calculated offset load assessment because, when the heeling moment corresponding to a crew limit of eight people was applied, the stability model predicted that the vessel would heel to one side until the cockpit became swamped. *Wheelyboat 123* therefore did not comply with the ISO design category C stability and buoyancy requirement at the crew limit of eight people and in the condition at the time of the accident.

Figure 15: Swamp test at the Wolfson Unit

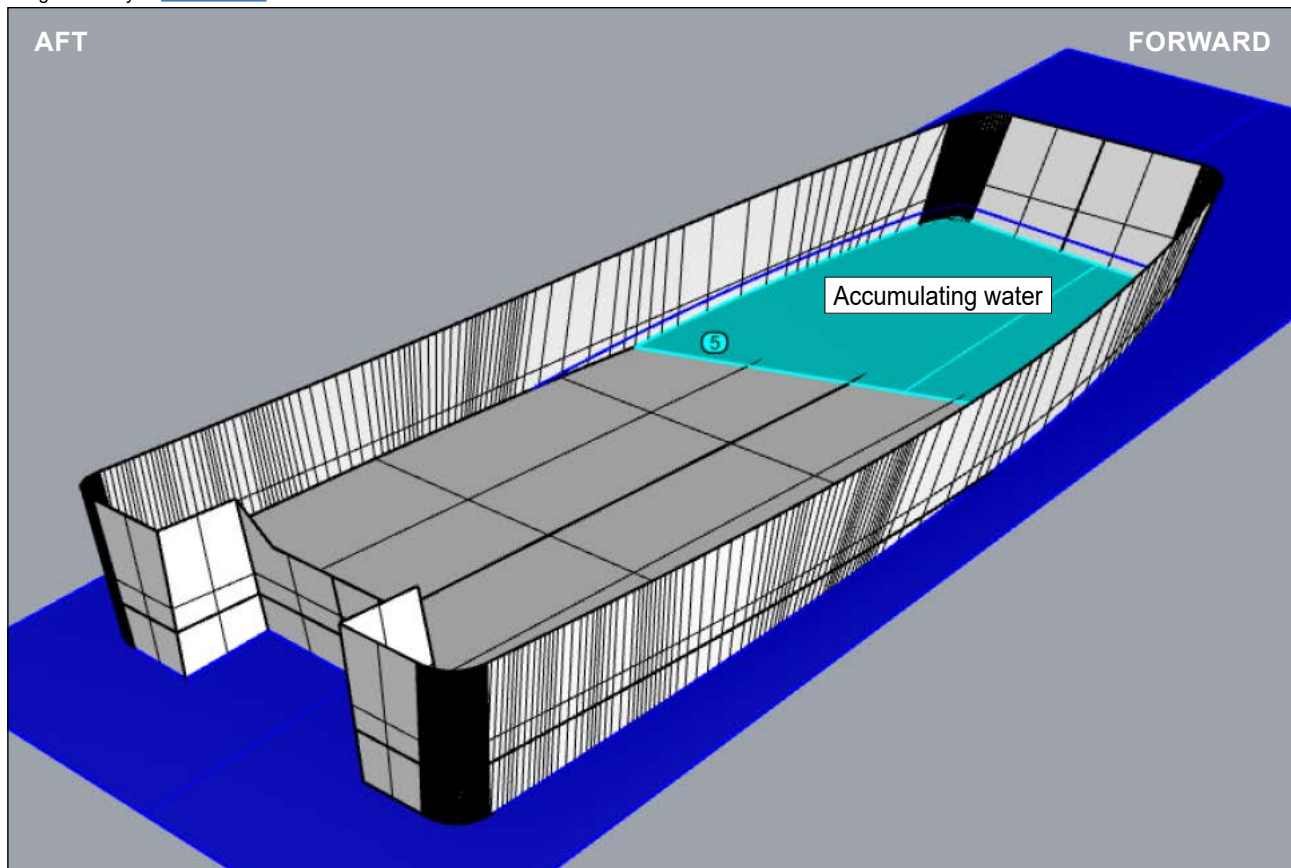
Figure 16: *Wheelyboat 123* in the as-modelled pre-capsize loading condition (Equilibrium waterline in blue)

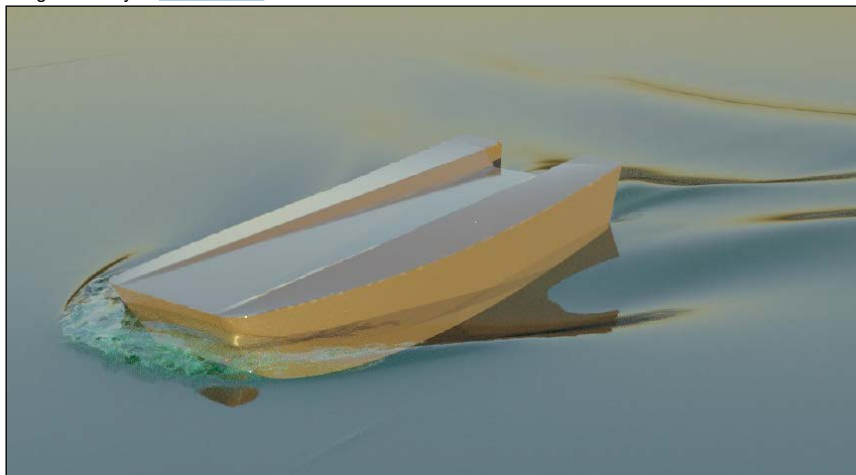
Figure 17: Computational fluid dynamics simulation of bow wave before capsize

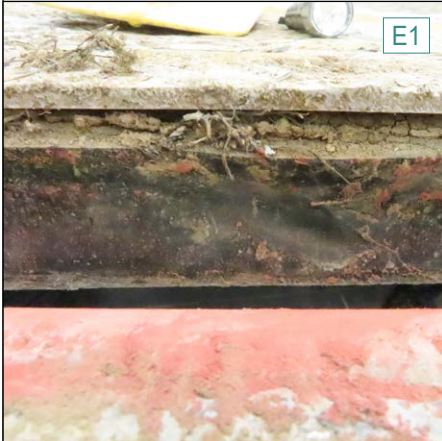
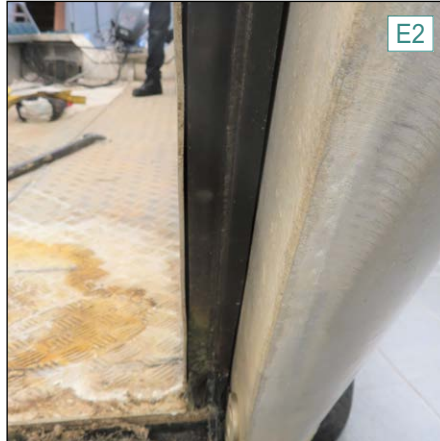
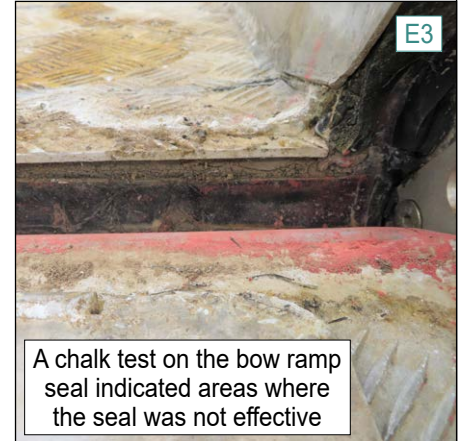
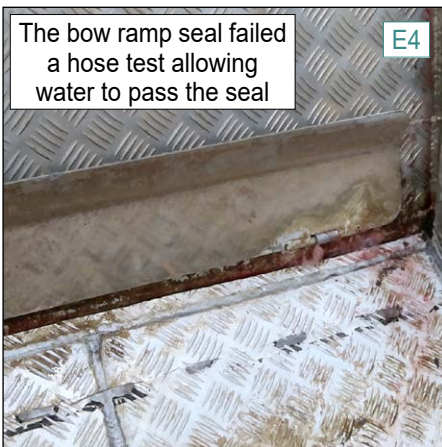
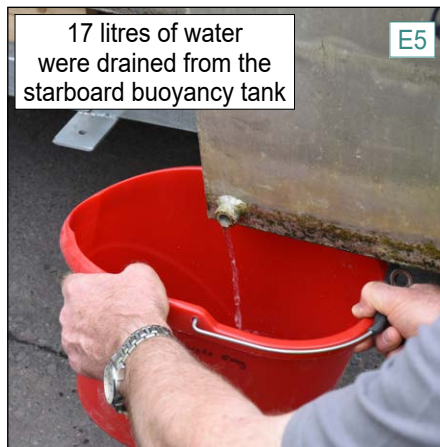
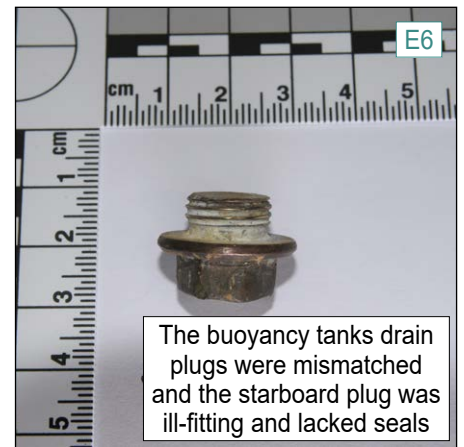
Bow ramp watertight seal was degraded and deformed with small amounts of debris embedded in the seal

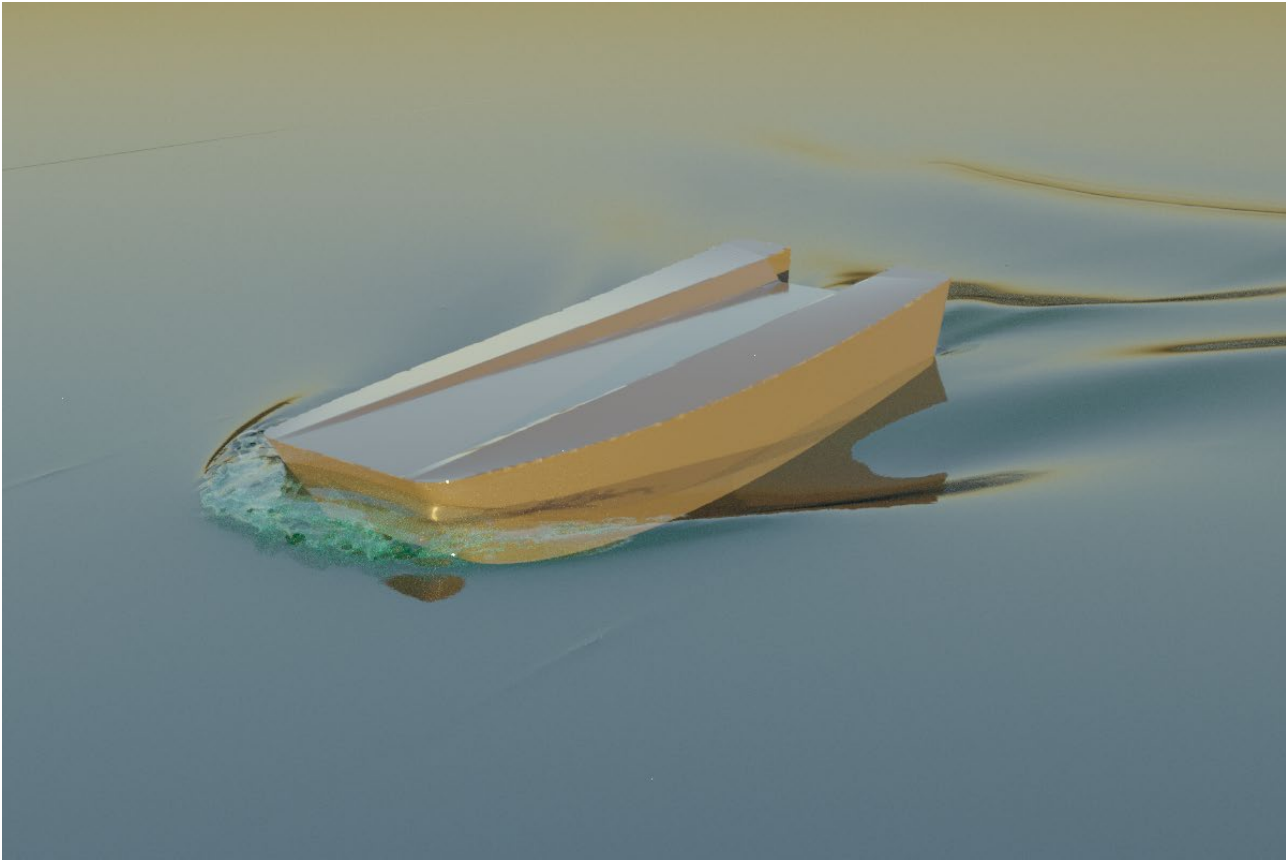
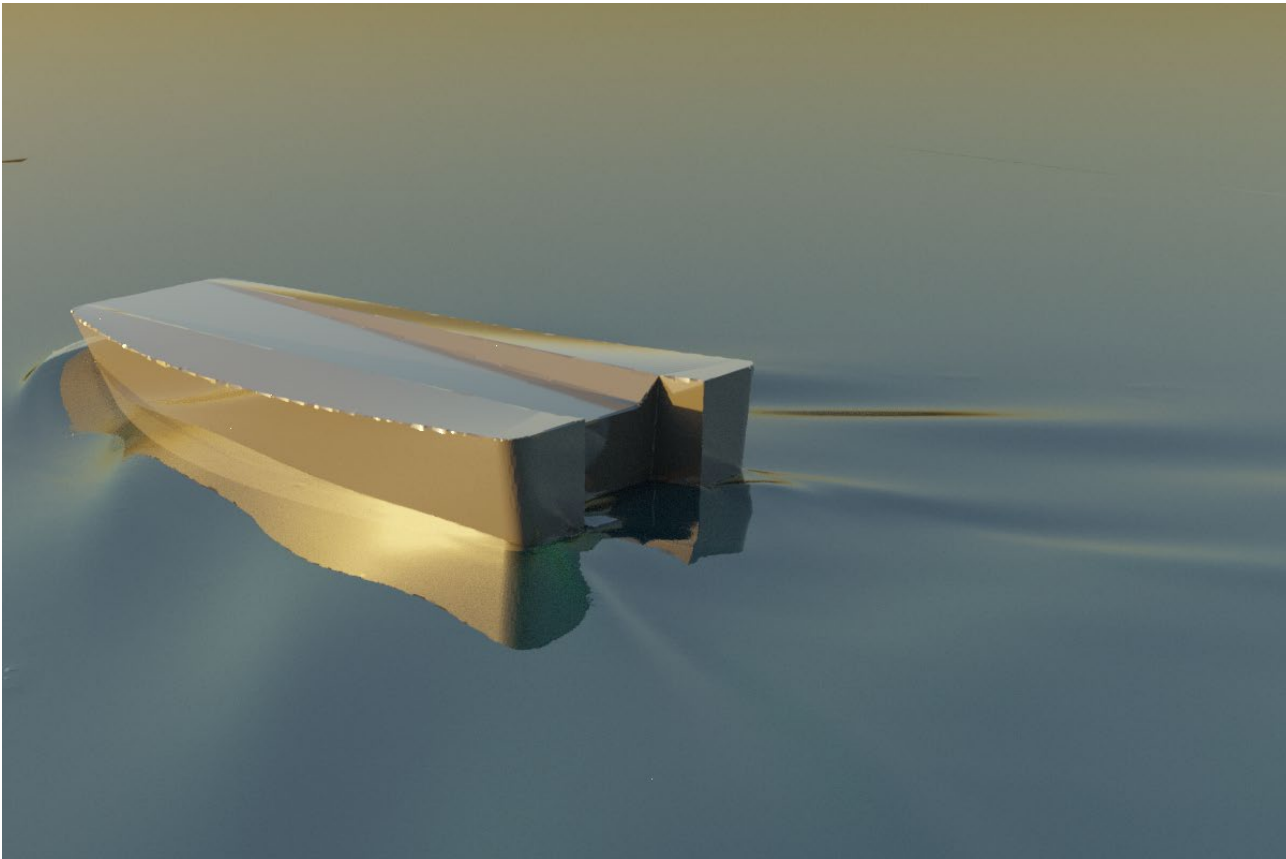
Figure 20 CFD predicted bow wave, loading condition: Pre-Turn #4, boat speed: 6 knots
2d slice through top of bow ramp seal, 475mm to port of vessel's centreline
