Report on the investigation of  
the capsizing and sinking of the tug

***Biter***

***Hebridean Princess***

off Greenock, Scotland  
on 24 February 2023

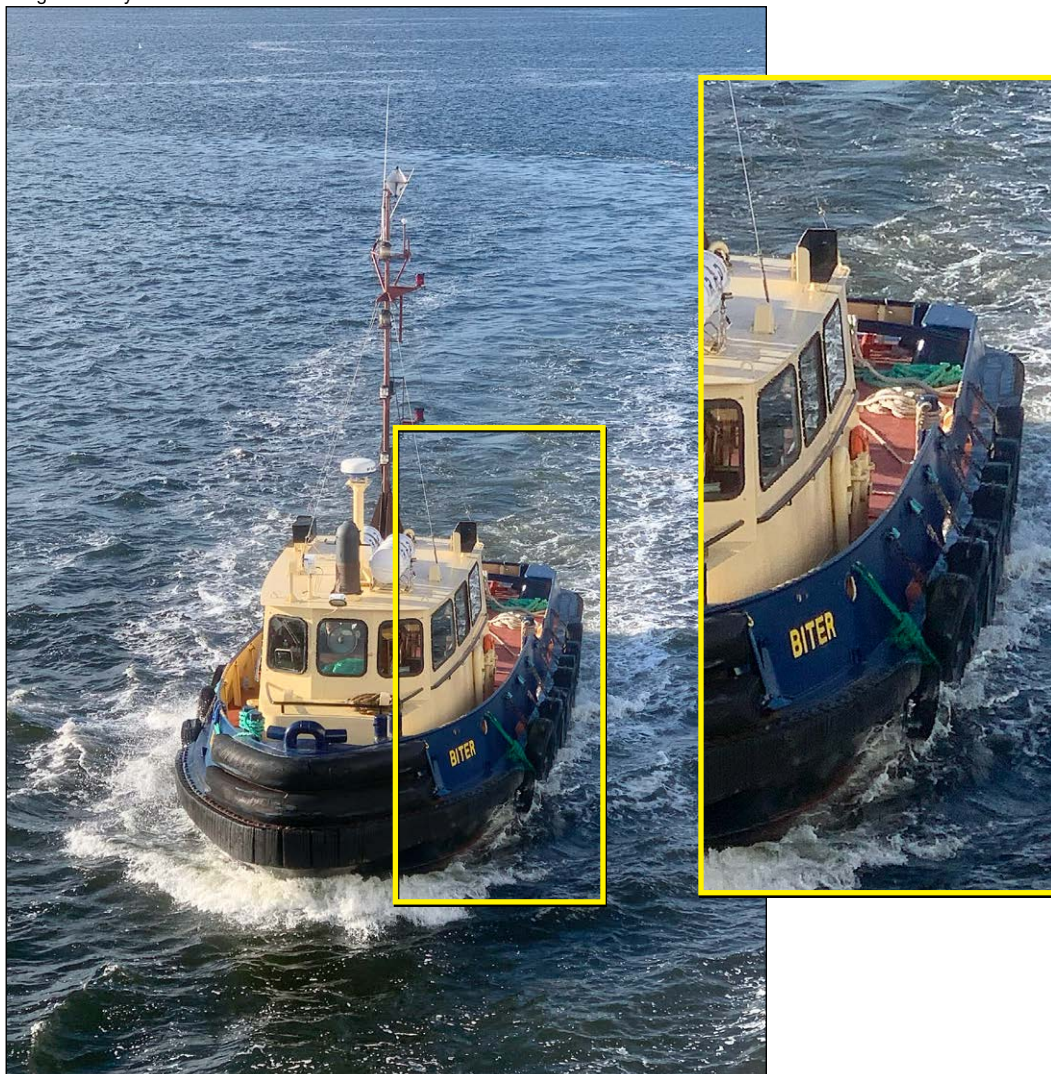
**Figure 4:** *Biter* running alongside *Hebridean Princess's* starboard quarter, before the lines were passed, showing the tug's gob rope secured to the port side samson post

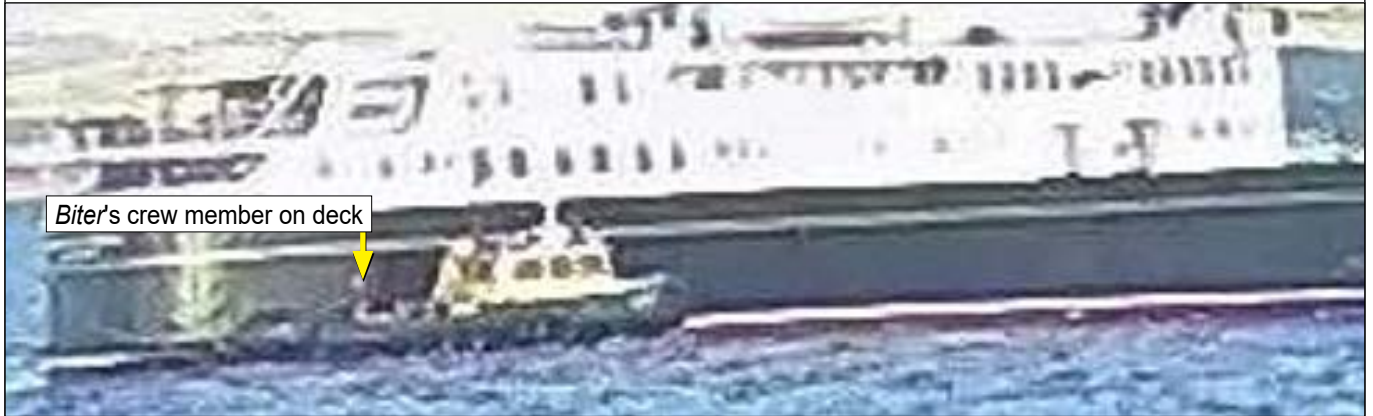
*Biter* turns to starboard and peels away from *Hebridean Princess's* starboard side at 1526:40

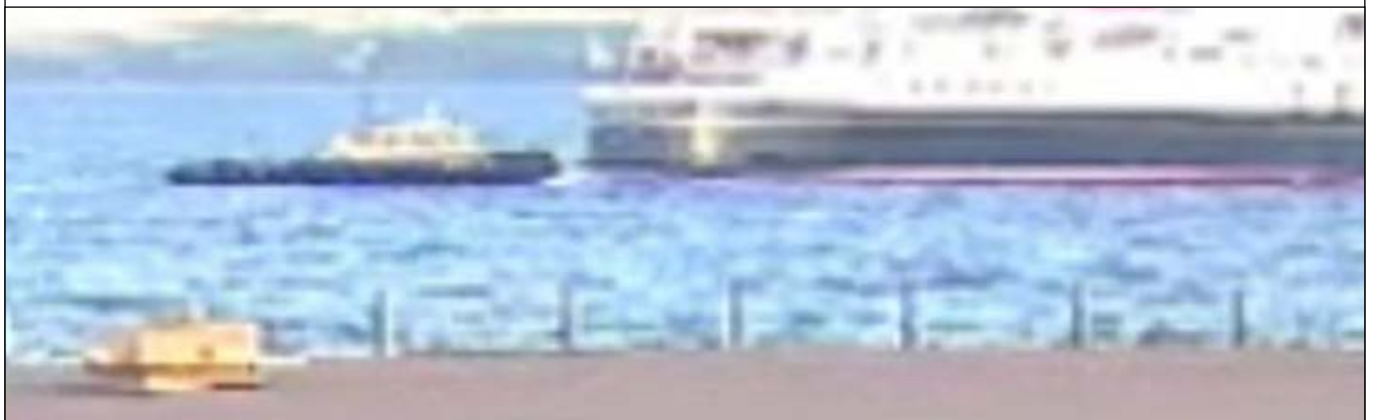
*Biter's* bridle attached to the starboard side of *Hebridean Princess* becomes taut and the tug's turn stops at 1526:58

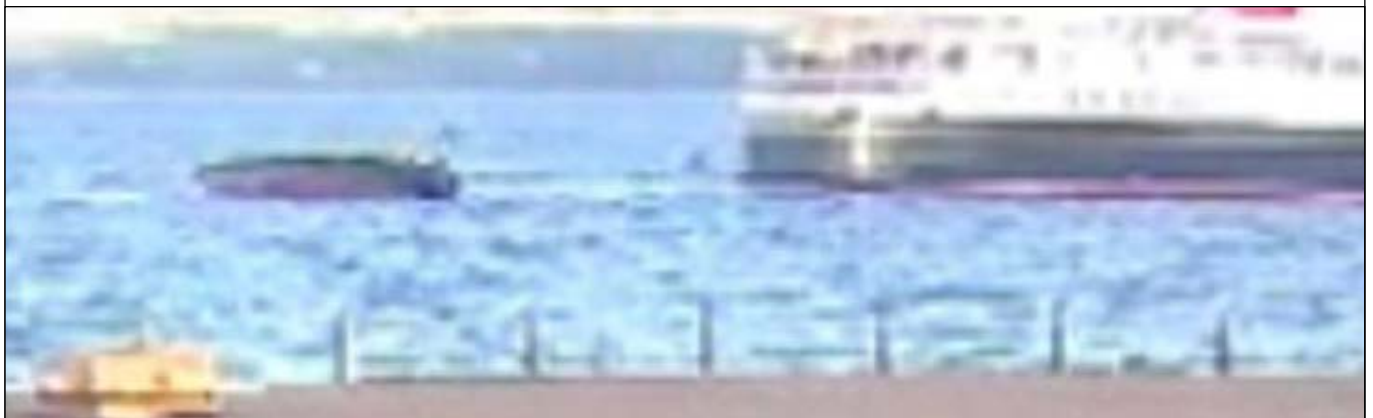
*Biter* is pulled sideways by the bridle and heels to port at 1527:01

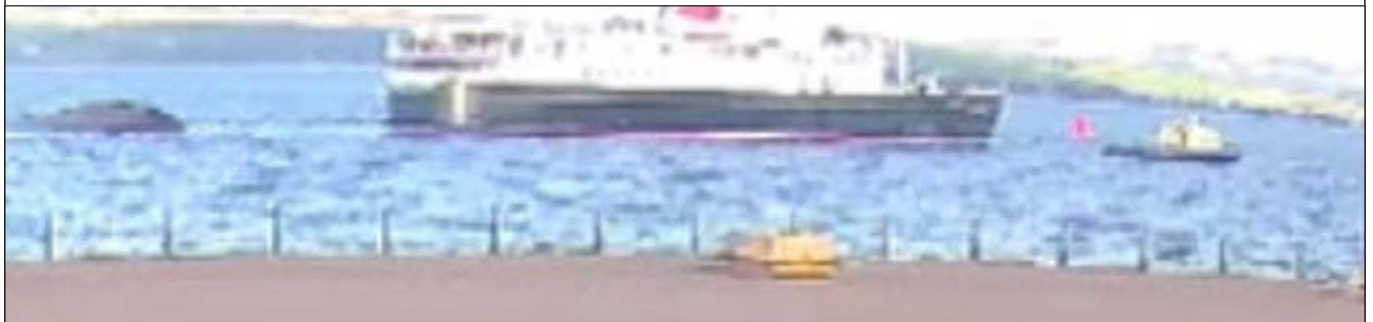
*Hebridean Princess's* aft mooring party saw that *Biter* was heeling to port and that water was coming over the tug's port bulwark. They also noted that the tug's deckhand was standing just outside the open wheelhouse door. At 1527:08, *Biter* capsized (**Figure 6**).

*Biter* capsizes at 1527:08

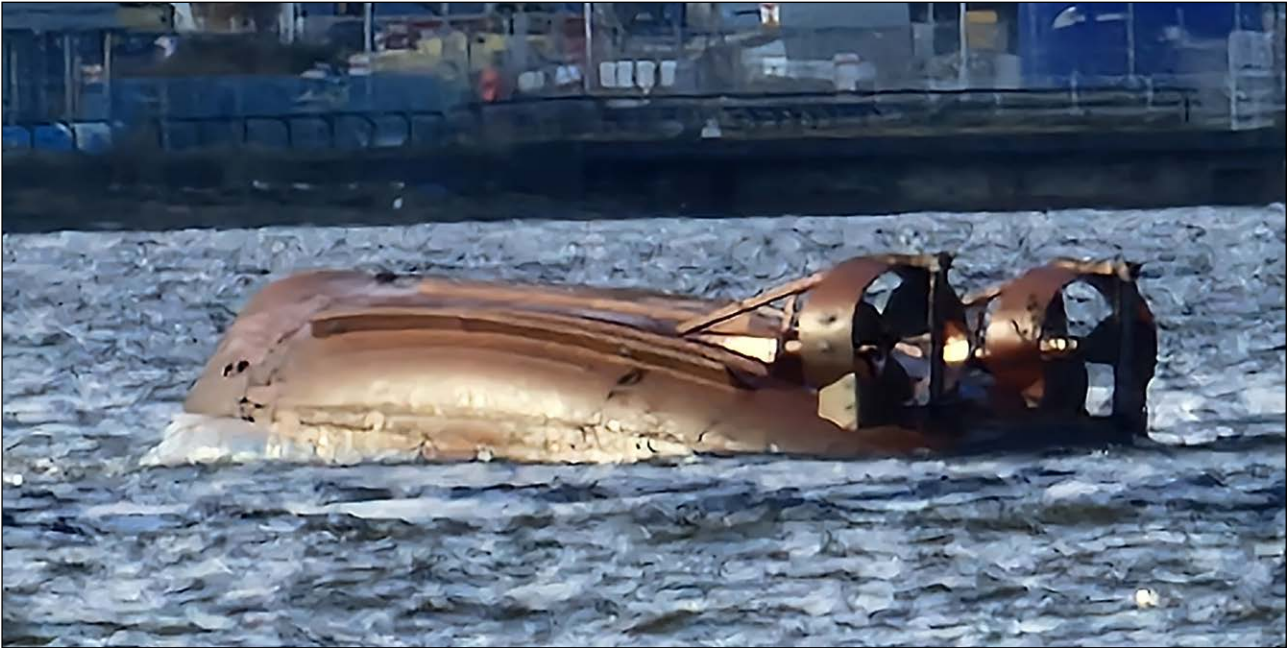
**Figure 6:** *Biter* capsized with its rudders set at approximately 30° to starboard

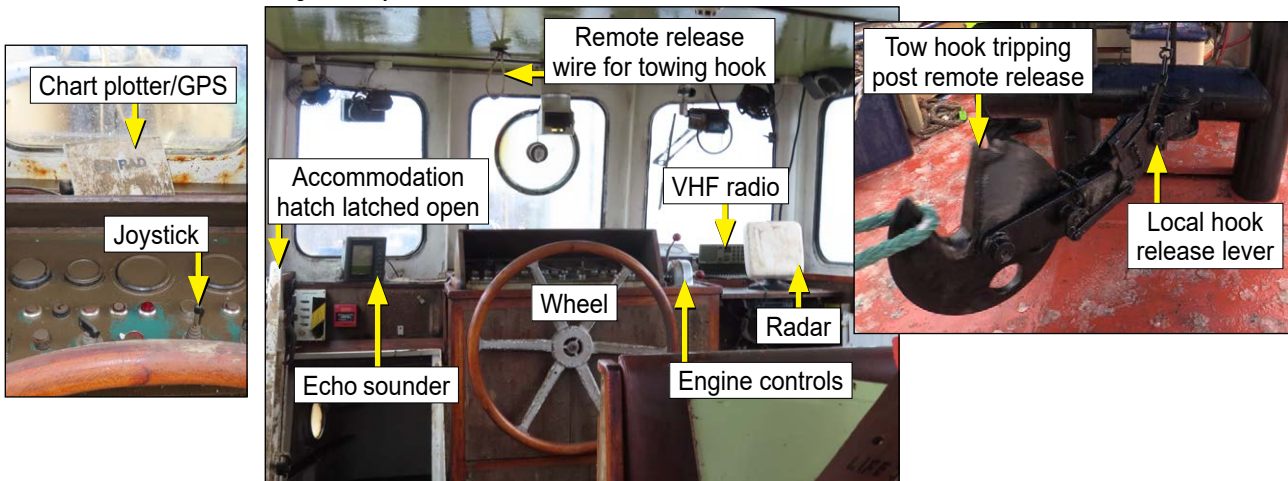
**Figure 8:** *Biter's* wheelhouse and tow hook post-salvage

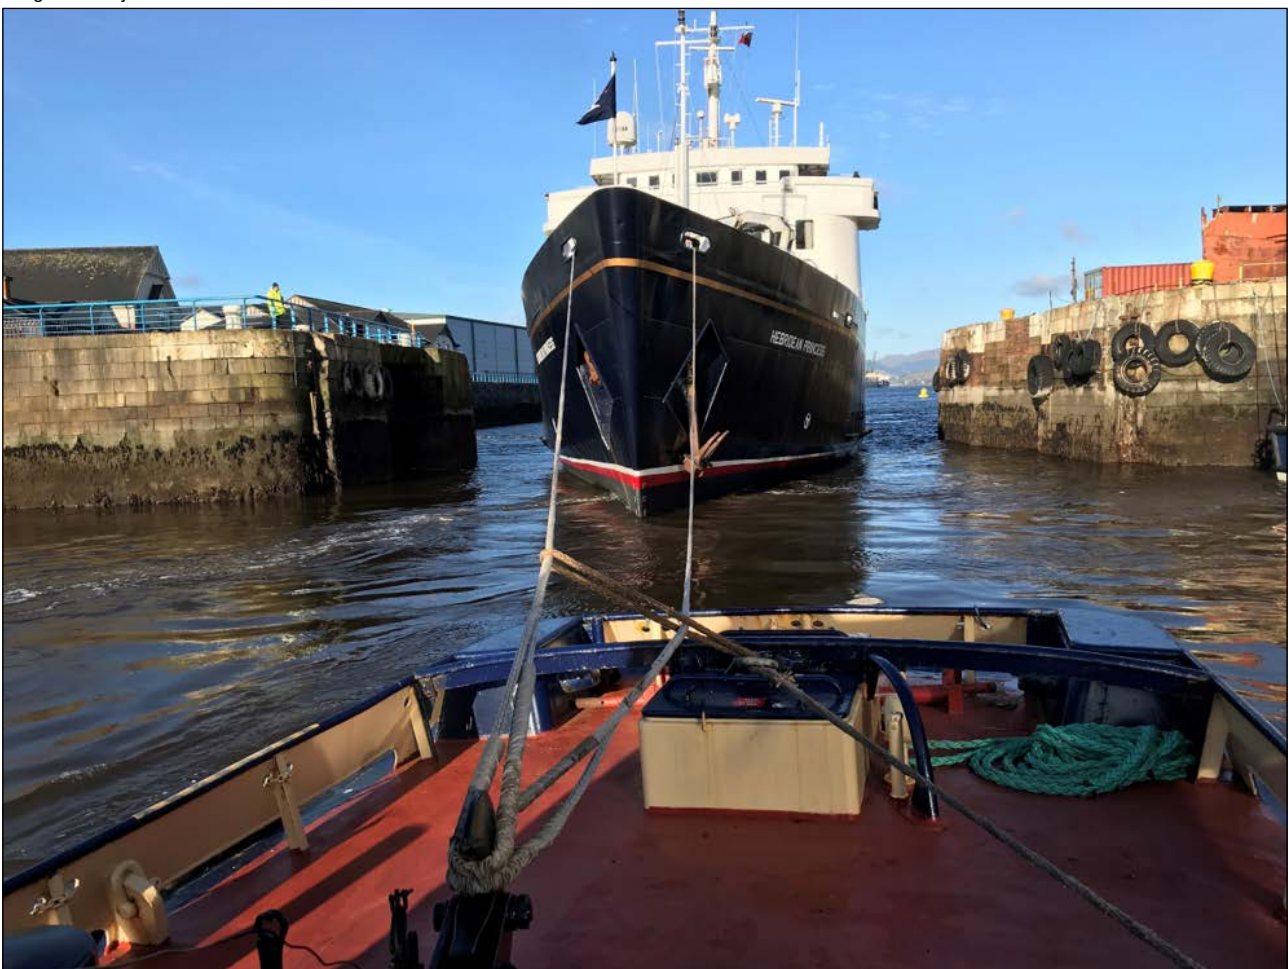
Photographs of *Biter* in operation indicate that the preferred option for securing the gob rope was for it to be turned up four or five times around the port side samson post before locking turns were placed on the post's two stag horns. The gob rope could be manually loosened or tightened when secured around the samson post; when secured using figure of eights around the towing hook frame the increased friction made the arrangement more secure and harder to adjust. There had been no reported issues with the securing arrangements for the gob rope in CMS's conventional tugs and these methods of securing the gob rope had been in use for many years and were decided on by the tug master. In common with other tug operators, neither method of securing the gob rope had been formally tested or evaluated. Further, neither method allowed the gob rope to be adjusted when the towline or bridle was under tension.

**Figure 13:** *Biter*'s gob rope while assisting *Hebridean Princess* to leave James Watt Dock on the morning of 24 February 2023

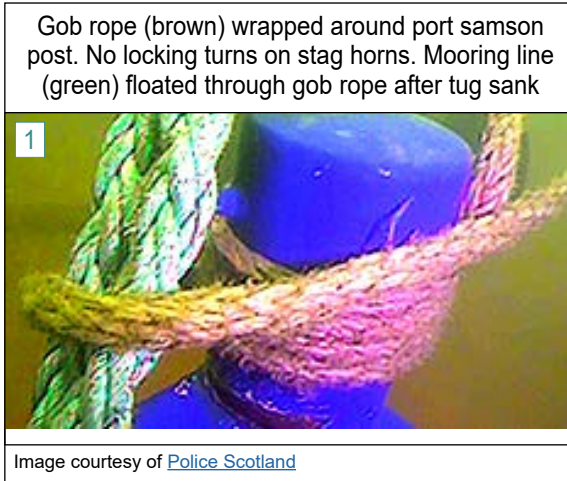
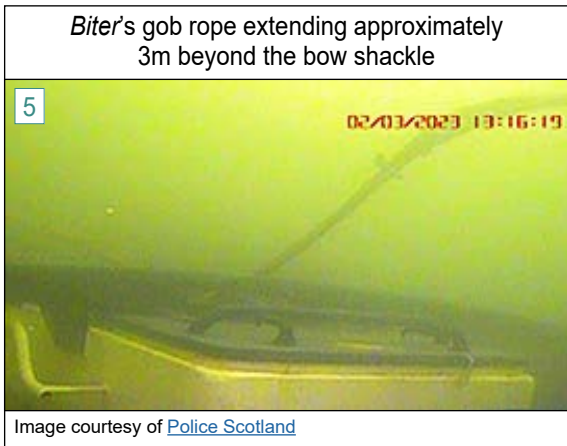
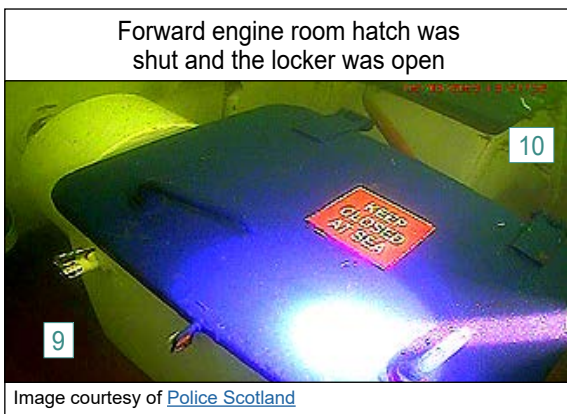
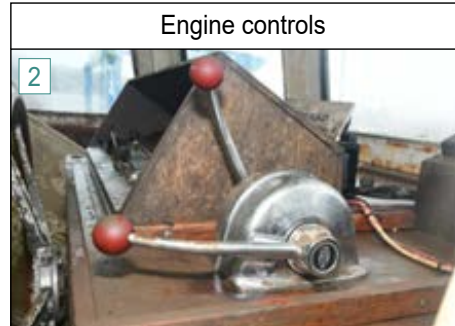
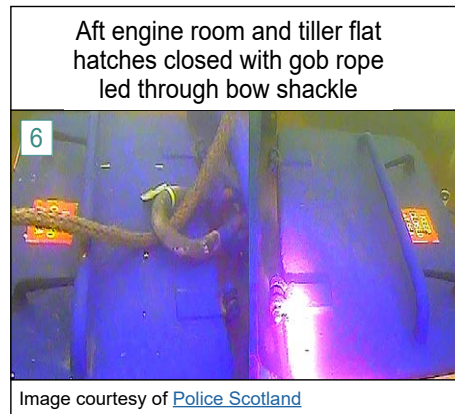
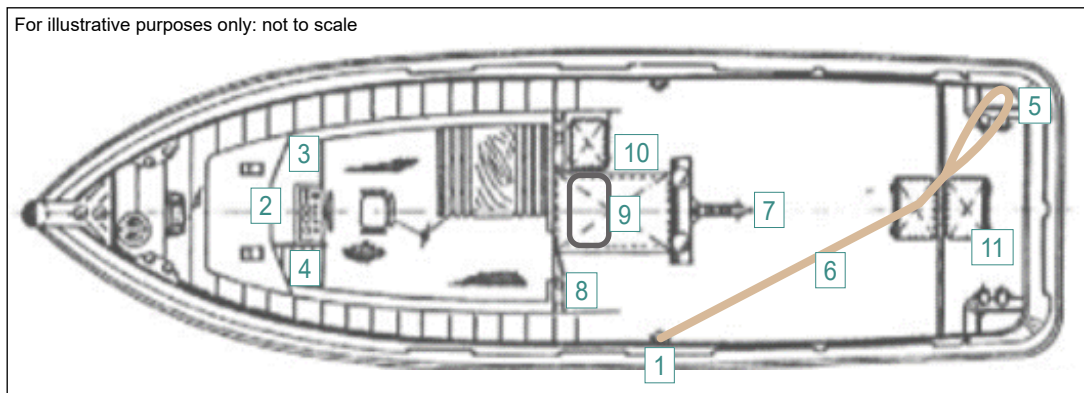
Figure 16: Biter post-accident inspection

*Biter* was inspected ashore after its salvage. The post-salvage inspection and photographs taken after the accident and during a Police Scotland dive inspection on 2 March 2023 resulted in the following observations (**Figure 16**):

- *Biter's* wooden external wheelhouse door was missing and the internal hatch between the wheelhouse and accommodation space was open. All other compartment doors and hatches were shut.
- Only one side of some of the doors and hatches was marked with *KEEP CLOSED AT SEA*. This warning sign was therefore obscured when the hatch between the wheelhouse and accommodation space was open.
- The chart plotter/GPS and radar displays in the wheelhouse were covered.

- The tow hook had not been released. When the tow hook was tested post-salvage, the local release mechanism at the hook and the emergency release wire located in the wheelhouse operated correctly.

- During the dive survey the gob line was seen to be wrapped around the port samson post and had been led aft through a bow shackle mounted between the engine room and aft peak hatches. There were no locking turns on the samson post. Close inspection of the gob line after salvage found that 2.58m of the 25m rope had been melted and fused. The location of the fused area was coincident with the section of the rope that would have been wrapped around the samson post.

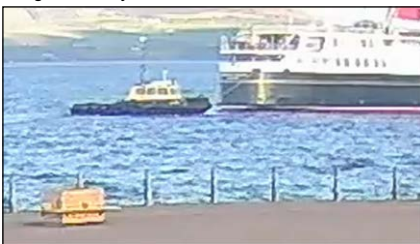
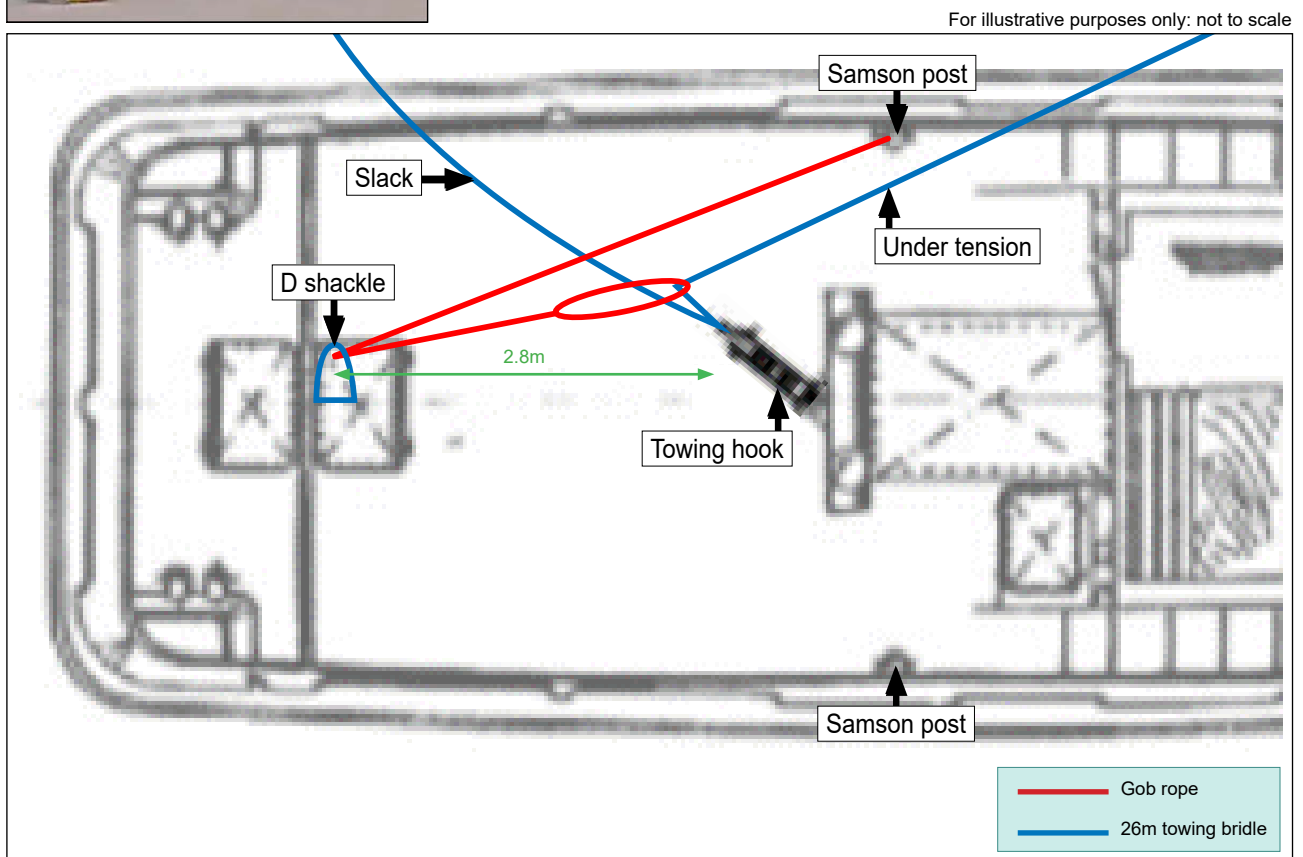
*Hebridean Princess's* speed exceeded the port's guidelines and led to a significant load being placed on *Biter's* gob rope and latterly onto its securing arrangements, almost certainly contributing to the subsequent rendering.

**Figure 19:** Illustration of the load on the towing bridle being transferred to *Biter's* gob rope
