**SERIOUS INCIDENT**

| <b>Aircraft Type and Registration:</b> | 1) Boeing 737-8AS, EI-DPC<br>2) Boeing 737-8Z9, G-GDFR<br>3) Boeing 757-28A, G-OOBA |
| <b>Date &amp; Time (UTC):</b> | 8 September 2020 at 2227 hrs |
| <b>Location:</b> | Birmingham Airport |

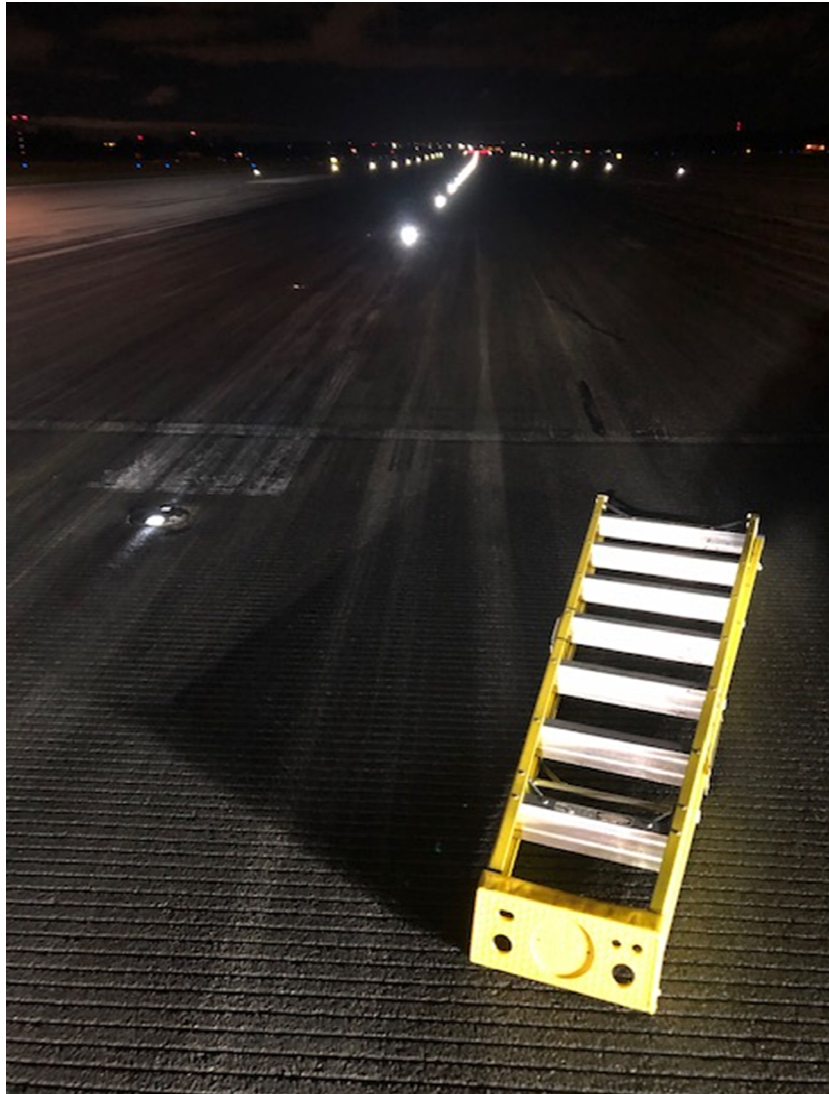
**Figure 1**

ATC ordered a runway inspection, which found a 7 ft A-frame step ladder on the runway.

View up Runway 33 with the ladder in the approximate position it was found

Figure 1 shows the position of the ladder as found on the runway. The ladder was removed from the runway by the ASU personnel before being collected by the technicians. The ladder was positioned to the right of the centreline of the runway in use (Runway 33) laying almost parallel with the centreline. It was lying beside touch down zone markings which are 550 m from the runway threshold and 150 m beyond the aiming point markings.

The first two aircraft that landed whilst the ladder was on the runway were Boeing 737-800 (B737). The third aircraft was a Boeing 757-200 (B757). There was no evidence that any of the aircraft had contacted the ladder whilst it was on the runway. The B737 has a smaller distance between its nosewheels and mainwheels. Assuming that the aircraft all landed with their nosewheels astride the centreline of the runway, and using landing gear dimensional data from the B737, this means the ladder was between 0.2 m and 2.29 m from that line.

With landing speeds in excess of 120 kt, an aircraft hitting an object such as the ladder may have resulted in substantial damage. In this case, taking the position of the ladder on the runway into account, and the main and nose landing gear track width, all three aircraft narrowly missed the ladder.

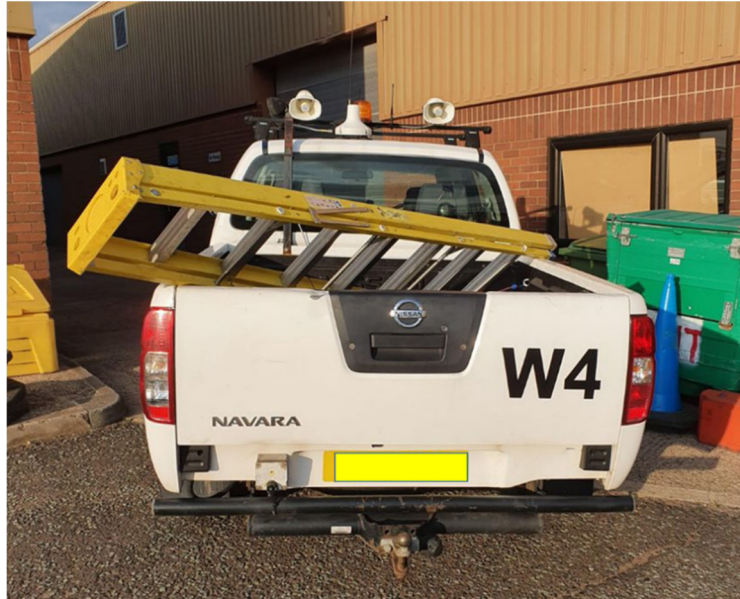
**Figure 4**  
Ladder loaded onto WV4

In preparation for the work on the approach light the stepladder was put into the load bay of WV4 and the elastic bungee strap used to secure it in place. Figures 4 and 5 show how the ladder was positioned and held in the load bay.

There were two reasons why the technicians selected WV4 rather than the apparently more suitable WV3 and WV10. Firstly, reliability was a cause for concern amongst the staff with WV3. Secondly, the inconvenience of tools and equipment falling out of WV10 when its doors were opened. WV4 would have been suitable providing the ladder had been held in the rear of the vehicle securely. However, this depended on how the ladder was positioned and secured in the load area. The choice of restraint was therefore significant.

- Working Instruction WI-EE-ES-AE-104 issued. Use of WV4. The load area must be kept sterile and clear of materials and tooling to avoid any FOD. Any exceptions to this must be pre-authorised by the Airfield Engineering Supervisor or Senior Airfield Technicians via email. Confirmation should be gained before proceeding with any use.
- Implement an airport vehicle management procedure for all users to include a vehicle FOD inspection procedure.
- Undertake a suitability assessment of all engineering services vehicles used to undertake tasks on the runway and manoeuvring area.

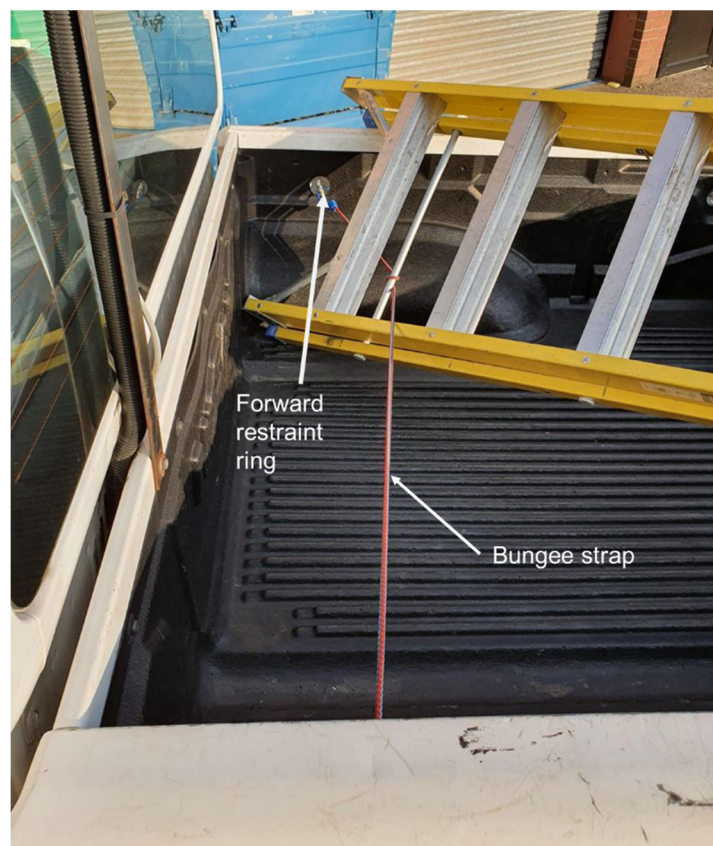
**Figure 5**  
Ladder restraint method in WV4  
(Picture taken after the event and reconstructed by one of the technicians)

At first sight the bungee may have seemed suitable to secure the ladder in WV4. However, when the actual method used was demonstrated, it could be seen why the bungee was unsuitable. The bungee had been stretched almost to its limits around a strut on the ladder and hooked to the right and left forward fixed rings in the load bay side panels (Figure 5). When the vehicle is stationary or moving slowly the method used would keep the ladder in place. Any gentle acceleration or moderate cornering would cause the ladder to move, and the remaining elasticity in the bungee would have provided sufficient restraint.

It is likely that as WV4 accelerated, having passed the aiming point markings, the ladder was caused to move more rapidly, and its inertia resulted in a 'snatch' load on the bungee when it reached the limit of elasticity. At this point, the snatch load would have been transferred into the wire hooks fitted to the ends of the bungee. In this case one of the hooks opened out (Figure 7) making it less effective in the restraint ring. As a result it most likely unhooked, rapidly sprang back, and unravelled itself from the ladder strut. This left the now unrestrained ladder to topple rearwards from WV4. As it fell out and contacted the runway it slid a short distance before coming to a stop causing the abrasion to the edges of the plastic at the top of the ladder (Figure 6).

During examination of WV4 and the ladder, a safer method of carrying the ladder was demonstrated. The ladder was placed upright in the load area angled forward, leaning against a vertical frame attached to the roof bars with its feet against the base of the tailgate. The frame was ideally placed to fix the ladder in place with a ratchet strap.

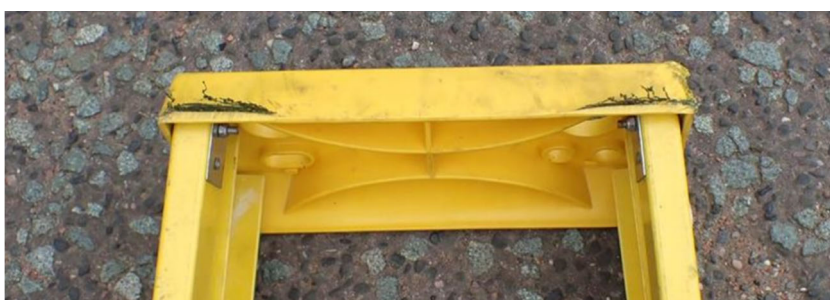
**Figure 6**

The ladder was recovered from the runway by the airport operations staff. Later examination of the ladder found minor scuff damage on the corner edges of the combined step and hinge plate. A small amount of material towards the edge of the scuff marks had been frayed and discoloured with a grey-black appearance (Figure 6). The bungee was examined, and this was in good condition except for the opening out of one of its hooks (Figure 7).

Scuff damage to the top of the ladder

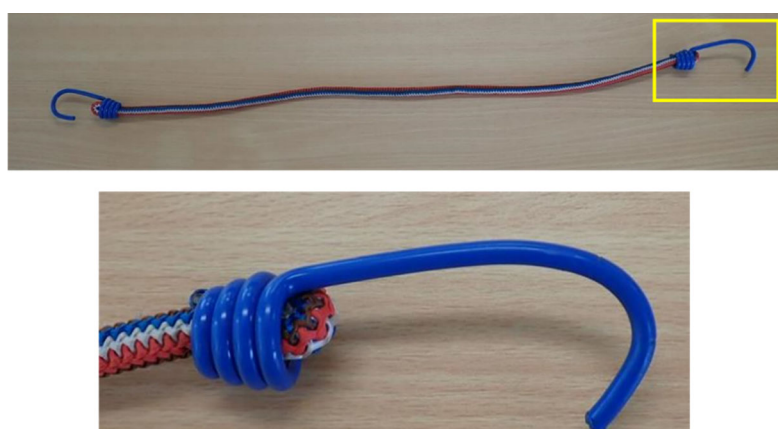
**Figure 7**

Bungee strap and damage to hook

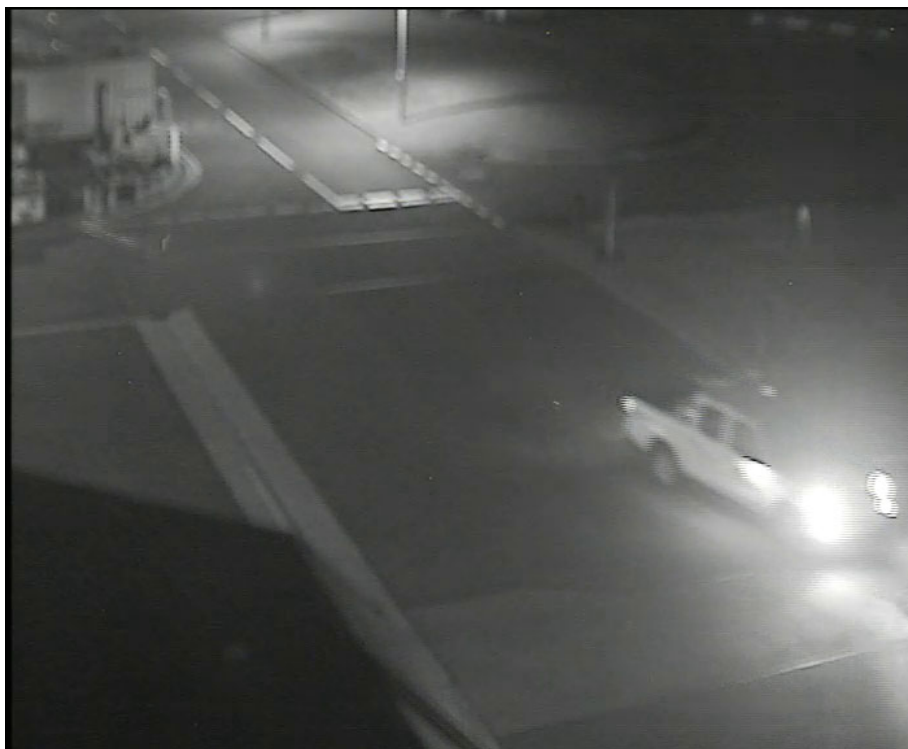
**Figure 8**

WV4 passing the fire station at 2133 hrs

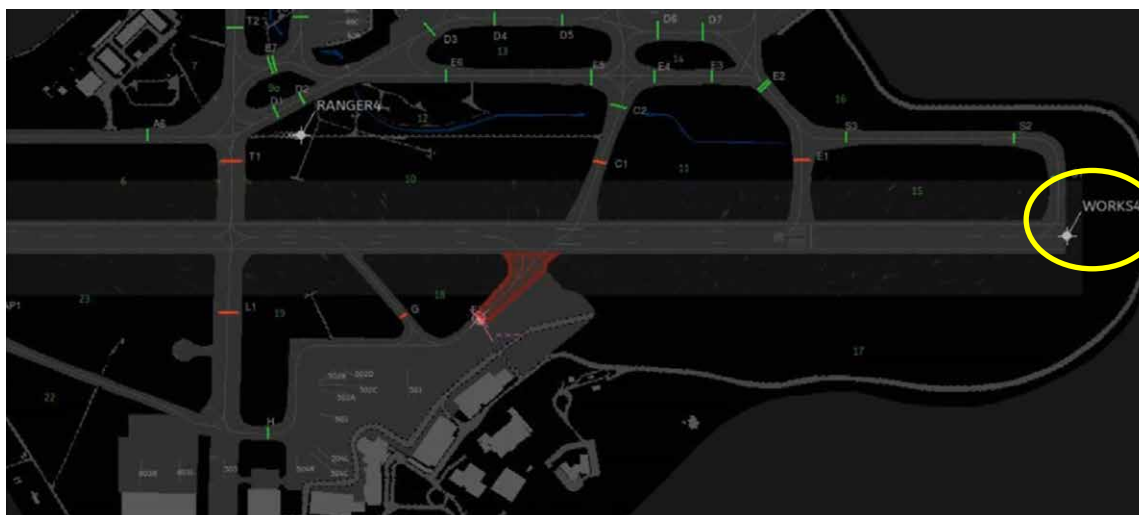
**Figure 9**

WV4 at the beginning of Runway 33

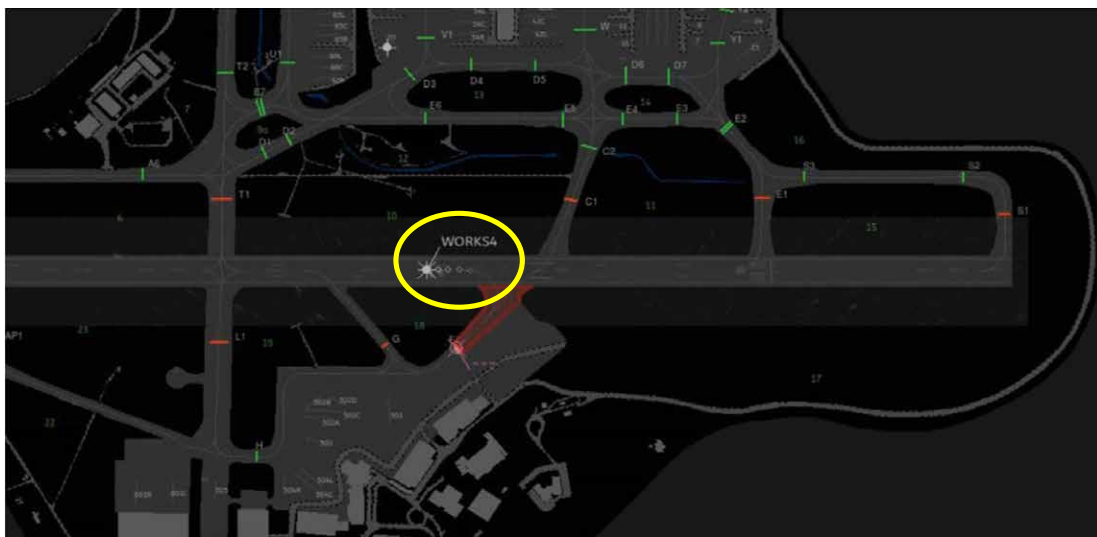
**Figure 10**

WV4 at the location where the ladder was found

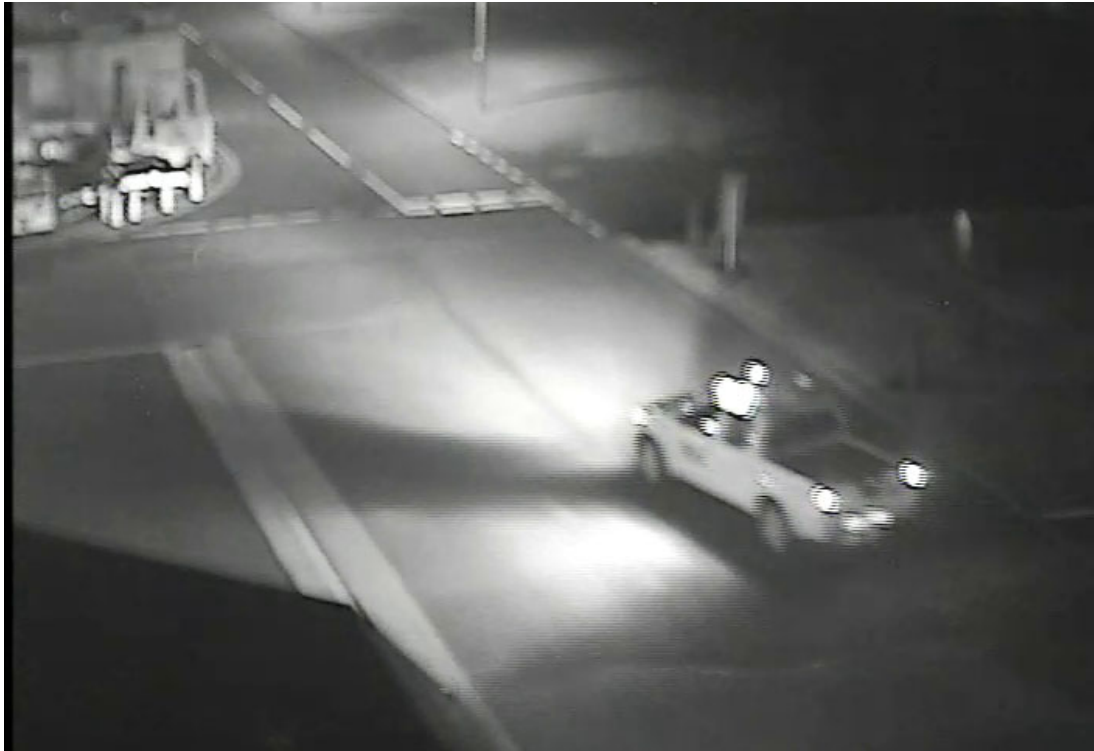
**Figure 12**

At 2218 hrs Technician 1 was informed by ATC that the first inbound aircraft was 20 nm from touchdown. This was acknowledged by Technician 1, and Technician 2 got back into the vehicle before they vacated the runway via Taxiway B. The vehicle again passed the fire station at 2220 hrs as shown at Figure 12. Note, the tailgate of the truck is up, and the ladder is not present.

WV4 passing the fire station at 2220 hrs

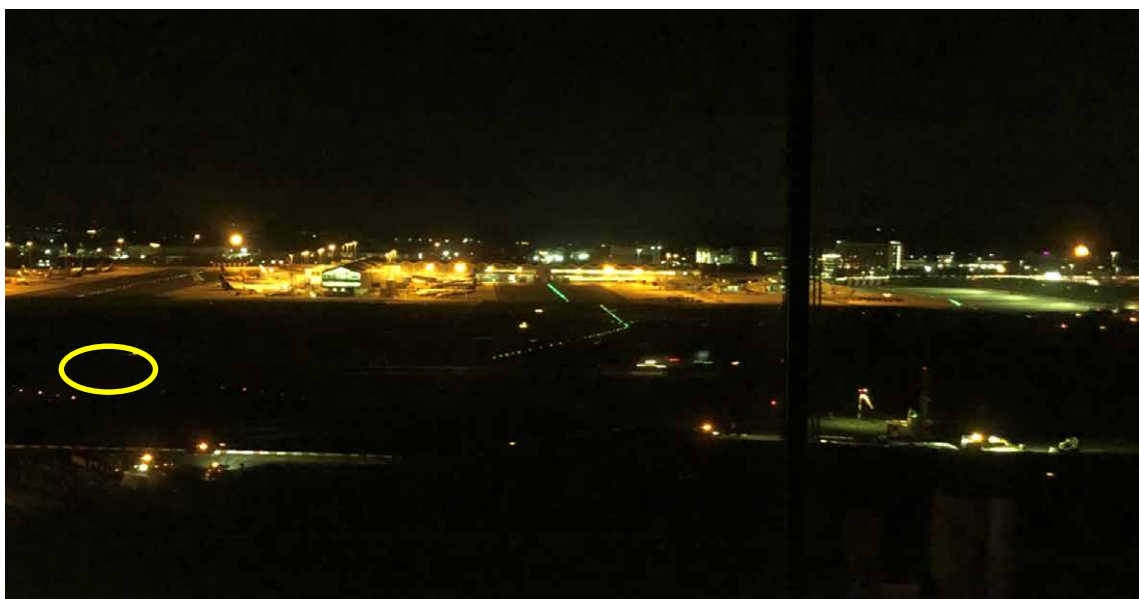
**Figure 13**

The visual control tower has a view of the whole manoeuvring area of the airport. At night this view is restricted simply because large parts of the airport, including the runway, are not illuminated by overhead lighting. Figure 13 shows the view from the visual control tower at night. It is clear from the picture that it was not possible for the tower controller to either see the ladder coming off WV4 or to spot it laying on the runway. The approximate area where the ladder was found is highlighted.

View from the visual control tower at night with the approximate area where the ladder was found highlighted
