## Grounding and subsequent loss of the fishing vessel *Ocean Maid* (BA 55) on Cairnbulg Point, Aberdeenshire, Scotland on 24 October 2022

### SUMMARY

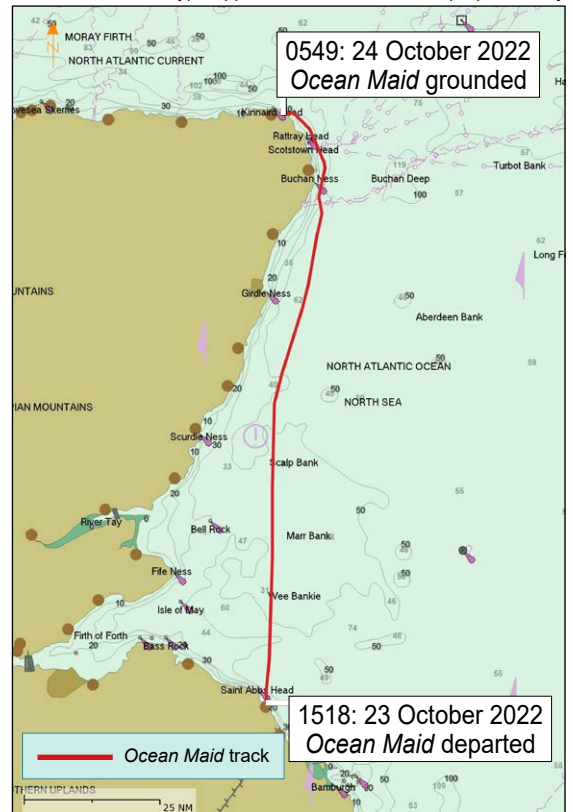
**Figure 1:** *Ocean Maid*'s route before it grounded near Fraserburgh

At 1518 on 23 October 2022, the fishing vessel *Ocean Maid* left Eyemouth, Berwickshire, Scotland to make the overnight passage to a shipyard in Fraserburgh, Aberdeenshire, Scotland for planned vessel maintenance and minor repairs (**Figure 1**). On board were the skipper/co-owner (the skipper), the skipper's father, who co-owned the vessel (the co-owner) and two crew members – a watchkeeper and deckhand. The visibility was poor and, as it was dark and foggy, the co-owner took the first navigational watch alone in the wheelhouse. Once clear of Eyemouth Harbour, the skipper and crew watched television in the accommodation area two decks below the wheelhouse until 2100, after which the watchkeeper and deckhand went to their bunks to rest.

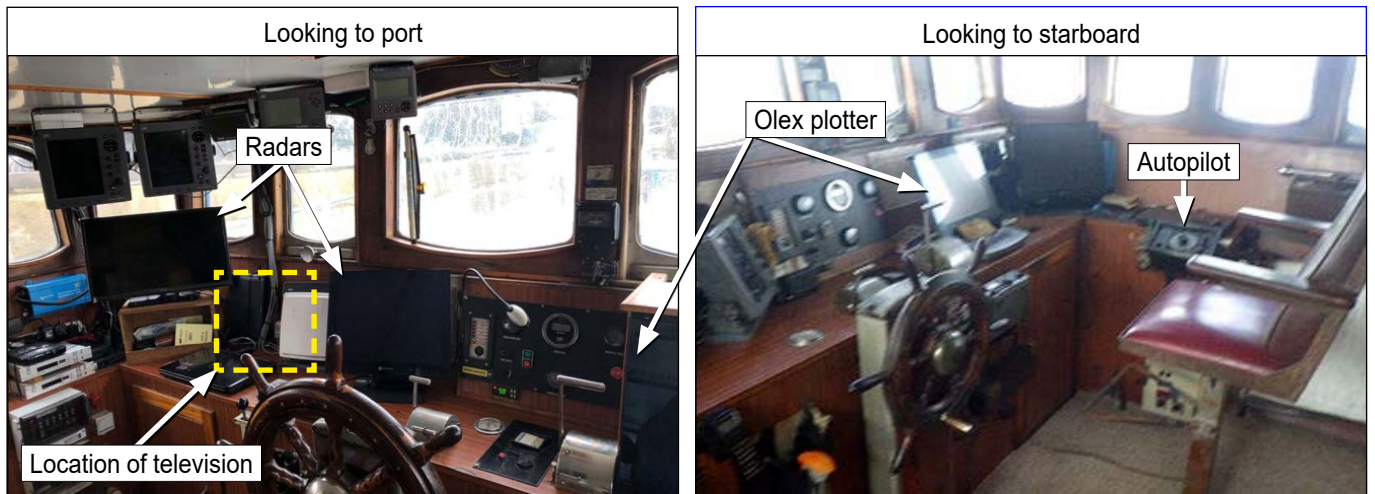
**Figure 2:** Wheelhouse equipment

The navigation equipment in the wheelhouse included one Sodena chart plotter, two Olex chart plotters, two radars (one was broken at the time of the accident) and one Navitron watch alarm connected to the autopilot. The instruments in operation were set to night mode during the transit to Fraserburgh. It was reported that the watch alarm had a 3-minute dormant period, after which a pre-alarm buzzer warning would sound in the wheelhouse. If not reset within 30 seconds, an alarm would then sound in the galley and accommodation. The reset button could be reached from the wheelhouse chair. The wheelhouse was also equipped with a television. At the time of the accident this was tuned to a music channel. No issues were raised during certification with respect to wheelhouse visibility.

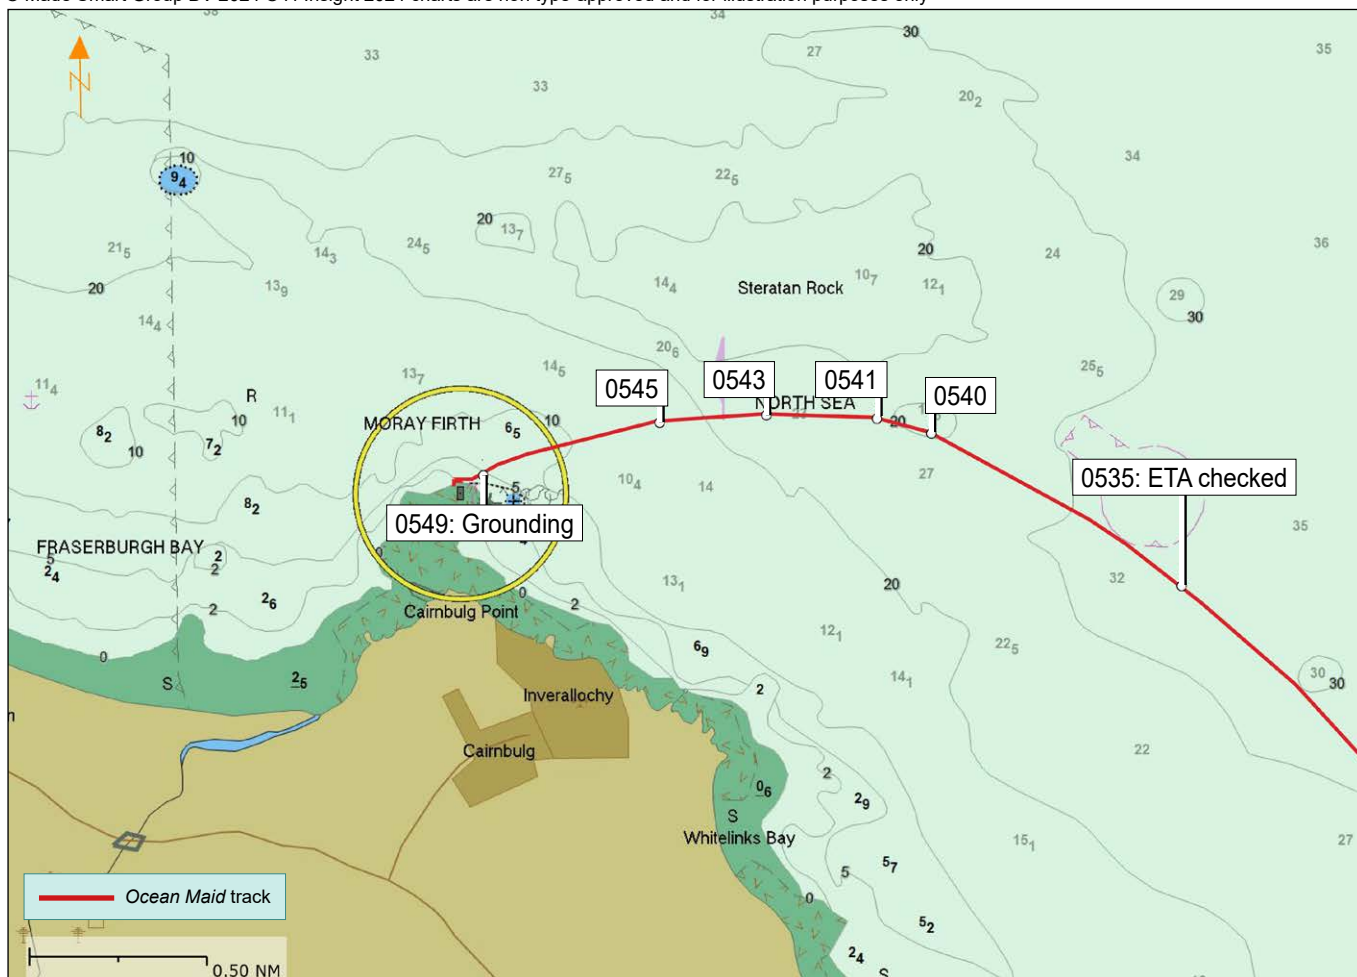
**Figure 3:** Chart showing the four course alterations leading up to the grounding

At about 0539, the watchkeeper returned to the wheelhouse and reset the watch alarm, which had just started to sound. At 0540, the watchkeeper made an alteration of course<sup>2</sup> to 285° to intercept a track indicated by a yellow line on the Sodena electronic chart plotter showing the route into Fraserburgh. The watchkeeper then made three more course alterations: to 271° at 0541; to 265° at 0543; and to 260° at 0545 (**Figure 3**). The watchkeeper did not recall making the four alterations or checking the vessel's position after 0540. At about 0545, the watchkeeper returned to the galley to finish making the tea and called down into the accommodation to wake the rest of the crew.

At 0549, as the watchkeeper returned to the wheelhouse, a loud bump was heard as the vessel started to go aground on Cairnbulg Point at a speed of 8kts.

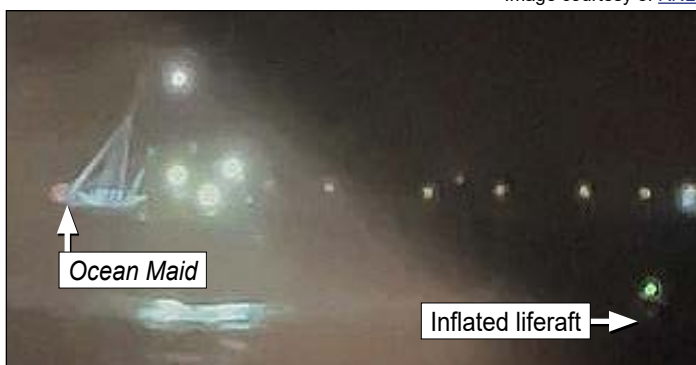
**Figure 4:** RNLI video still, showing the position of the liferaft just before rescue

At 0605, the RNLI ALB departed Fraserburgh. A few minutes later, *Ocean Maid*’s skipper embarked the liferaft and the crew pushed it away from the vessel’s side. *Ocean Maid* was still rolling violently and the crew were increasingly concerned that the vessel would strike them as the liferaft was still attached to the vessel but drifting on its painter towards the western side of Cairnbulg Point (**Figure 4**).

At 0612, the ALB arrived at Cairnbulg Point and located the liferaft. The proximity of the liferaft to the rocks prevented the ALB from reaching it and so the RNLI crew launched the XP boat. The ALB coxswain talked to *Ocean Maid*’s skipper via radio, instructing the skipper to cut the liferaft painter. The RNLI crew on board the XP boat threw the liferaft a heaving line, which the skipper attached to the liferaft, enabling the XP boat to tow it to the ALB and recover the crew of *Ocean Maid* safely onto the lifeboat.

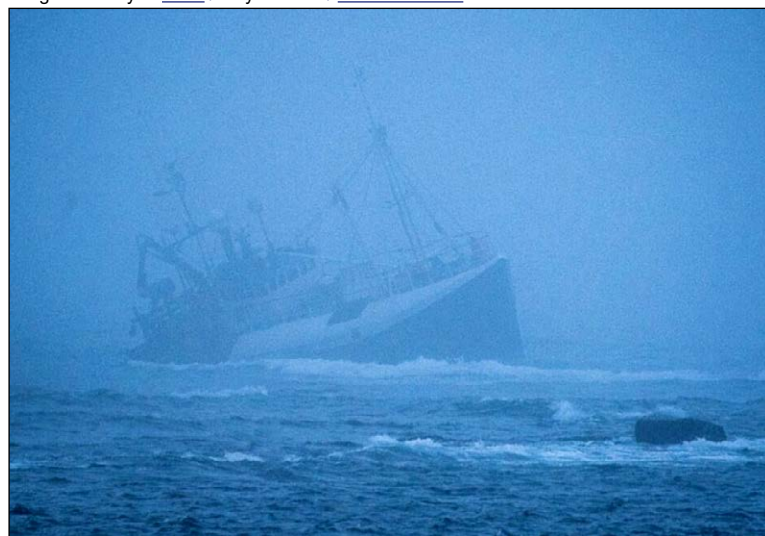
**Figure 5:** *Ocean Maid* aground on Cairnbulg Point

The vessel was aground on Cairnbulg Point for most of the 24 October (**Figure 5**) but had broken up by the following day.

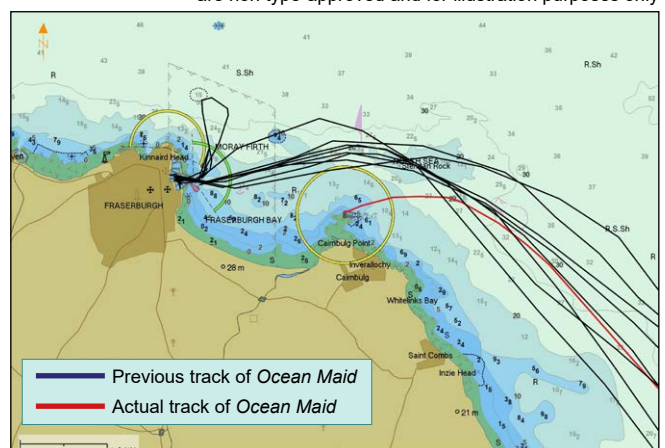
**Figure 7:** Summary of *Ocean Maid*'s available AIS past tracks in the year leading up to the accident

Analysis of *Ocean Maid*'s AIS track showed a series of small deliberate alterations to indicate when the watchkeeper was in the wheelhouse. The watchkeeper believed they were following the correct route into Fraserburgh Harbour and did not realise that their actions were beginning to turn *Ocean Maid* towards Cairnbulg Point when they started the series of small alterations from 0540 (see **Figure 2**). The reasons why the watchkeeper turned the vessel too early (see **Figure 7**), mimicking the previous tracks (see **Figure 7**) taken in previous passages to Fraserburgh, could not be

determined during the investigation due to the watchkeeper's recall of events. It is likely the watchkeeper was relying on external visual indicators rather than the electronic chart plotter to determine the vessel's position.

With no formal passage plan, the hazards to navigation were not identified and led to the watchkeeper's navigation being reactive and unplanned, increasing the risk of disorientation and the likelihood of grounding.
