# ***AAIB Bulletin***

***5/2025***

<b>Aircraft Type and Registration:</b>	ATR 72-212 A, G-CMJM	
<b>No &amp; Type of Engines:</b>	2 Pratt & Whitney Canada PW127M turboprop engines	
<b>Year of Manufacture:</b>	2017 (Serial no: 1464)	
<b>Date &amp; Time (UTC):</b>	31 October 2023 at 0917 hrs	
<b>Location:</b>	On departure from Edinburgh Airport	
<b>Type of Flight:</b>	Commercial Air Transport (Passenger)	
<b>Persons on Board:</b>	Crew - 4	Passengers - 55
<b>Injuries:</b>	Crew - None	Passengers - None
<b>Nature of Damage:</b>	Fractured nose landing gear axle	
<b>Commander's Licence:</b>	Airline Transport Pilot's Licence	
<b>Commander's Age:</b>	61 years	
<b>Commander's Flying Experience:</b>	9,530 hours (of which 150 were on type) Last 90 days - 148 hours Last 28 days - 54 hours	
<b>Information Source:</b>	AAIB Field Investigation

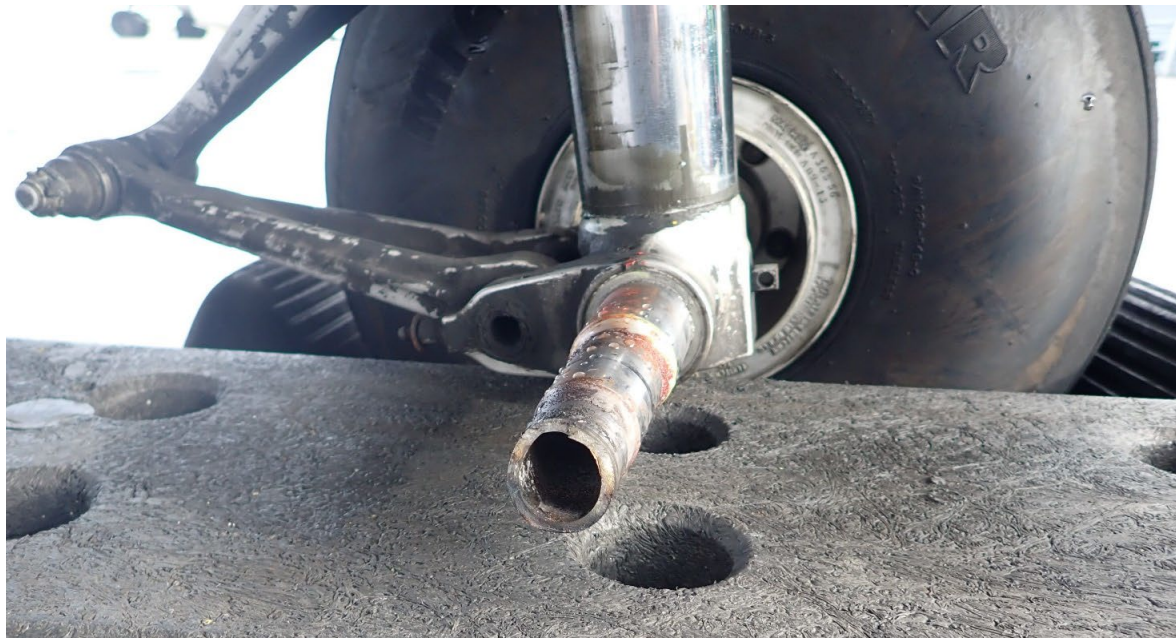
**Figure 3**

The nose leg gear axle was sheared off and showed evidence of heat damage (Figure 3). Extensive checks of the aircraft nose landing gear bay showed no signs of other damage or fluid leakage. A detailed inspection of the aircraft structure and engines revealed no damage due to the release of the nosewheel. There was no hard landing or abnormal runway contact reported by flight crews during the flight when the wheel was lost or on previous flights.

G-CMJM fractured nose landing gear axle

Inspection of the failed components indicated exposure to high temperatures which were consistent with a wheel bearing failure event. Laboratory analysis for the failed axle did not identify the precise region of crack initiation but the metallurgical analysis of the axle indicated that the thermal shock and evidence of cadmium liquid metal embrittlement both likely contributed to the complete fracture of the axle.

The right NLG wheel detached from the aircraft because the axle on which it is located fractured. The axle fractured due to overheating of the bearing in the wheel which caused a combination of thermal shock and liquid cadmium embrittlement. The cause of the bearing overheating could not be positively determined, but inspection of the failed components identified a number of factors that could have contributed. These included over greasing of the inner and outer bearings, the lack of wheel balancing weights and the application of an interposition product between the mating faces of the two half-wheels which can cause the tie bolts to loosen. The manufacturer of the nose leg gear assembly highlighted the importance of adherence to the AMM and CMM by aircraft maintainers and component repair/maintenance facilities respectively to ensure safety. As well as providing access to the aircraft and component technical publications for wheels and brakes on the ATR 72, the manufacturer's maintenance portal also contains in-service experience advice for operators and MROs.

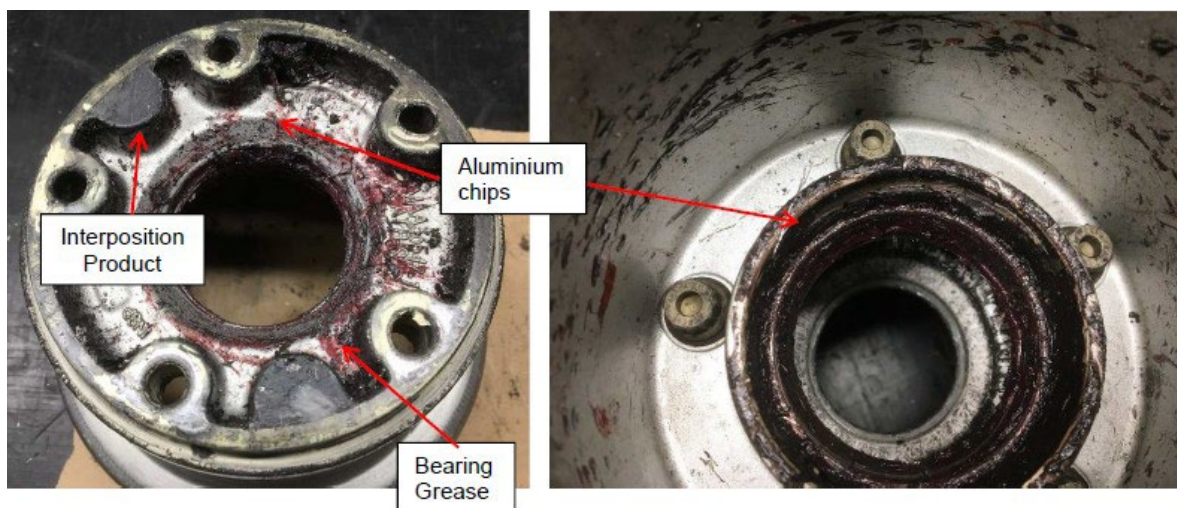
**Figure 5**

- The right NLG wheel assembly was found assembled with all tie bolts loose.
- No balancing weights were found fitted on either the outer or inner half-wheel sections<sup>1</sup>.
- The outer half wheel hub was found fractured.
- There was an interposition product found on the mating faces of the two half-wheels (Figure 5); this product is not allowed in this area<sup>2</sup> as it can lead to micro displacements of the two faces and tie-bolt loosening.
- Evidence of bearing grease indicated over-greasing of both bearings.

Inner half wheel condition (image used with permission)

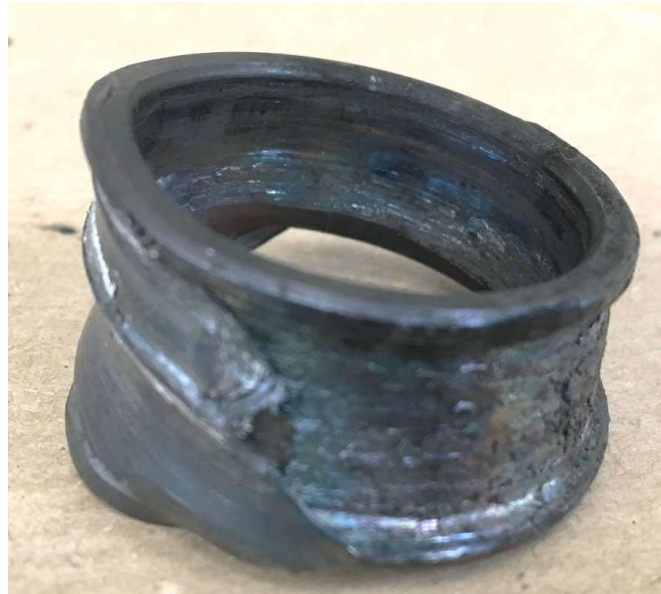
**Figure 6**

- Outer bearing assembly. The outer bearing assembly cone was completely deformed due to the heat generated during the bearing failure (Figure 6). The cage, outer bearing seal and retaining ring were missing. There was evidence of material transfer on the internal diameter and only one roller, which was damaged, was present.

Outer bearing cone heat damage (image used with permission)

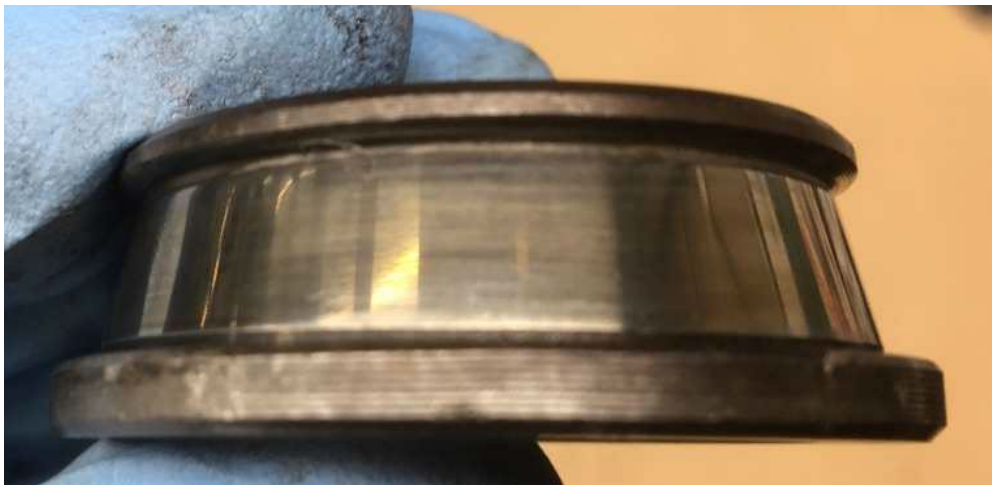
**Figure 7**

- Inner bearing assembly. The rollers, cage, circlip, grease and seal were all missing due to the heat damage. Roller marks were observed on the bearing race (Figure 7), which is an indication that the rollers were not aligned properly.

Inner bearing cone circumferential marks (image used with permission)

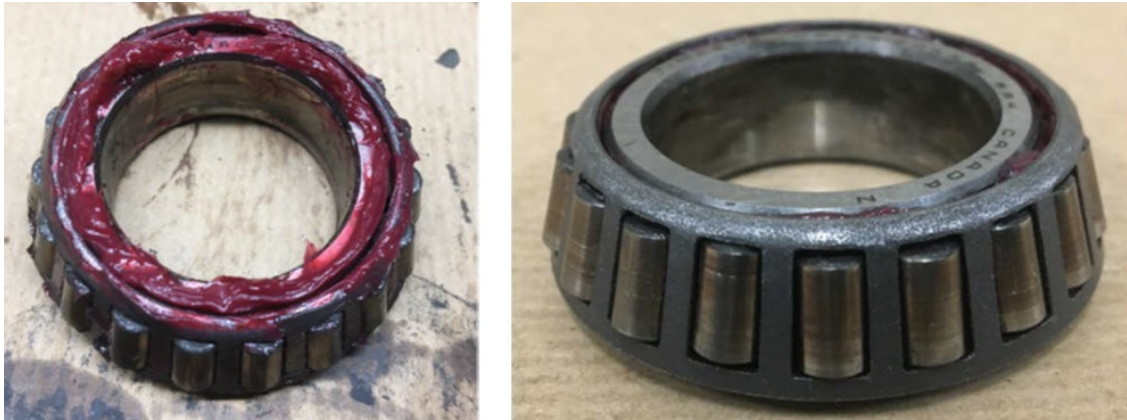
**Figure 8**

The left NLG wheel assembly was inspected and all the tie bolts holding the half-wheels together were found loose. An interposition product was found between the two half-wheels, and the balancing weights were not fitted on the NLG wheel. The bearings (Figure 8) were in better condition but also showed signs of over greasing and heat damage.

LH NLG wheel bearing (image used with permission)

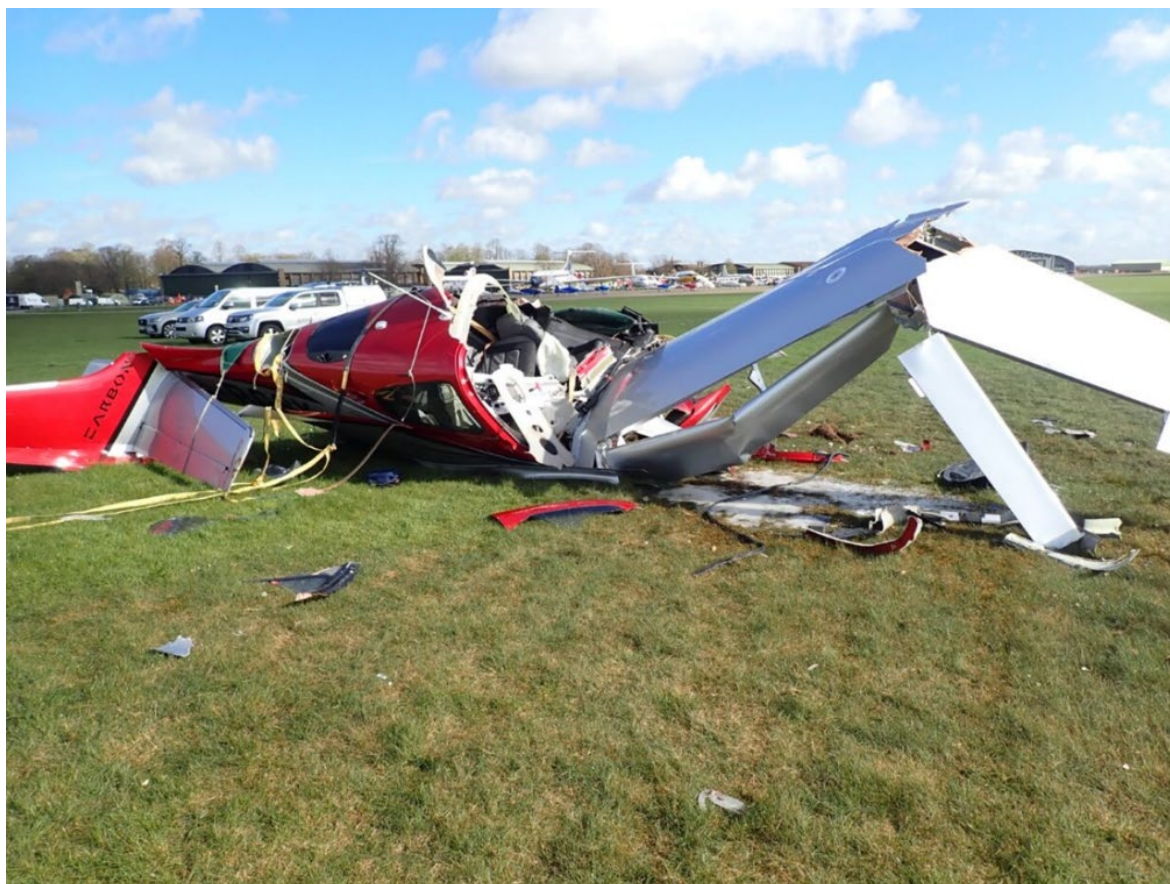
The aircraft came to rest on a grassed area near to the threshold of Runway 06L at Duxford Airfield. The initial ground impact mark was clearly discernible from which a fan shaped discolouration of the grass had occurred. This had been caused by the spray of fuel ejected from the ruptured aircraft fuel tanks during the impact. Despite this there was no fire. The aircraft was in a highly disrupted state and had come to rest approximately 40 m from the initial impact point. Examination of the wreckage trail suggests a heading on impact of 308°T. All the propeller blades had detached from the hub and were embedded in the ground about 6 m from the initial impact. The engine cowlings, cockpit doors and part of the cockpit roof had detached and were lying nearby.

The Cirrus Airframe Parachute System (CAPS)<sup>2</sup> parachute had deployed to full extension and was laying out flat along the ground. It was attached to the aircraft by its suspension lines. These were cut by AAIB staff on initial examination of the site to prevent inflation of the chute and dragging of the wreckage. The rocket motor had fired and was found lying on the ground at the top end of the canopy. Both wings were severely damaged, the left wing had detached, and the right wing was twisted around its root with its aileron and flap control surfaces partially detached (Figure 4). The rear fuselage had broken in the vicinity of the tailplane leading edge and was twisted around.

**Figure 4**  
Aircraft structural damage

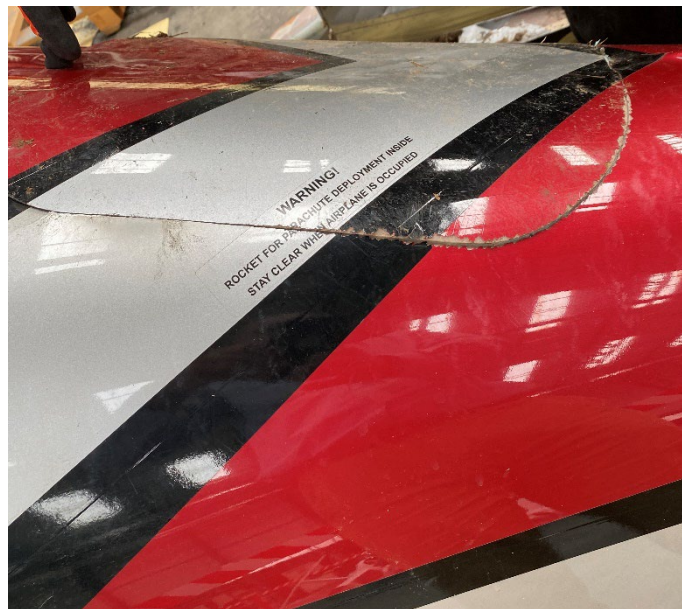
**Figure 8**

From a distance and in low light conditions these placards are barely discernible and do not draw particular attention to the potential danger within. Figure 8 shows the placard on the left side of G-RGSK.

CAPS placard left side

**Safety Recommendation 2025-001**

It is recommended that the Federal Aviation Administration mandate the application of conspicuous, unambiguous markings to the external surfaces of all in-service and future Cirrus SR20 and SR22 aircraft to warn of the presence, location and hazards of the Cirrus Airframe Parachute System (CAPS) and for all other Part 23 aircraft fitted with a Ballistic Parachute Recovery System (BPRS).
