Rail Accident Investigation Branch

Rail Accident Report

**Fatal accident at Waterloo Underground station,
London
26 May 2020**

Report 05/2021
September 2021

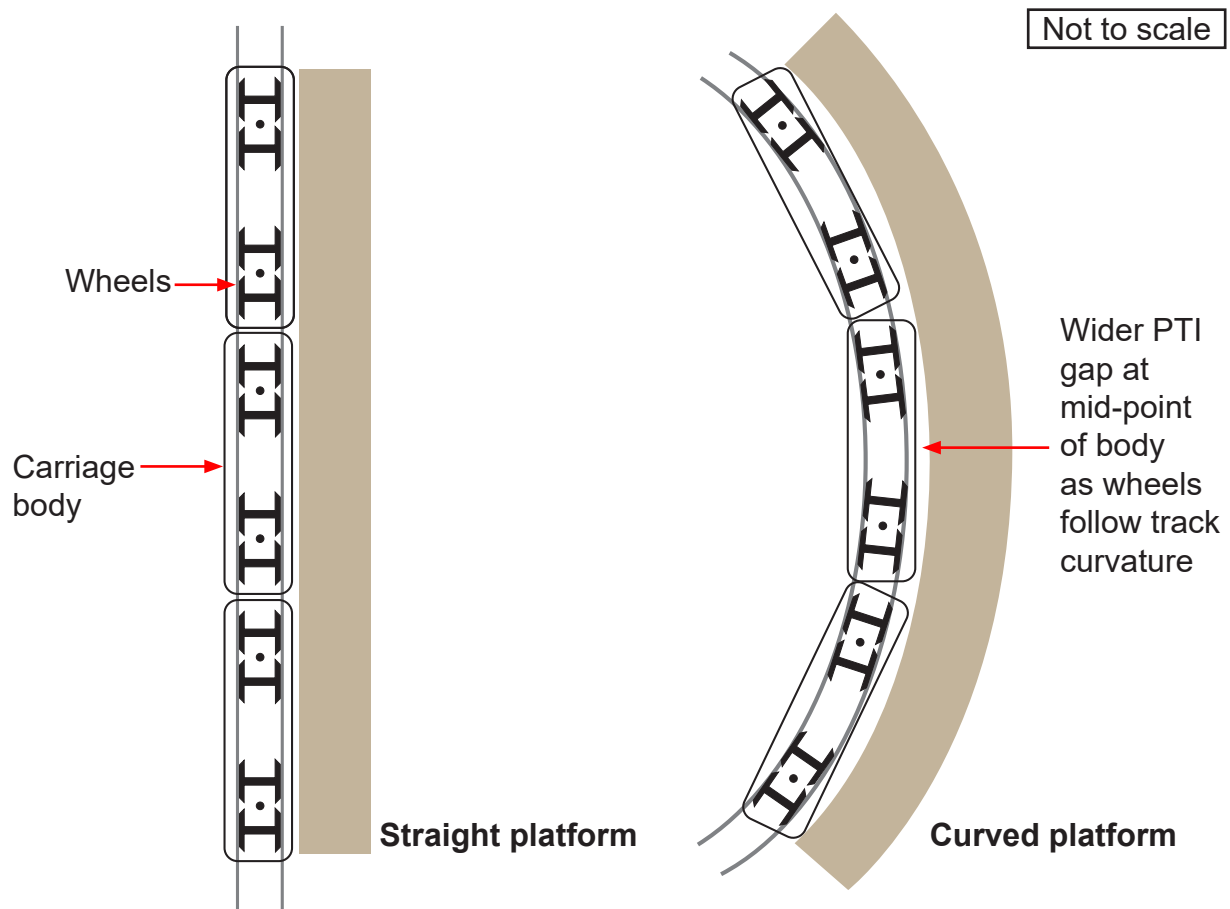
- 6 The railway is tightly curved to the left (in the direction of travel of trains) through the platform, and this results in larger gaps between the platform and the train in some parts of the platform than would be found at a straight platform (figures 2 and 3). A lineside signal on the approach to the station controlled the movement of trains into the platform area and another signal, about 10 metres beyond the departure end of the platform, controlled movements out of the platform towards the next station.

Figure 2: Diagram showing increased gap between the train and platform as a consequence of track curvature

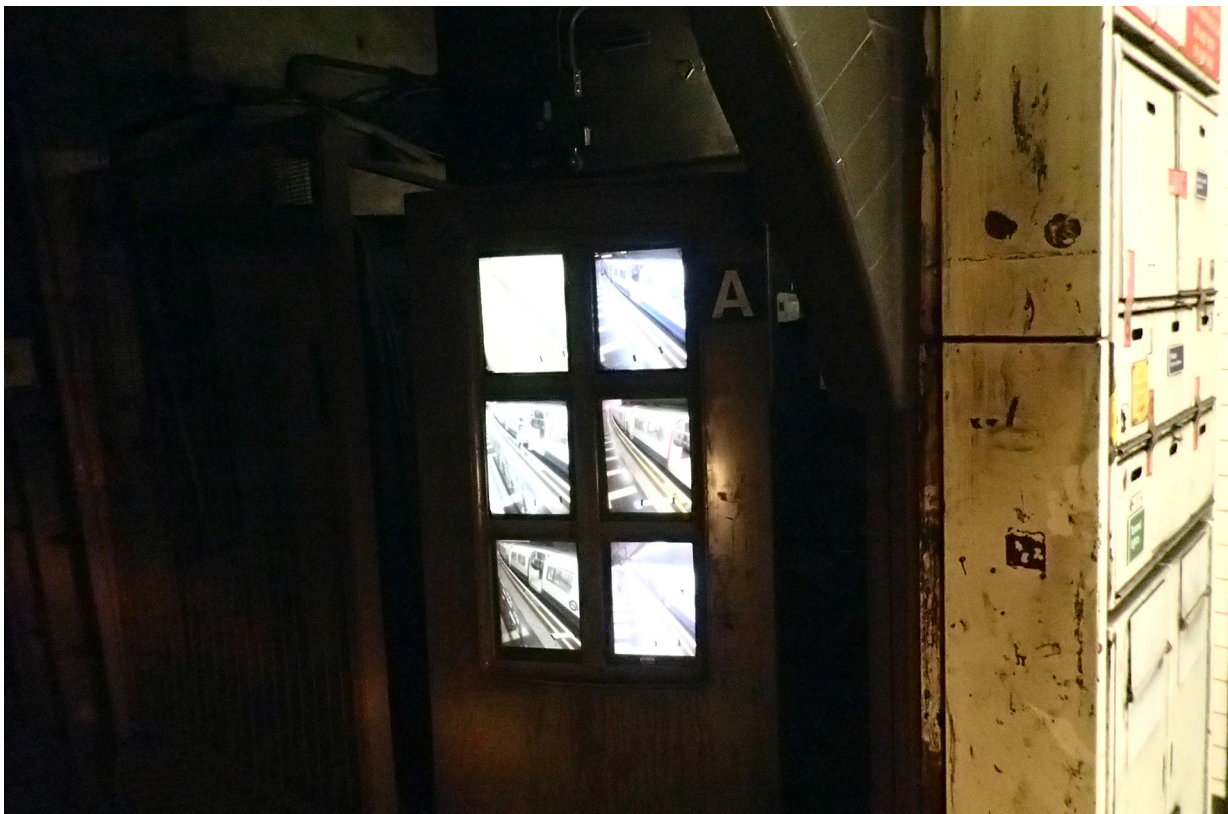
Figure 5: OPO monitors provided inside the tunnel at Waterloo Bakerloo line platform 3

- 47 At Waterloo Bakerloo line platform 3, the six OPO monitors that allow train operators to view the full length of the PTI (paragraph 12) were positioned behind a glass screen approximately 3.2 metres from the train operator's driving position (station CCTV images show that train 210 had stopped in the correct position at the time of the accident). The monitors are inspected each morning to confirm that the cameras are correctly aligned and the images are displayed distinctly. The monitors were checked at 04:55 hrs on the day of the accident and no defects were recorded.

- 53 A replacement OPO platform CCTV system, compliant with the 1997 standard (or the 2003 revision), combined with more modern cameras and monitors, would have provided a larger and higher quality image. Although this would have improved the conspicuity of the passenger's arms across the platform white line, it is likely that the passenger's dark-skinned head would have remained difficult to distinguish against the dark background. Given that the image of the passenger's arm(s) would still occupy only a very small fraction of a monitor screen that was located 3.2 metres from the driving position, it is uncertain, but considered unlikely by RAIB, that the train operator would have noticed the presence of the passenger had more modern cameras and monitors been installed in the same positions as the current equipment.

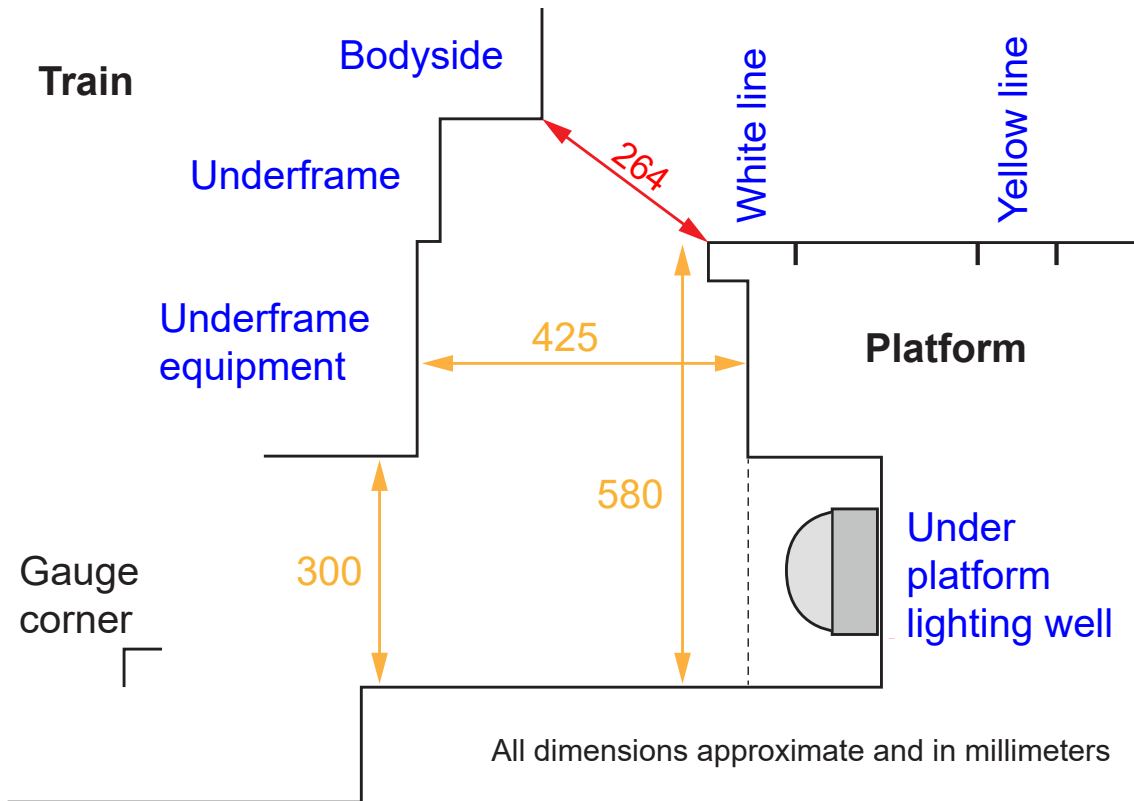
- 36 When the Bakerloo line was constructed at the start of the 20th century, the northbound track alignment through Waterloo station incorporated a tight curve with a radius of between 133 metres and 156 metres. This curve creates a large PTI gap close to the middle of the carriages (figure 6). With a train of this type stationary in the platform, RAIB found the gap to be approximately 264 mm when measured diagonally between the lower corner of the train body and the edge of the platform at the mid-point of the fourth carriage, the area in which the passenger fell (figure 7).

Figure 7: Cross-section between the platform and mid-point of carriage 4 at Waterloo Bakerloo line platform 3
