Report on the investigation of
the grounding of the chemical tanker

Key Bora

in the approaches to Kyleakin pier, Isle of Skye, Scotland
on 28 March 2020

REPORT NO 15/2021

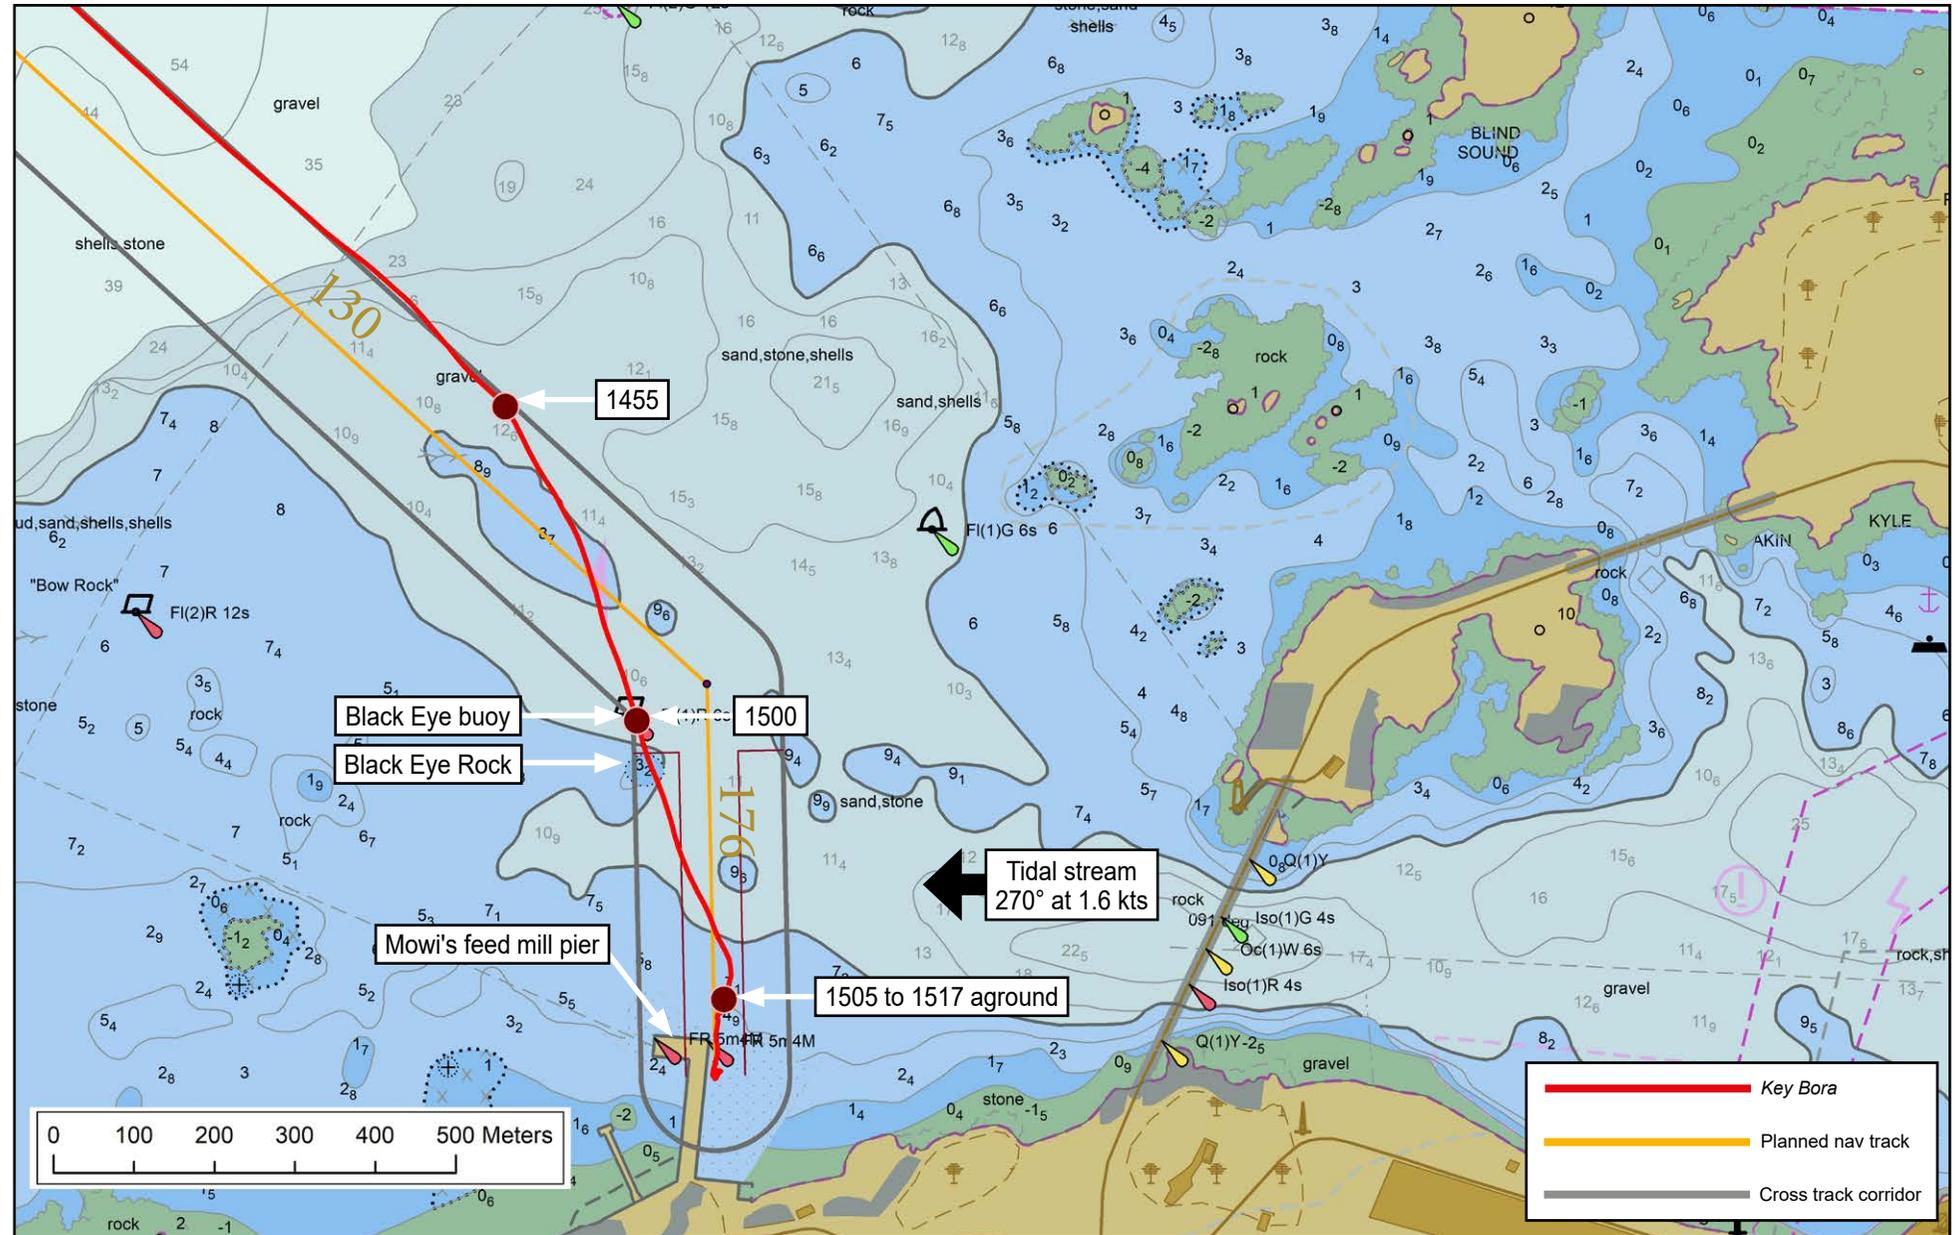
Figure 2: Key Bora's approach to Kyleakin

At 1445, the master reduced *Key Bora*'s speed to 4 knots (kts). At about the same time¹, the chief officer (C/O) arrived on the bridge to take over as OOW. The 2/O and C/O conducted their handover, then the 2/O left the bridge and went to the forecandle in preparation for berthing.

Having passed Black Eye buoy, the master assessed that the vessel was also clear of Black Eye Rock and started concentrating on the approach to the pier, 400m away. As *Key Bora*'s speed reduced, the master made a succession of alterations of course to port in an attempt to counter the effect of the apparent tidal stream. With about 100m to go to the berth, the master found he had to steer 134° for *Key Bora* to regain its 176° planned navigational track.

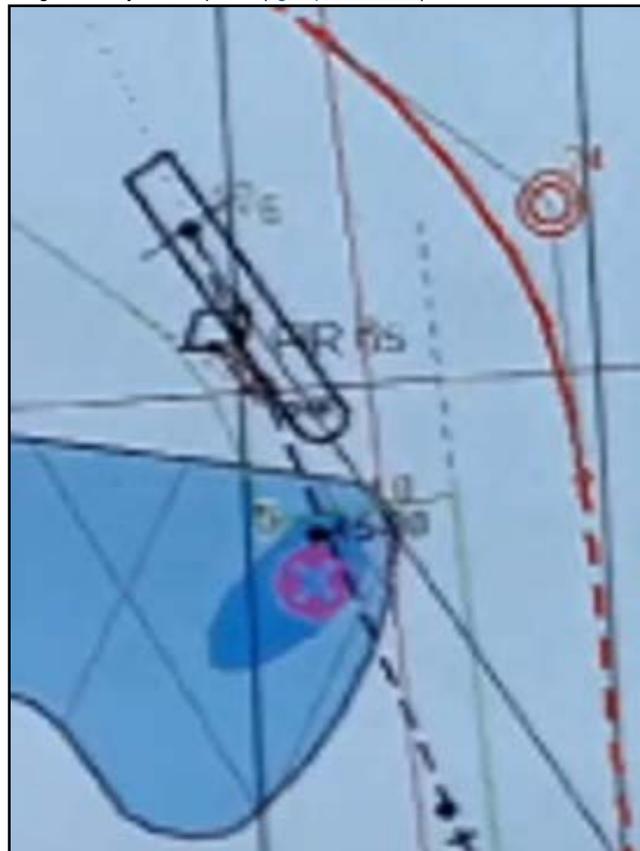
Figure 3: Screenshot of *Key Bora*'s ECDIS display as vessel passed Black Eye buoy

In the final approach, the C/O advised the master of a 4.9m charted depth just north of the pier; the master responded that the echo sounder was reading 7.0m depth of water so he was content to proceed with the berthing.

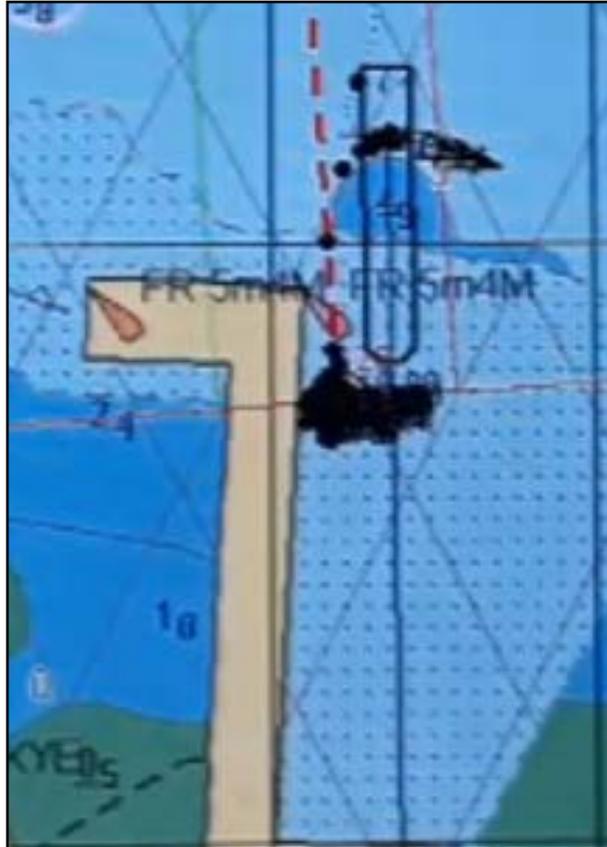
Figure 4: Screenshot of *Key Bora*'s ECDIS display as vessel grounded on the 4.9m hazard

At 1505, and 50m north of the pier, *Key Bora* shuddered, the bow swung to the south and it came to a stop (**Figure 4**). Realising that the vessel was aground, the master attempted to manoeuvre clear using the engines, rudder and bow thruster, but without success.

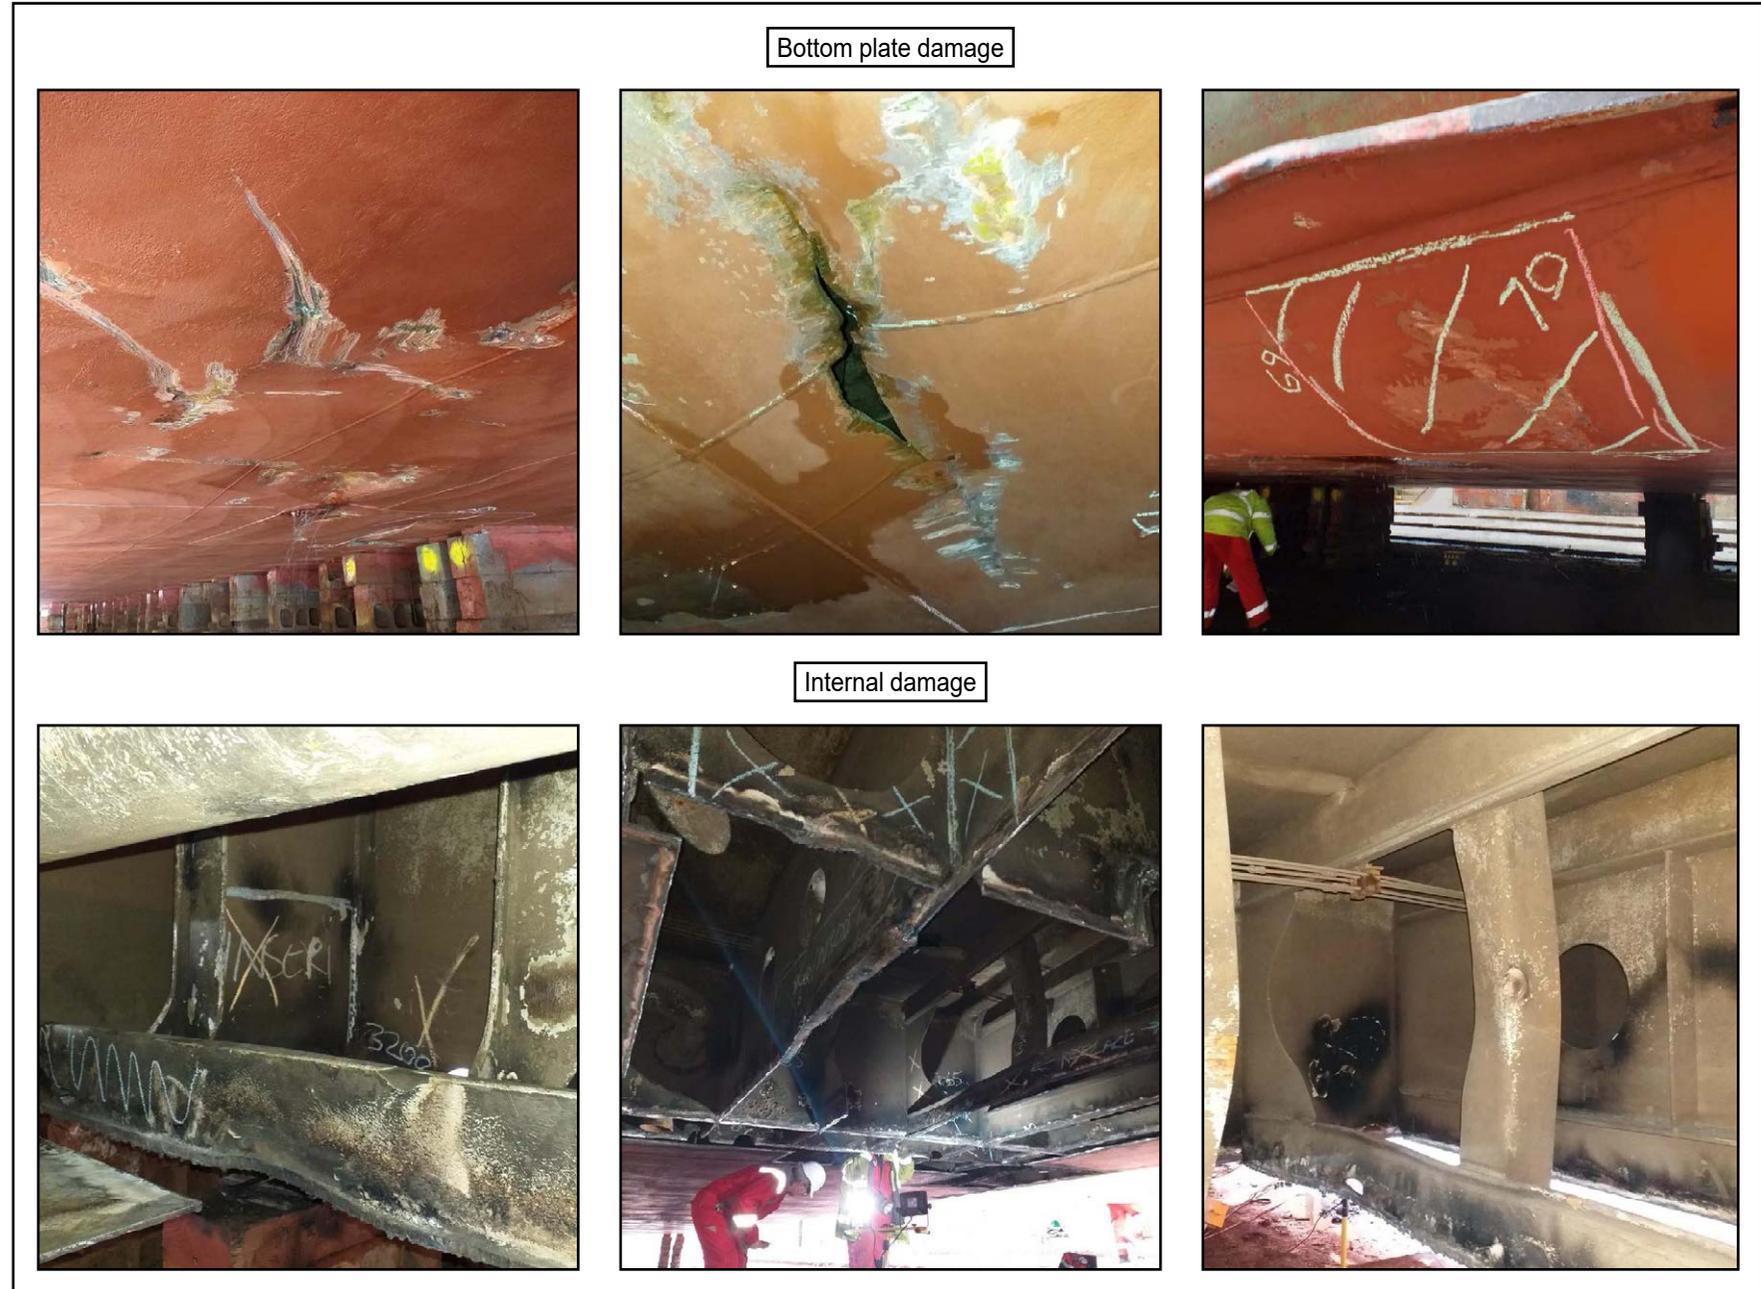
Figure 5: Grounding damage to *Key Bora's* hull

Once alongside, *Key Bora*'s master informed the company's designated person (DP) about the grounding. The following day, a diver inspection revealed hull damage, including shell plating ruptures (**Figure 5**). Once the cargo had been discharged, and with dispensation from its classification society, *Key Bora* proceeded to Glasgow for dry docking and repairs.

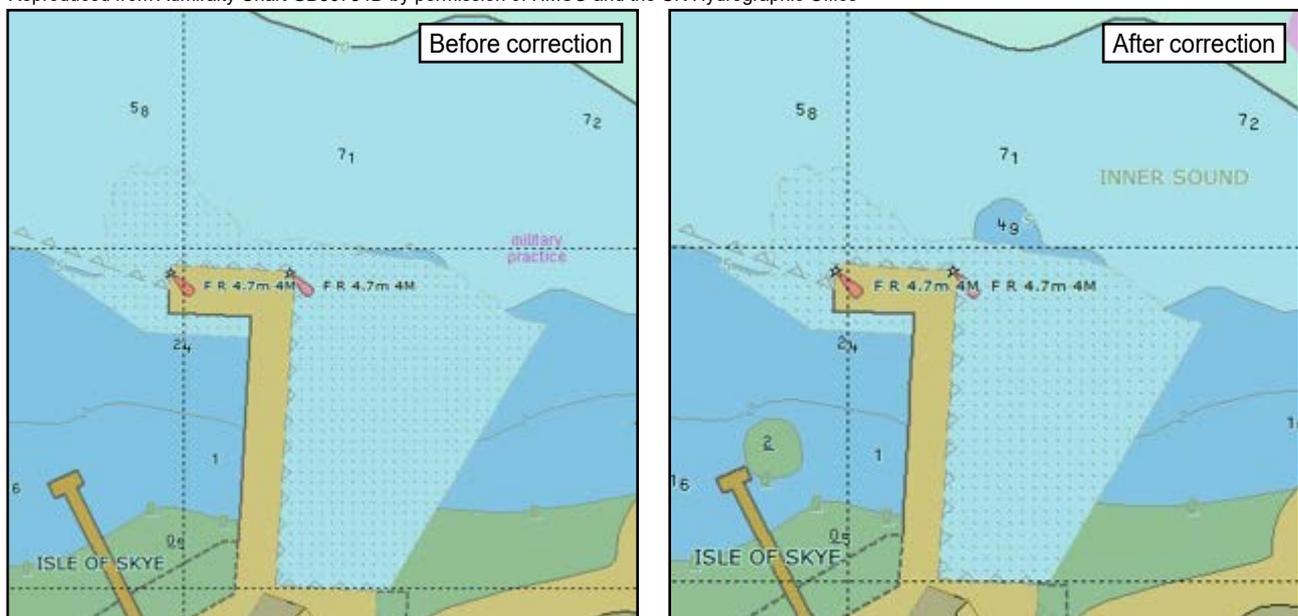
Figure 7: Copy of the ENC before and after 20 March 2020 correction

The sea area around Kyleakin had been routinely surveyed using MBES as part of the CHP in 2013 and 2019. When the results of the 2019 survey were analysed by the UKHO, a new isolated feature with a spot charted depth of 4.9m was identified, 50m north of the recently constructed pier at Kyleakin. Once this data had been scrutinised and validated by the UKHO, a chart correction was issued which inserted the 4.9m feature on to the ENC (**Figure 7**).

The UKHO's ENC correction had been automatically downloaded into *Key Bora's* ECDIS system on 20 March, 8 days prior to the accident. ECDIS includes a 'view update' operator function to indicate when changes have been made to an ENC. Neither *Key Bora's* 2/O or the master had checked the update status of the ENC as part of the planning process and both were unaware that the 4.9m obstruction was a recent correction.

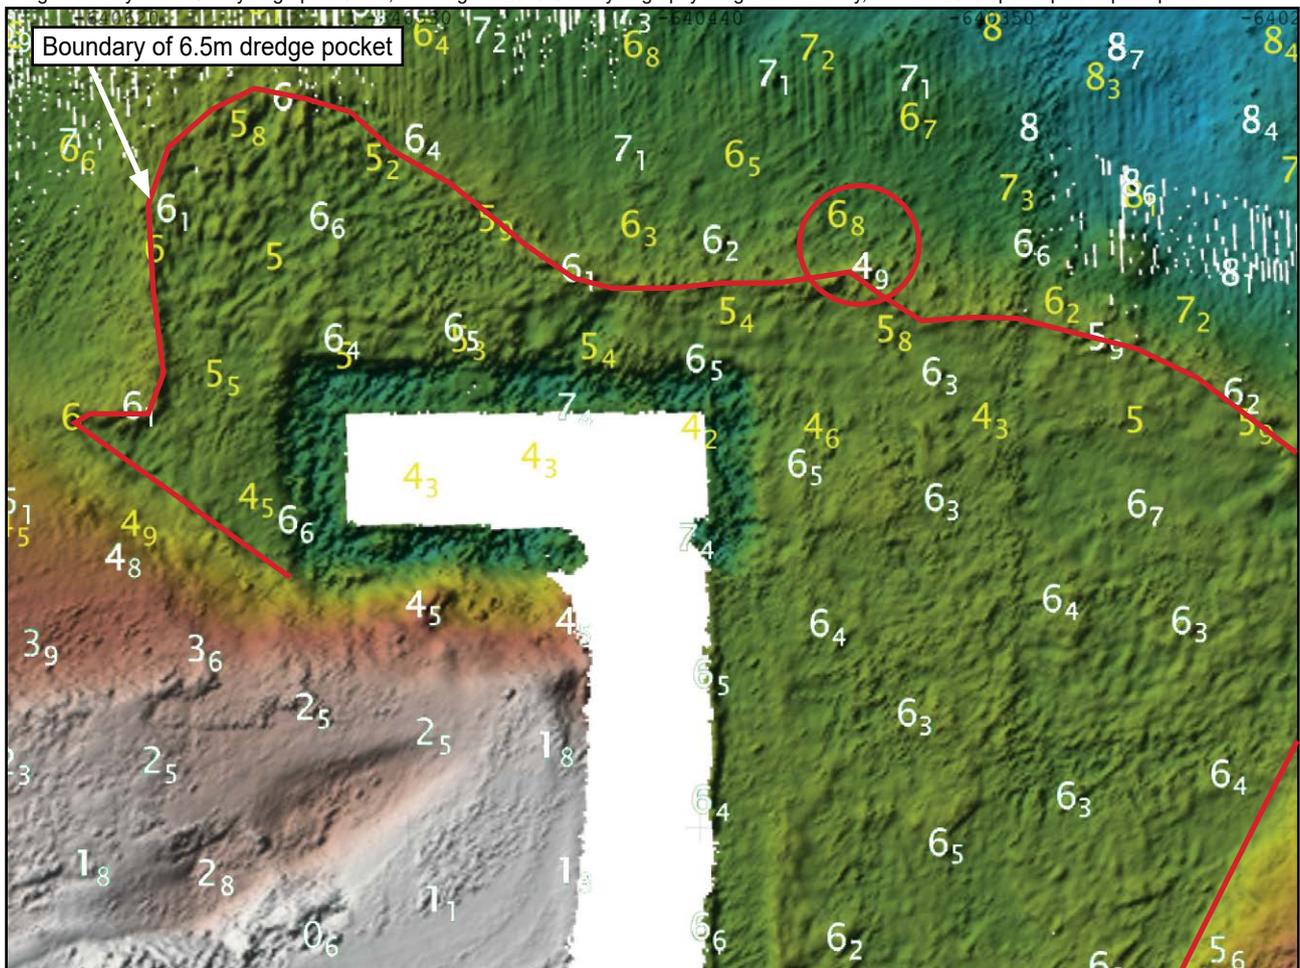
Figure 8: Comparison of soundings from the 2013 (yellow) and 2019 (white) Civil Hydrography Programme surveys

With the co-operation and assistance of the UKHO, the MAIB was granted access to the 'raw' data from the 2013 and 2019 CHP surveys of the area. This showed that the seabed feature identified during the 2019 survey in the location of the grounding and subject to the 2020 chart correction had not been present during the 2013 survey. **Figure 8** shows a comparison of the 2013 CHP data soundings (yellow) and the 2019 CHP data soundings (white).

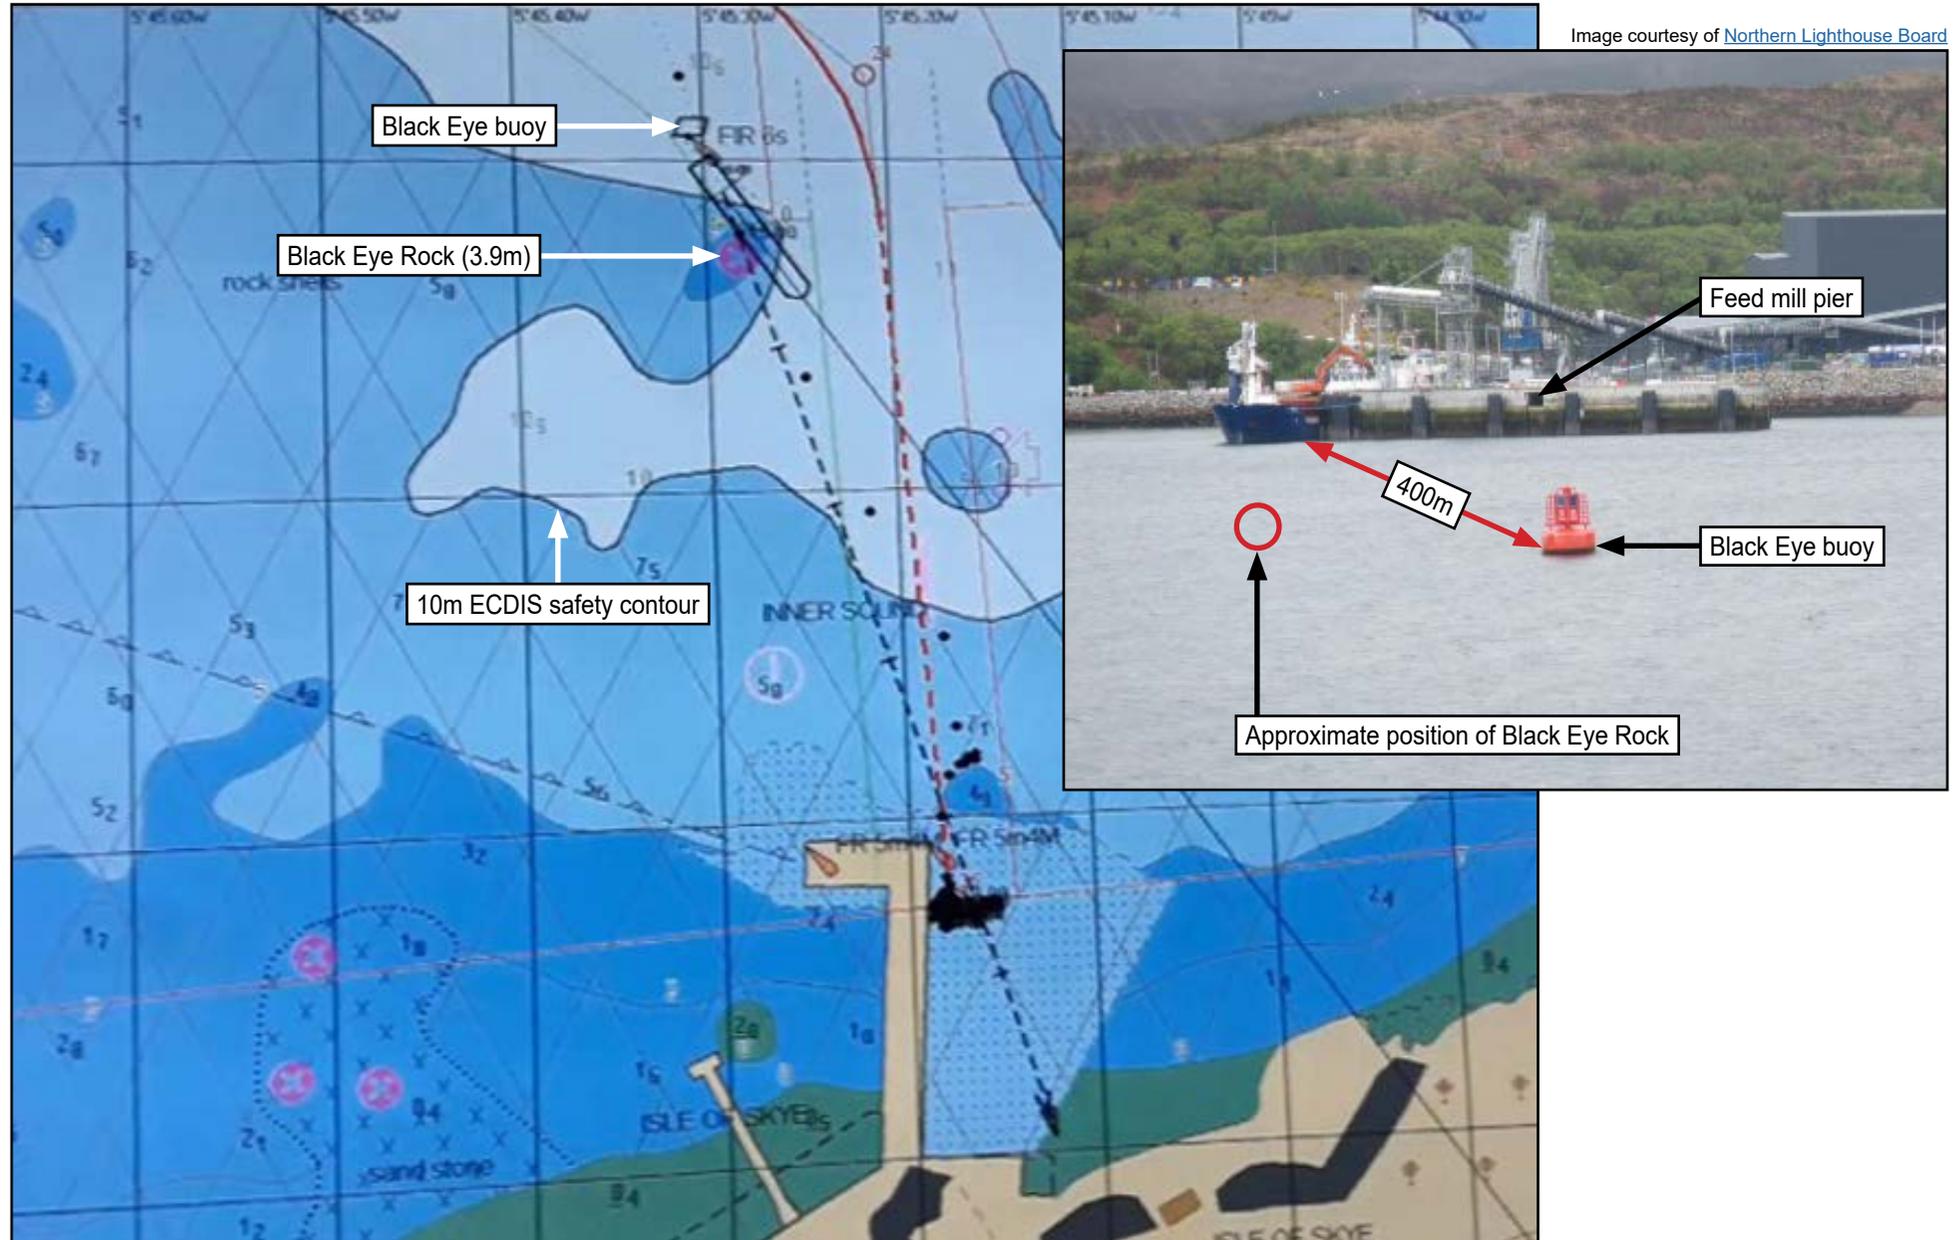
Figure 9: ECDIS screenshot of *Key Bora* passing Black Eye Rock, with inset photograph of approach

Black Eye buoy was one of a series of lateral markers laid by the NLB as an aid to navigation for vessels passing east and west under the Skye Bridge and through the Kyle of Lochalsh. These channel marking buoys were laid prior to the Kyleakin development. Although named after the adjacent hazard, Black Eye buoy, which was 400m north of the pier, was intended to assist transiting vessels to remain clear of all hazards to the west and south (**Figure 9**).

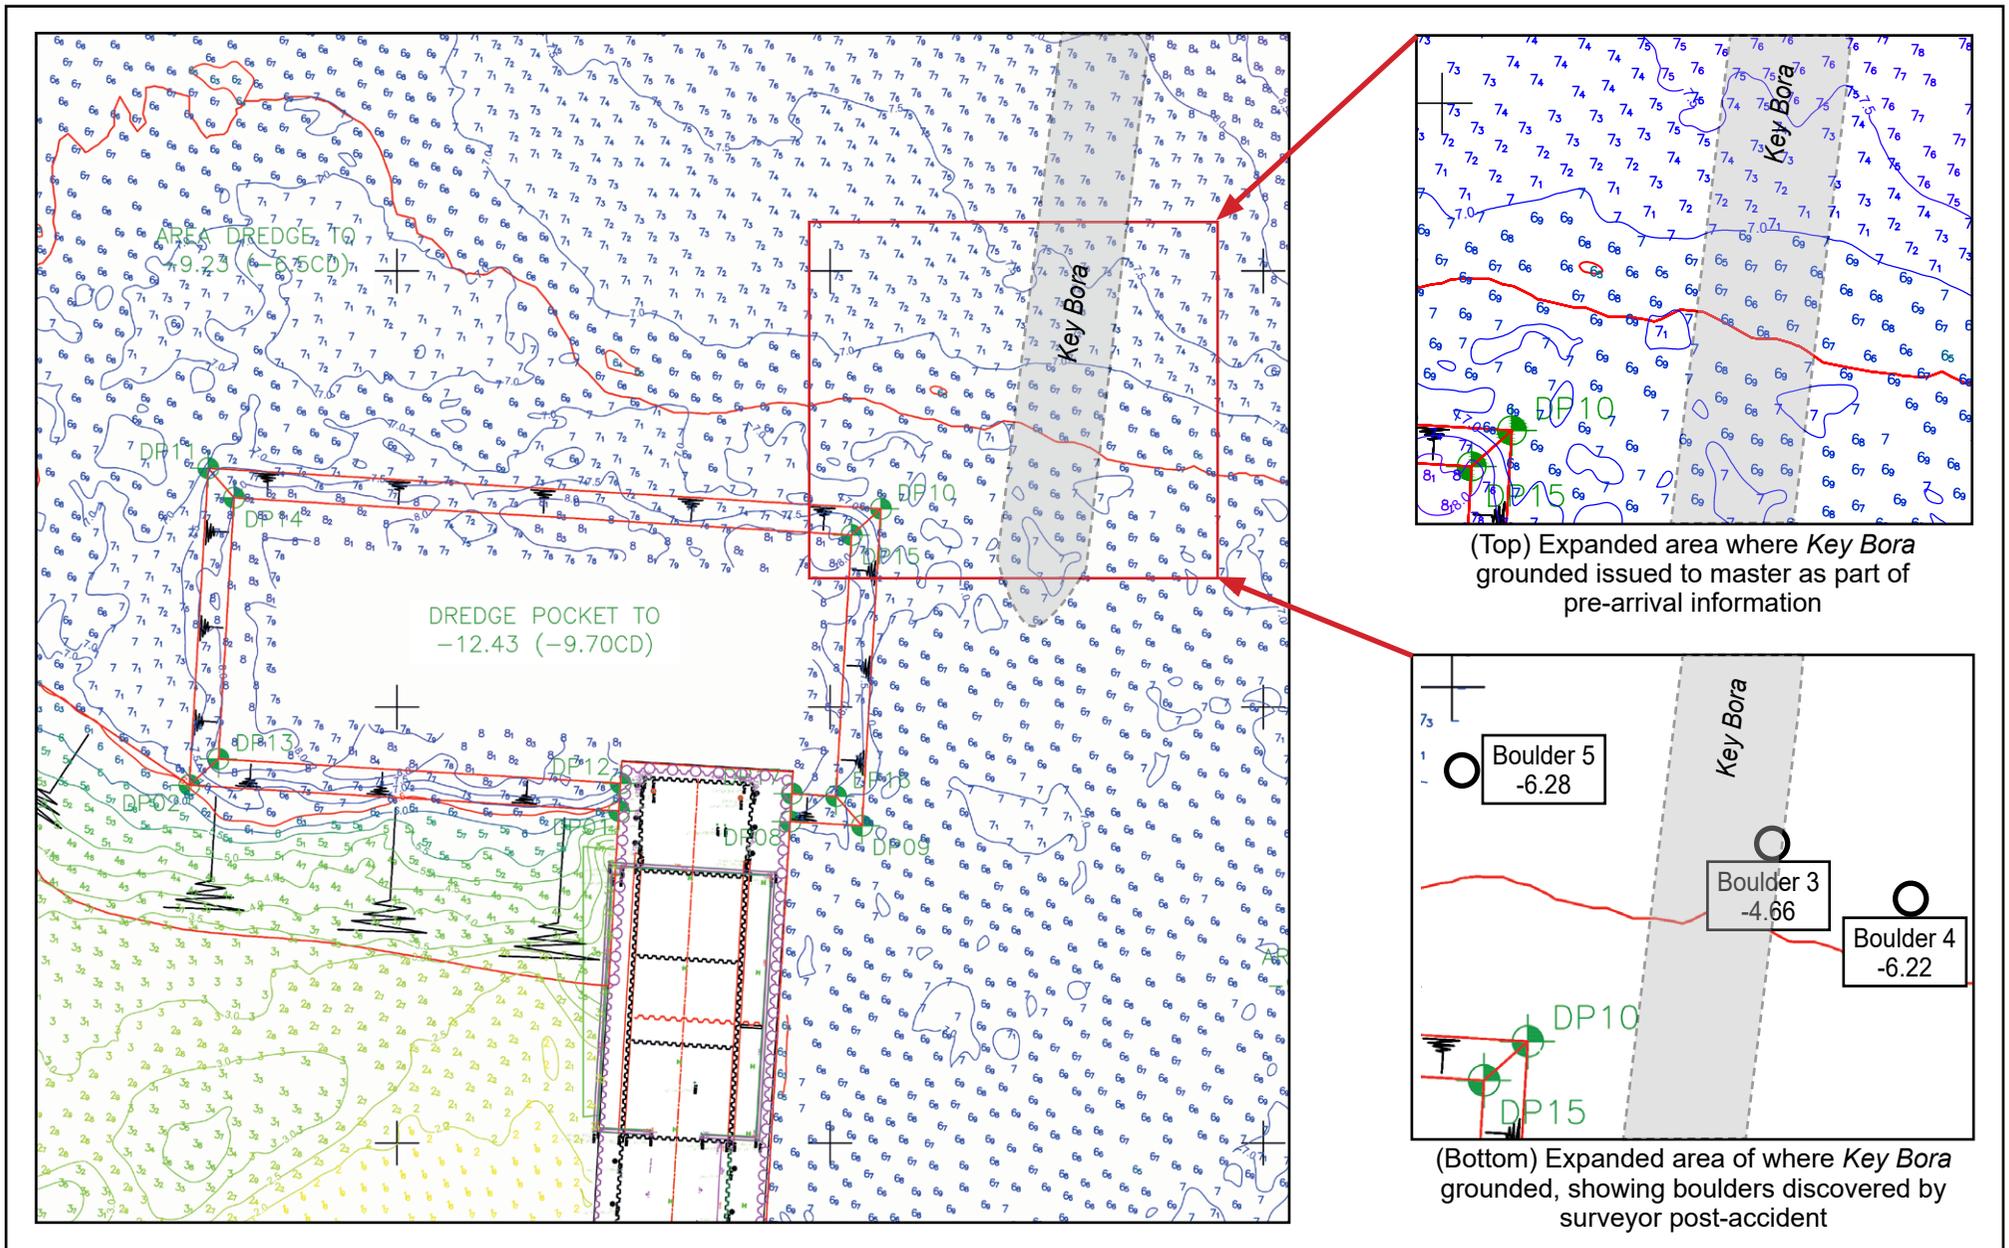
Figure 11: Post-dredge survey, dated 30 August 2018, with insets showing expanded area of where *Key Bora* grounded (top) and the boulder discovered post-grounding (bottom)

Following *Key Bora's* grounding, Mowi requested Aspect Surveys to review their MBES survey data recovered during the dredging operations. This analysis showed the presence of several 'boulder-like' obstructions outside the boundary of the area that had been designated to be dredged to 6.5m (**Figure 11**). In April 2020, after the grounding, Aspect Surveys conducted a further MBES survey of the approaches to the pier, which revealed a large 3m long granite boulder that extended 1.9m above the surrounding seabed, in the location of *Key Bora's* grounding (**Figure 12**). In August 2020, contractors removed all of the obstructions from the approaches to the pier and disposed of them ashore.

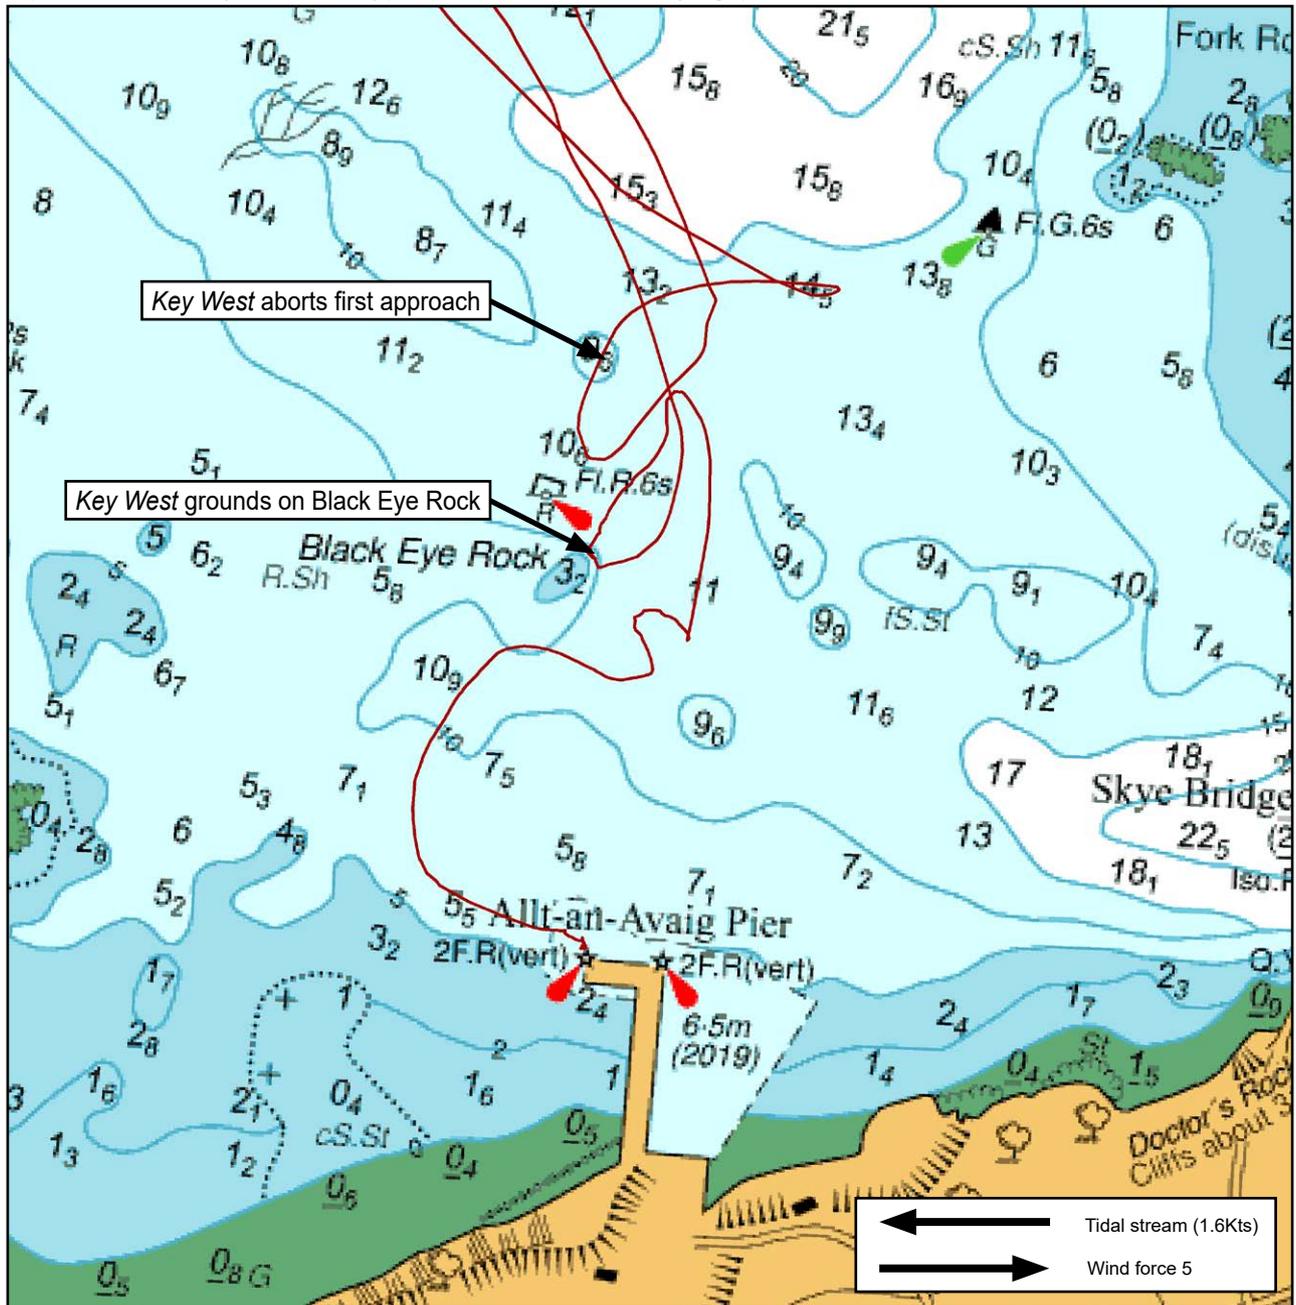
Figure 13: Key West's grounding on Black Eye Rock

The MAIB conducted a preliminary assessment¹⁴ into this grounding and found that *Key West*'s master had to abort his approach to the Kyleakin pier as there was no-one ashore to tend the mooring lines. After assurance that Mowi staff were available to assist with berthing, *Key West*'s master commenced a second approach but, with about 400m to run, the same concern arose. On the second occasion, the

master applied astern propulsion to delay arrival, rather than head back to the open sea. As *Key West*'s speed reduced, it was swept west by the tidal stream and ran aground on Black Eye Rock (**Figure 13**).

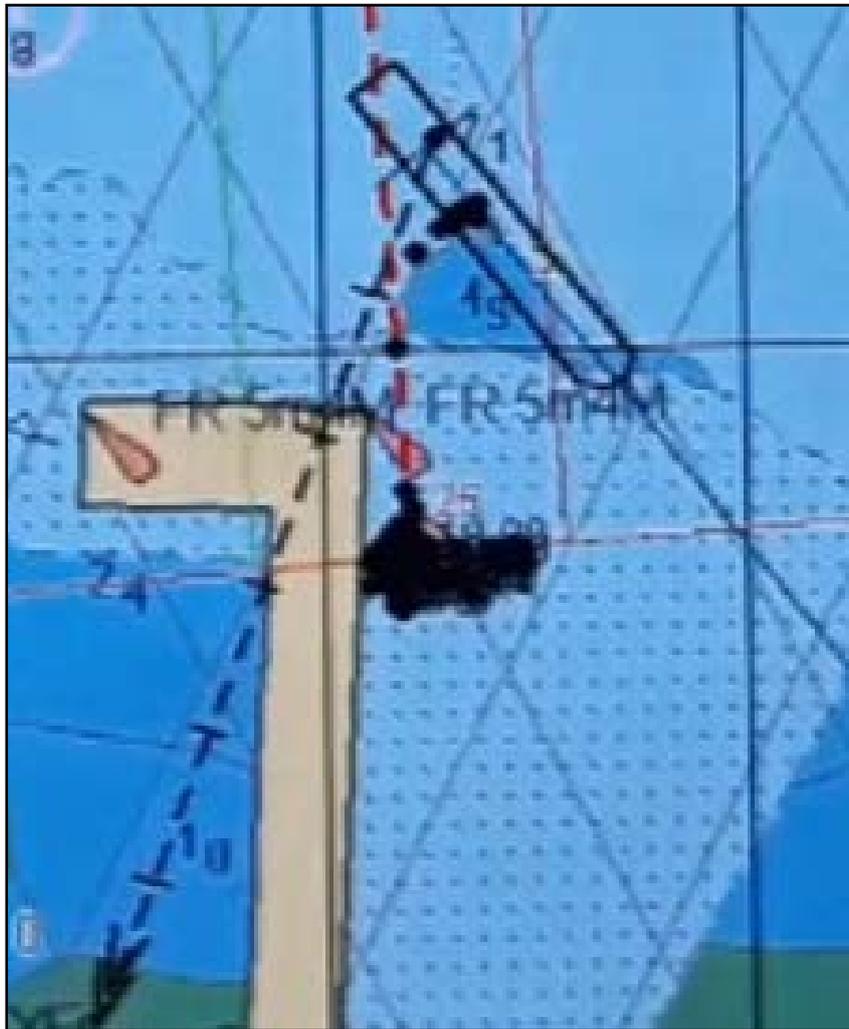
Figure 14: Screenshot from *Key Bora*'s ECDIS immediately prior to it grounding, predicting that it would strike the jetty

As *Key Bora* approached the pier, a succession of course alterations were necessary to maintain track; this alerted the master to the presence of tidal stream, which was not expected. These course alterations came soon after the C/O had alerted the master to the vessel passing very close to Black Eye buoy, another clue to the close proximity of danger and potential risk. Either of these events alone would have been sufficient to abort the berthing, especially as there was no pilot on board or tugs available. However, *Key Bora* was, by this time, past the planned 'no-go' point and committing to berthing, at least in planning terms. Moreover, analysis of *Key Bora's* predicted movement from ECDIS (**Figure 14**) showed that it would almost certainly have been swept onto the pier had it not grounded.

Furthermore, the ECDIS look ahead function was switched off, which resulted in an absence of any alarm to warn of danger. However, given that the master had committed to the berthing and was ignoring the ENC's 4.9m sounding, it is highly likely that an associated ECDIS alarm would also have been ignored.

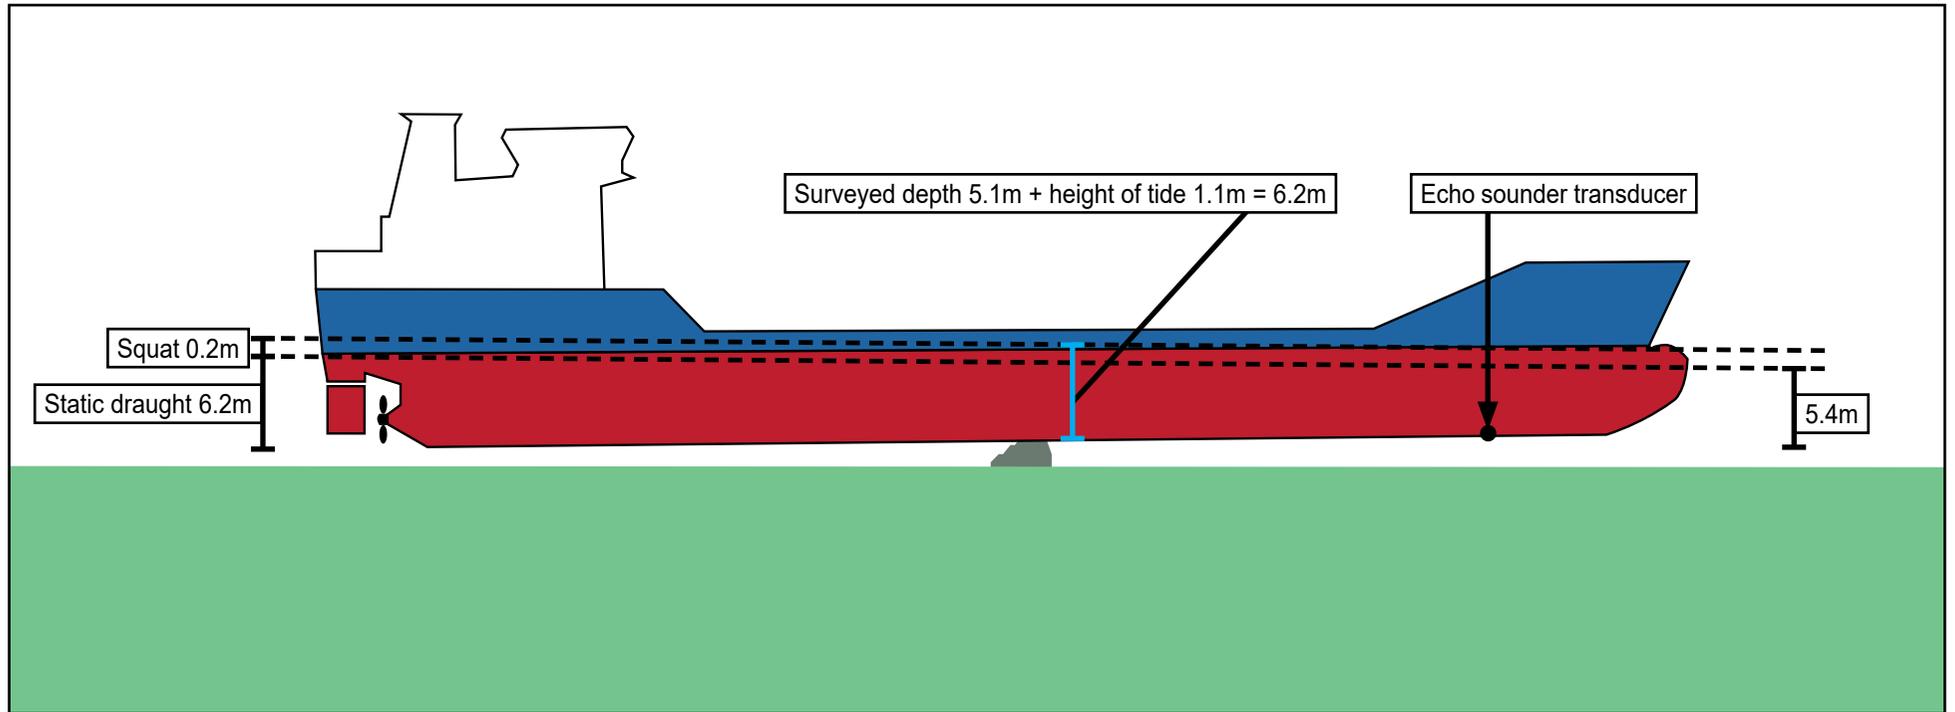
Figure 15: Illustration of *Key Bora* aground

Immediately prior to grounding, having received a verbal warning of the potential danger from the 4.9m sounding from the C/O, the master stated that he intended to proceed with the berthing as the echo sounder was reading sufficient depth. However, the echo sounder was of little use as a navigational safety barrier as it would only be effective with a shelving seabed and sufficient room to avoid the detected danger. Neither of these conditions existed so the 7m echo sounder reading did little more than give the master false confidence in the plan to press ahead with the berthing (**Figure 15**).

Although there were indications during the vessel's final approach to the jetty that conditions were not as expected, these did not trigger a decision to abort the approach. This happened because *Key Bora* had passed the passage plan's abort point and the echo sounder reading underpinned the decision to press on. Furthermore, any late decision to abort would potentially have induced a risk of grounding similar to the earlier *Key West* accident.

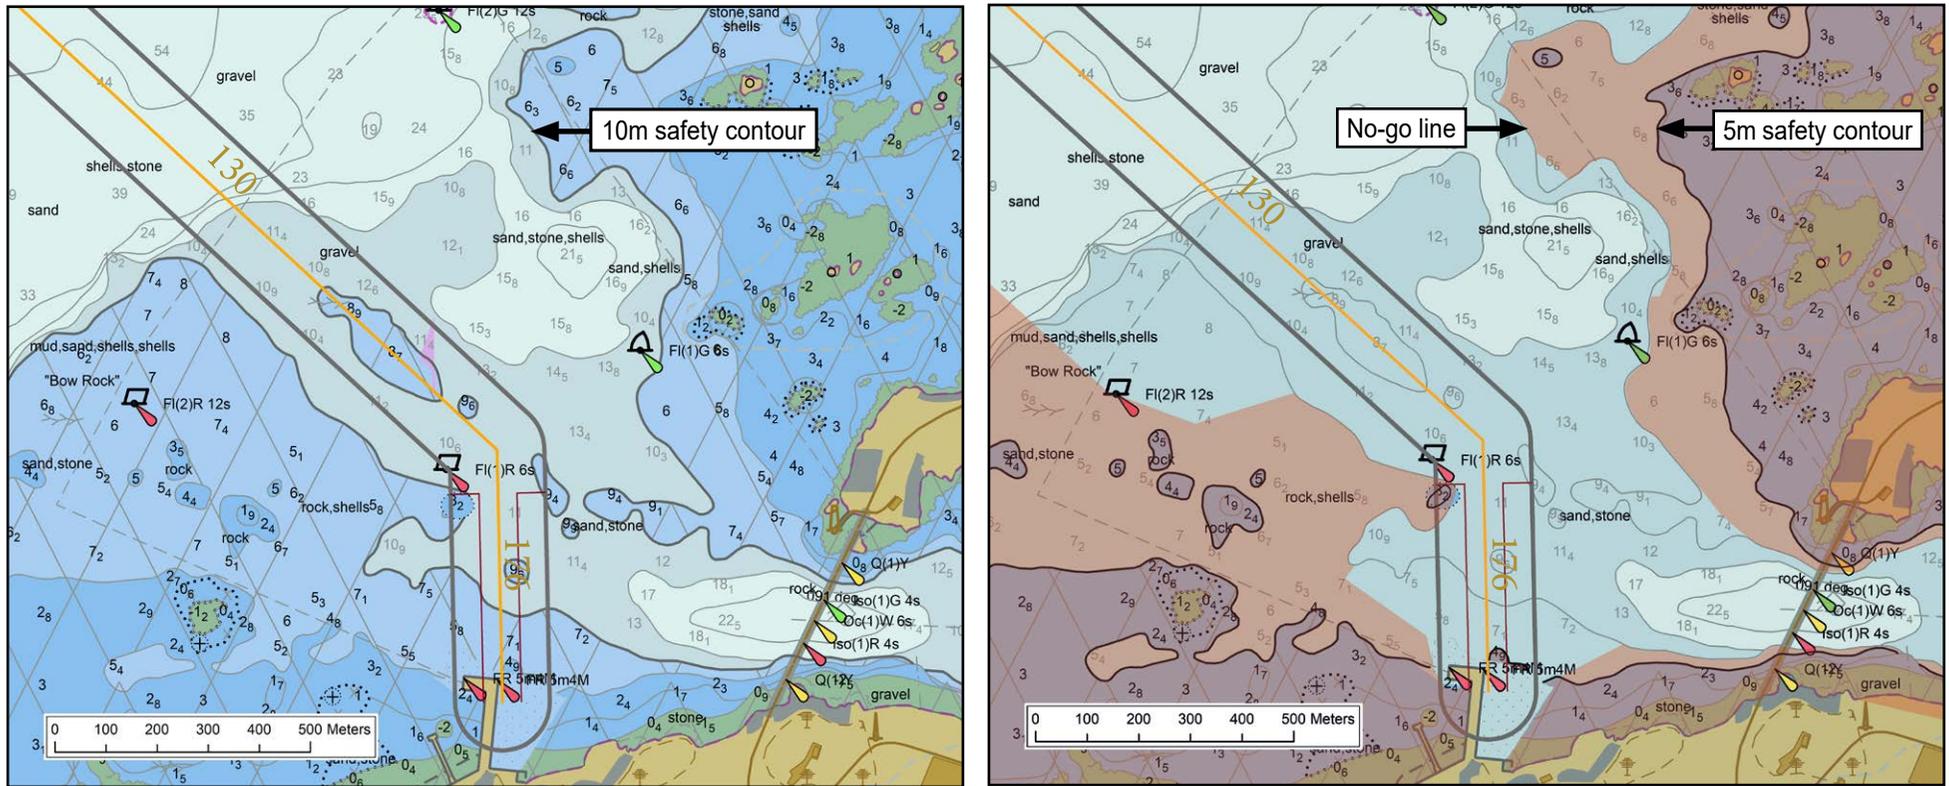
Figure 16: Comparison of ECDIS display with 10m safety contour (left) and 5m safety contour and no-go area based on 6.48m safety depth (right)

For the approach to Kyleakin, *Key Bora's* calculated ECDIS safety depth was 6.48m and, as this was not an ENC contour, the system had defaulted to the next deepest contour of 10m. This meant that it was not possible for the vessel to reach the berth without crossing the 10m safety contour (**Figures 2 and 9**) on several occasions; however, neither of the workaround methods to resolve this [Section 1.4.4] was actively used on the bridge. **Figure 16** shows a reconstruction of the ECDIS passage plan, including the 10m safety contour (NP 232 method 1) and a hand-drawn safety contour with the 5m contour selected (NP 232 method 2). Had method 1 been adopted, *Key Bora* would have had to cross the 10m safety contour several times during the approach, which would have caused an ECDIS alarm and alerted the crew to danger. Equally, method 2 would also still have shown the 4.9m hazard as impassable.

Without a robust method of utilising ECDIS in the approach, and the look ahead function also not in use, the primary navigation system was not being effectively utilised to support safe navigation. This analysis is underpinned by the fact that, prior to the grounding, the vessel had already been placed in significant navigational danger when passing over or extremely close to Black Eye Rock, without alarm or corrective action. Nevertheless, any ECDIS alarm may have been ignored given the decision not to avoid the ENC's 4.9m sounding.
