Serious Incident

Aircraft Type and Registration:	De Havilland Aircraft of Canada Limited DHC-8, 9H-LWB	
No & Type of Engines:	2 Pratt & Whitney Canada PW150A turboprop engines	
Year of Manufacture:	2010 (Serial no: 4332)	
Date & Time (UTC):	23 April 2024 at 1740 hrs	
Location:	Runway 27, Guernsey Airport	
Type of Flight:	Commercial Air transport (Passenger)	
Persons on Board:	Crew - 5	Passengers - 63
Injuries:	Crew - None	Passengers - None
Nature of Damage:	None	
Commander's Licence:	Airline Transport Pilot's Licence	
Commander's Age:	56 years	
Commander's Flying Experience:	8,472 hours (of which 241 were on type) Last 90 days - 110 hours Last 28 days - 45 hours	
Information Source:	AAIB Field Investigation

Synopsis

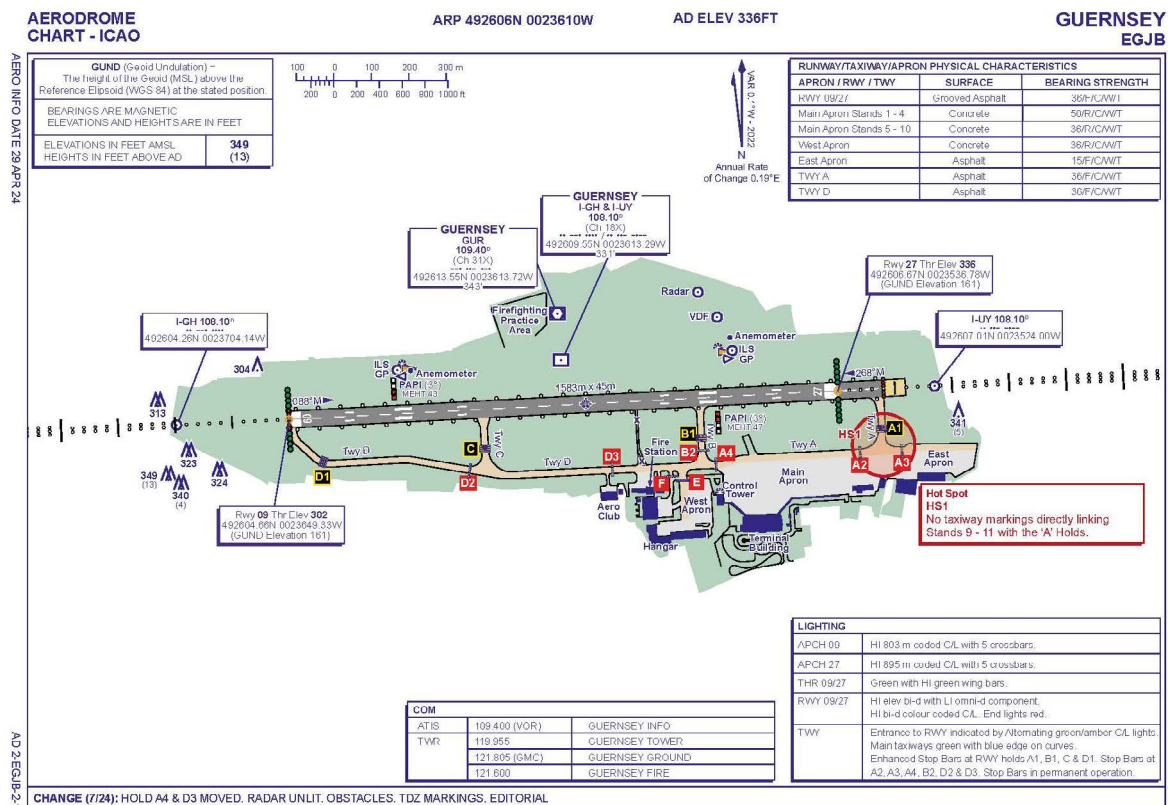
Figure 1
 Guernsey Airport AIP Aerodrome Chart

The commander stated he would normally aim to touchdown on Runway 27 at the touchdown markers abeam Taxiway B (Figure 1). He stated that on this occasion he flew across the runway threshold at about 50 ft, as intended, and then flared the aircraft to try and achieve gentle touchdown. This resulted in the aircraft floating down the runway for an extended period, compounded by the runway gently sloping away from the aircraft. The commander stated that a combination of the aircraft pitch and runway slope meant he was unaware of how far down the runway the aircraft had travelled. Both the co-pilot and safety pilot reported they had also not realised how far the aircraft had travelled and did not consider they needed to warn the commander or call for a go-around. When the aircraft did finally touch down, it was about two-thirds of the way down the runway.

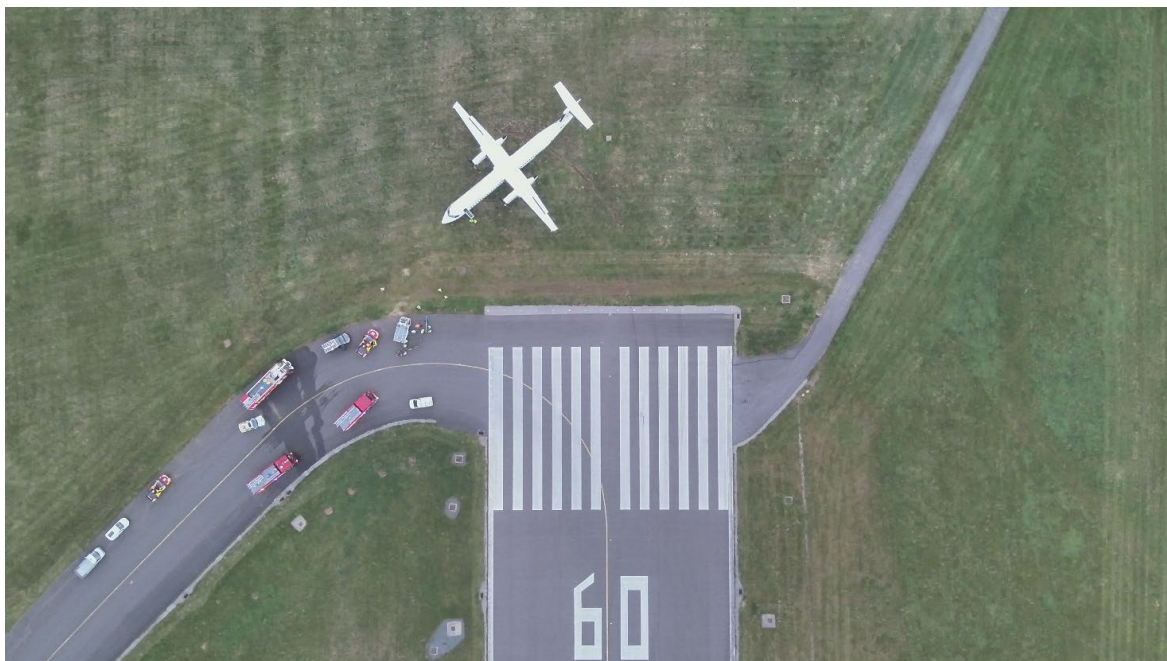
Figure 2

The aircraft stopped approximately 30 m from the end of the runway in the grassed area (Figure 2), the main landing gear (MLG) had ploughed a deep furrow in the grass, and the nose gear right wheel had accumulated a thick layer of soil. There were tyre markings on the runway showing the aircraft veering to the right towards the end of the runway. The tyre markings had the characteristic intermittent skid pattern showing where the Anti-Skid system was functioning. Other than disruption of the grassed area there was no other damage to the airfield surfaces or equipment.

Location of aircraft (image used with permission)

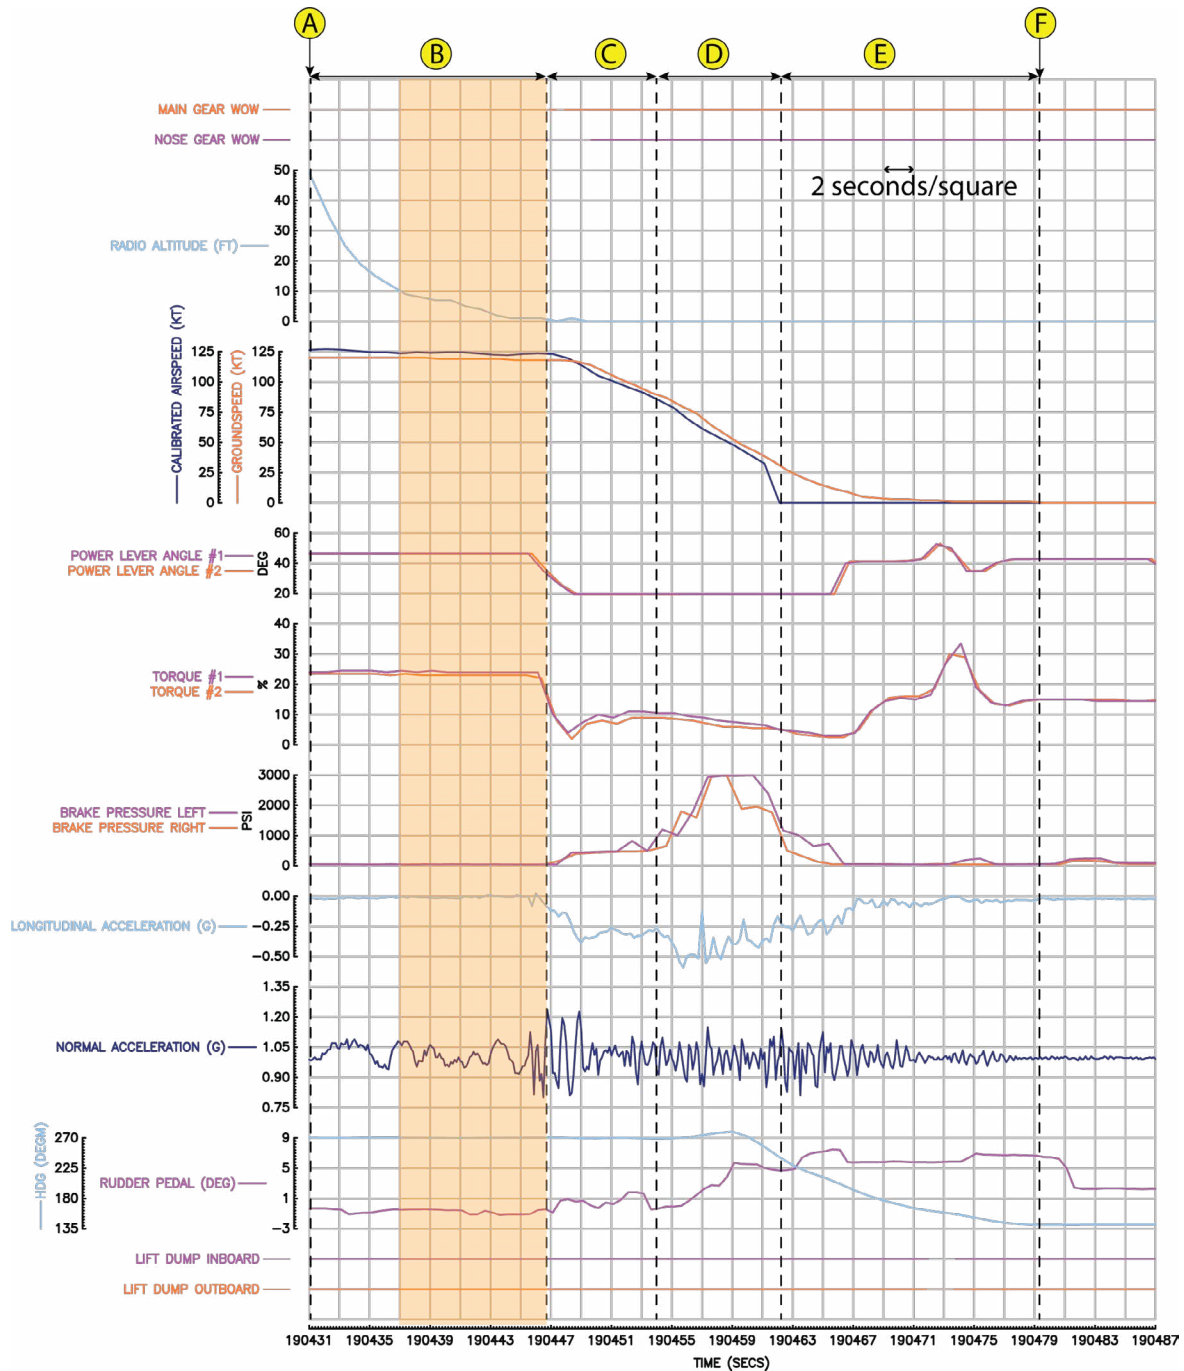
Figure 3
FDR data of the landing

This shows that 9H-LWB passed over the runway threshold at a height of 50 ft and with an airspeed of 124 kt, point A on Figure 3. Region B on Figure 3 shows 9H-LWB's descent from 50 ft to main landing gear touchdown and, the shaded region, represents the time that 9H-LWB was below 10 ft but hadn't yet touched down. During this 10 second period, with a ground speed of 120 kt, equivalent to 62 m/s, 9H-LWB would have consumed 620 m of the available landing distance (1,463 m). Region C shows that after a small bounce on the main landing gear manual braking was applied, using 500 psi out of 3,000 psi that was

available, the power levers were reduced to the DISC position¹ and the nose gear touched down. The recorded latitude and longitude at the point when the nose gear touched down placed 9H-LWB just after Taxiway C, approximately 520 m from the end of the runway. Region D shows initially symmetric braking, followed by an increased application of left rudder and then asymmetric braking to counter the deviation to the right, that is seen in the heading and, finally the application of maximum braking pressure of 3,000 psi, which was maintained for 3 seconds. Region E covers the period where 9H-LWB left the paved runway, at approximately 25 kt ground speed, until it came to a stop, at point F. During this period, an attempt was made to taxi the aircraft back onto a paved surface, which is seen in the data by use of increased levels of engine power.

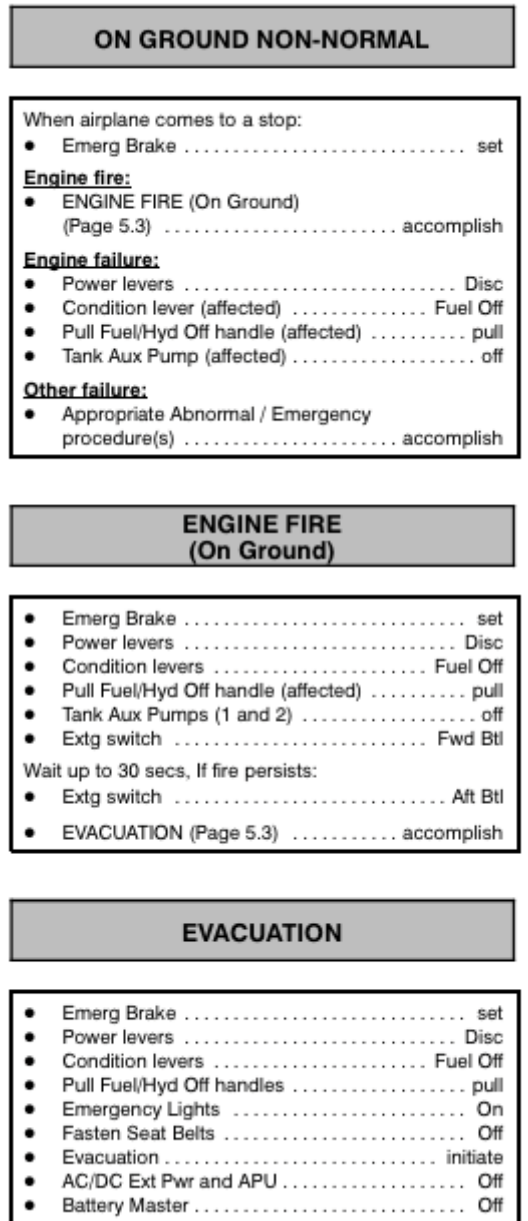
Figure 4

The aircraft carried a copy of the manufacturer's QRH. This included checklists entitled '*on ground non-normal*' and '*evacuation*' (Figure 4). It was noted during the investigation that these checklists were not signposted in the QRH index but were included under Section 5, marked in the index as '*Engines, APU, Propellers*' (Figure 5). Without specific knowledge of where the emergency shutdown and evacuation checks appeared, there was nothing to assist locating them.

On Ground Non-Normal and Evacuation QRH Checklists

The investigation highlighted the difficulty of finding the appropriate emergency shutdown checklist in the manufacturer's QRH. It is accepted that the crew did not attempt to find the checklist and so, in this instance, it is unlikely that this contributed to their failure to use them. It is, however, considered that in other circumstances the difficulty in identifying the emergency shutdown and evacuation checklist may have a significant outcome. The manufacturer is of the view that there is not an issue based on many years of operation and that it is for operators to develop and train on the use of the normal and abnormal emergency procedures. The operators will base their QRH on that provided by the manufacturer and are unlikely to deviate. However, at least one major operator has taken it upon themselves to make the checklist more easily identifiable and accessible.

It is recommended that De Havilland Aircraft of Canada Limited reviews the location and indexing of the 'on ground non-normal' and 'evacuation' checklists in the DHC-8 Quick Reference Handbook and makes appropriate changes to improve their ease of access during an emergency.

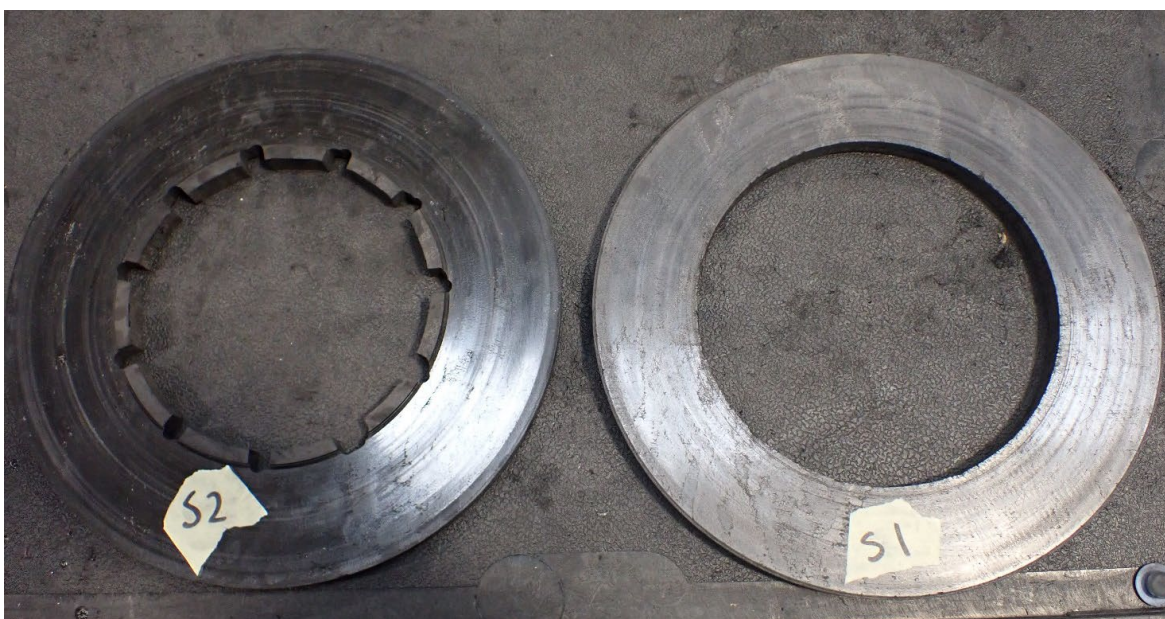
Figure 6

The brake unit with the broken stator was taken to the manufacturer for further examination. When disassembled it was found that stator No S1 had lost all its locating lugs (Figure 6) and was free to rotate around the brake torque tube.

Comparison of stators S2 and S1 showing lug wear on S1

The locating lugs which are made of carbon had been filed away by the splines on the torque tube. This occurred because the torque tube had suffered severe corrosion causing the surface to be rough, effectively acting as a file on the carbon locating lugs. The torque tube was sent for a metallurgical examination to understand what had caused the corrosion. The examination confirmed that at some point in its overhaul history the torque tube nickel

alloy surface had been incorrectly treated with a high temperature resistant coating such as paint. This was evidenced by the presence of aluminium on the surface of the torque tube and in the corrosion pits. The manufacturer concluded that this would have an approximate 25% reduction in braking performance on this individual brake unit, but that this effect would be compensated for by the Anti-Skid system. Analysis of braking distance performance showed that the increase in braking distance between the fully working brake system and the worst case of a seized brake calliper for a wet runway is an additional 13 metres of braking distance. The AMM³ for the aircraft calls for a visual inspection of the brake unit for signs of wear, damage and cleanliness, but does not require a physical check for stator movement of brake units during tyre/wheel changes. The thickness of brakes is monitored during operation and these will be removed for repair and overhaul as required and also checked as part of the aircraft base maintenance cycle. It was not possible to determine if the stator had become completely detached prior to the flight on which the serious incident occurred.
