Report on the investigation of  
a subsea explosion  
resulting in crew injuries and vessel damage  
to the crab potting vessel

***Galwad-Y-Mor (BRD 116)***

22 nautical miles north of Cromer, England  
on 15 December 2020

REPORT NO 1/2022

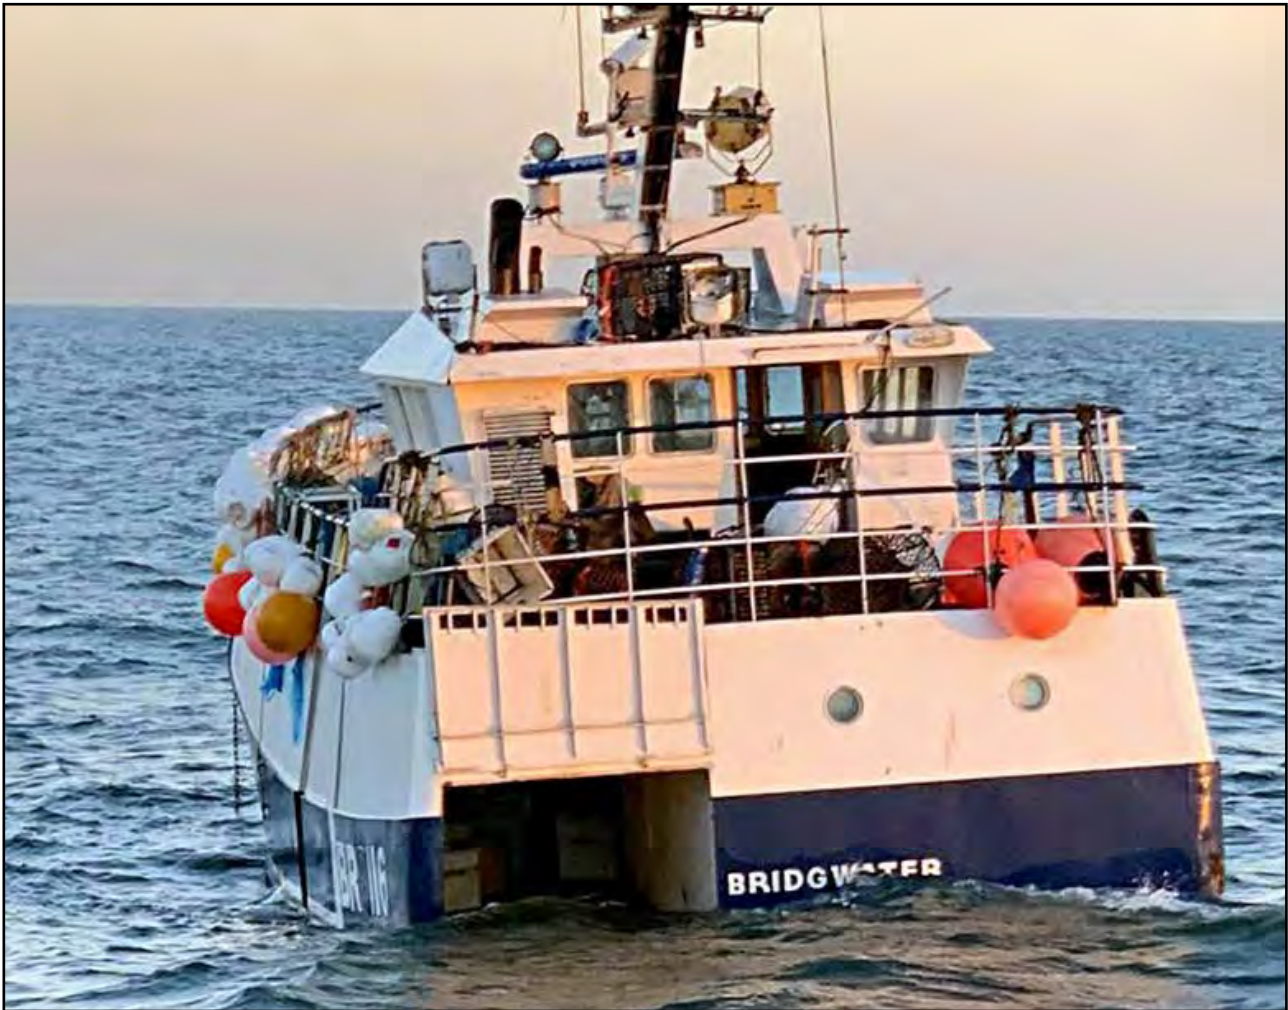
**Figure 2:** *Galwad-Y-Mor* settled low in the water

*Galwad-Y-Mor* remained afloat despite having one flooded compartment that caused the vessel to settle low in the water close to its maximum draught of 3.6m at the stern. The flooding of the engine room increased the vessel's draught and reduced the freeboard to such an extent that the main deck was at sea level, which allowed seawater onto the deck. As all main deck watertight doors and hatches were closed, and the transverse main deck bulkheads remained watertight, the seawater was prevented from entering other compartments, and the stability of the vessel was not compromised further.

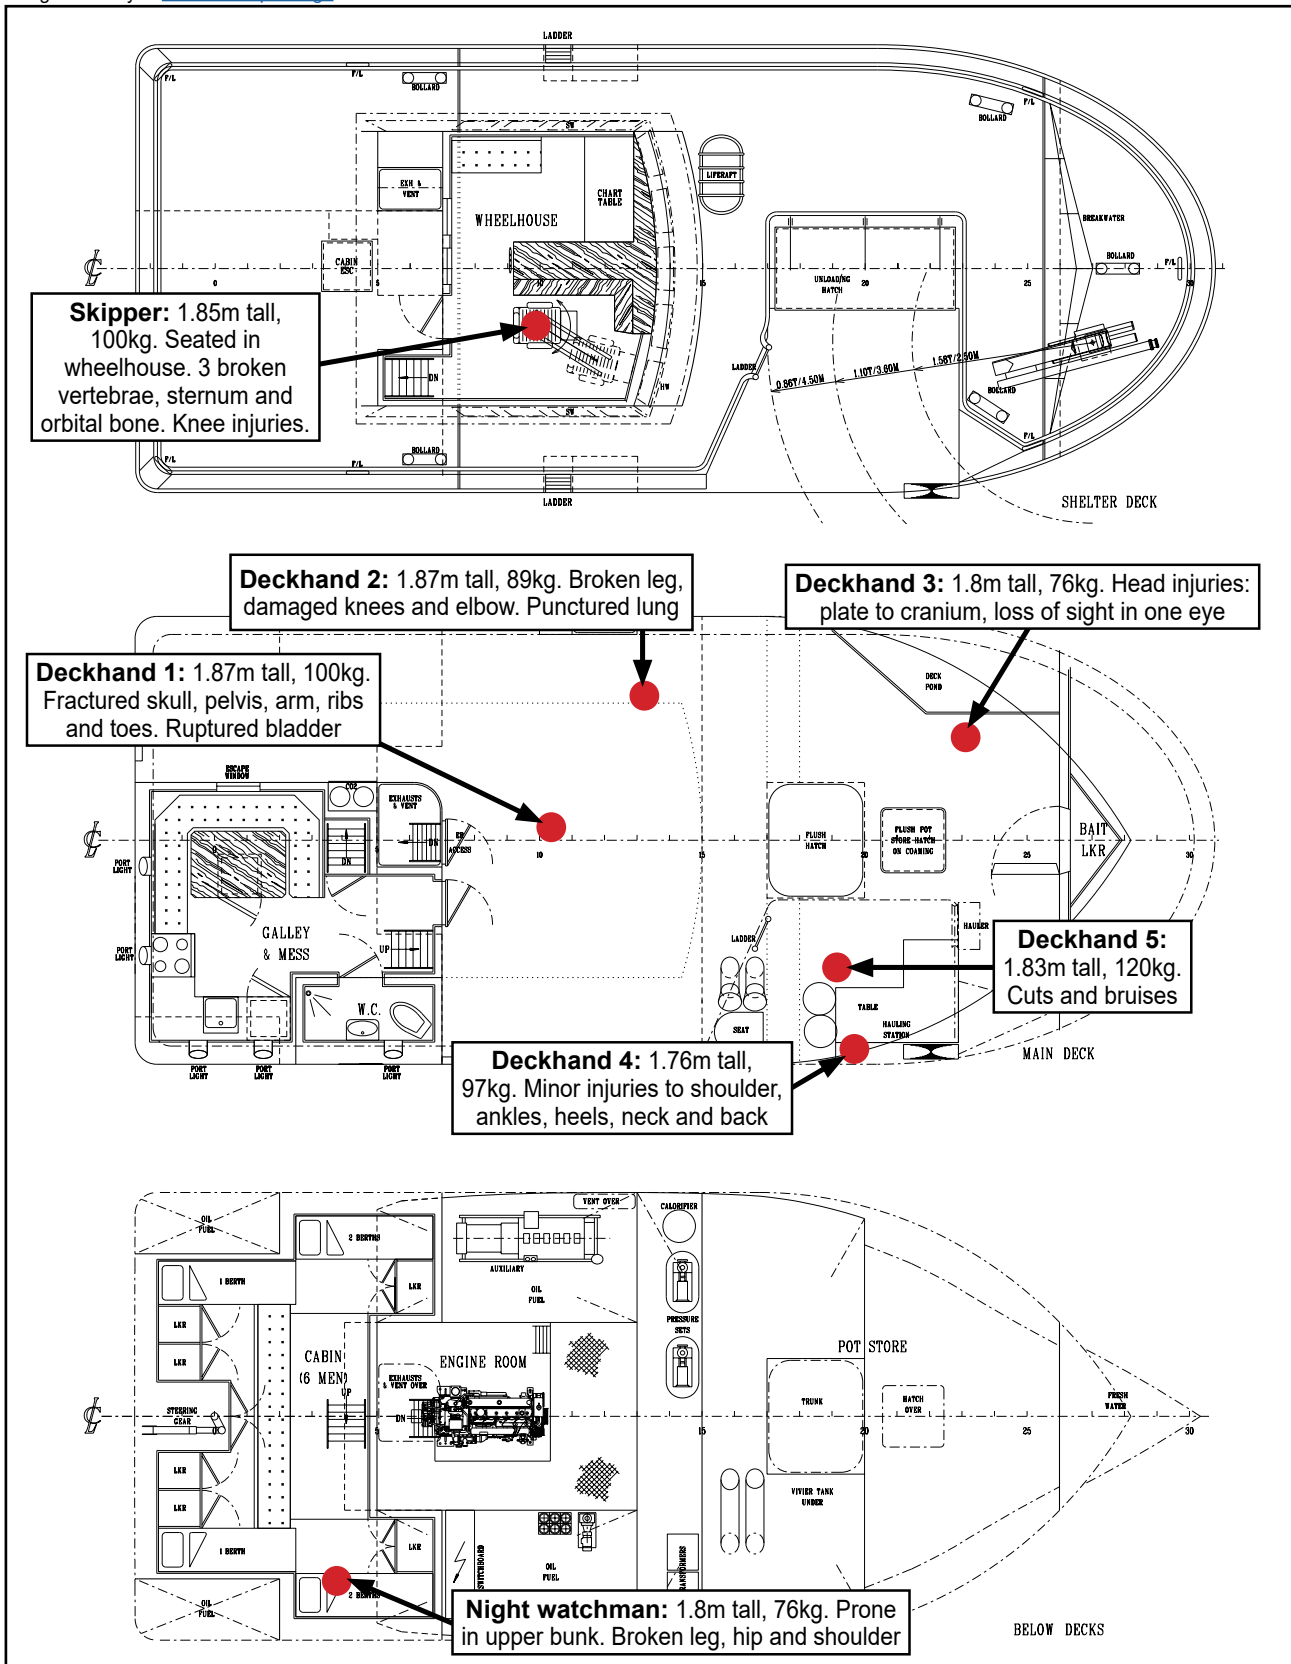
**Figure 6:** Position of crew and injuries sustained at time of the accident

Most of the injuries experienced by the crew were of a blunt force trauma nature and did not include penetrating wounds, burns or major internal damage (**Figure 6**). These were consistent with tertiary injuries most likely caused by the acceleration forces the crew experienced when *Galwad-Y-Mor* was thrown about. The head injuries to deckhands 1 and 3, who were not wearing safety helmets, suggests they struck the deckhead at the time of the accident. The skipper was seated when the

bomb exploded and struck his head on the wheelhouse deckhead, which caused injuries to his eye socket and face. His back and knee injuries were probably incurred when he landed back down on the deck.

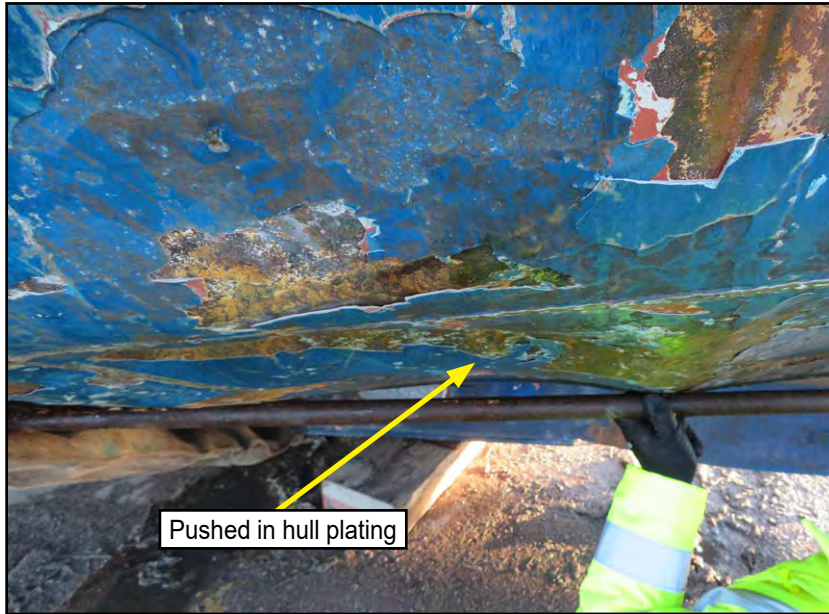
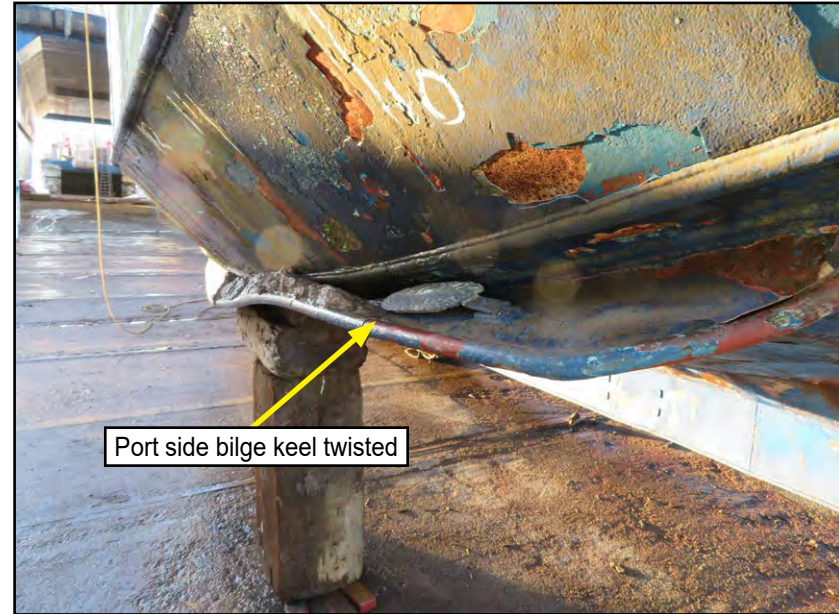
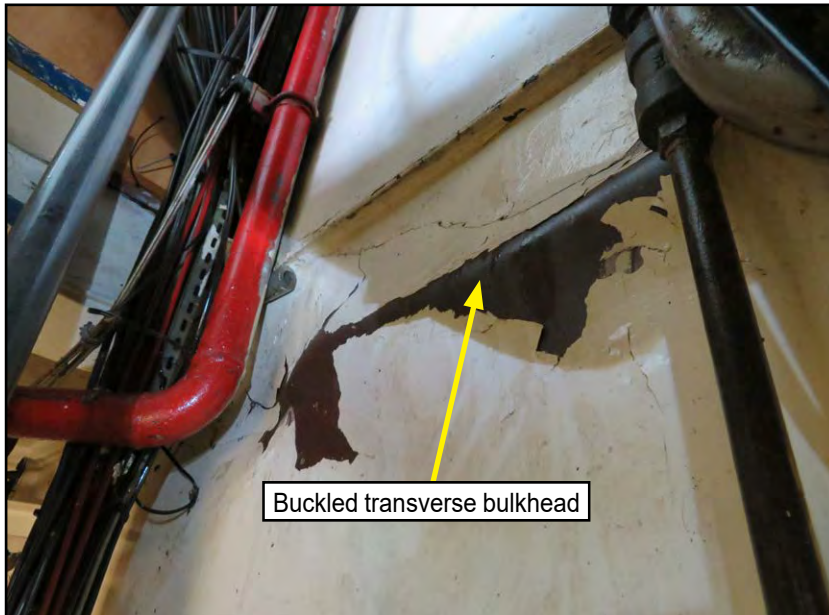
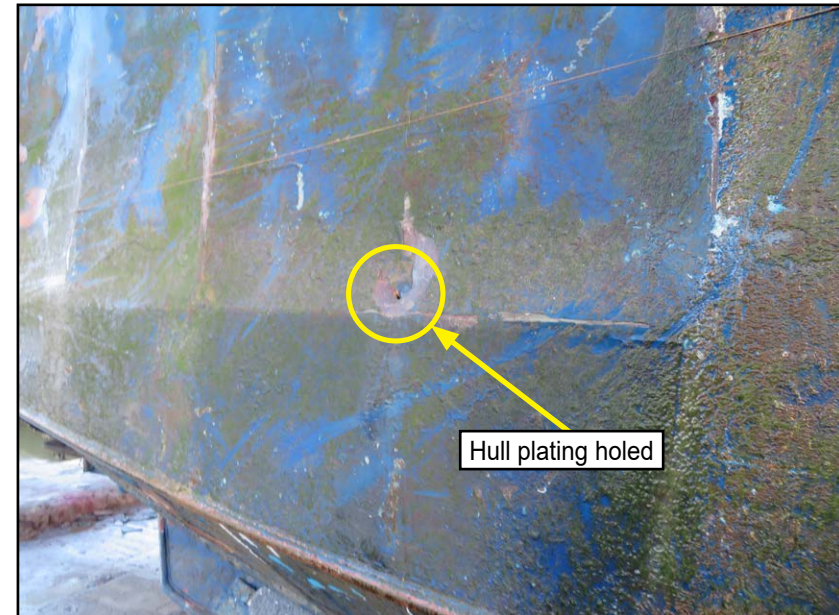
**Figure 7:** *Galwad-Y-Mor* structural damage

There was significant structural damage to *Galwad-Y-Mor*. Hull plating was pushed in by up to 40mm between frames and the starboard side hull plating was holed. The transverse bulkheads were buckled, and the port side bilge keel was twisted (**Figure 7**).

The potting string quickly tightening at the hauler suggested that the bomb was directly below the vessel on the seabed prior to the explosion. The hull plating deformation, buckled bulkheads, and machinery and equipment displacement were commensurate with *Galwad-Y-Mor* interacting with the shock wave created by the explosion. It is likely that the single hole to the hull plating was caused by the plating bending in way of the adjacent structure and fracturing as a result.

It is therefore concluded that *Galwad-Y-Mor* was close to the explosion and well below the MOD's recommended 530m safe stand-off distance for non-military vessels to be unaffected by a seabed explosion of this size. Nevertheless, *Galwad-Y-Mor*'s thick shell plating presented good resistance to the shock wave generated by the explosion, and the heavy section box keel was able to resist bending forces set up by the pulse bubble underneath the vessel.

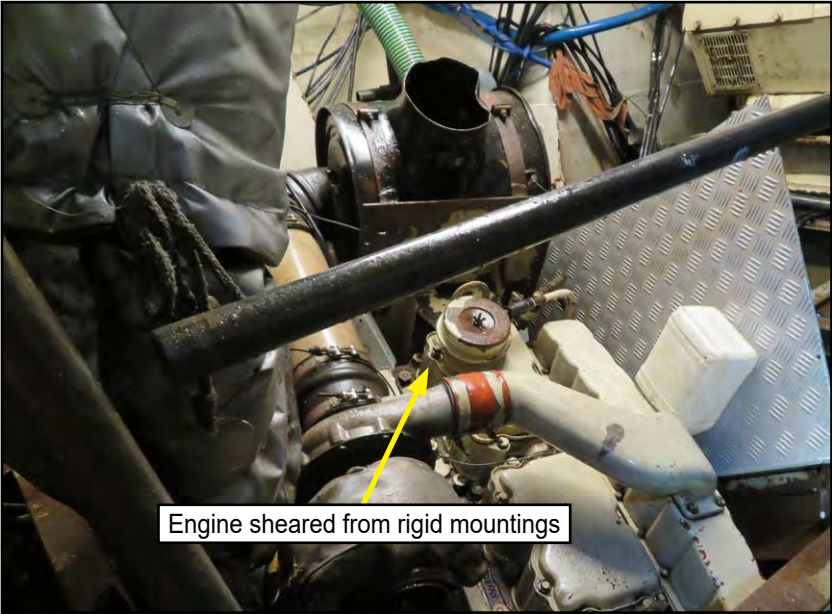
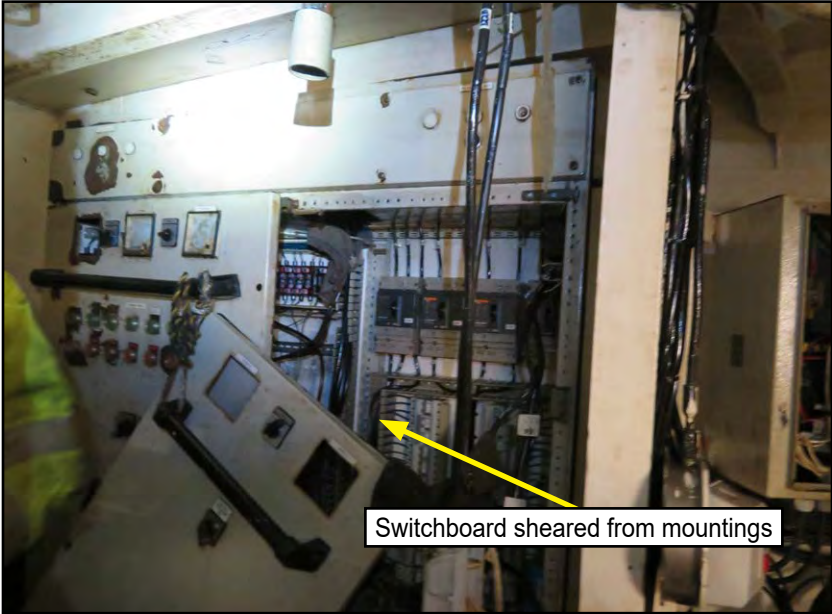
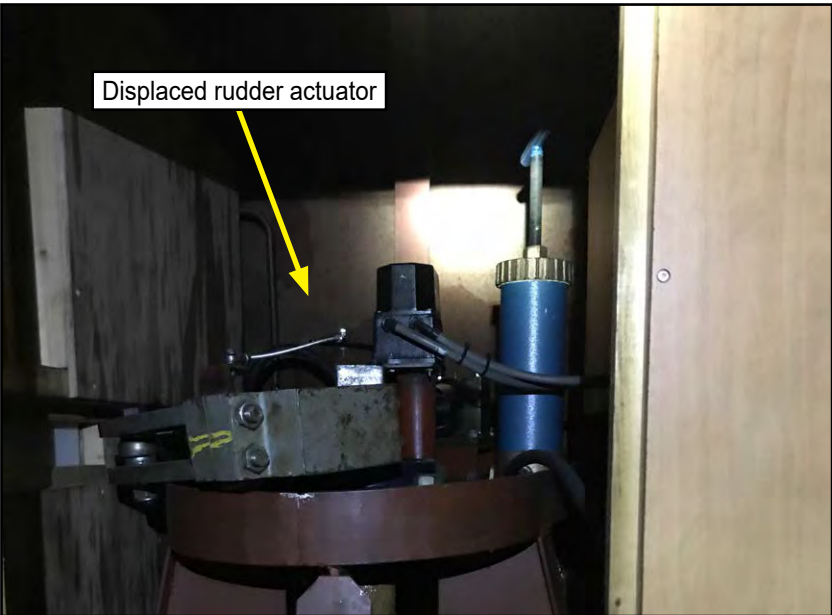
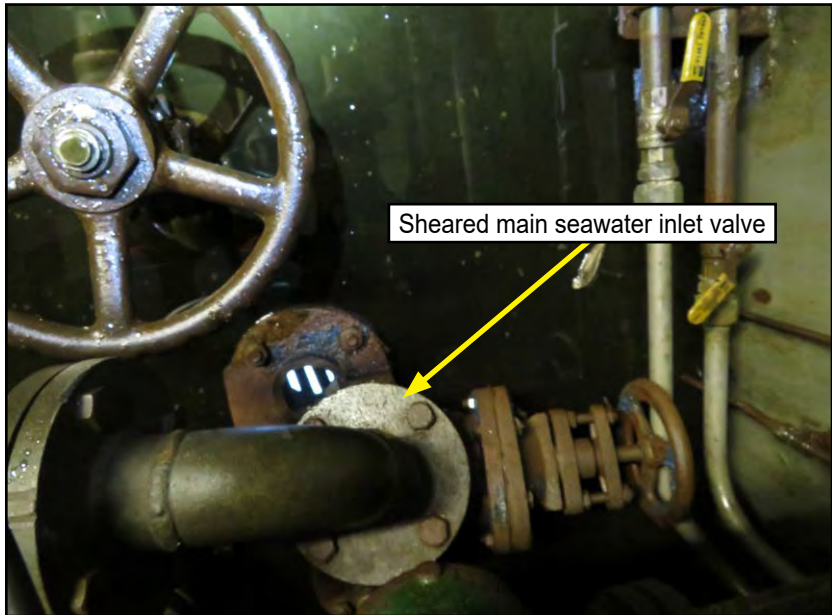
Figure 8: Galwad-Y-Mor machinery damage

The main engine, gearbox, generator, switchboard, hydraulic power pack and miscellaneous small pumps sheared from their rigid mountings. The main seawater inlet valve was sheared at its inlet flange and the engine room was flooded to the top of the compartment. The rudder actuator was displaced from the rudder stock (**Figure 8**).

*Galwad-Y-Mor*'s machinery mountings and internal fit out were damaged because they were not designed to withstand the forces created by the action of the vessel being thrown about.

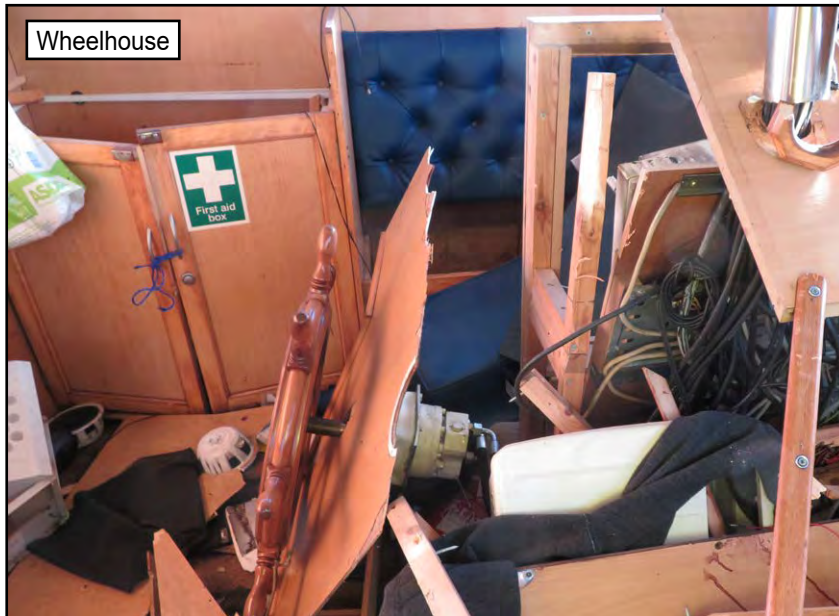
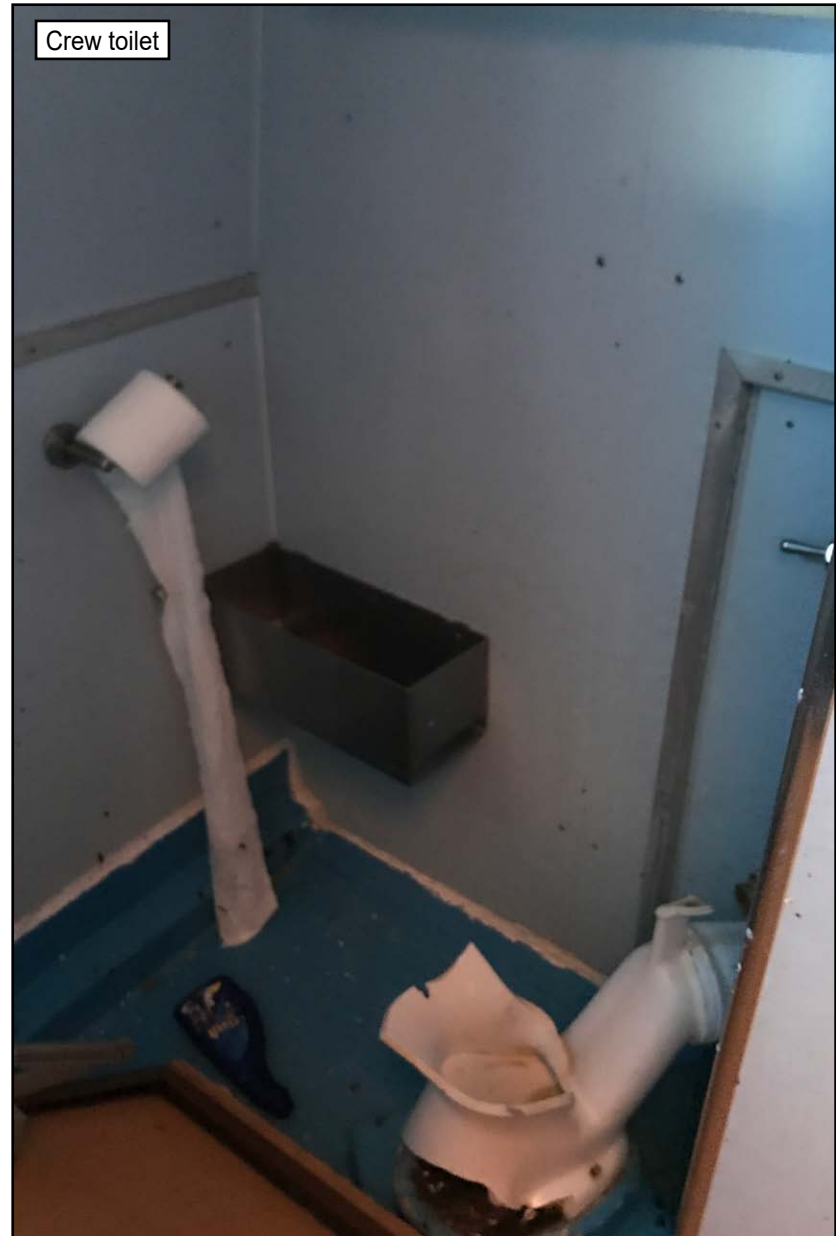
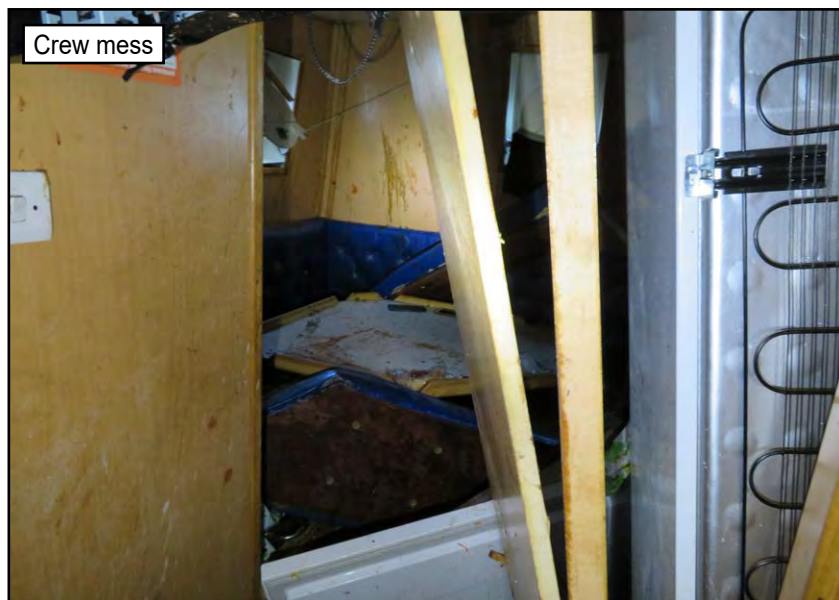
Figure 9: Galwad-Y-Mor interior damage

The wheelhouse equipment and linings were displaced from their mountings. The outfitting of the galley, crew mess, toilet and cabin was significantly damaged (**Figure 9**). There was a great deal of disruption to external deck areas with numerous instances of scattered equipment, damage to mast-mounted antennae, displaced light fittings, and broken pipe clamps.

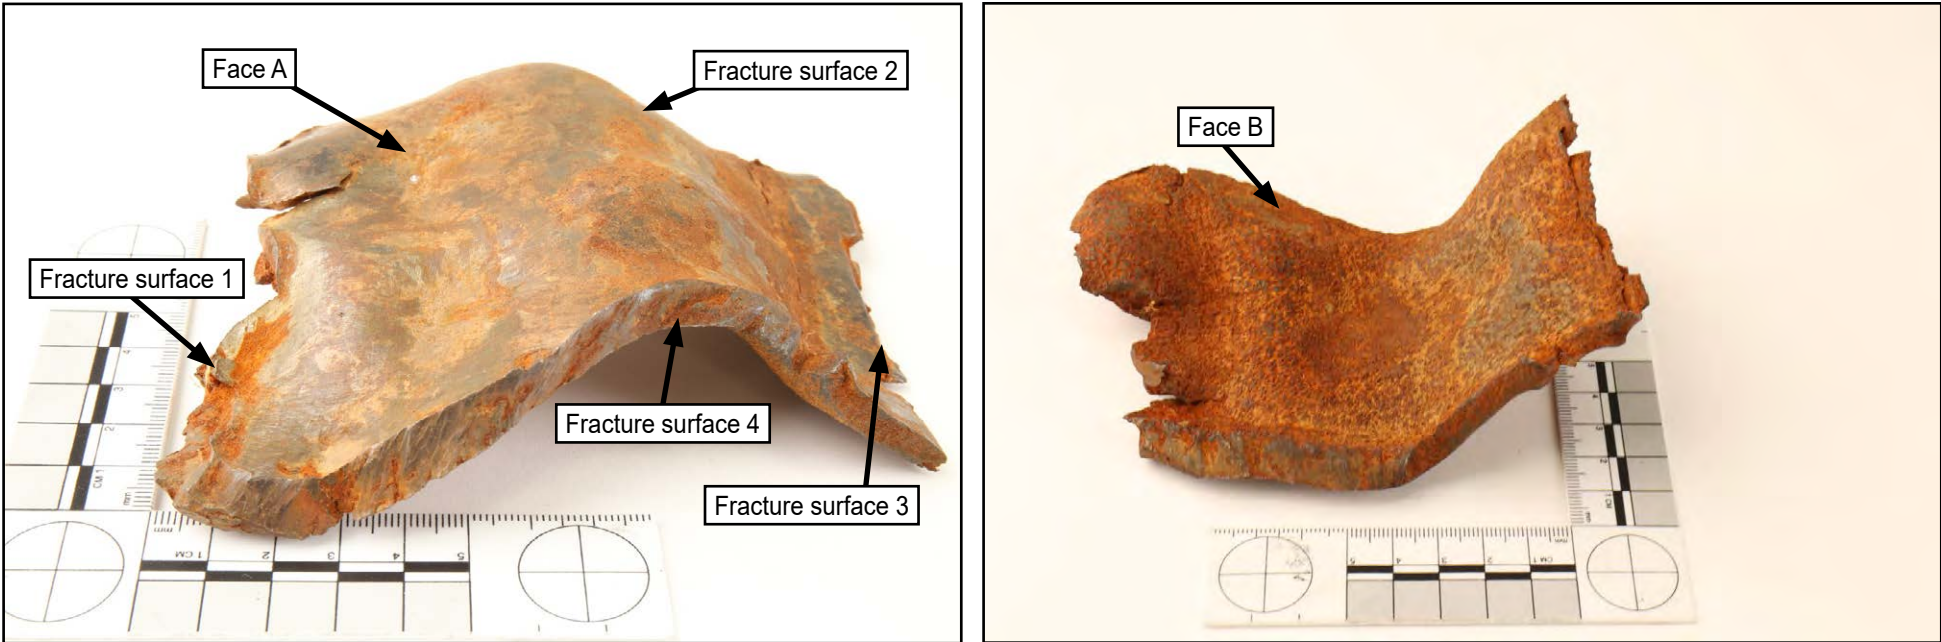
Figure 10: Steel fragment detail

The metal fragment (**Figure 10**) was magnetic and measured 94mm in length, 129mm in width and had a 7.41mm average thickness. Visual inspection showed that the metal fragment had deformed into a curved shape. Rust was visible on

both sides and observed as more progressed along the concave face (Face B), indicative of longer exposure to a corrosive environment or an accelerated reaction to corrosion.

The metal fragment's four fracture surfaces (**Figure 10**) were examined with scanning electron microscopy and showed features consistent with ductile microvoid coalescence (MVC)<sup>7</sup>. These features are indicative of ductile overload, which is the failure mode that occurs when a material is loaded to beyond its ultimate tensile strength. Optical profilometry showed machine tool marks on the metal fragment's convex face (Face A) (**Figure 10**) consistent with a turning tool<sup>8</sup> machining process.

The lack of overall corrosion to the recovered fragment suggests that the bomb was buried below the seabed for several years. The light corrosion to one surface of the metal fragment indicates that the bomb was intact and not flooded, therefore the explosive charge had not been washed away by seawater.

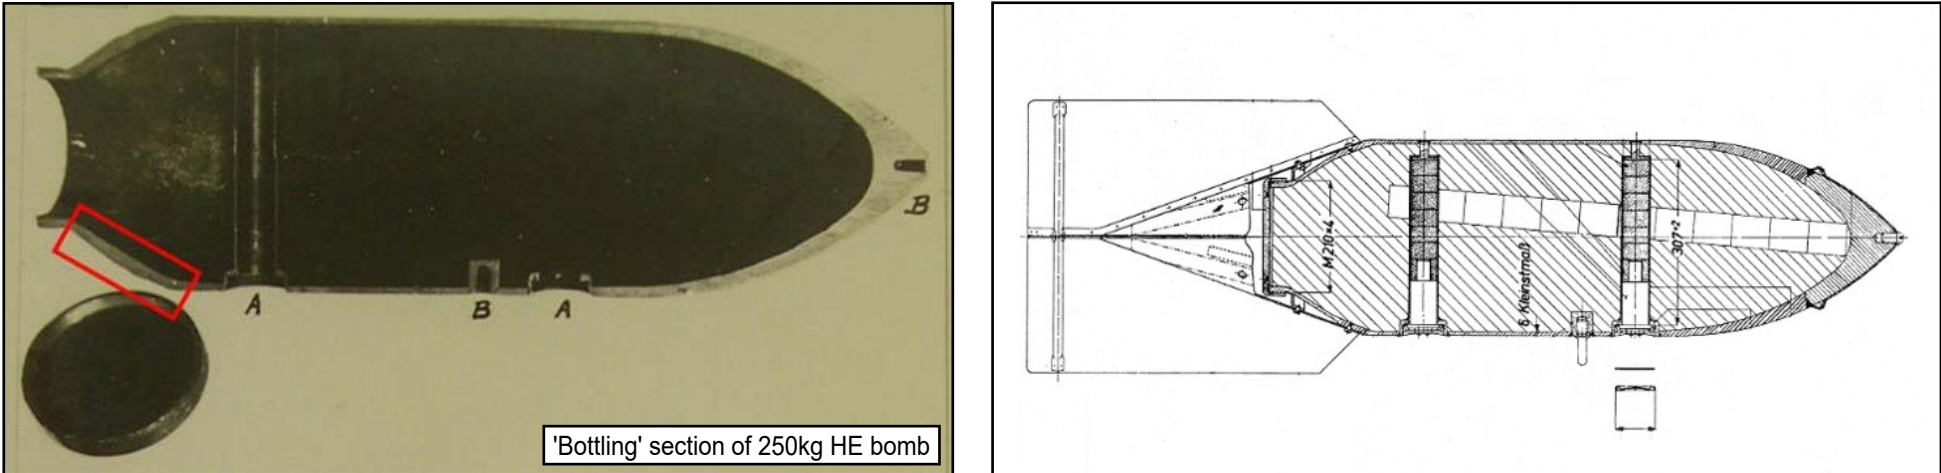
Figure 11: SC250 high explosive bomb

1. The material thickness was greater than that commonly used in torpedoes and depth charges.
2. The material thickness was greater than that used in WWI and WWII British and German sea mines. Also, the elemental composition of the fragment was remarkably different from a WWII German mine casing, which tests found was made from iron with 0.5% manganese and no other alloying elements.
3. The material thickness and machining method was comparable with that used on the 'bottling section' of a general purpose (GP) high explosive (HE) air-dropped bomb (**Figure 11**). The fragment's elemental composition was
