## Accident

<b>Aircraft Type and Registration:</b>	Amateur-built balloon (DB-6R), G-CMFS	
<b>No &amp; Type of Engines:</b>	1 Ultra Magic Mk 21 LPG twin burner	
<b>Year of Manufacture:</b>	2022	
<b>Date &amp; Time (UTC):</b>	25 June 2023 at 0519 hrs	
<b>Location:</b>	Ombersley Court, Worcestershire	
<b>Type of Flight:</b>	Private	
<b>Persons on Board:</b>	Crew - 1	Passengers - None
<b>Injuries:</b>	Crew - 1 (Fatal)	Passengers - N/A
<b>Nature of Damage:</b>	Balloon destroyed	
<b>Commander's Licence:</b>	Commercial Pilot's Licence (Balloon)	
<b>Commander's Age:</b>	25 years	
<b>Commander's Flying Experience:</b>	569 hours (of which 33 were on type) Last 90 days - 10 hours Last 28 days - 3 hours	
<b>Information Source:</b>	AAIB Field Investigation

## Synopsis

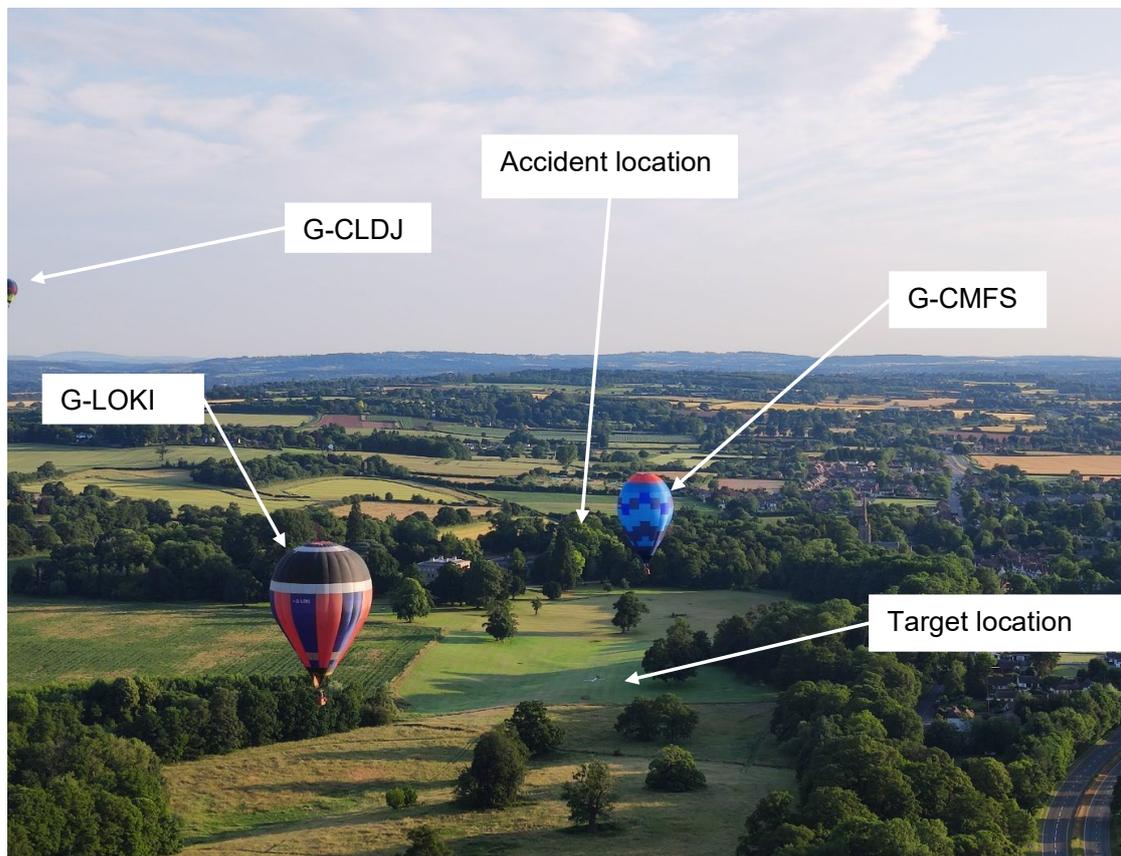
**Figure 5**

Balloons approaching the target at Ombersley Park (taken from G-CLHS)

G-CLHS's pilot recalled G-CMFS had just flown over the target and was climbing rapidly. He recalled seeing grey smoke coming from G-CMFS, although he stated this was not unusual and it just suggested the pilot was using the burner frequently and for long enough to cause the heat resistant material at the base of the balloon to singe. The next time he looked up he saw the balloon 'streamered' and descending rapidly (Figure 6).

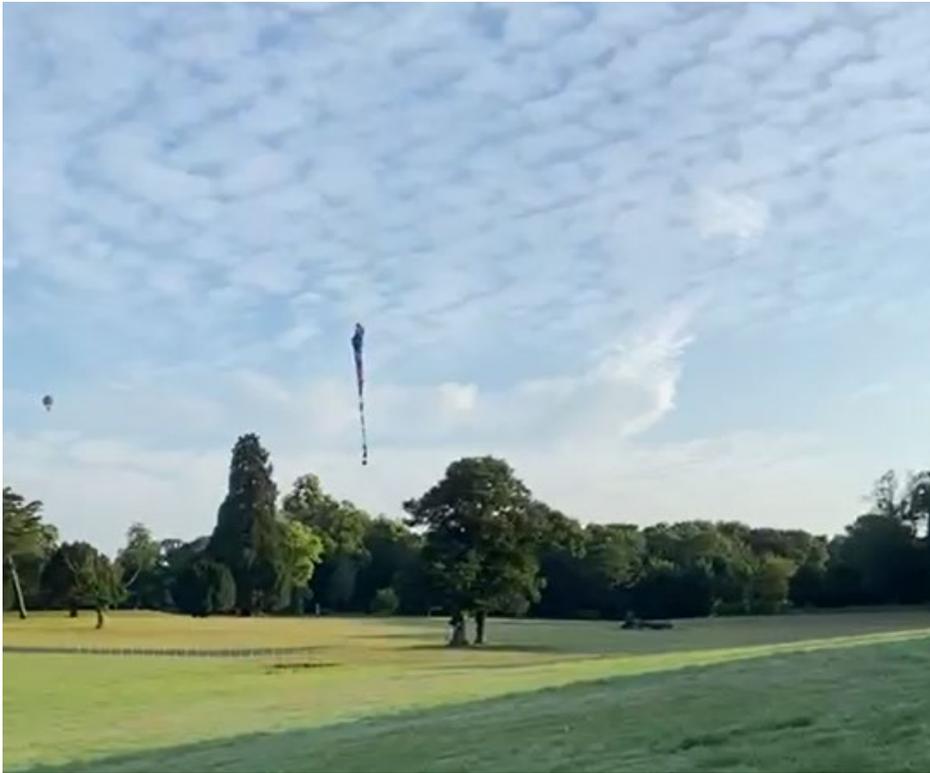
**Figure 6**

G-LOKI's pilot reported seeing G-CMFS climbing fast, she also recalled seeing the smoke. She recalled that she then heard the sound of fabric "whipping", "the crack of fabric, like you might hear during inflation when the wind caught the balloon". This sound caused her to look up and she saw G-CMFS falling with the balloon streamered. She recalled just seeing burnt fabric streaming above the basket.

G-DANJ's pilot also recalled seeing the balloon envelope streamered and dropping to the ground.

G-CMFS descending to the ground with the balloon streamered

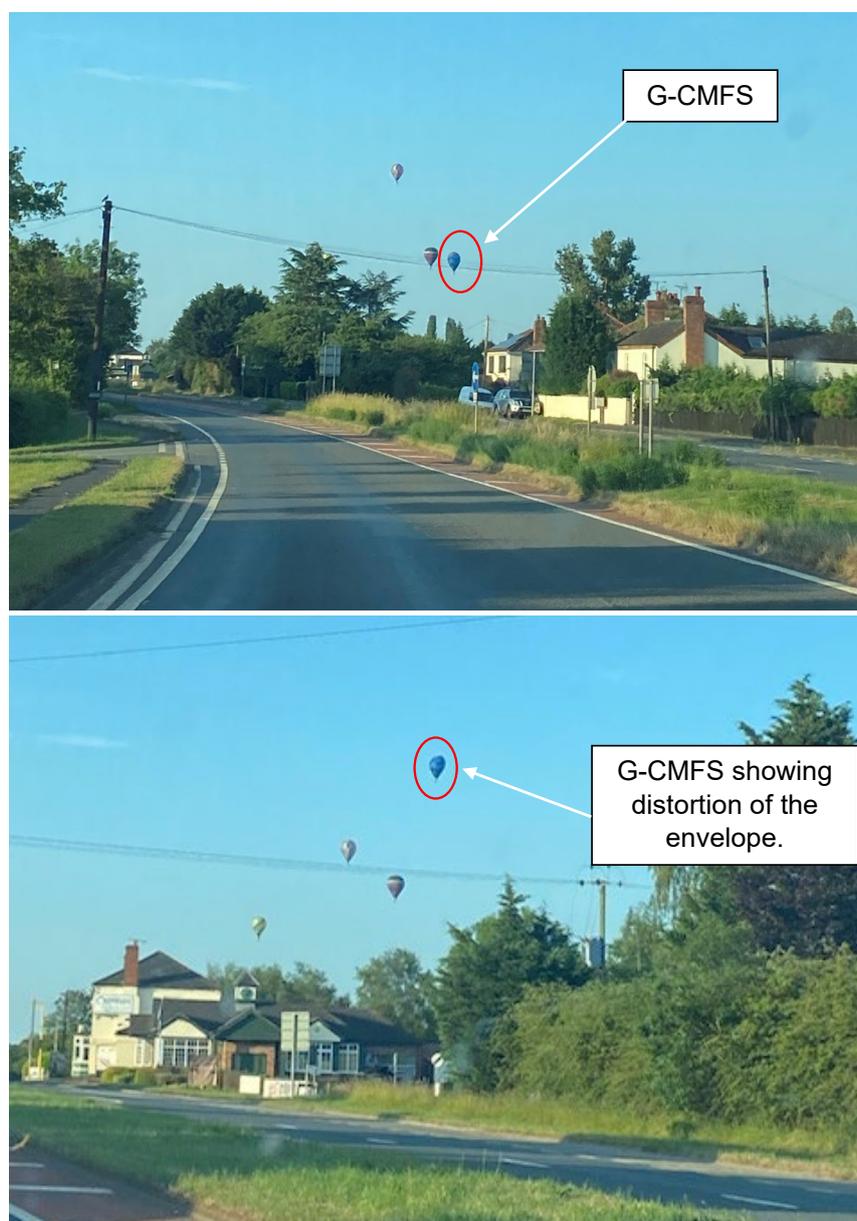
**Figure 7**

One couple at a petrol station on the A449 saw the balloons flying and took some photographs, which were all time-stamped at 0518 hrs (Figure 7). One of them commented that, within seconds of taking the second photo, "the blue one didn't look inflated properly, it looked like it did not have enough air in it". They described that one side of the balloon looked like it was pushed in at its widest part and "it looked like a half-moon shape". As this happened, they instantly saw the burner come on but described that "it caught the right side

of the balloon” with “the flame on the outside of the balloon”. They then saw the basket fall to the ground. They described seeing “just the basket” and what looked like “a long piece of string”. They said it looked like “tissue paper or a shoelace with a thin flame and black smoke”, “just a basket on its own dragging a piece of string”.

Photos taken by a witness on the A449 both taken at 0518 hrs

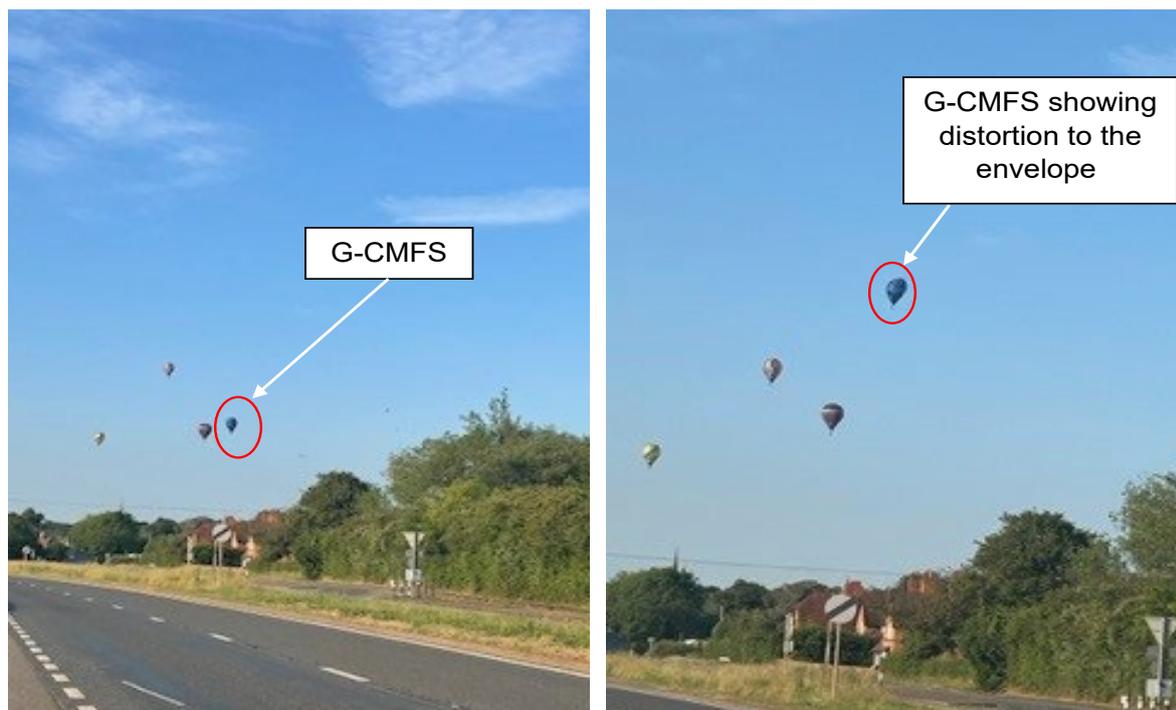
**Figure 8**

Another witness also took some pictures from the A449 (Figure 8), all time stamped at 0518 hrs. A further witness on the A449 recalled that the burner was still burning during the descent, but there was no fire other than the flame from the burner. A witness, who was 150 – 200 m away from the eventual accident location, was watching G-CMFS as it ascended. He described hearing a “loud puff” and said it was like all the air suddenly disappeared from the balloon, “like the top had opened up” or “someone had lifted the lid on it”. He said there was no fire or explosion.

Sequence of photos taken by a witness on the A449 at 0518 hrs

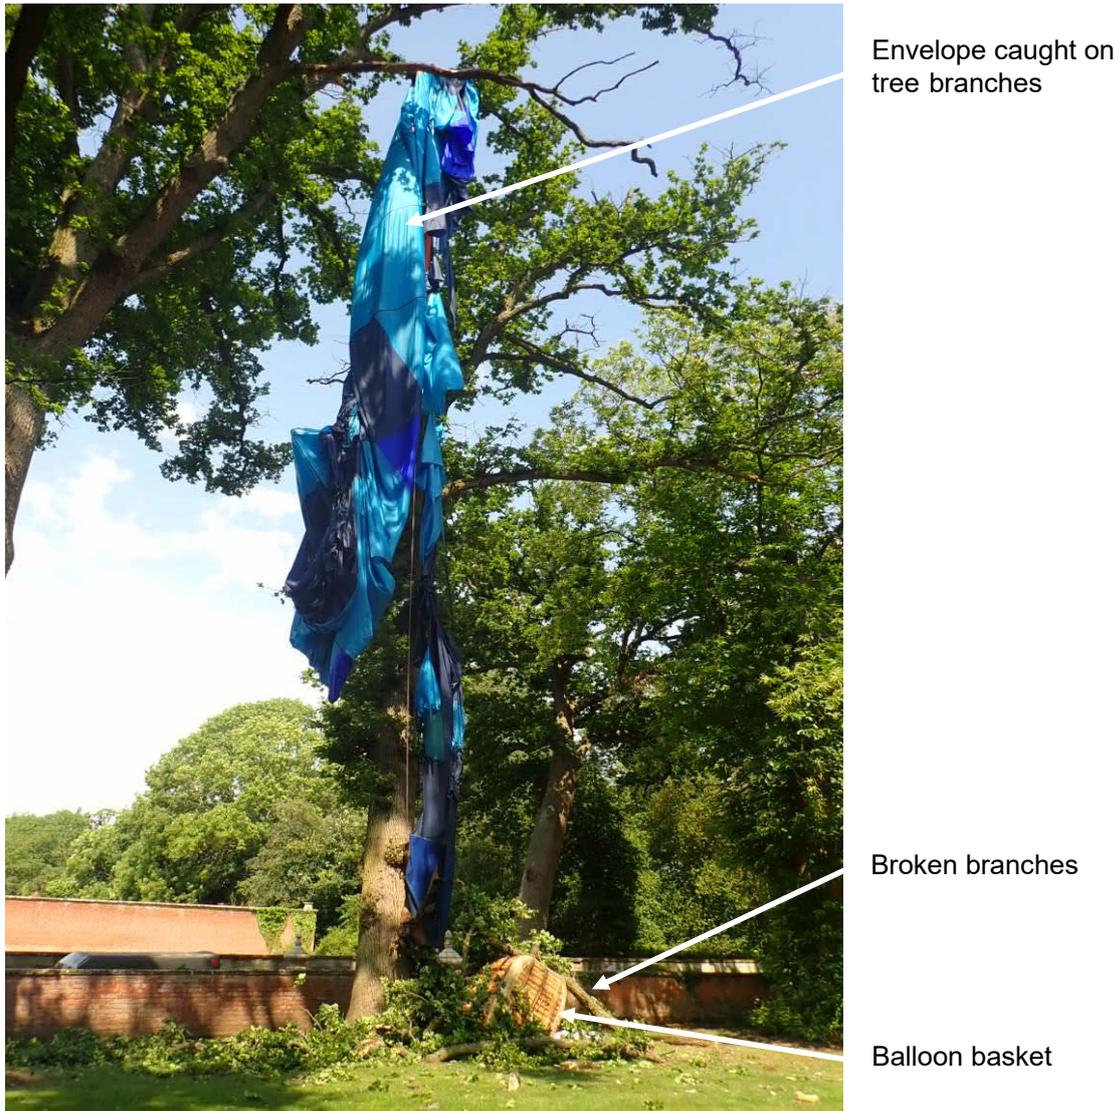
**Figure 13**

The balloon's envelope was suspended vertically above the ground where it had snagged on the fractured remains of tree branches (Figure 13). Broken branches were scattered around the base of the tree with some landing on top of the balloon's basket.

Balloon envelope suspended by broken tree branches above the basket

The envelope appeared to have been torn by the sharp remains of the branches as it descended through the foliage. Further damage was caused to the envelope as the wind increased throughout the day and conditions became increasingly blustery, resulting in additional tearing as the material billowed in the turbulent air.

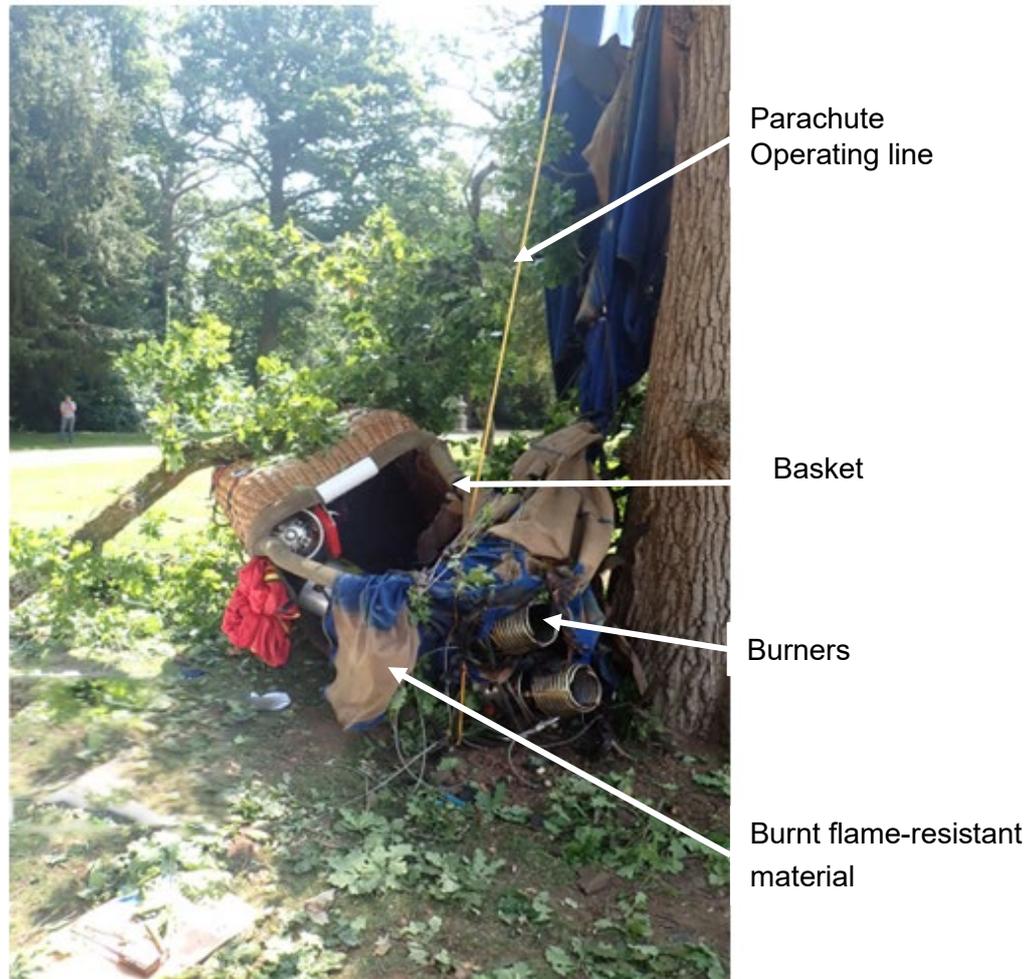
**Figure 14**

At the base of the tree, the balloon's basket was on its side with the burners still mounted to the basket by burner support rods. The rigging points and karabiners were intact and remained attached to their steel rigging lines. The charred remains of blue heat-resistant material were wrapped around the burners, rigging lines, and the bright orange and yellow fluorescent parachute operating line (Figure 14).

Basket on its side showing burners, operating line and burnt heat-resistant material

There were no signs of fire damage on the ground, around the tree or on the tree trunks. The carbon fibre parachute operating line had suffered some heat damage, with small amounts of orange and yellow nylon rope material that had melted and dripped onto the lower panels of the envelope and the basket. However, the carbon fibre line had not burned through and was still in one piece.

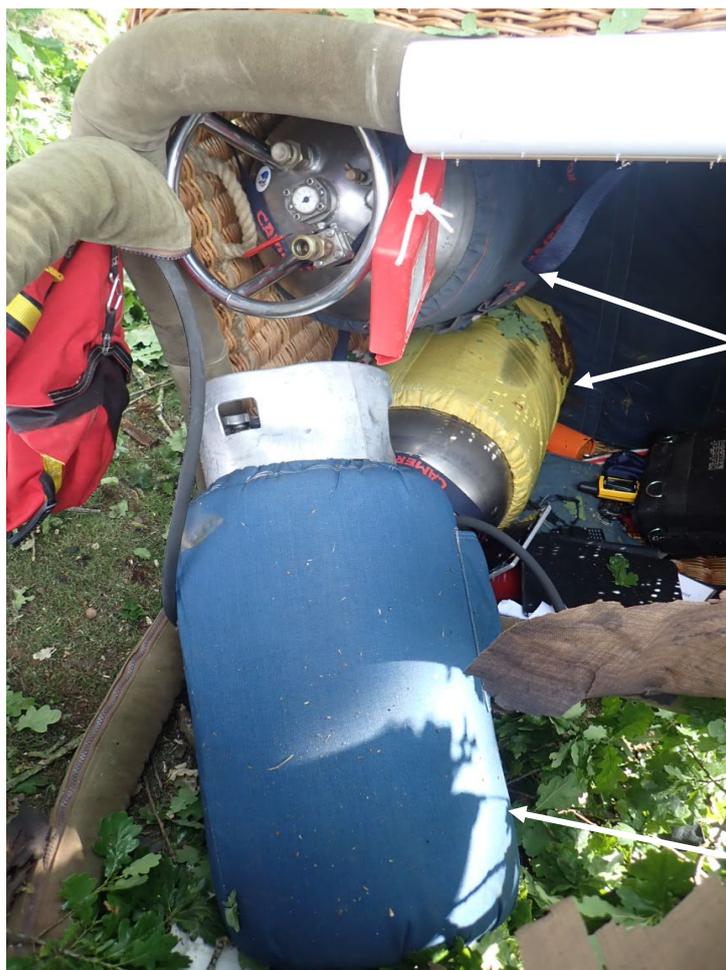
Two LPG cylinders  
strapped to the basket

Third LPG cylinder had  
been moved by  
rescuers

Whilst the loose cylinder was empty of fuel, the yellow jacketed cylinder, shown in Figure 15, was connected to the burners and was found to be approximately half full. The blue jacketed cylinder seen at the top of Figure 15 that was partially strapped to the basket, was not connected to the burner unit and had a damaged contents gauge. It was found to be full during fuel transfer to an undamaged cylinder.

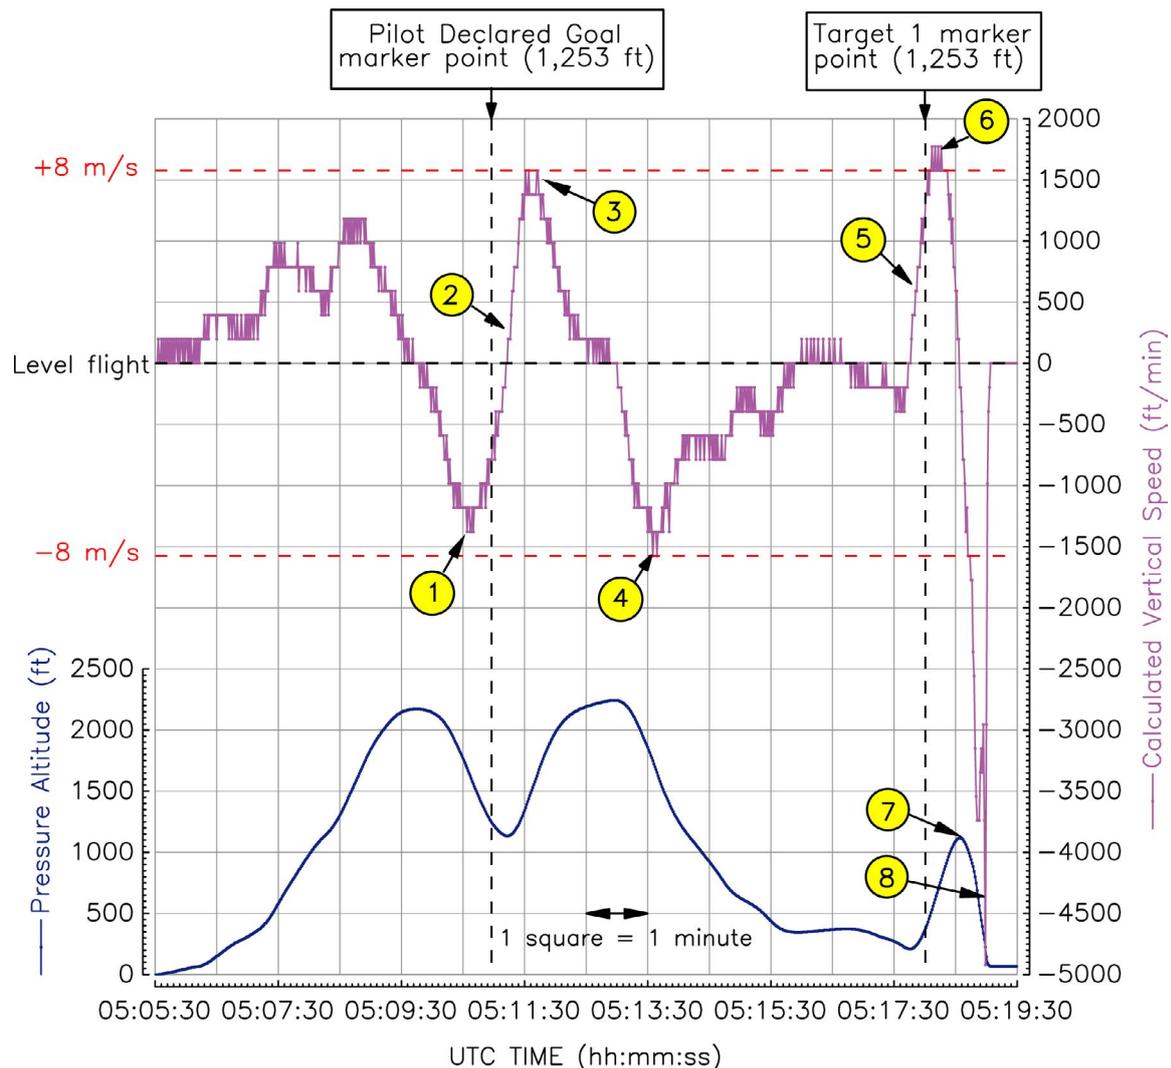
**Figure 16**

Altitude (blue) and vertical speed (purple) profile of the accident flight

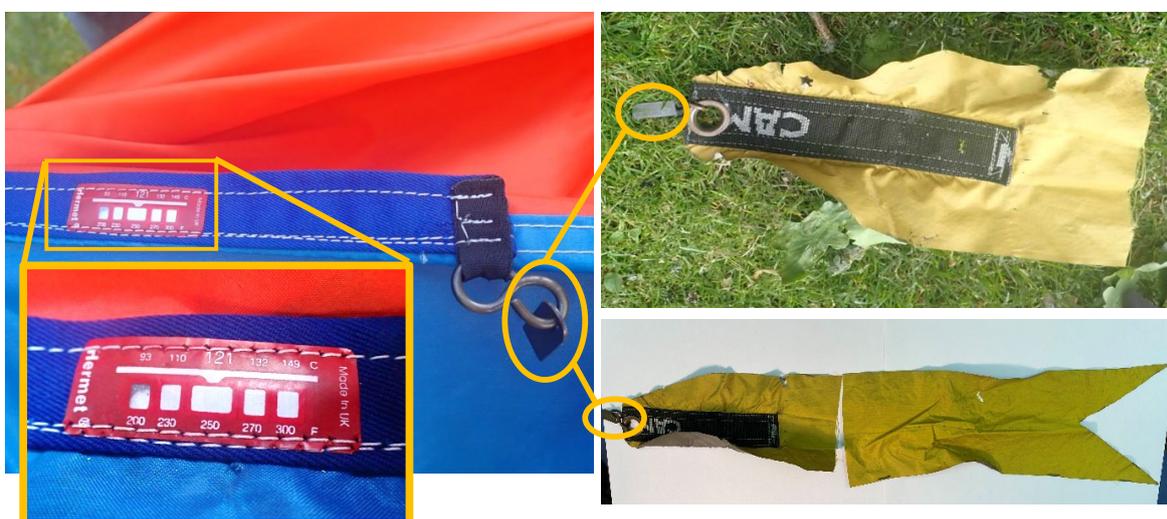
**Figure 18**

The envelope material was substantially ripped and torn where it had been dragged through the broken tree branches during the accident and later by the sharp edges of the broken tree limbs when the wind increased. Where the material had been ripped and the tear had reached load tapes or seams, the rip had not propagated further. The seam around the circular aperture at the top of the balloon was in good condition with no rips or tears and no sign of distortion or melting from potential overheating. Whilst the temperature streamer had separated from its soldered link, which was clipped to the envelope (Figure 18), there were no signs of heat damage on the upper sections of the envelope. The streamer flag material had also been torn in half widthways. The temperature sensor did not indicate that there had been excessive air temperatures present in the upper areas of the envelope, although the 93°C indicator showed potential signs of discolouration.

Temperature sensor (left) and damaged streamer showing soldered link (right)

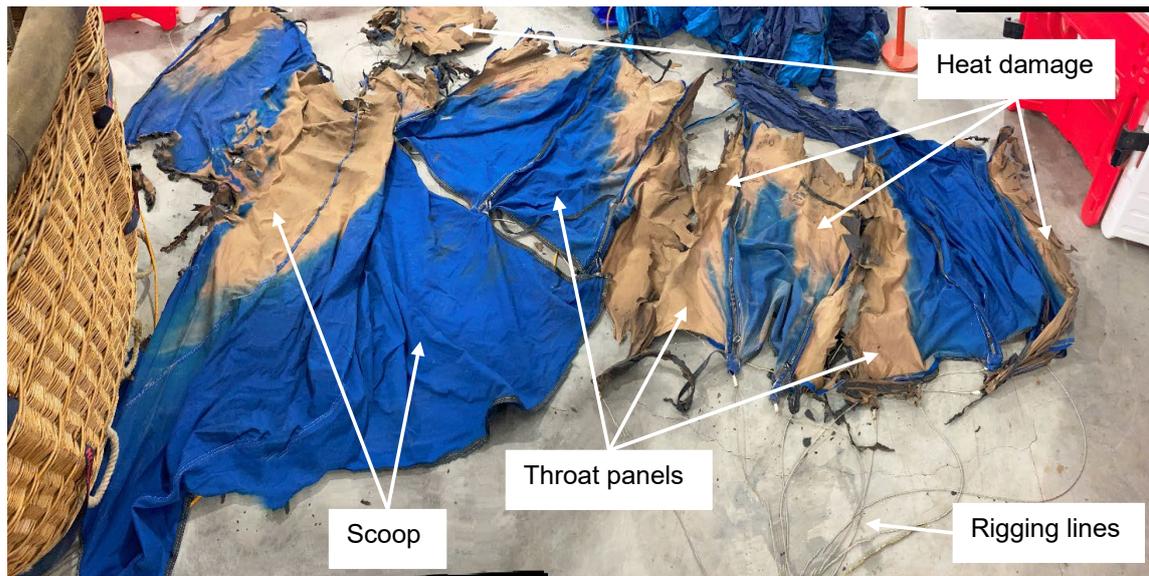
**Figure 19**

At the bottom of the envelope, all the vertical load tapes that connected the envelope to the steel rigging lines remained fastened to the lowest edge of the heat resistant throat material. The throat panels showed significant signs of heat damage (Figure 19). The original blue colour of the material was discoloured in multiple, vertical burn patterns. The horizontal load tape seams along the lower edge of the envelope had melted in several places together with some of the vertical load tapes and envelope material.

Panoramic picture of the heat resistant throat section with the scoop attached and showing multiple areas of significant heat damage

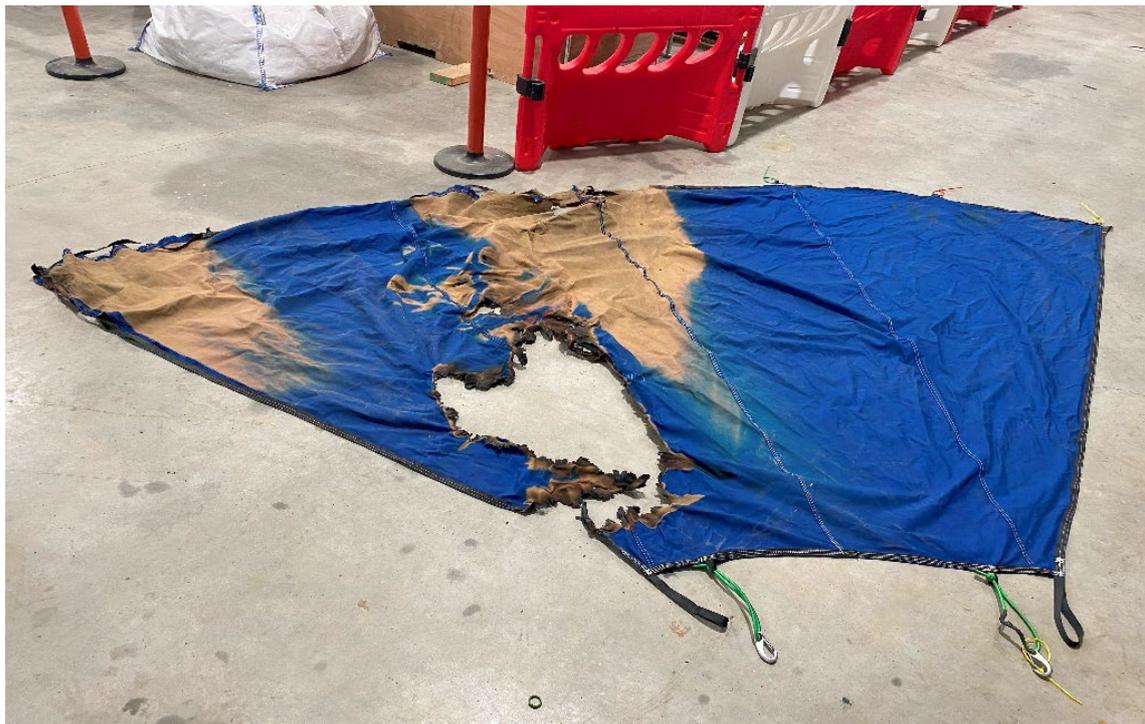
**Figure 20**

Scoop showing a hole burned through the material and V-shaped burn patterns

When the throat and the scoop were separated, the full extent of the burn patterns were revealed. The scoop shown in Figure 20 had a large hole burned through the fabric and two V-shaped burn patterns. Much of the upper horizontal seam of the scoop had melted and separated from the edge of the scoop.

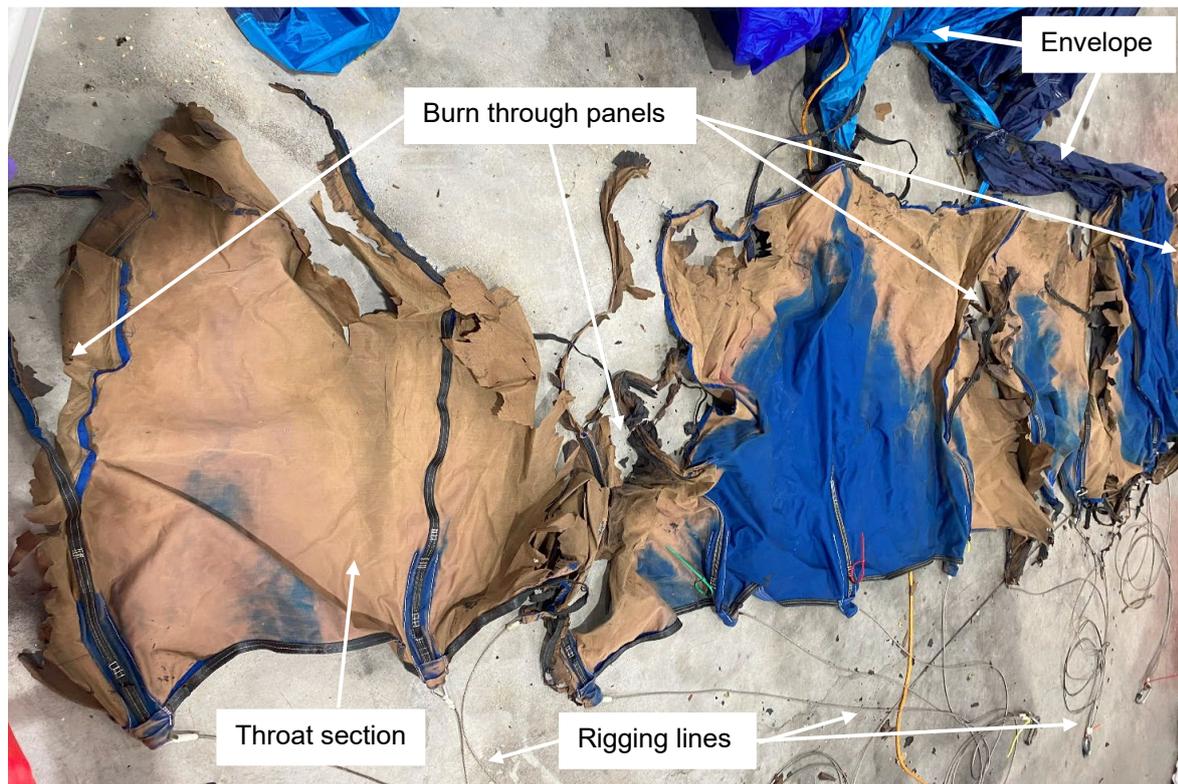
**Figure 21**

Heat resistant material that formed the throat of the balloon showing multiple, vertical heat damaged areas and burn through

The throat material was in poor condition having been significantly damaged by heat from the burners (Figure 21). There were several burn-throughs and the horizontal load tape attached to the upper edge of the throat panels had melted, separating most of the throat material from the envelope.

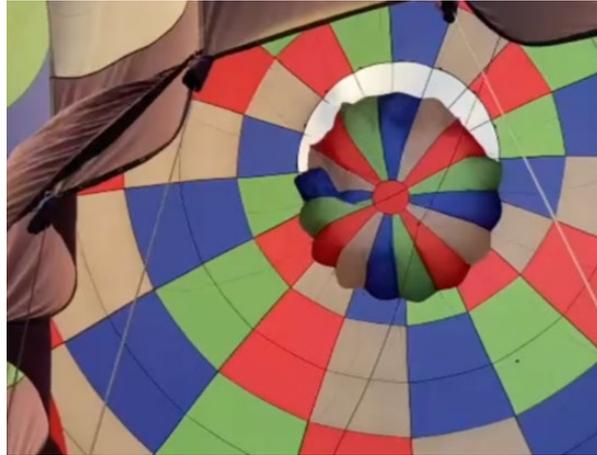
**Figure 23**

An identical envelope to G-CMFS was made available to the AAIB, and a series of four ground-tethered tests were conducted at a manufacturer's facility to observe the parachute's characteristics during operation. The tests showed that the parachute tended to 'float' when activated for between four and five seconds, before snapping back to seal the aperture at the top of the envelope (Figure 23).

Parachute 'floating' during ground testing

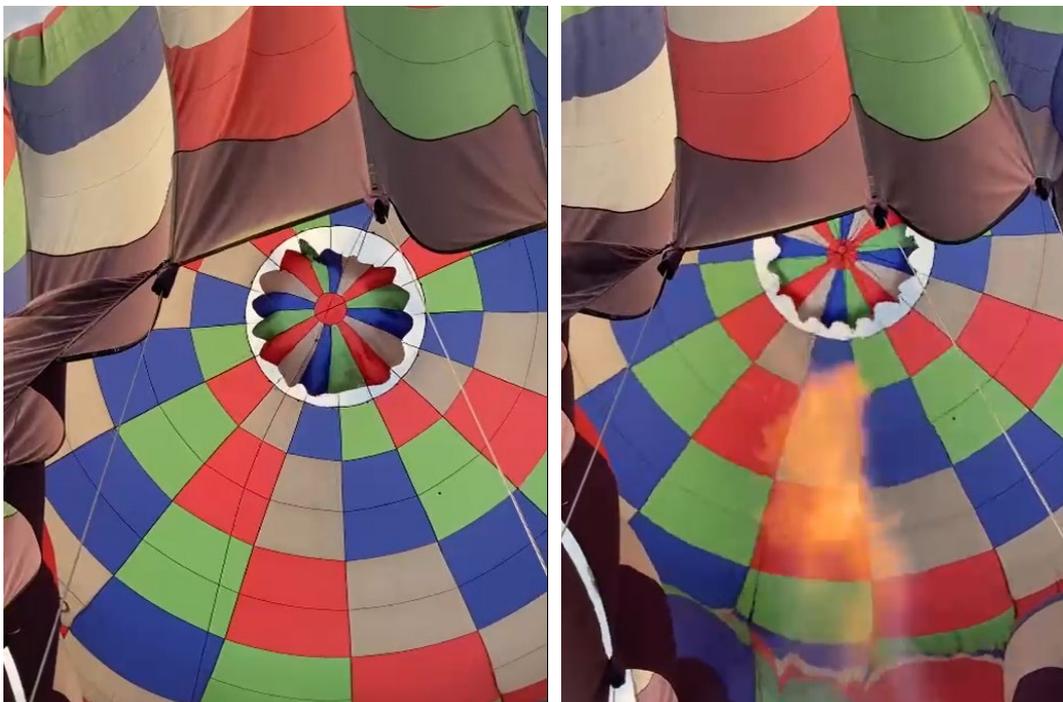
**Figure 24**

When the parachute operating line was pulled for approximately six seconds, the parachute stalled (Figure 24 left) and the envelope started to collapse before the burners were promptly activated to reseal the parachute and re-inflate the envelope (Figure 24 right).

Parachute stalled (left) and burners used to reseal the parachute and re-inflate the envelope as it started to collapse (right)
