Rail Accident Report

Runaway and derailment of wagons at Toton, Nottinghamshire 17 January 2021

Report 09/2021
December 2021

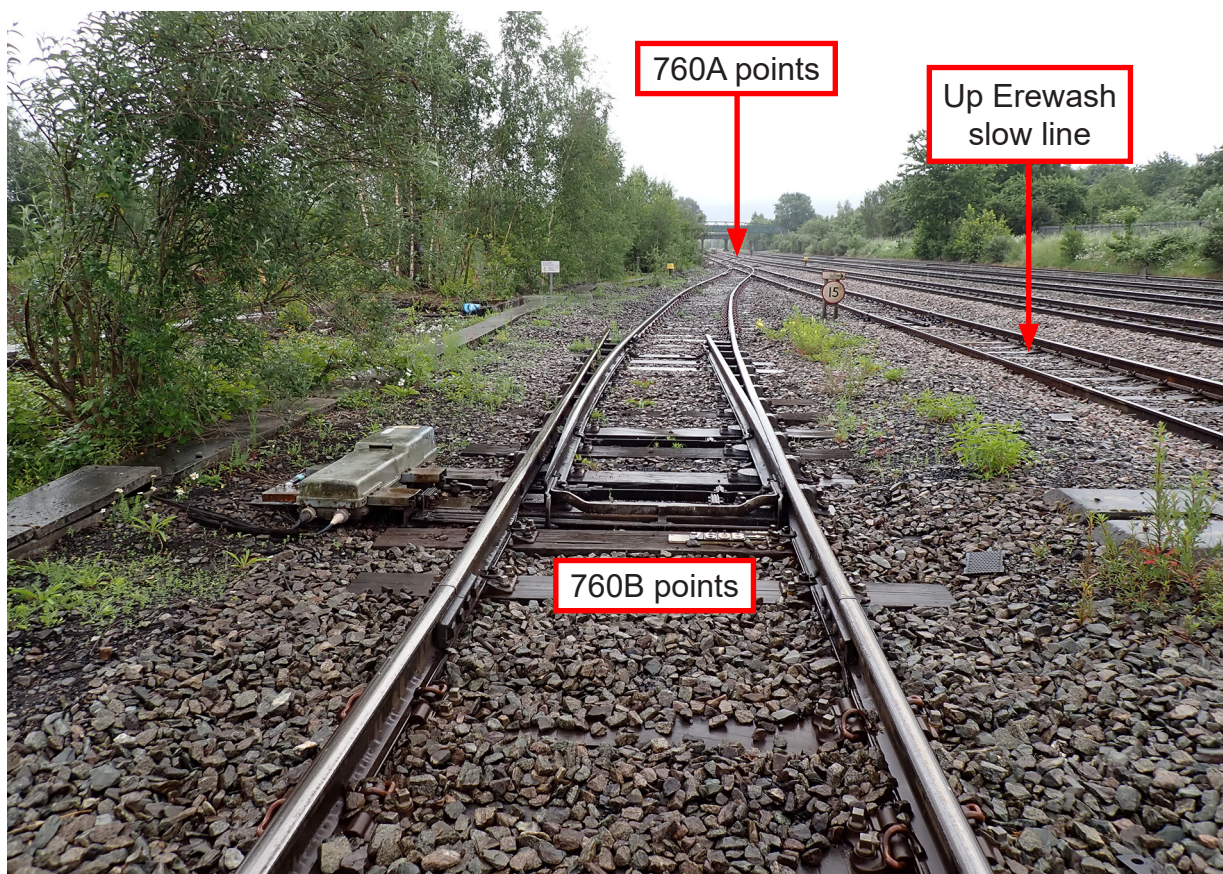
Figure 3: The trap points

- 38 The rake then continued for a short distance before it derailed on the run-out rails of 760B trap points. The rake eventually came to a stop with the leading two wagons obstructing the up Erewash slow line at Toton South Junction. Track section PJN on the up Erewash slow line showed as occupied at 04:45:59 hrs, due to the wheels of the derailed wagons damaging axle counter equipment.

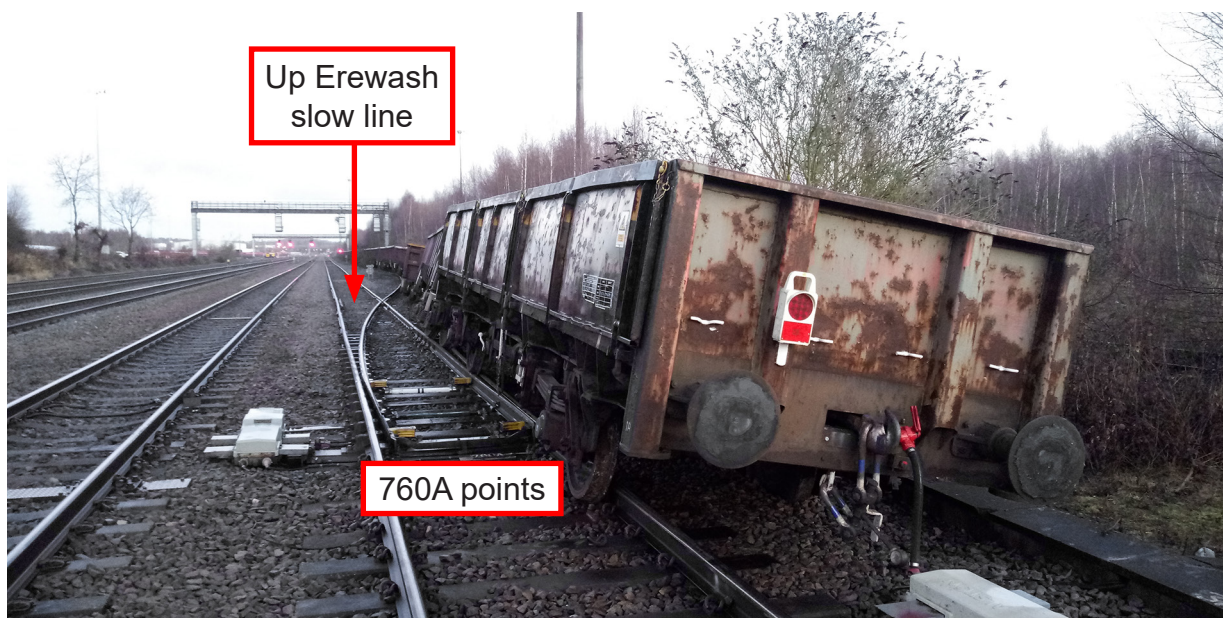
Figure 4: The derailed wagons (courtesy of DB Cargo)

- 6 The derailed wagons sustained some damage during the derailment and were uncoupled from the rest of the rake, which was pulled back into Old Bank sidings on 17 January. The derailed wagons were subsequently recovered by 13:30 hrs on 19 January. Track and signalling equipment where the wagons ran derailed also sustained damage. Repairs to this infrastructure were completed by 09:00 hrs on 21 January.

108 A factor that exacerbated the consequences of the event was that once derailed by the trap points, the leading two wagons stopped foul of the adjacent running line (paragraph 88, **Recommendation 4, Learning point 2**).

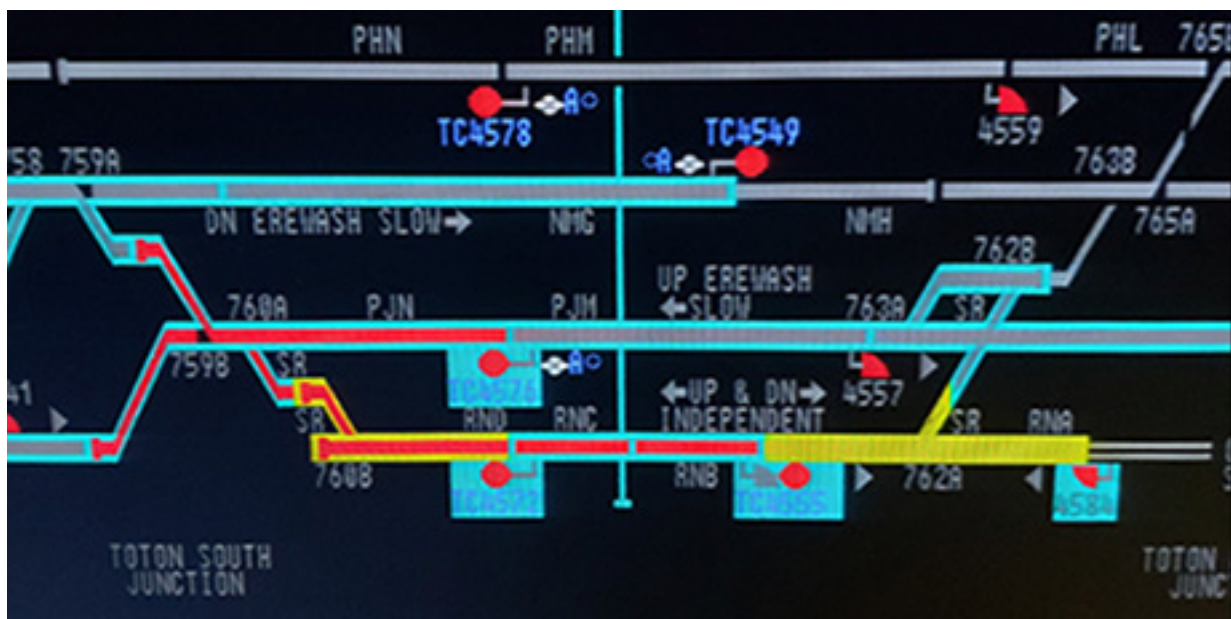
Figure 7: Photograph of part of the screen on the Erewash workstation at EMCC (courtesy of Network Rail)

- 35 Around 8.5 hours after being left in siding number five, the rake of wagons from train 6G02 began to slowly roll out of the southern end of Old Bank sidings, which are on a falling gradient (paragraph 9). At 04:42:41 hrs on 17 January, the signalling equipment for the Erewash workstation at EMCC recorded that the leading end of the rake had passed onto Network Rail's infrastructure and occupied track section RNA on the up and down independent line (figure 7). As it did this, the rake passed signal TC4584, the exit signal from the southern end of Old Bank sidings, which was displaying a stop aspect. This caused an alarm to sound on the workstation, which gained the attention of the signaller.

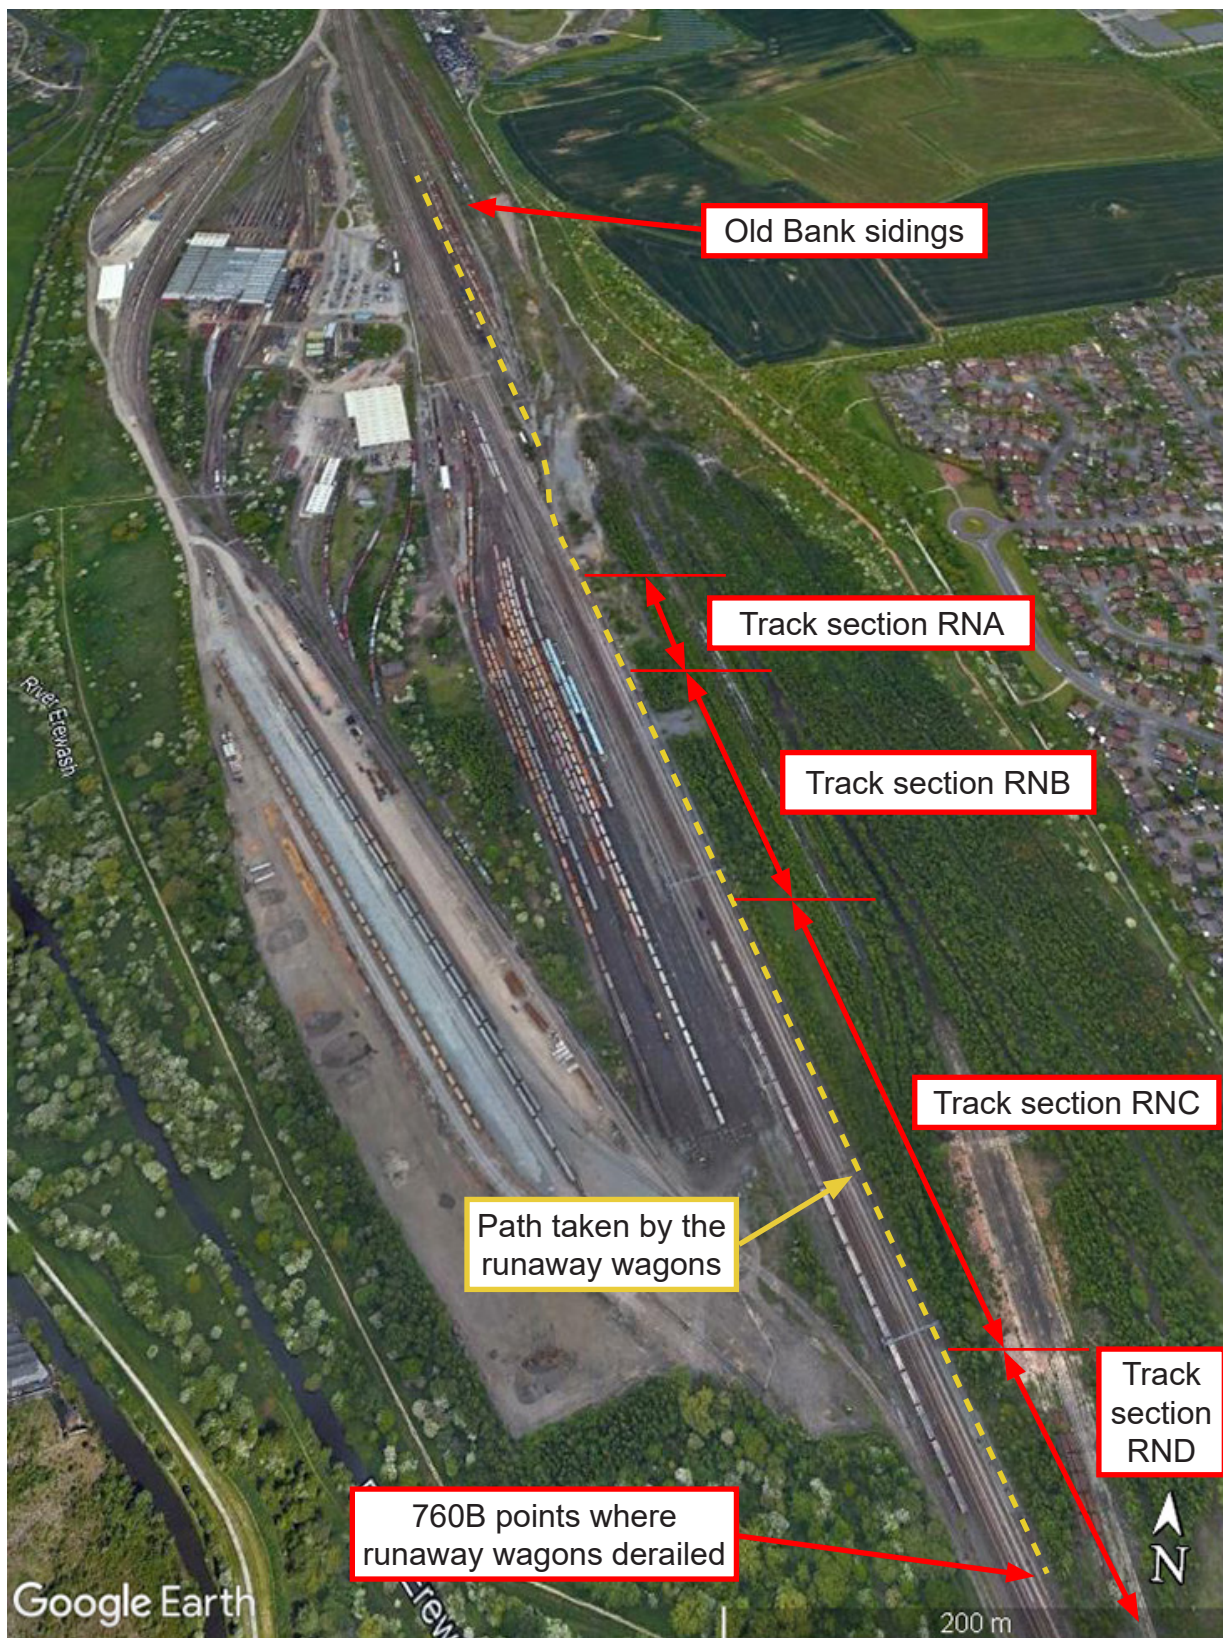
Figure 8: Track sections on the up and down independent line

- 36 At 04:43:12 hrs, the leading end of the rake occupied the next track section, RNB, on the up and down independent line. The rake's average speed over track section RNA was 5.0 mph (8.0 km/h) (figure 8). The rake occupied the next track section, RNC, at 04:44:20 hrs. The rake's average speed over track section RNB was 6.5 mph (10.5 km/h).
- 37 At 04:45:29 hrs, the leading end of the rake occupied track section RND after passing signal TC4572, which was also displaying a stop aspect. This caused another alarm to sound on the Erewash workstation. The rake's average speed over track section RNC was 7.6 mph (12.2 km/h).

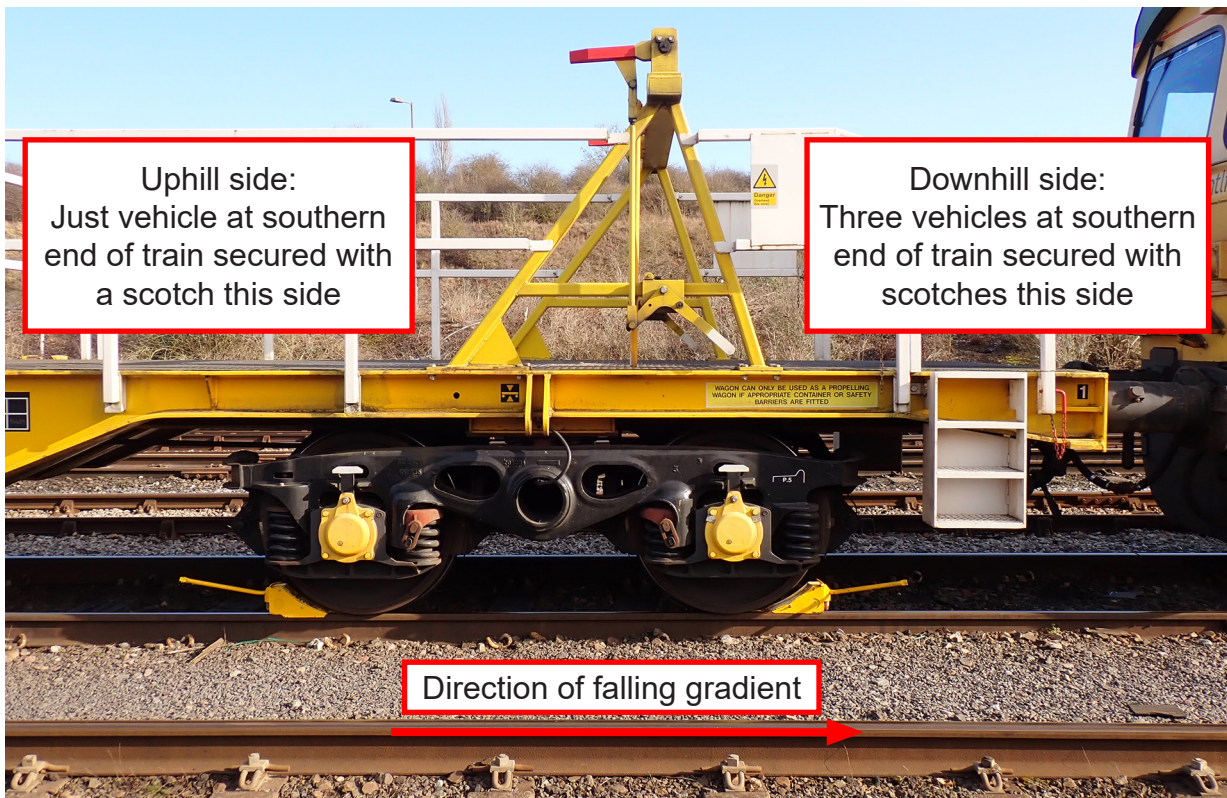
Figure 10: How vehicles should be secured in Old Bank sidings (courtesy of DB Cargo)

52 Once the train was fully accommodated within the required siding, the common safe system of work called for the first three vehicles at the southern end of the sidings to be secured using scotches on the downhill side. It also called for the leading end of the first vehicle to also be scotched in both directions (figure 10). Securing the train in this way, with or without a locomotive attached to it, was also in accordance with requirements in the Rule Book, GO/RT3056 and DB Cargo's supplementary operating instructions (paragraph 47). While ground staff are trained to secure the train in this way, the common safe system of work did not state who was responsible for securing the train (see paragraph 86).

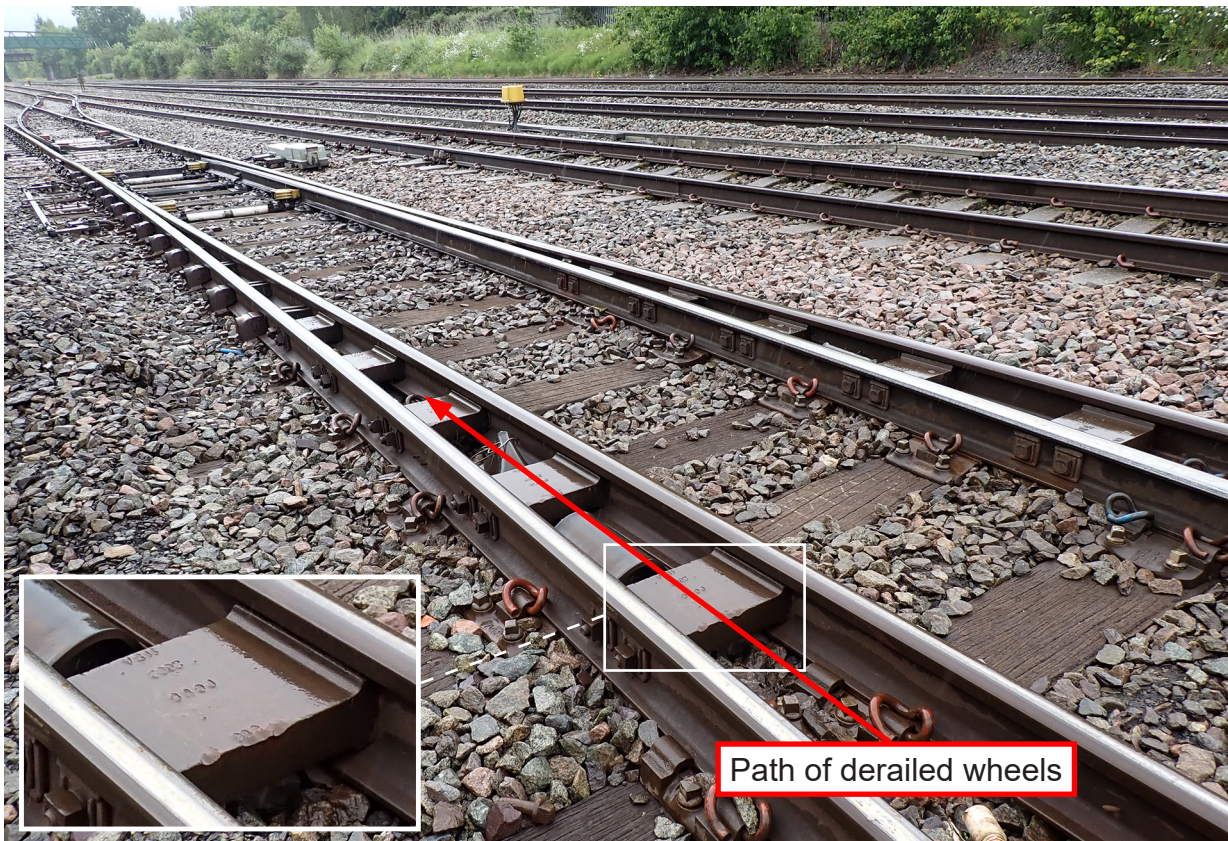
Figure 12: Impact marks on 760A points

91 The leading wagon travelled 75 metres while running derailed to reach 760A points. One reason the rake of wagons had travelled this far was because all but one of the wagons were loaded. This increased the mass of the rake from 606 tonnes (unladen) to a reported 1869 tonnes (paragraph 15). Based on the speed that the rake was travelling just before it derailed (paragraph 37), it possessed about 10.8 MJ of kinetic energy. This compares to about 3.5 MJ for a rake of unladen wagons, a ratio of around 3:1. However, the wheels of laden wagons are likely to dig into ballast more deeply than empty wagons when running derailed, so the drag forces will be higher than those applied to an unladen rake. Based on the distance travelled by the wagons, and accounting for the amount of kinetic energy and likely drag forces, analysis undertaken by RAIB suggests that a rake of empty wagons is likely to have travelled about 30 metres after derailling on the trap points. This would mean its leading wagon would have stopped short of fouling the adjacent line.
