## Fatal man overboard from the fishing vessel *Reul A Chuain* (OB915) in the Sound of Rùm, Scotland on 24 June 2021

### SUMMARY

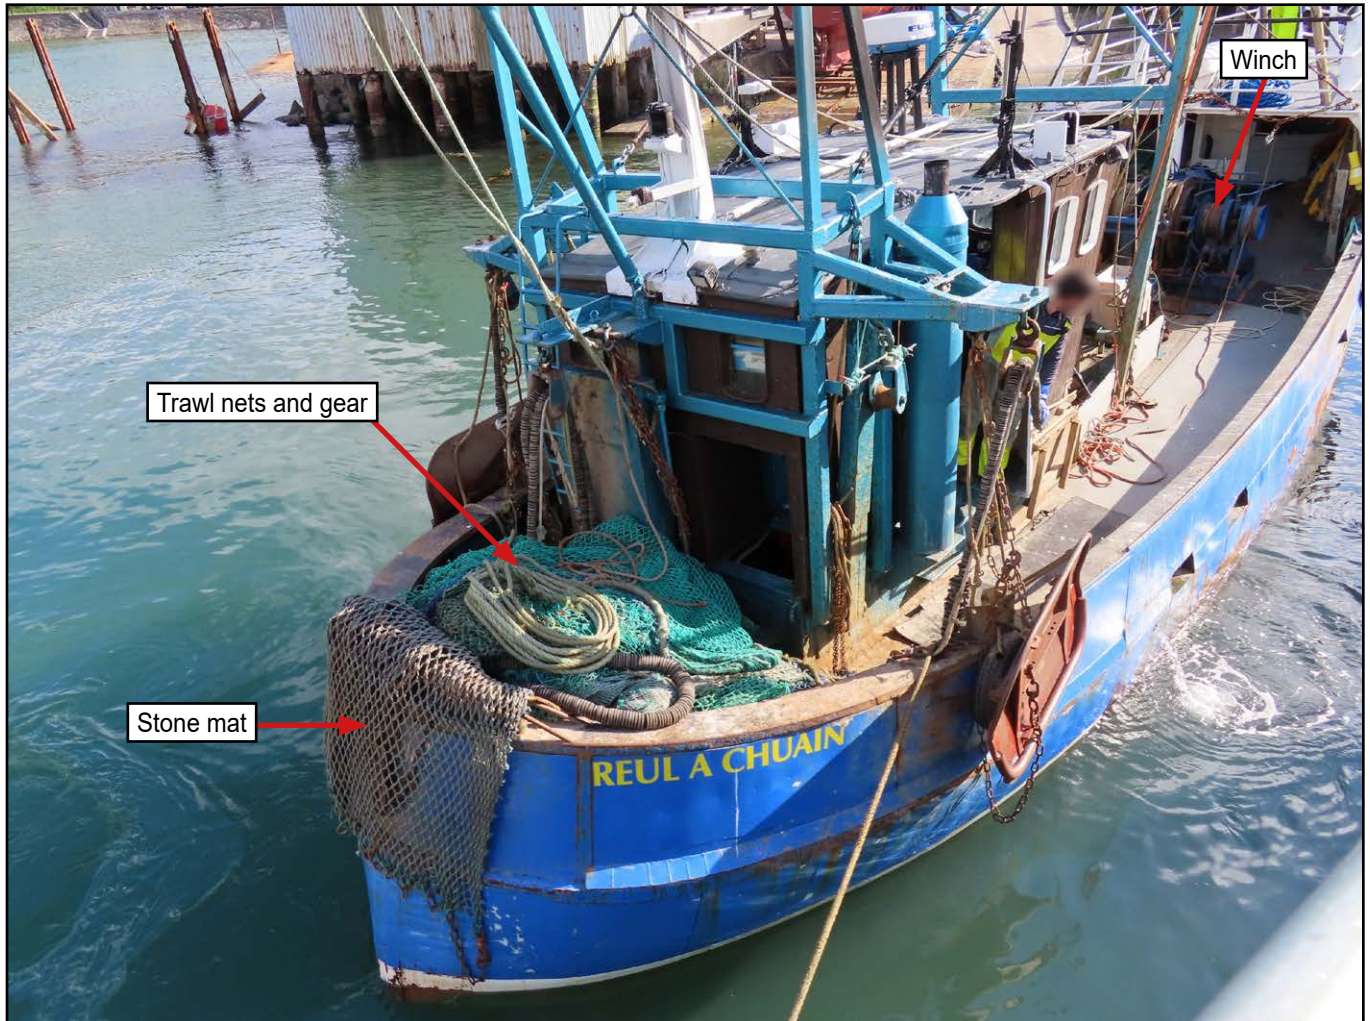
**Figure 2:** Nets stowed at stern (post-accident)

The stowed nets protruded above the 700mm bulwark and made them vulnerable in adverse weather. Recovery of the nets during fishing was a daily operation for the crew and the nets' stowage position was unchangeable. The situation changed when *Reul A Chuain* encountered unexpected bad weather that caused the vessel to roll heavily and an unlash net to slip overboard. The net recovery operation then changed when the net hook became unusable and the conditions made rerigging it impractical and risky. The decision to recover the net by hand may have been a logical solution, but it introduced additional

- The volume of the trawl nets at the stern resulted in them being above the height of the bulwark in the stowage area; they were not secured, and partially fell overboard when *Reul A Chuain* rolled in heavy weather. The subsequent net recovery was hampered by the failure of the net hook, which prompted the senior deckhand to put himself in danger to try and help recover the net by hand.

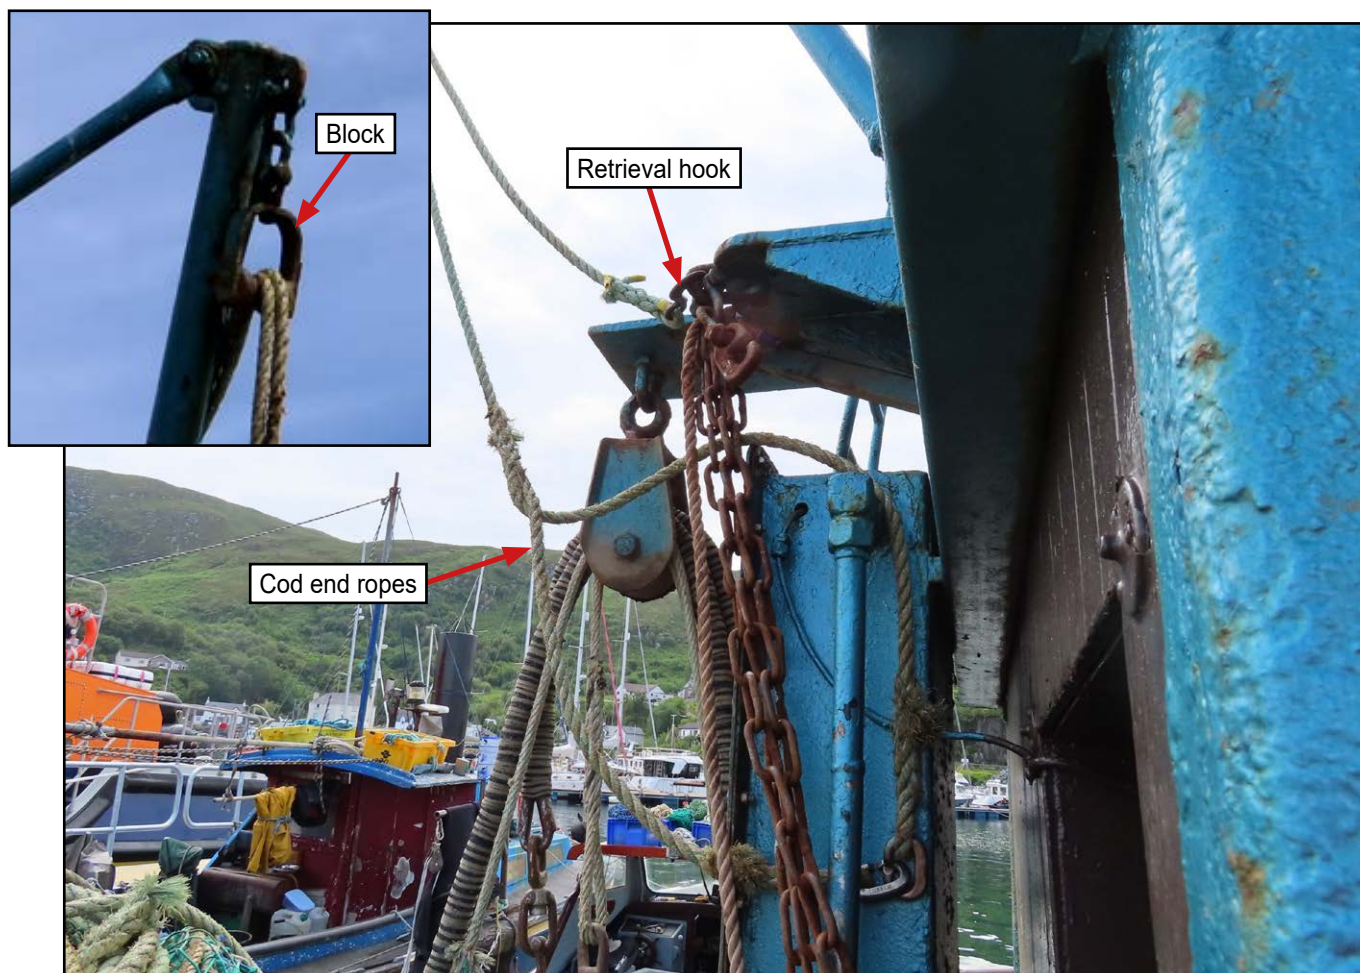
**Figure 3:** Net retrieval hook, block, and cod end ropes

repeated the process but, as the net was being heaved up a second time, the hook slipped out of the net's mesh and the tension on the line caused it to shoot up and through the block at the top of the lifting gantry.

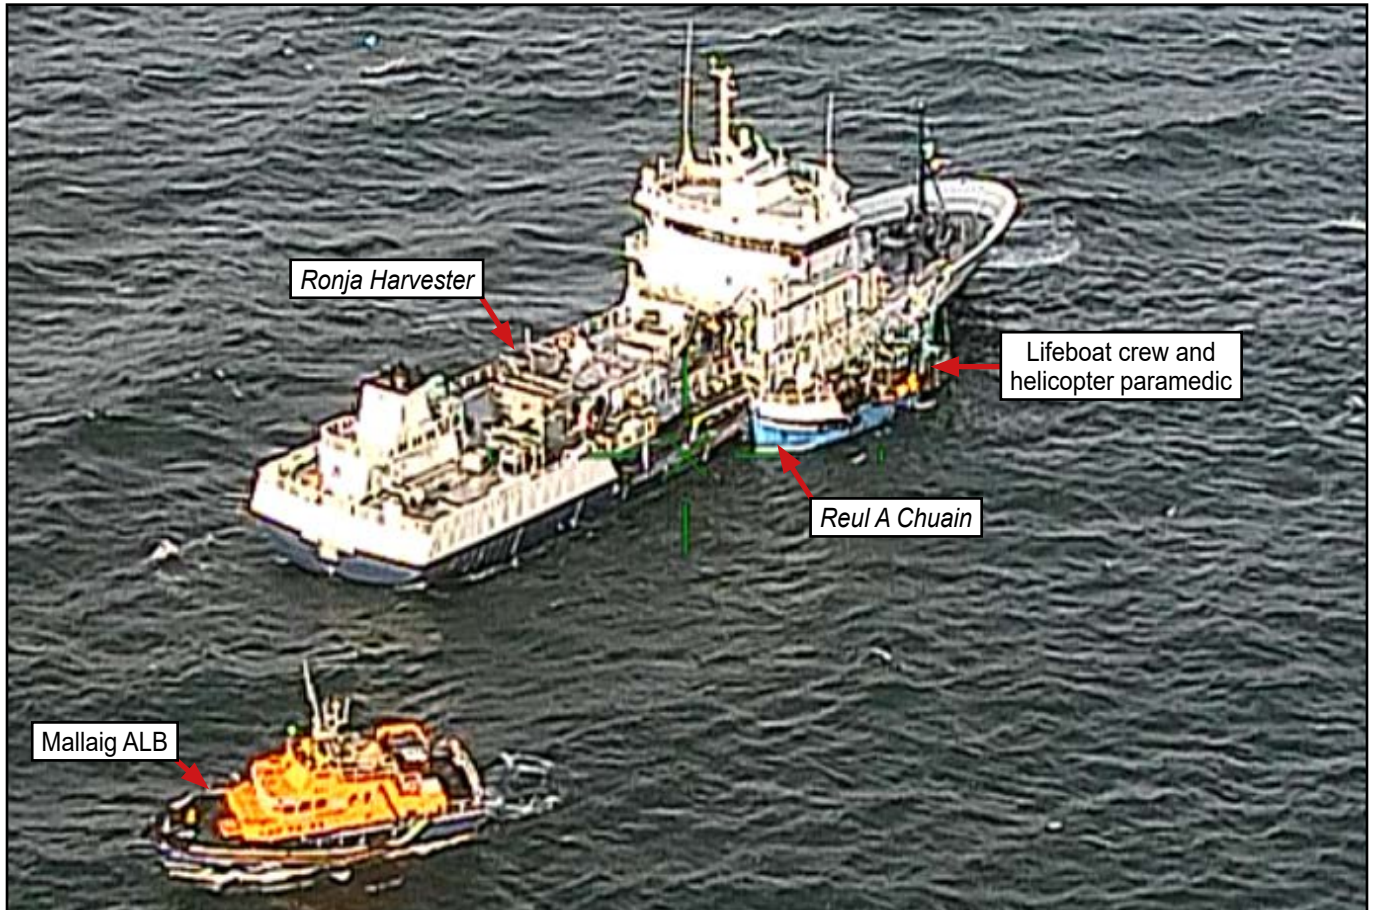
**Figure 6:** *Ronja Harvester* starboard side alongside the starboard side of *Reul A Chuain*, with the Mallaig ALB waiting to assist

By 1949, one of the nearby vessels, *Ronja Harvester*, had arrived on the scene and manoeuvred alongside *Reul A Chuain's* starboard side (**Figure 6**). Three of *Ronja Harvester's* crew transferred across with oxygen and a defibrillator to assist with the CPR of the casualty. The lee created by *Ronja Harvester* enabled the ALB to go alongside and transfer across medical personnel, who then took over the CPR.
