Rail Accident Investigation Branch

Rail Accident Report

Track worker struck by train near Chalfont & Latimer station, Buckinghamshire 15 April 2022

Report 05/2023
May 2023

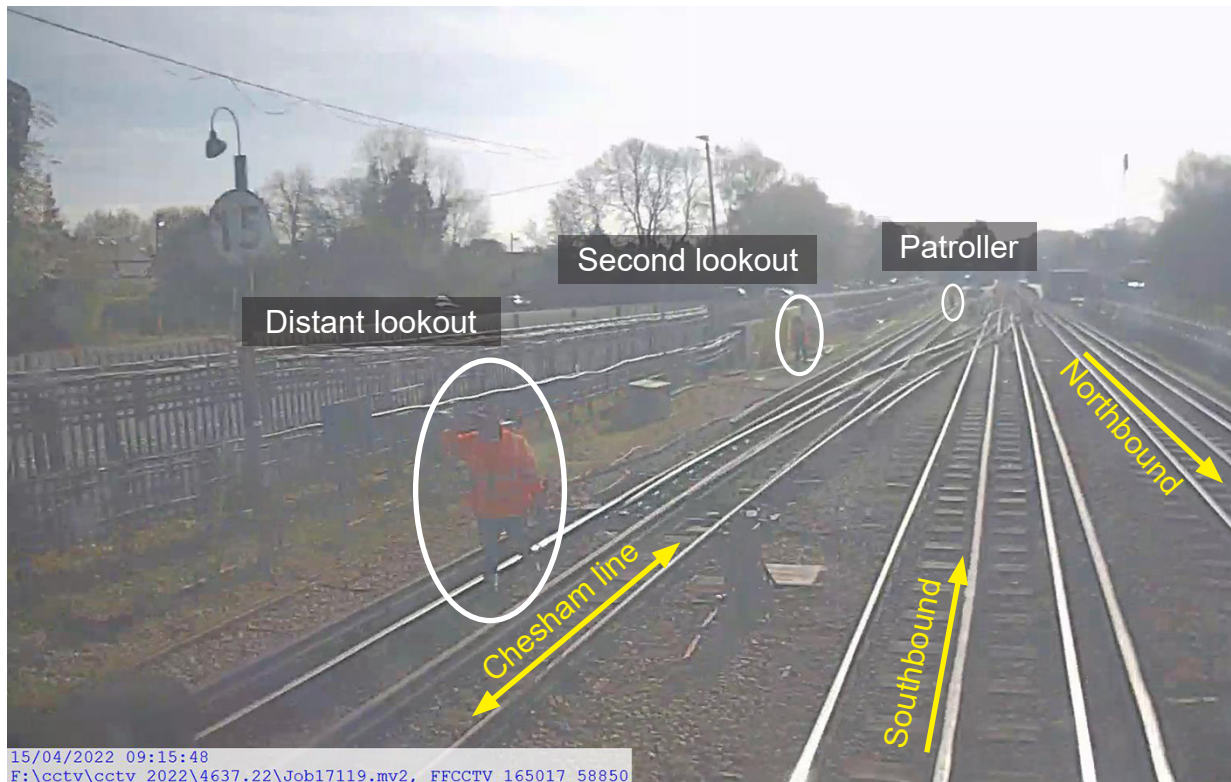
Figure 4: FFCCTV image from train 2C13 (courtesy of Chiltern Railways).

- 30 At approximately 09:15 hrs, train 2C13, a southbound Chiltern Railways train, approached the work group. Witness evidence suggests that when the distant lookout sounded a warning for this train, which was relayed to the patroller by the second lookout, all three track workers were in the four-foot¹ of the southbound line. FFCCTV images from train 2C13 showed that the second lookout moved to the Chesham single line cess, while the distant lookout and the patroller moved to the Chesham single line four-foot. This was not a recognised place of safety to stand in while the train passed (figure 4).

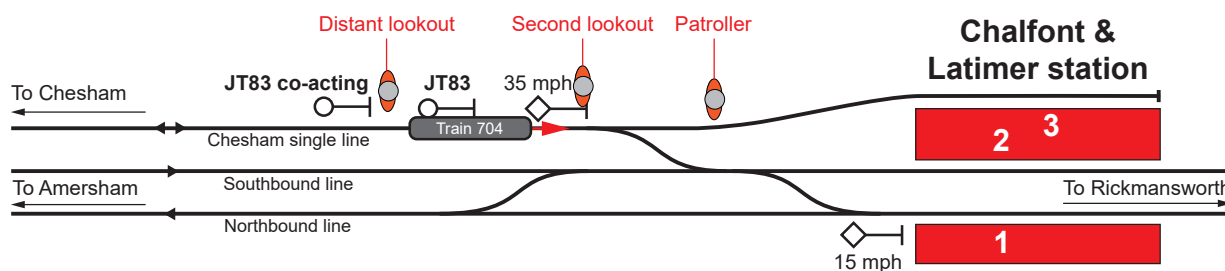
Figure 5: Positions of the track workers when train 704 passed them.

- 32 At approximately 09.19 hrs, four minutes after the first train had passed, a second train passed the work group. This was train 704, a southbound LUL train from Chesham that was travelling along the single line and heading for platform two at Chalfont & Latimer station. The distant lookout saw the train and gave a warning which was repeated to the patroller by the second lookout. Although train 704 was not fitted with FFCCTV equipment, witness evidence indicated that both the patroller and the distant lookout moved to the cess of the Chesham single line, the designated place of safety, where the second lookout was already positioned (figure 5).

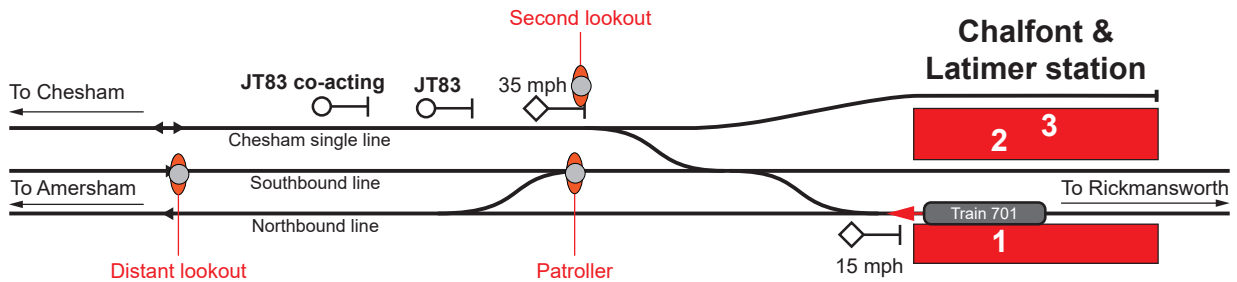
Figure 6: Positions of the track workers when train 701 sounded a warning.

36 The train operator stated that he saw there was one track worker nearest to him in the ten-foot walking northbound (the patroller), one in the Chesham cess (the second lookout) and one further away acting as a southbound lookout (the distant lookout) (figure 6).

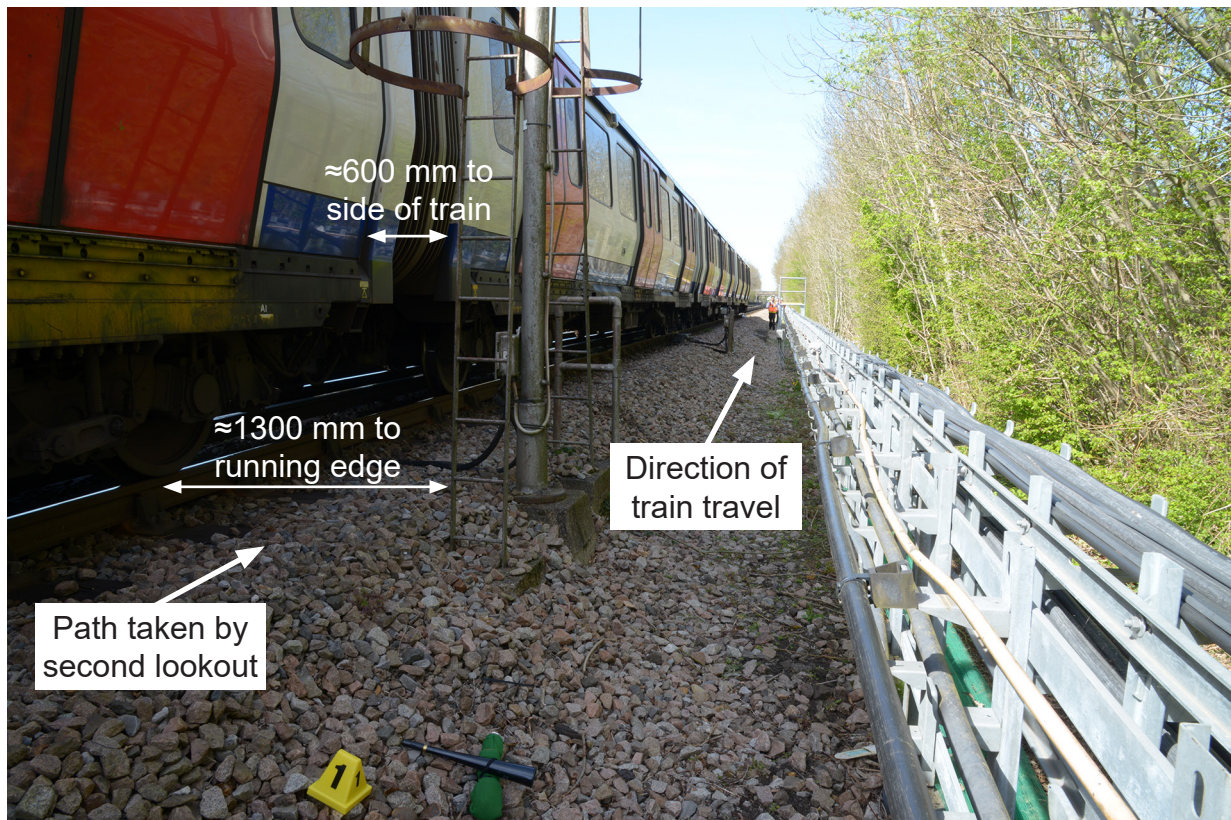
Figure 7: Space in which the second lookout walked as the train approached.

37 The second lookout remained walking in the Chesham single line cess in a position of safety as train 701 approached her. However, in the final seconds of the train's approach, the second lookout moved from the cess and into a position between a signal post and the track to get a better view of the trains approaching from Chesham as she walked (figure 7). She was not aware that train 701 was approaching her from behind.

- 38 As the train approached the second lookout, the train operator did not realise that she had moved nearer to the Chesham single line and was in the swept path of the train. As the train passed the group, the train operator heard a 'bang' and applied the emergency brake. The train's OTDR showed that the train stopped approximately 8 seconds after the emergency brake was applied, having travelled around 43 metres. At the time of impact, the train was travelling at approximately 27 mph (43 km/h).

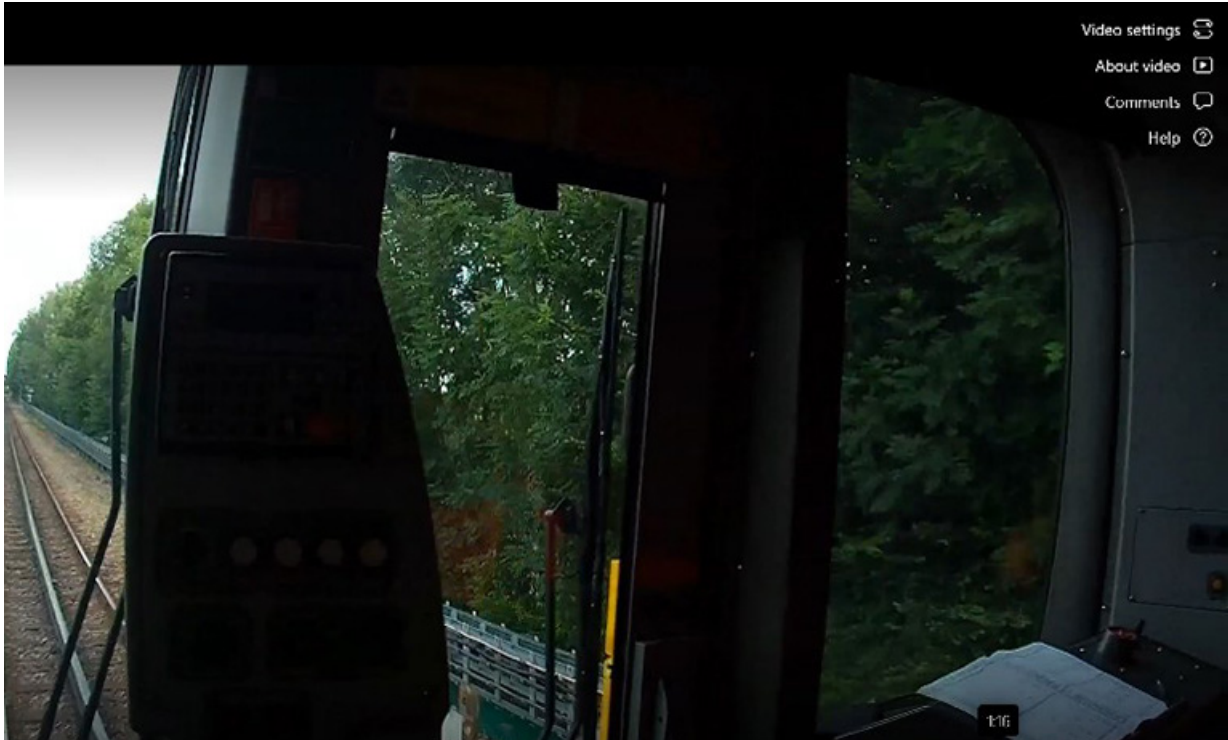
Figure 11: Approximate point the second lookout would have last been visible to the train operator.

76 The train operator was unaware that the second lookout had moved towards the track. This may have been because his attentional focus was no longer on the second lookout, believing that she was safe and had acknowledged the warning whistle, and was switched instead to the view ahead. Alternatively, if the second lookout moved towards the track in the final seconds of the train's approach, it is possible that the train operator's view of her was obscured by the cab structure.

77 During a reconstruction of the train's path from Chalfont & Latimer station onto and along the Chesham single line, RAIB observed that the train operator generally has good forward visibility although there is some obscuration of the right-hand side view caused by a central console and structural pillar. RAIB's analysis, based on OTDR information and this reconstruction, suggests that the second lookout would have been visible to the train operator during the train's approach until the last seconds before impact (figure 11).
