ACCIDENT

Aircraft Type and Registration:	Flight Design CT2K, G-CBDJ	
No & Type of Engines:	1 Rotax 912ULS piston engine	
Year of Manufacture:	2001 (Serial no: 7850)	
Date & Time (UTC):	24 March 2022 at 1400 hrs	
Location:	Beccles Aerodrome, Suffolk	
Type of Flight:	Private	
Persons on Board:	Crew - 1	Passengers - None
Injuries:	Crew - 1 (Fatal)	Passengers - N/A
Nature of Damage:	Aircraft destroyed	
Commander's Licence:	Private Pilot's Licence	
Commander's Age:	87 years	
Commander's Flying Experience:	2,677 hours (of which 1,621 were on type) Last 90 days - 20 hours Last 28 days - 9 hours	
Information Source:	AAIB Field Investigation

Synopsis

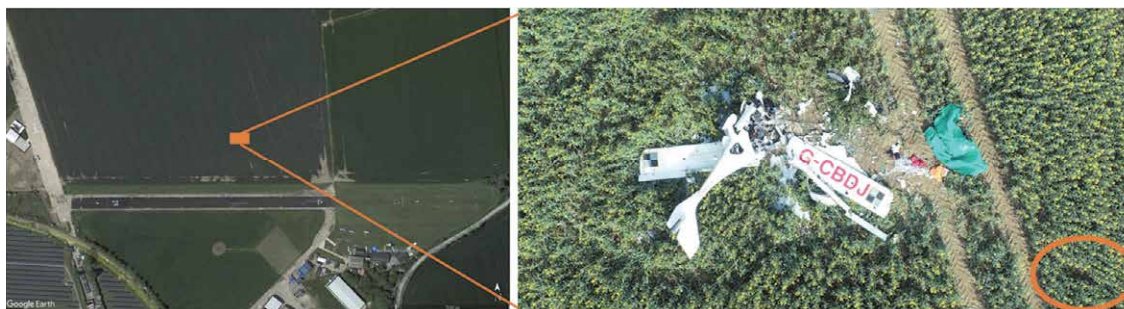
The aircraft came to rest approximately 100 m to the north of Runway 09 and 240 m from the threshold. Both wings had detached from the fuselage, with the lower surfaces upper most. The fuselage was on its right side, on top of the wings with severe disruption to the nose section (Figure 1). The field to the north of the runway was planted with a rapeseed crop which was approximately 1 m in height. The crop was heavily damaged in the immediate area of the aircraft and there was a short visible swath cut into the crop (highlighted in Figure 1 right) that was consistent with the left wingtip being the first part of the aircraft to make contact with the field.

Aerial view of the accident site

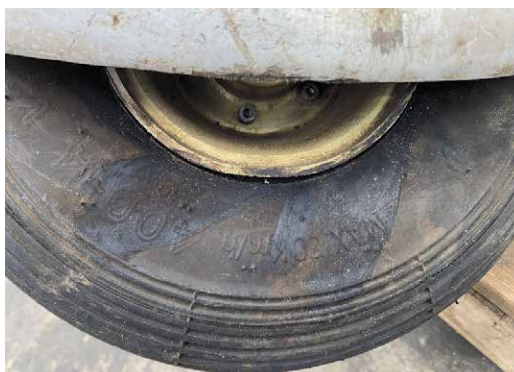
Figure 3

The wreckage was recovered to the AAIB for detailed examination. Continuity of the flying controls was confirmed, along with the engine controls. Witness marks on the fuselage correlated to the flaps being deployed to their full (landing) configuration at the time of the accident. There was evidence of over compression on the left side of the nose landing gear tyre and there was slight deformation of the wheel hub (Figure 3). A detailed engine teardown revealed that the engine was probably performing normally prior to the accident.

Damage to the nose landing wheel
