Accident

Aircraft Type and Registration:	Extra NG, G-MIIL
No & Type of Engines:	1 Lycoming AEIO-580-B1A piston engine
Year of Manufacture:	2021 (Serial no: NG028)
Date & Time (UTC):	2 April 2022 at 1059 hrs
Location:	Upper Heyford, Oxfordshire
Type of Flight:	Private
Persons on Board:	Crew – 1 Passengers – None
Injuries:	Crew – 1 (Serious) Passengers – N/A
Nature of Damage:	Aircraft destroyed
Commander's Licence:	Private pilot's licence
Commander's Age:	62 years
Commander's Flying Experience:	593 hours (of which 28 were on type) Last 90 days – 7 hours Last 28 days – 4 hours
Information Source:	AAIB Field Investigation

Synopsis

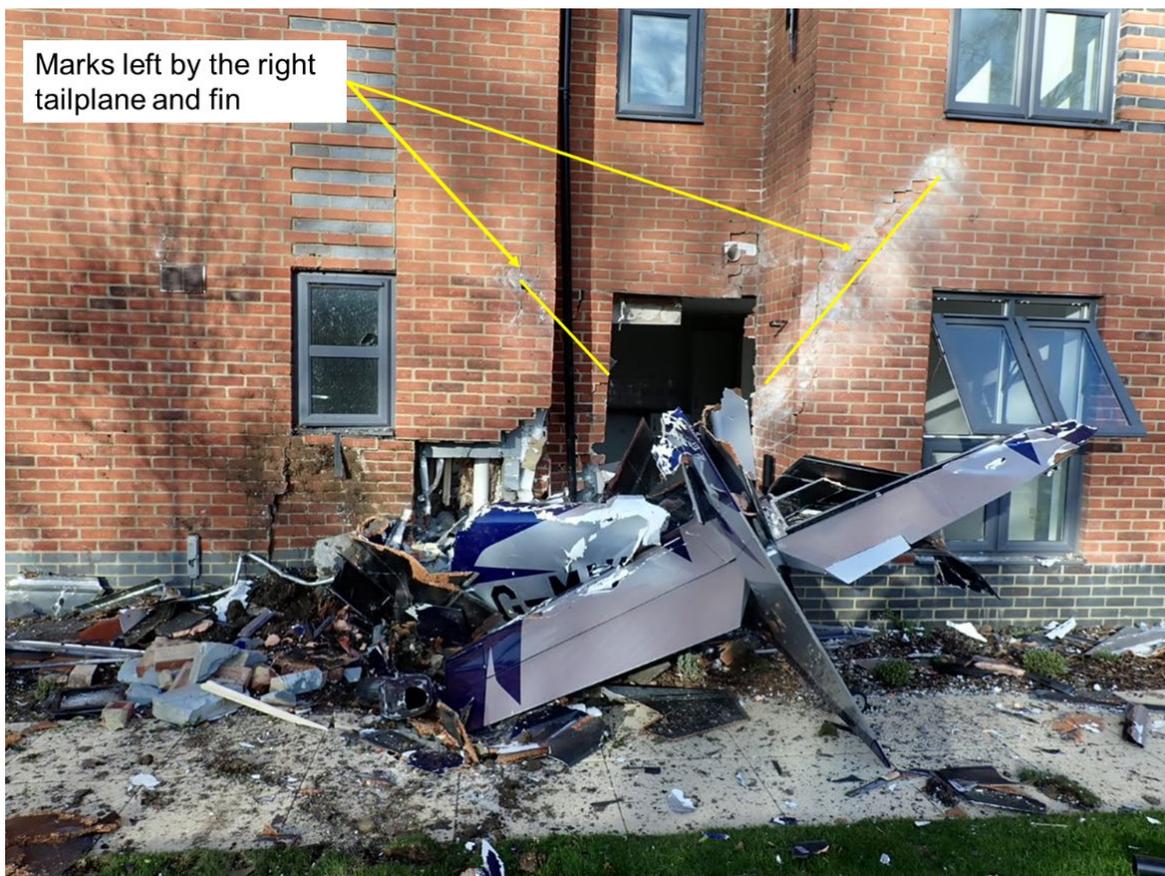
Figure 1

The aircraft hit the ground approximately 1 m from an unoccupied newly built block of flats. Marks on the ground and on the building show the aircraft was at a shallow angle at impact with enough energy to continue to penetrate the building. The engine embedded itself into the foundations of the building and was lodged beneath the ground floor concrete beams. The outer walls and a window of two adjacent flats had collapsed inwards. The aircraft had disintegrated to the extent that the only recognisable parts were the tailplane and fin. Marks on the brickwork left by the leading edges of the tailplane and fin indicated the trajectory of the aircraft at impact (Figure 1).

Accident site showing marks on the walls made by the fin and tailplane

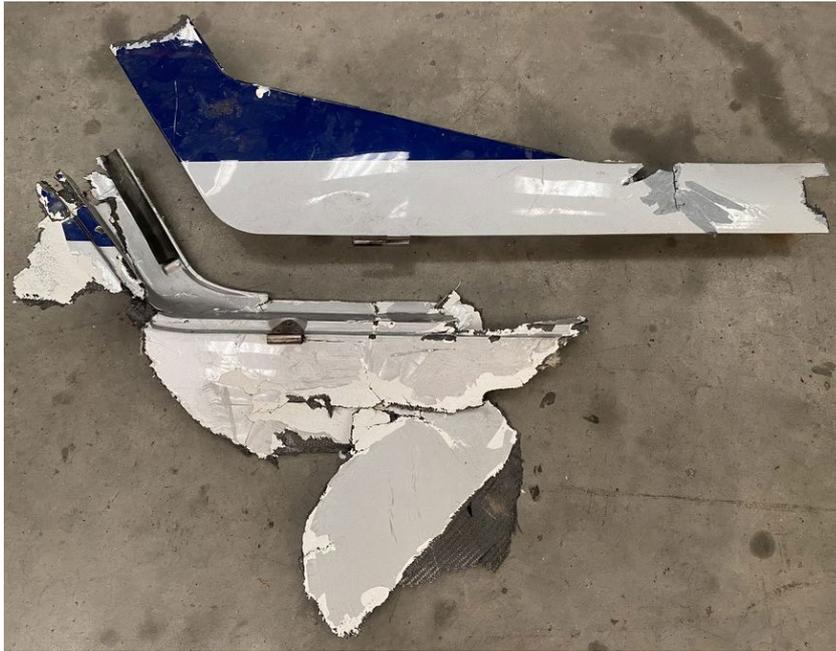
Figure 2

Right rear section of canopy frame and hinge

The rear section of the right of the canopy frame (Figure 2), still had its hinge pin attached to its bracket.

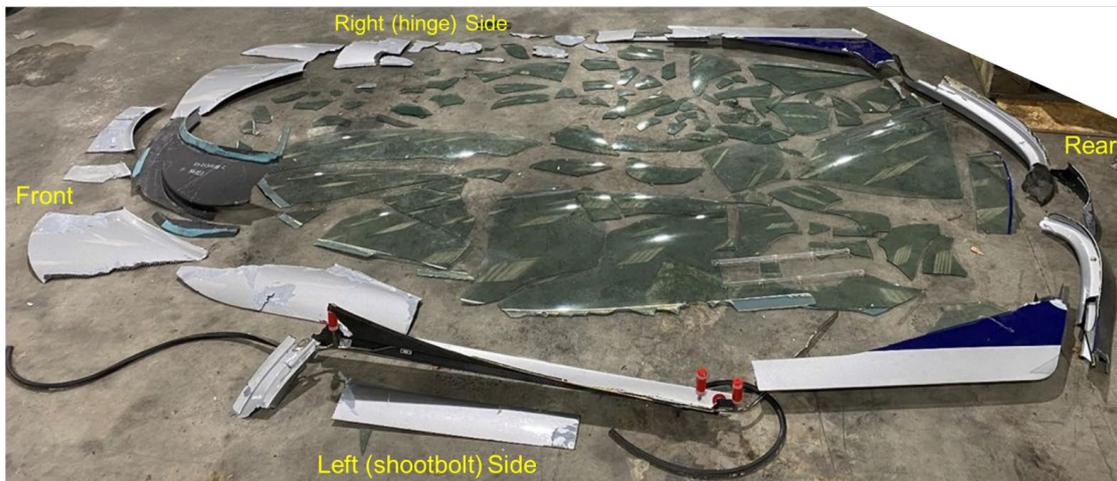
Figure 9

All the canopy parts were laid out and despite the extensive fragmentation showed that the left side of the canopy had fragmented into generally larger parts than the right (Figure 9).

Canopy remains

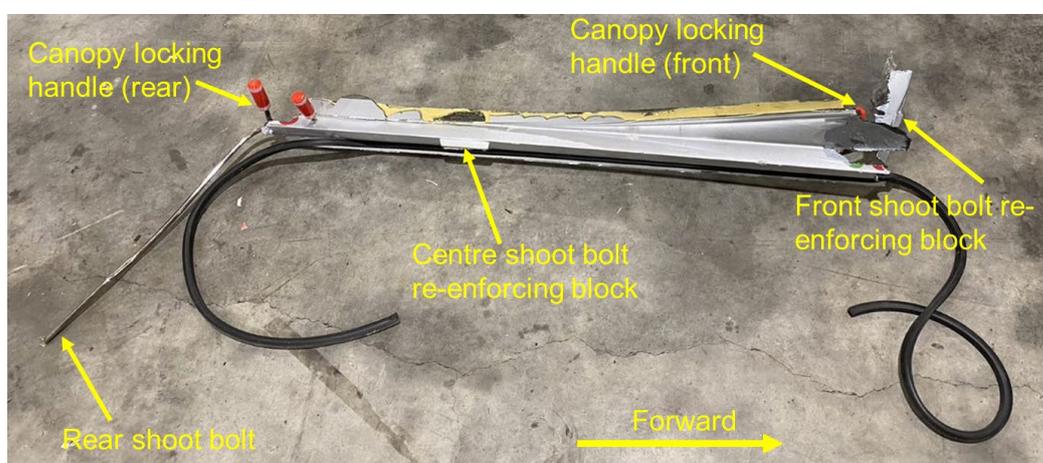
Figure 10

The left side of the canopy frame was severely damaged and distorted, but the shoot bolts, linkage tube and its handles were present. Despite the extensive damage the linkage tube and shoot bolts were being held in the closed and locked position by the spring (Figure 10). This part of the canopy had landed in a ploughed field. There was no evidence of soil or organic matter on any part of this structure indicating that the damage had occurred prior to it hitting the ground.

Left side canopy frame

(Figures 10 and 11). The absence of soil or organic matter on this part of the canopy and shoot bolts show this was not caused on impact with the ground. Had the shoot bolts also been caused to unlock from a partially locked condition, this extent of bend damage could not have occurred. This shows the damage was sustained as part of the canopy break-up sequence in flight. Figure 25 represents this sequence resulting in the canopy releasing itself from the shoot bolt lugs during its break-up.

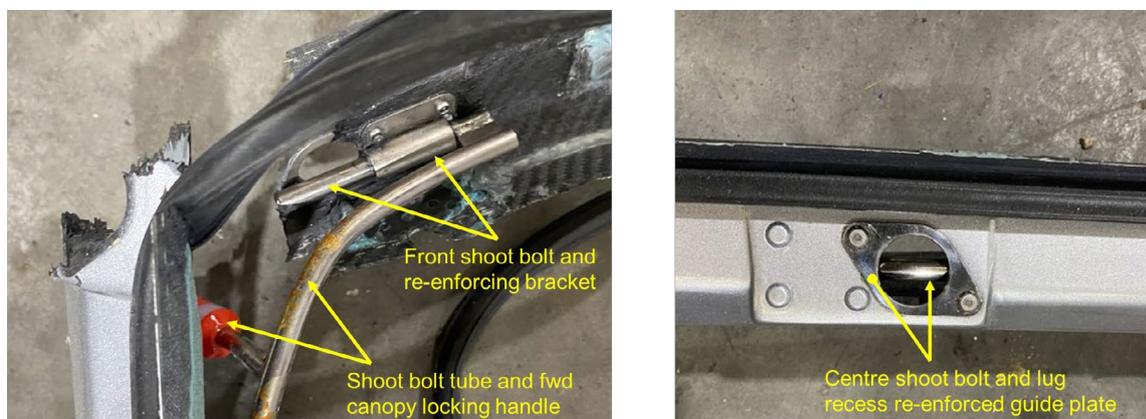
Figure 11

The front shoot bolt tube showed evidence of having been forced away from the fuselage mounted lug and roller. The centre shoot bolt assembly and surrounding canopy frame was undamaged with the shoot bolt in its locked position (Figure 11).

Front and centre shoot bolt assemblies

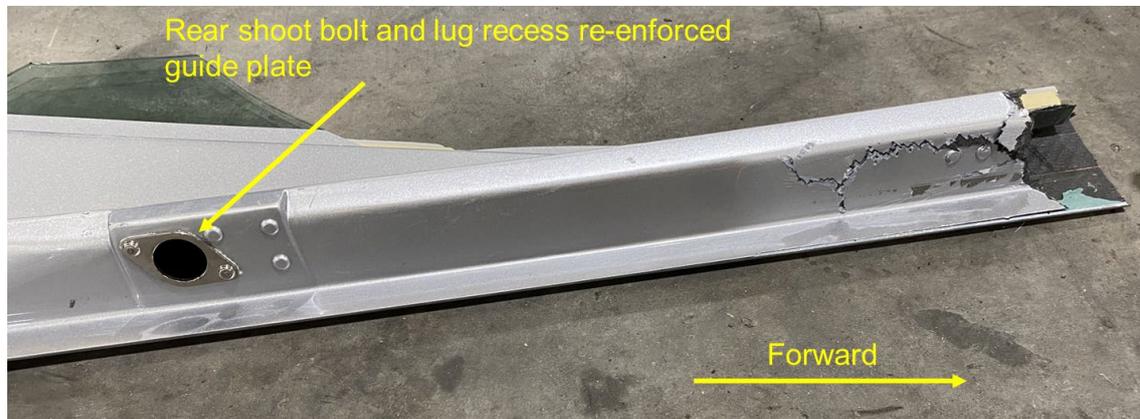
Figure 12

The rear shoot bolt was of a slightly different design to the two other shoot bolts as it was fitted into the end of the linkage tube on to which they were all attached. The canopy frame surrounding the rear shoot bolt had become detached. However, its re-enforcing plate and bracket were undamaged (Figure 12).

Left side rear canopy frame section

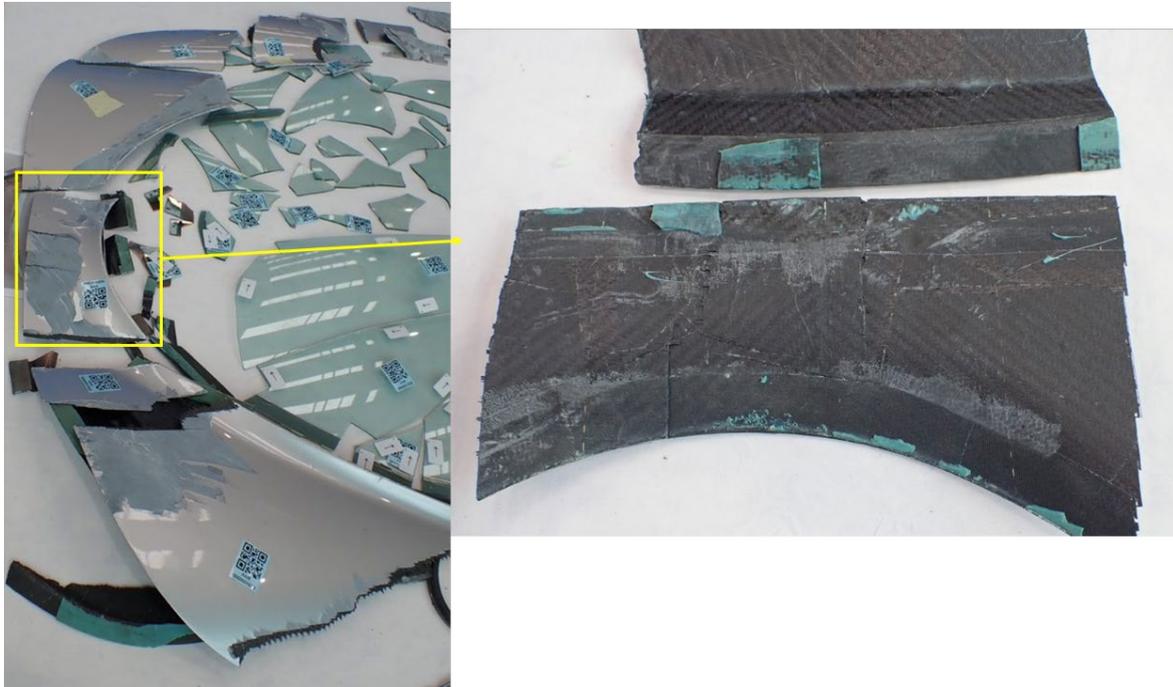
Figure 14
Canopy front section

Examination of the canopy frame parts revealed significant differences in the way the front area of the frame had broken up compared to the rear. The front parts had broken into small pieces (Figure 14). The outer skin had separated from the inner 'U' channel from the front lug to the front hinge.

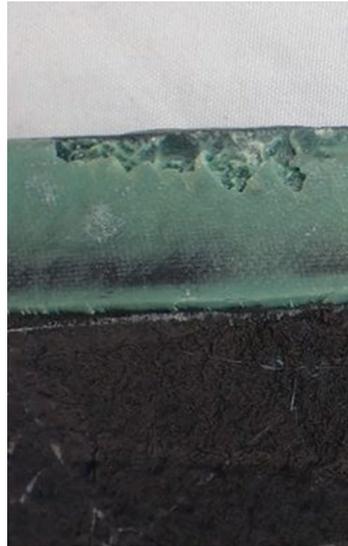
Figure 15

One small section of the front canopy frame had a small area of bond which showed an apparent 'crystalline' feature and to be very thinly spread into the peel ply surface (Figure 15).

Epoxy bond 'crystalline' feature

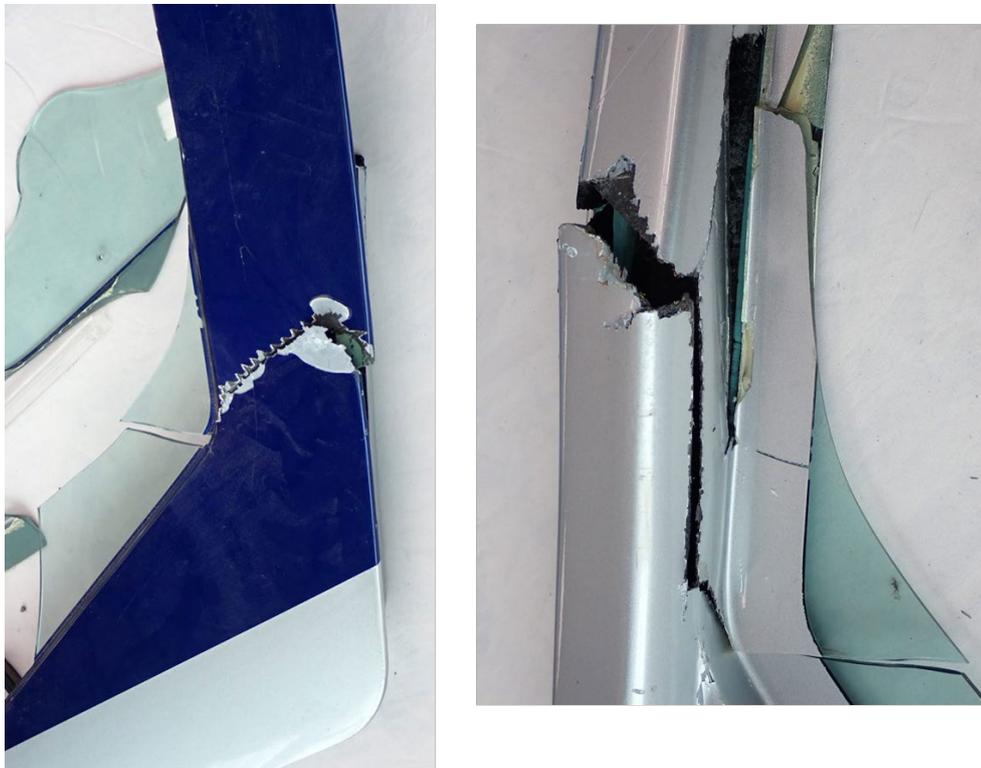
Figure 16

Parts of the rear canopy frame had breaks through the inner and outer skin. Other than small areas either side of the breaks, the remains of the inner and outer skin were still bonded together (Figure 16).

Part of the rear left side corner of the canopy frame

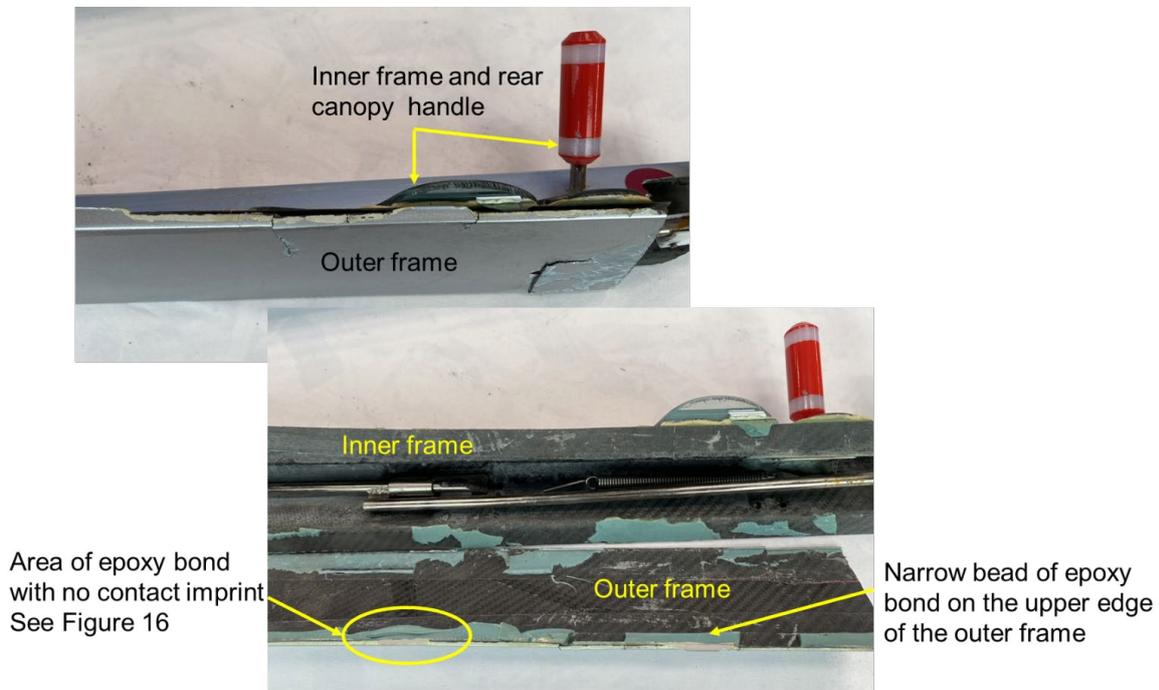
One area of the outer frame covering the shoot bolt mechanism had not been attached to the left channel of the canopy frame (Figure 17). The bead of bond material at the top of this piece of the structure was inconsistent and narrow and had not been fully applied over the peel ply area. In one small area, about 50 mm in length, it had not made contact with the inner frame at all (Figure 18).

Figure 17
Canopy inner and outer frames left side

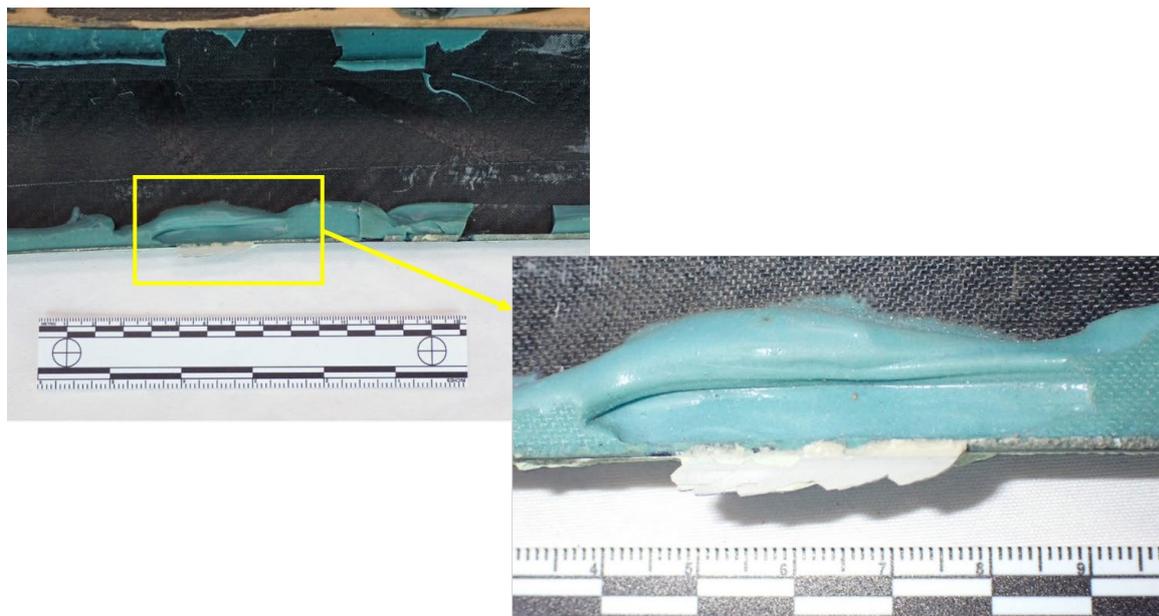
Figure 18
Area of epoxy bond showing there was no contact with the inner frame

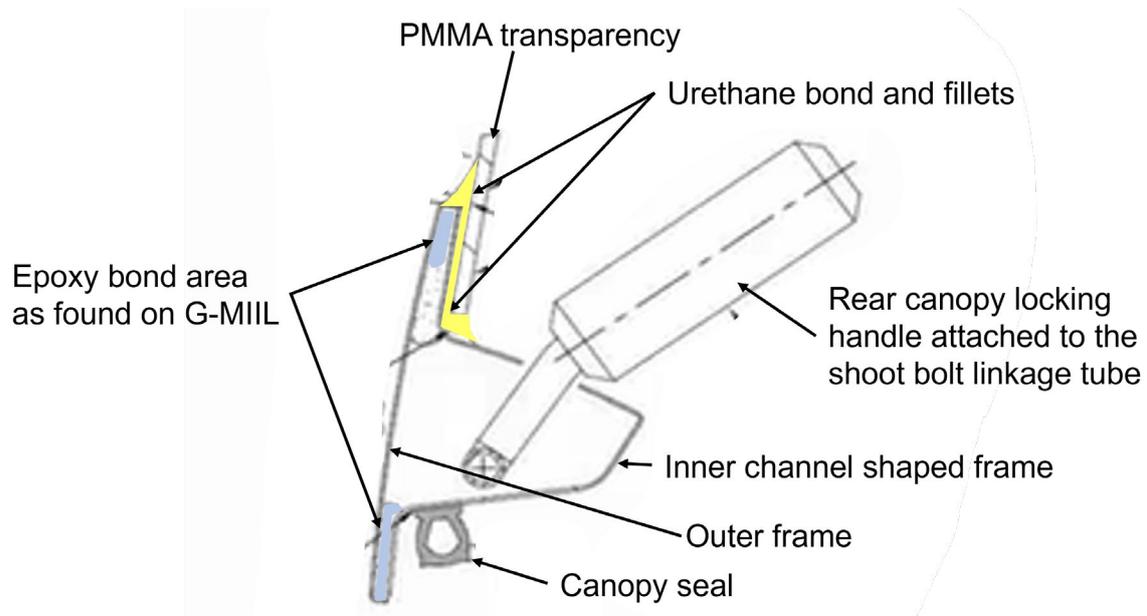
Figure 20

A schematic cross section of this area of the frame showing the extent of the epoxy bond that should have been applied is at Figure 19. A schematic of the same section as found is shown in Figure 20.

Epoxy bond area between the inner and outer canopy frames as found on G-MIIL

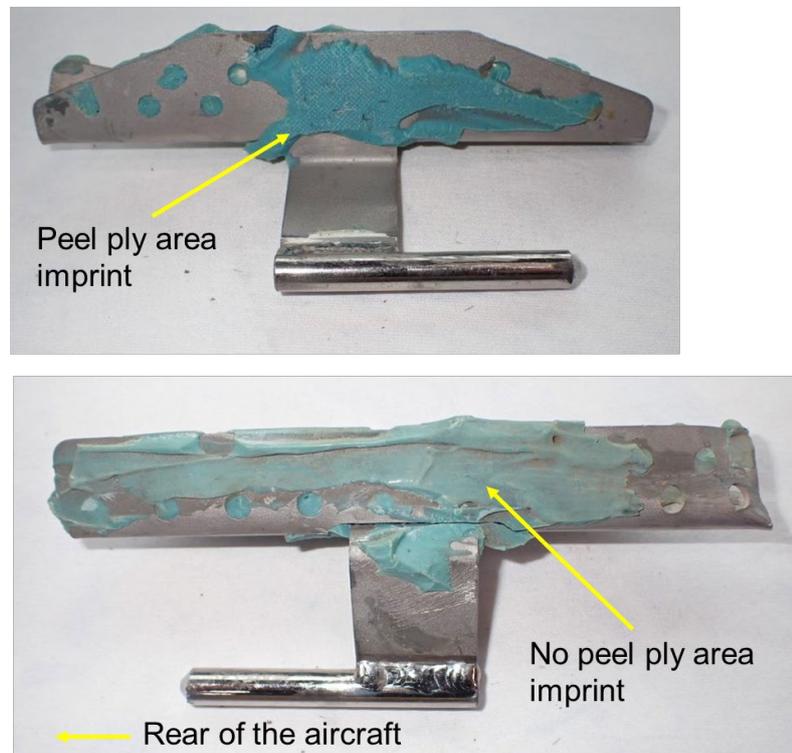
Figure 21

Imprints left in the epoxy bond present on the surface of the hinge that was found completely detached, appears only to have been in contact with a peel ply surface on one of its faces. The other face showed only partial contact with a large area of the epoxy bond showing no peel ply area imprint (Figure 21).

Both sides of unidentified canopy hinge showing the extent of the epoxy bond in contact with the peel ply area

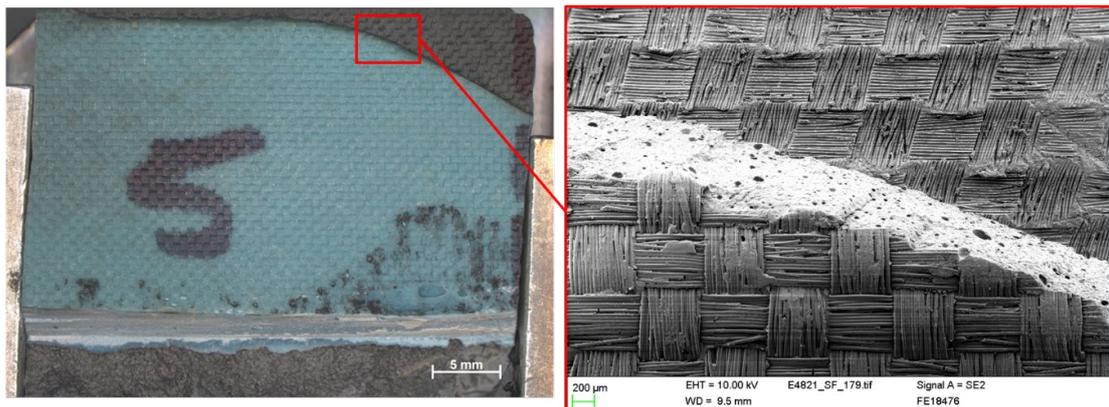
It was found that the surfaces on several sites were relatively clean with little matrix or resin present, showing an adhesive⁴ failure at the interface. There was also significant porosity in some of the adhesive layer, which may be indicative of a problem with the bonding method. Figure 22 shows an example of this phenomena on one of the sample pieces. Numerous other pieces showed similar characteristics with apparent adhesion failure. There did not appear to be any areas which exhibited cohesion⁵ failure.

Resin bond adhesion failure and porosity

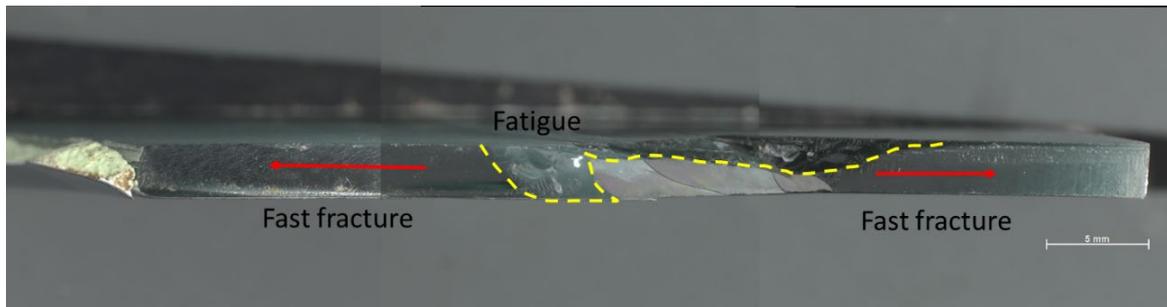
Parts of the transparency were also examined using the same method, particularly the edges where they had been bonded onto the canopy frame. Clear evidence of fatigue initiation was found. This resulted in crack initiation followed by fast, unstable crack propagation extending into the material. Figure 23 shows an example of this and Figure 24 shows its location.

Evidence of fatigue and crack initiation

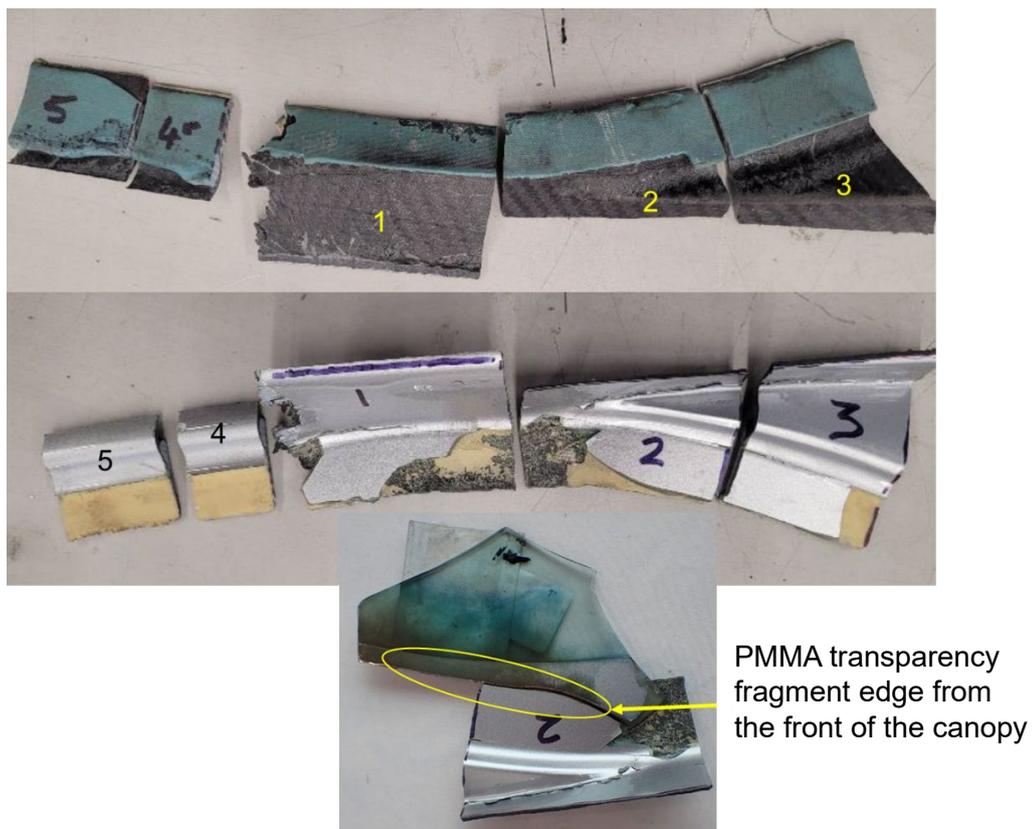
Figure 24

Parts of the inner frame from the front of the canopy (see also Figures 13, 14 and 15)

Fractures in this type of transparency material, when examined at high magnification, can show the direction of a crack propagation leading to fracture. Examination of the sample parts in relation to each other, in this case, exhibited this type of feature and showed in general, that the cracks propagated from the front of the canopy.

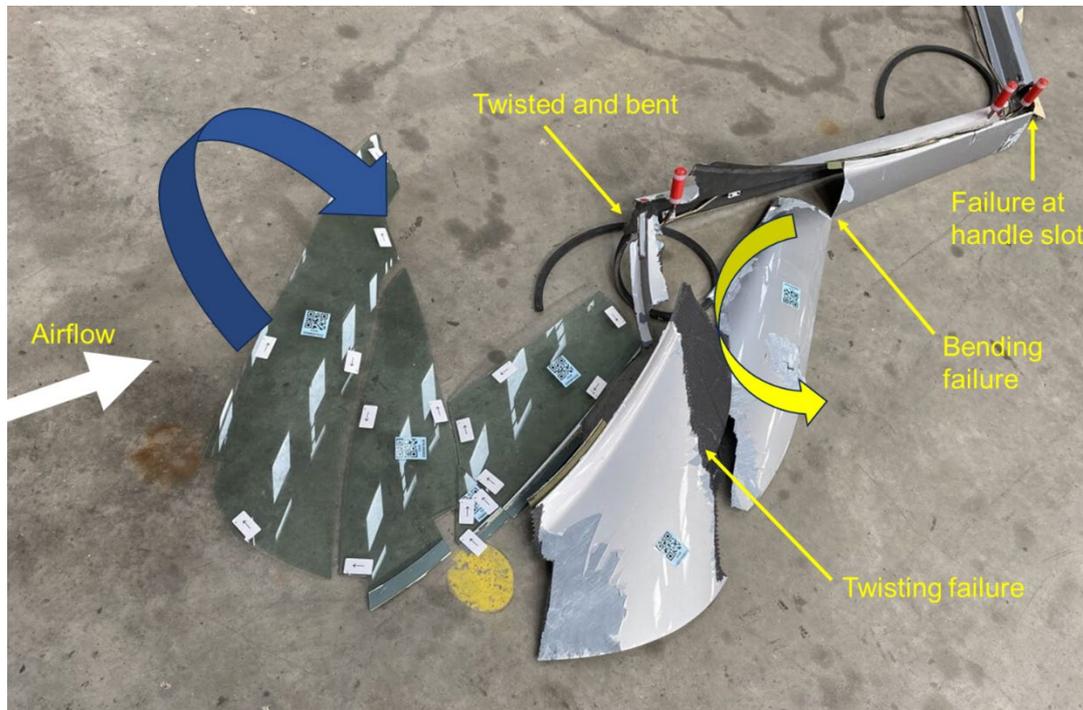
Figure 25

During part of that sequence the outer frame detached from the channel section surrounding the shoot bolt mechanism leading to a loss in its rigidity. As this happened, it is highly likely the continuing air flow loads on the pieces attached to that section wrenched the shoot bolts out of their roller lugs. In doing so, the remaining sections of the frame would have moved away from the lugs leaving the centre and rear reinforcing plates undamaged. The bends at the front and rear of the recovered shoot bolt illustrate the magnitude of the forces involved

Canopy shoot bolt release and break-up sequence

It is recommended that the European Union Aviation Safety Agency (EASA) ensure the canopies fitted to all Extra NG aircraft are manufactured to meet the required certification standards and can withstand expected aerodynamic and flight loads.

It is recommended that the European Union Aviation Safety Agency (EASA) assess the effectiveness of SB-NG-2-22 in rectifying inadequate bonding.
