Independent investigation into the circumstances around multiple stranded trains and passenger self-evacuation to track in the Lewisham and New Cross area in the evening of 2 March 2018

Report for Network Rail South East Route and Southeastern

17 August 2018

Reference P18000523/025rep

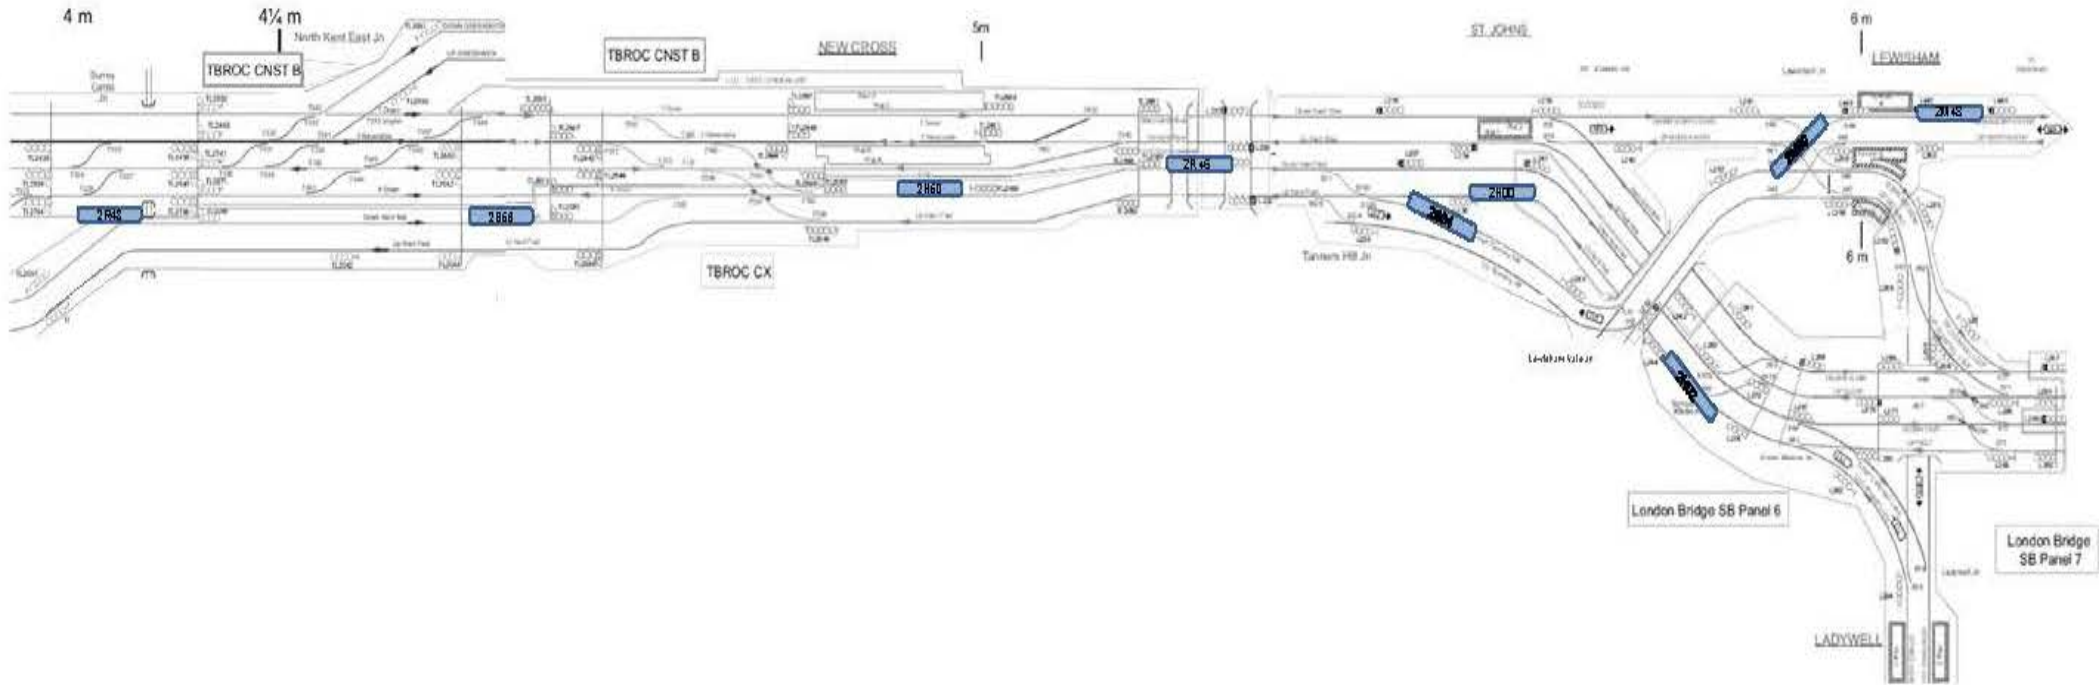
Figure 1: Map of track layout and stranded train locations

Table 2 (below) is an outline of the sequence of events throughout the evening from the points failure prior to the initial arrival of train 2M48 at Lewisham to the point at which all nine stranded trains were moving again. This is a summary of the detailed investigation analysis undertaken by train, interviews with key personnel, control/signalling/ECR logs and including all the recorded communications and downloads from the trains involved. This timeline should be read in conjunction with the diagram of the track layout and stranded train locations included at the end of this appendix (Figure 1).
