Fatal injury to a recreational diver after contact with the recreational diving support boat

Karin

MAIB SAFETY BULLETIN 2/2024

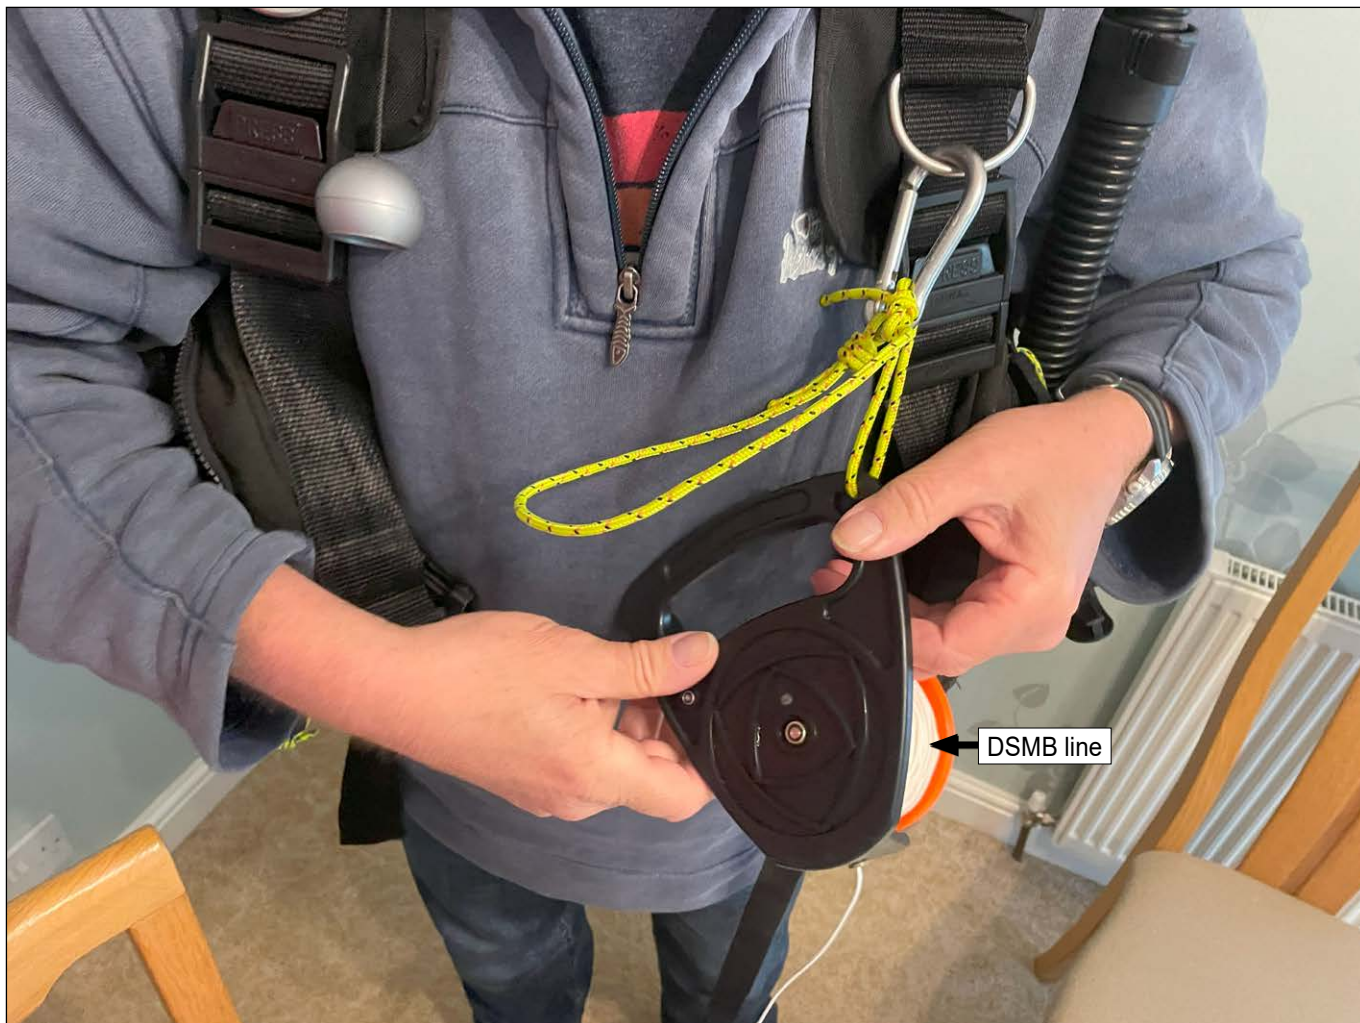
The diver and their dive buddy had ascended to their final scheduled decompression stop 3m below the surface. The divers were conducting a drift decompression away from the available shot line¹ but their presence was indicated by their delayed surface marker buoy (DSMB)², the line of which was clipped to the casualty's dive vest (**Figure 2**). The DSMB was visible to the second dive boat waiting on the other side of the wreck site, but it was not sighted by *Karin*'s crew before *Karin* motored over it.

Figure 2: DSMB line attached to harness

- Divers using a DSMB should hold the line in their hand, as recommended by the British Sub-Aqua Club, rather than attach it to their person. In the event that the DSMB becomes snagged by a passing craft, the diver can then release the line to avoid entanglement and potentially being drawn to the surface or into contact with the craft.
