Rail Accident Report

**Near miss between a rail grinding train and
an empty passenger train at Sileby Junction,
Leicestershire
5 May 2021**

Report 06/2022
July 2022

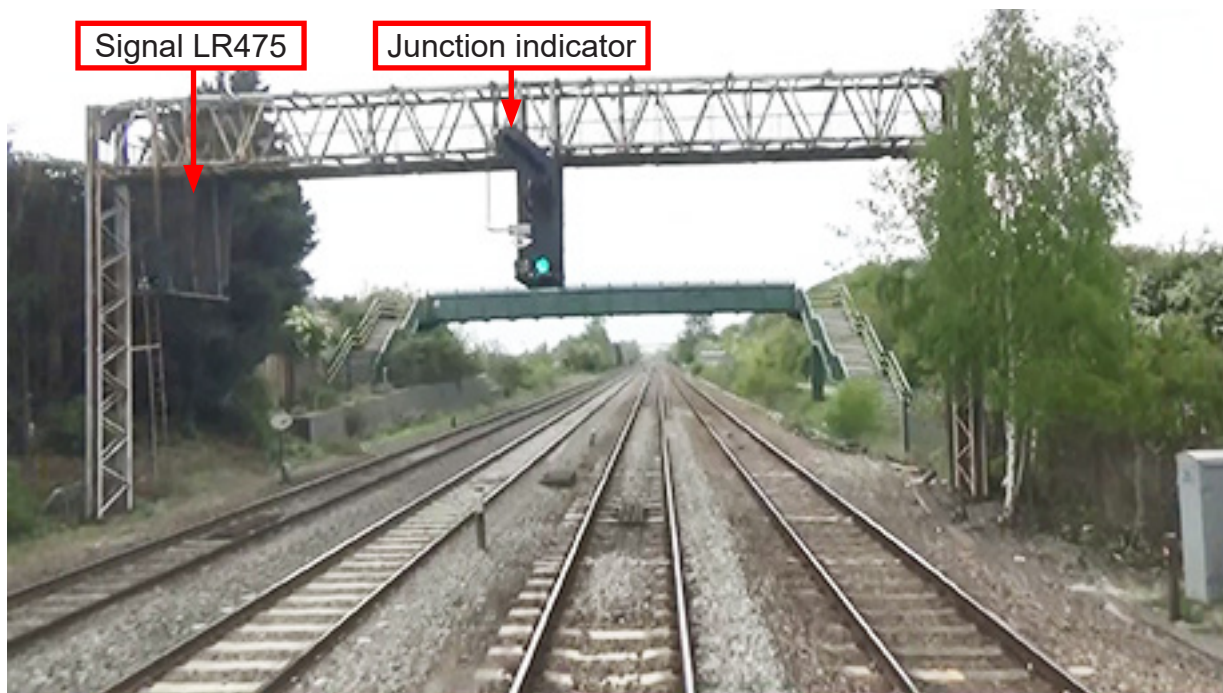
Figure 6: Signal LR477 (Colas Rail UK)

- 23 On the approach to signal LR477, there is a slight left-hand curve before the track straightens through Sileby station, which itself is around 160 metres on the approach to signal LR477. A post-incident signal sighting committee convened by Network Rail determined that the signal was first visible from 450 metres on the approach.
