## **Wrong side signalling failure and derailment at Dalwhinnie, Badenoch and Strathspey 10 April 2021**

Report 11/2022  
September 2022

# Wrong side signalling failure and derailment at Dalwhinnie, Badenoch and Strathspey, 10 April 2021

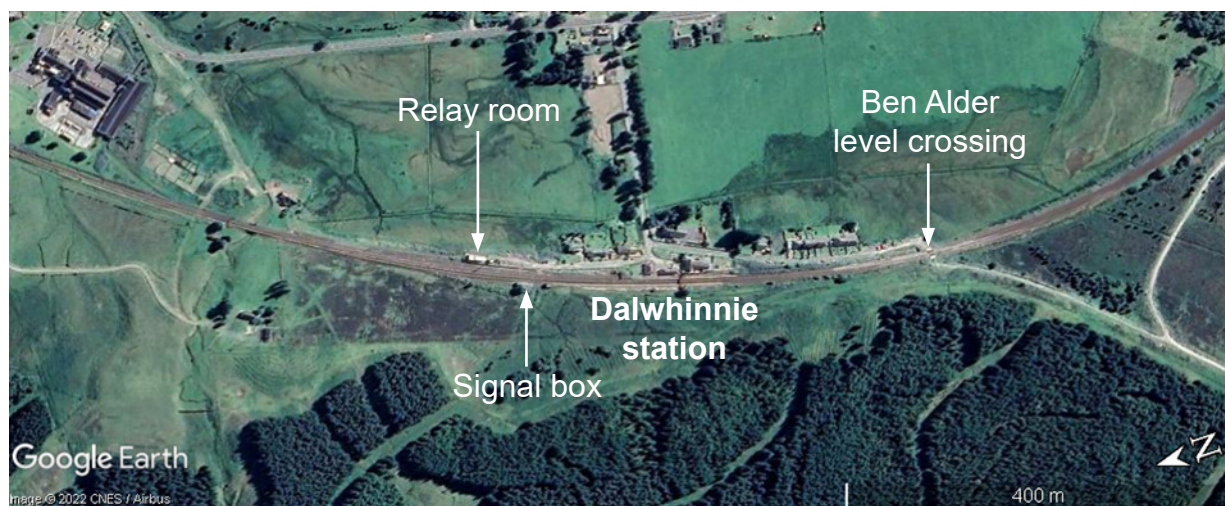
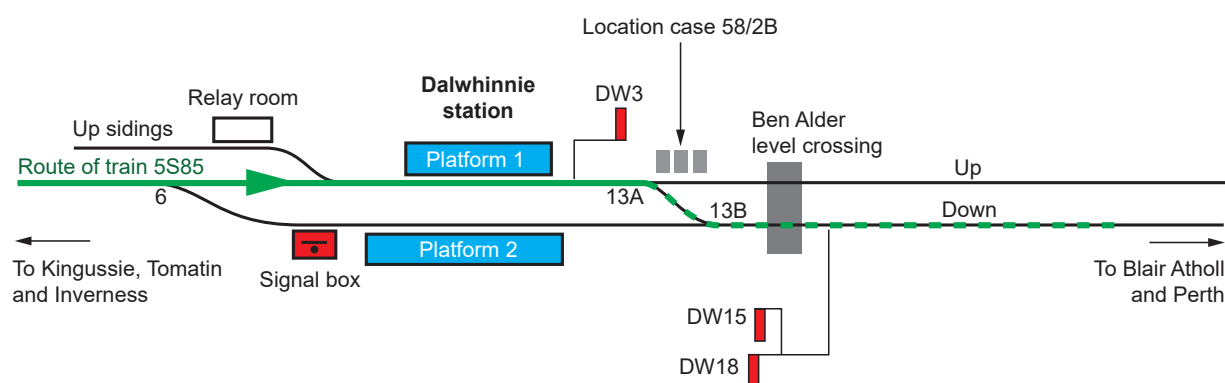
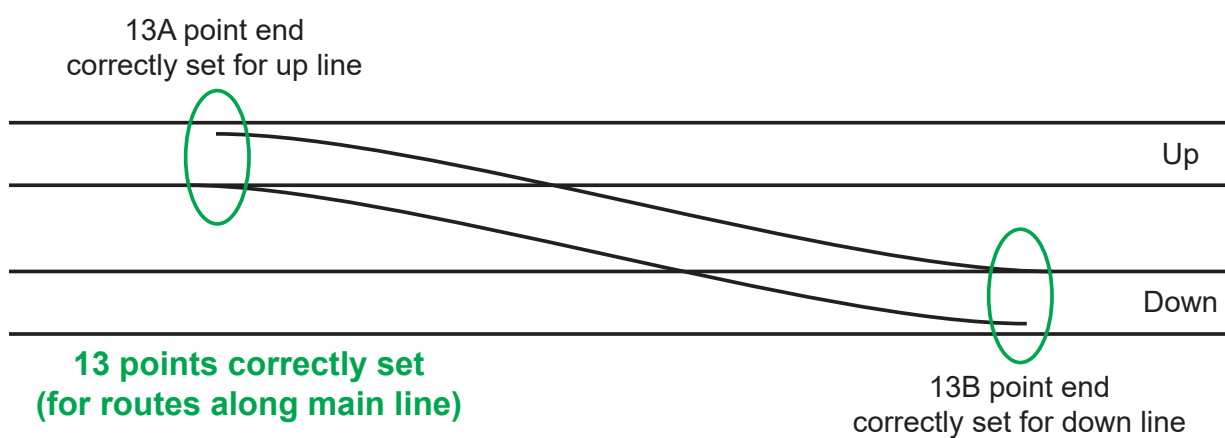
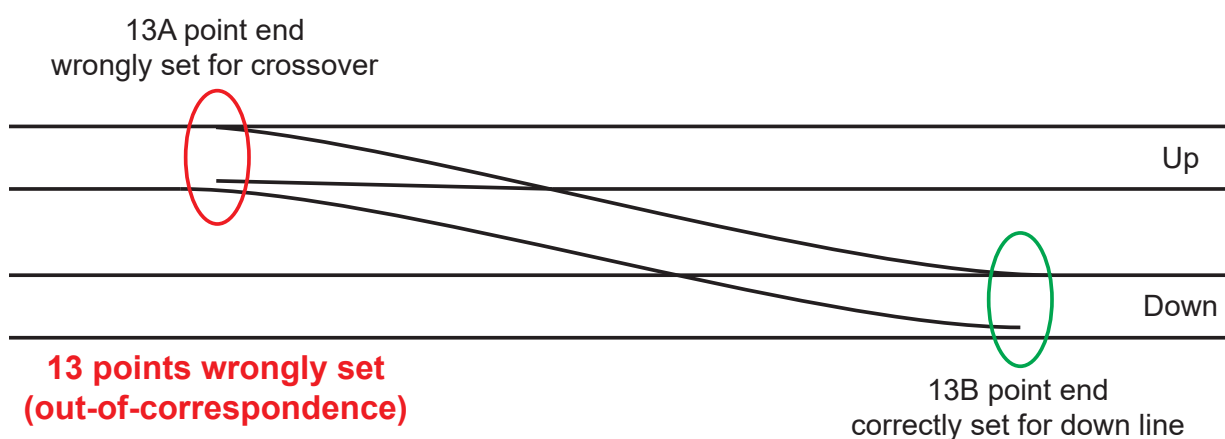
The train was wrongly diverted because, even though the signaller had recently called the double-ended set of points to be in a position for the route along the main line, the points at the facing end of the crossover had remained set towards the crossover, while the points at the trailing end had moved to the correct position. The signaller was able to clear the protecting signal, which allowed the train to approach the crossover in this condition, because of a wiring error in the signalling system that was introduced when the point machine at the trailing end was replaced some nine months earlier. The front of the train was directed over the crossover and then trailed through and forced apart the points at the trailing end. The signalling system only then detected that the points were not correctly set and automatically re-sent a command for both point ends to move to the position that the signaller had earlier commanded. This caused the points at the facing end to move under the train, which derailed the rear of train as it passed over them.

Figure 2: Layout of the railway at Dalwhinnie station showing the route of the train. The lower diagrams shows 13 points in the correct and incorrect (as encountered by the train) positions.

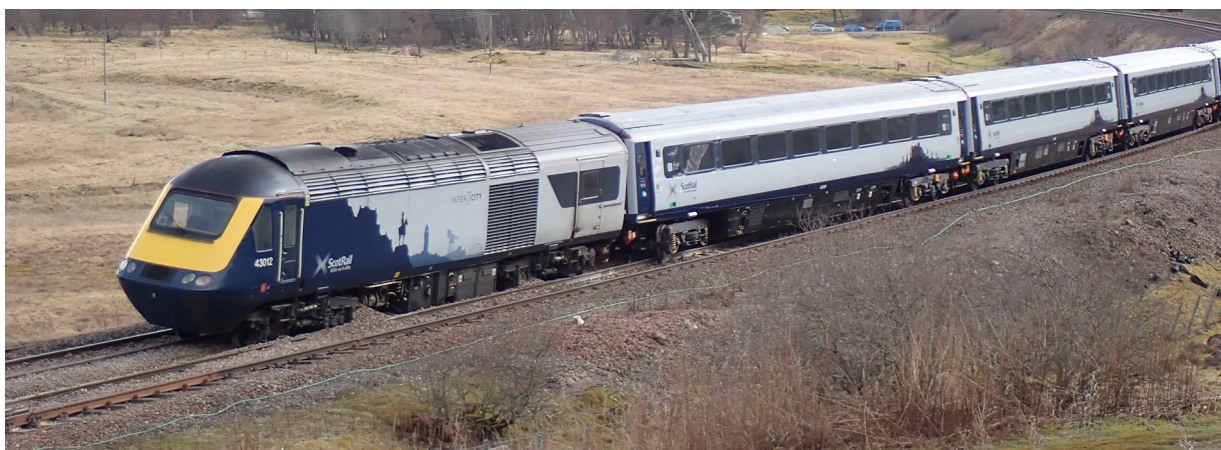
Figure 3: Derailed train – trailing power car and coaches

- 6 The driver, who had started to reduce power, felt a lurch as the train moved across onto the down line. He applied the emergency brake as the train stopped. The rear of the train came to a stand around 35 metres beyond the toes<sup>2</sup> of 13B point end. The driver then alerted the signaller.

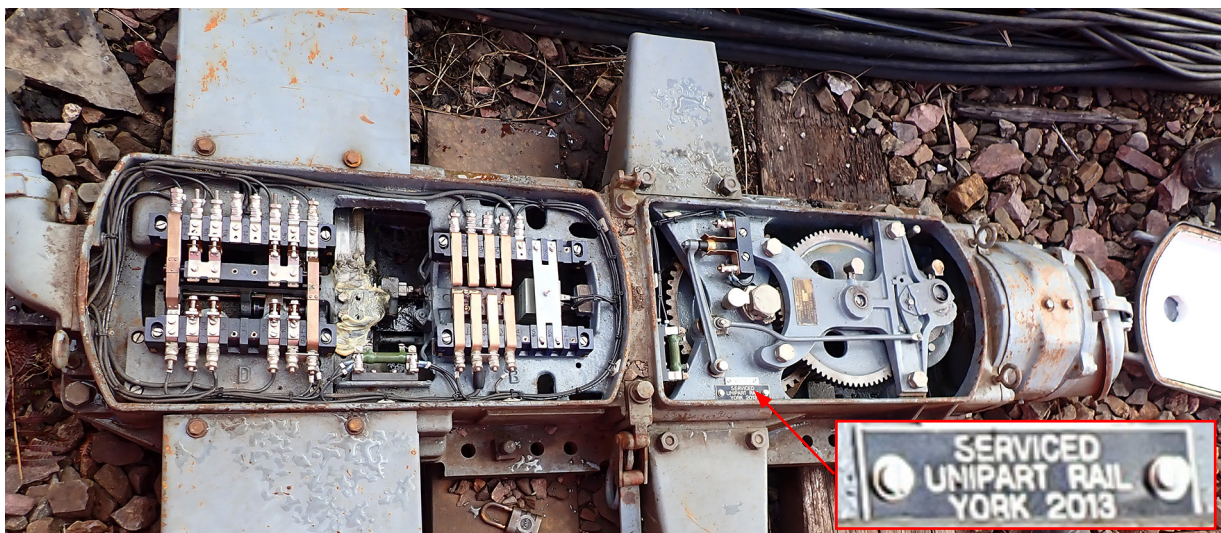
Figure 5: GRS 5E type point machine installed at 13A point end, with covers removed. Inset shows the plate fitted when it was last reserviced

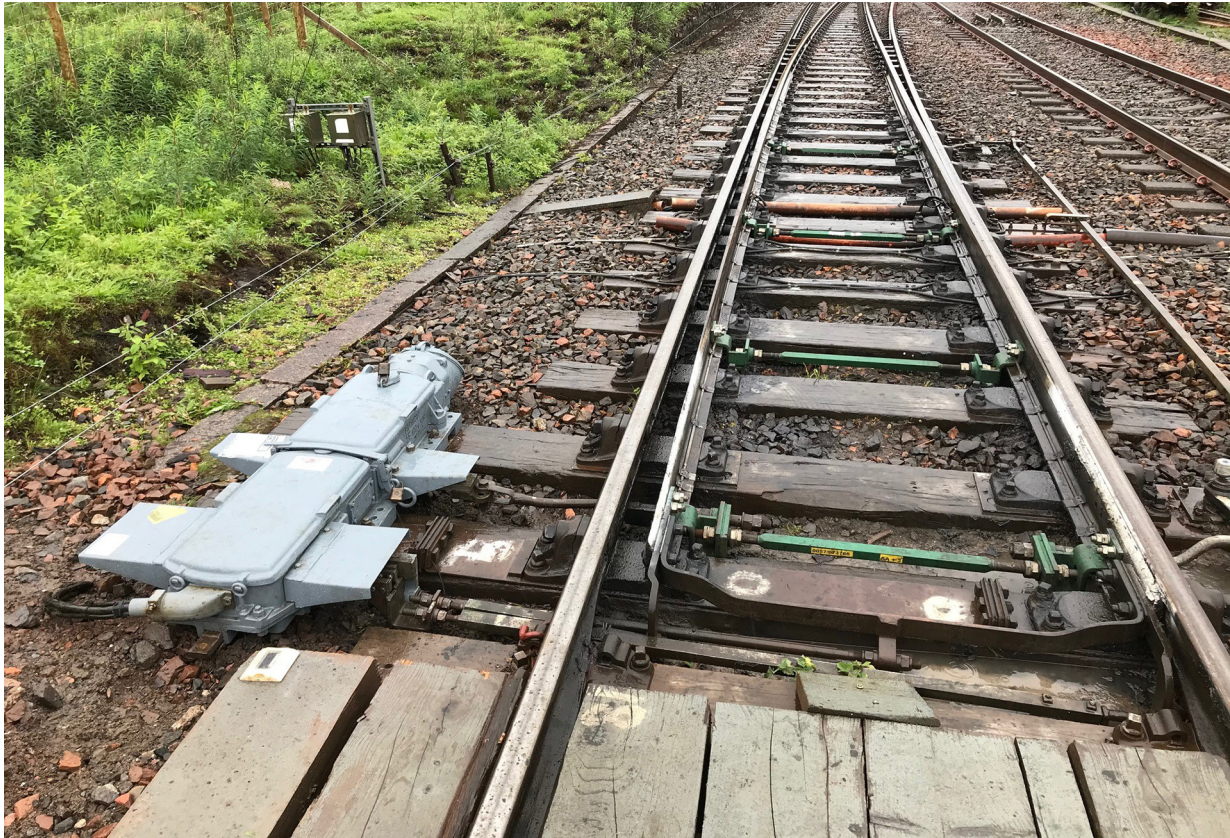
Figure 7: The newly-installed point machine at 13B point end (photograph courtesy of Network Rail)

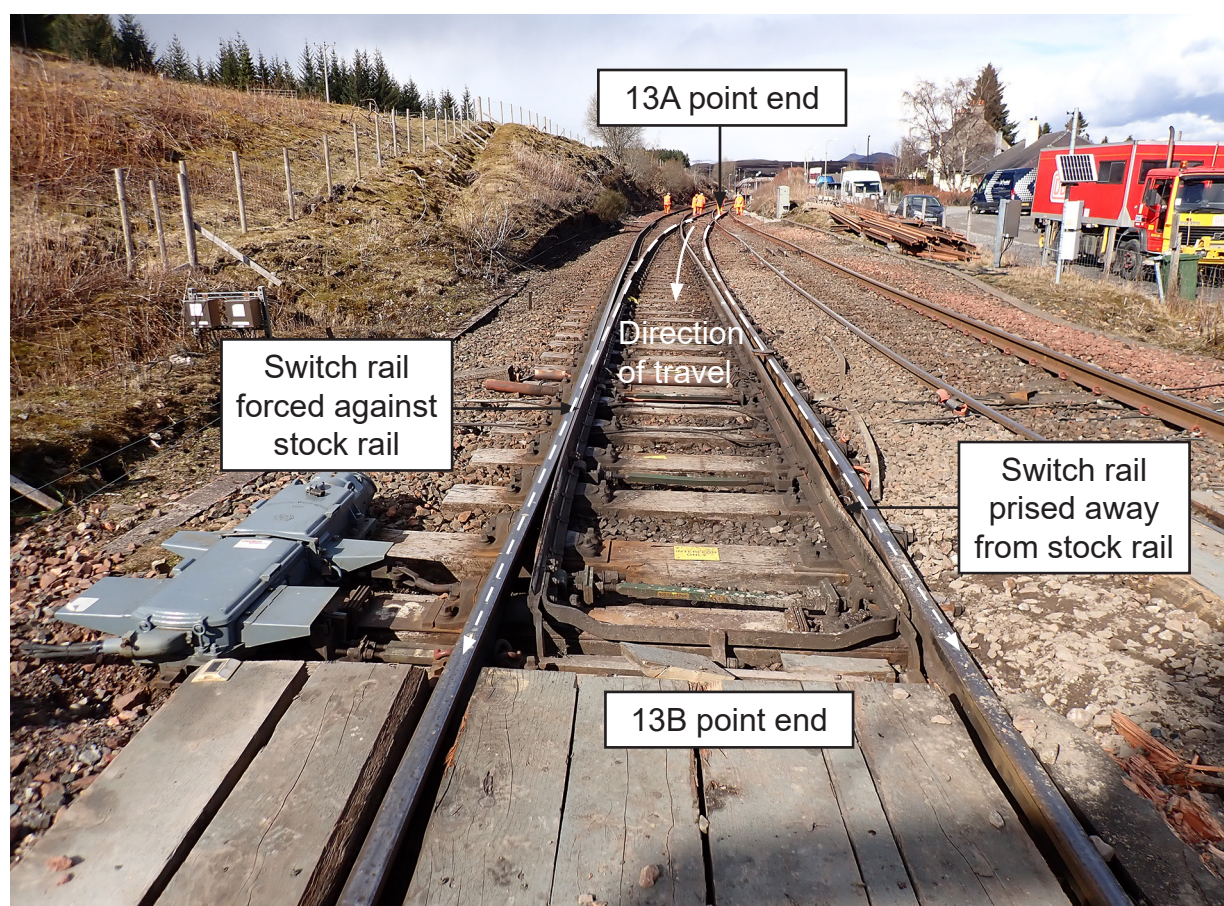
- 47 RAIB inspected the track and the derailed train at Dalwhinnie finding marks and damage at 13B point end indicating that:
- The left-hand wheels initially encountered the switch rail closed against the stock rail (the fixed rail section within a set of points), and that the train's wheels had prised the switch rail away from the stock rail as they passed.
  - The right-hand wheels had forced, and deformed, the opposite switch rail against its stock rail.

Both are consistent with the leading wheelsets being diverted onto the crossover after encountering 13A point end (incorrectly set) in the reverse position, and then encountering 13B point end (correctly set) in the normal position and running through onto the down line in the trailing direction<sup>14</sup> (figures 2 and 8).

Figure 8: Track damage at 13B point end, showing paths of the wheels that ran through

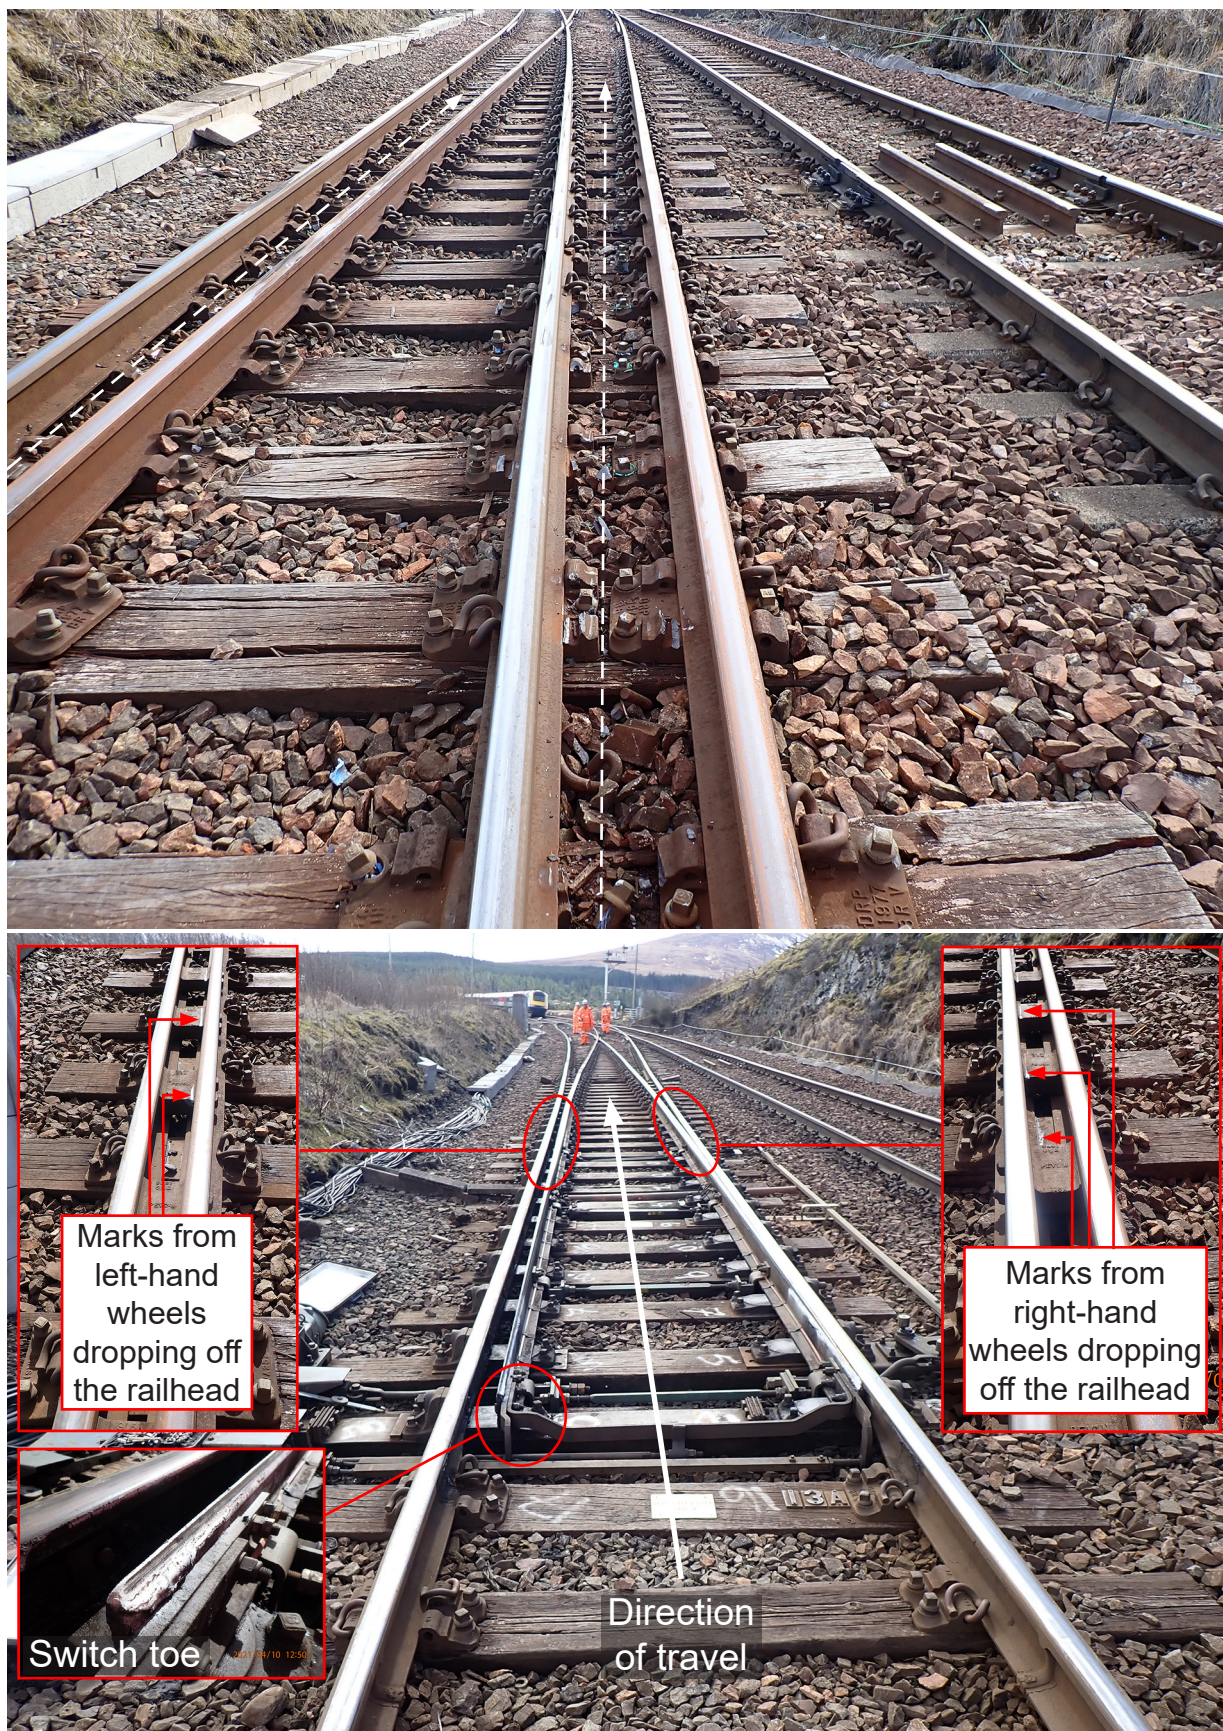
Figure 9: Derailment marks at 13A point end, switch rails in the normal position (as found after the derailment)

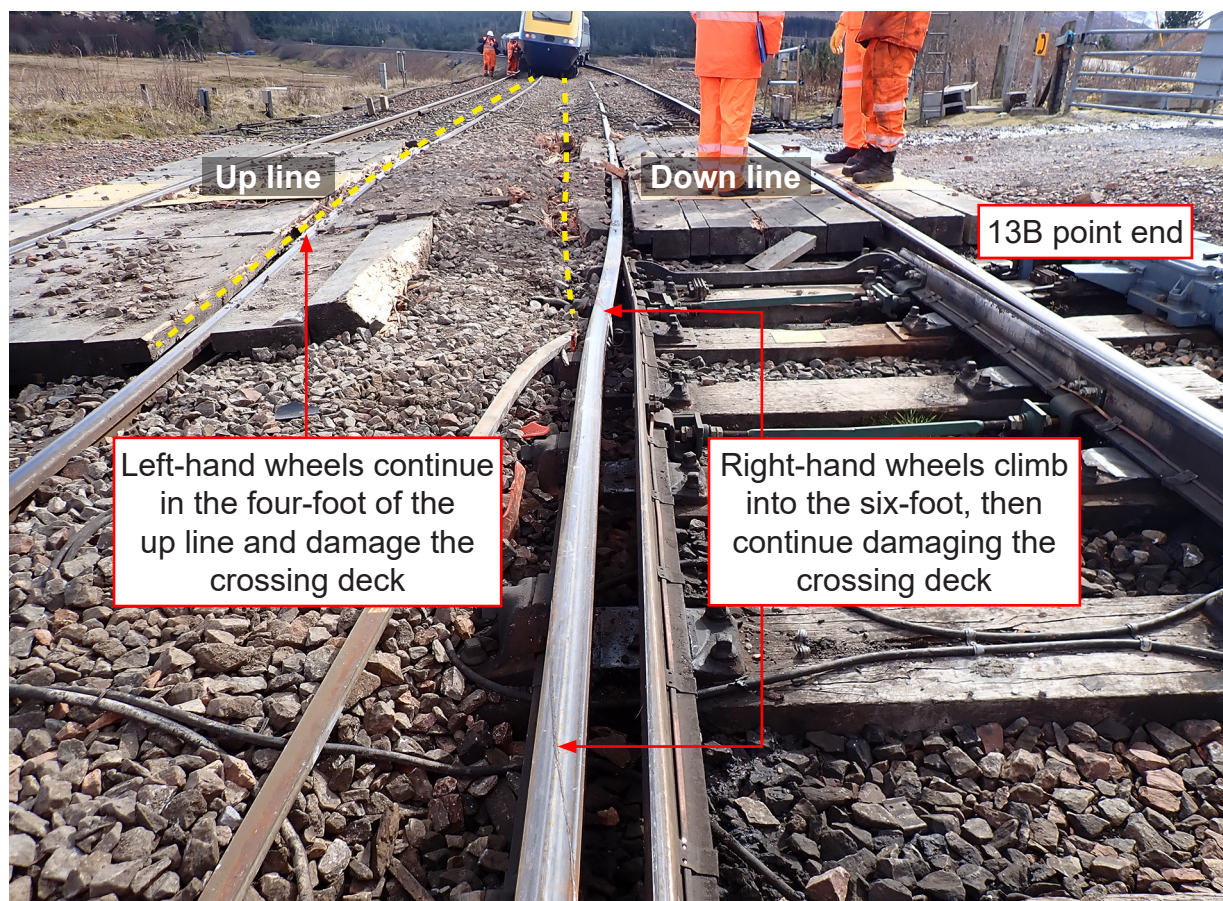
Figure 10: Marks and damage from the last three bogies on the train

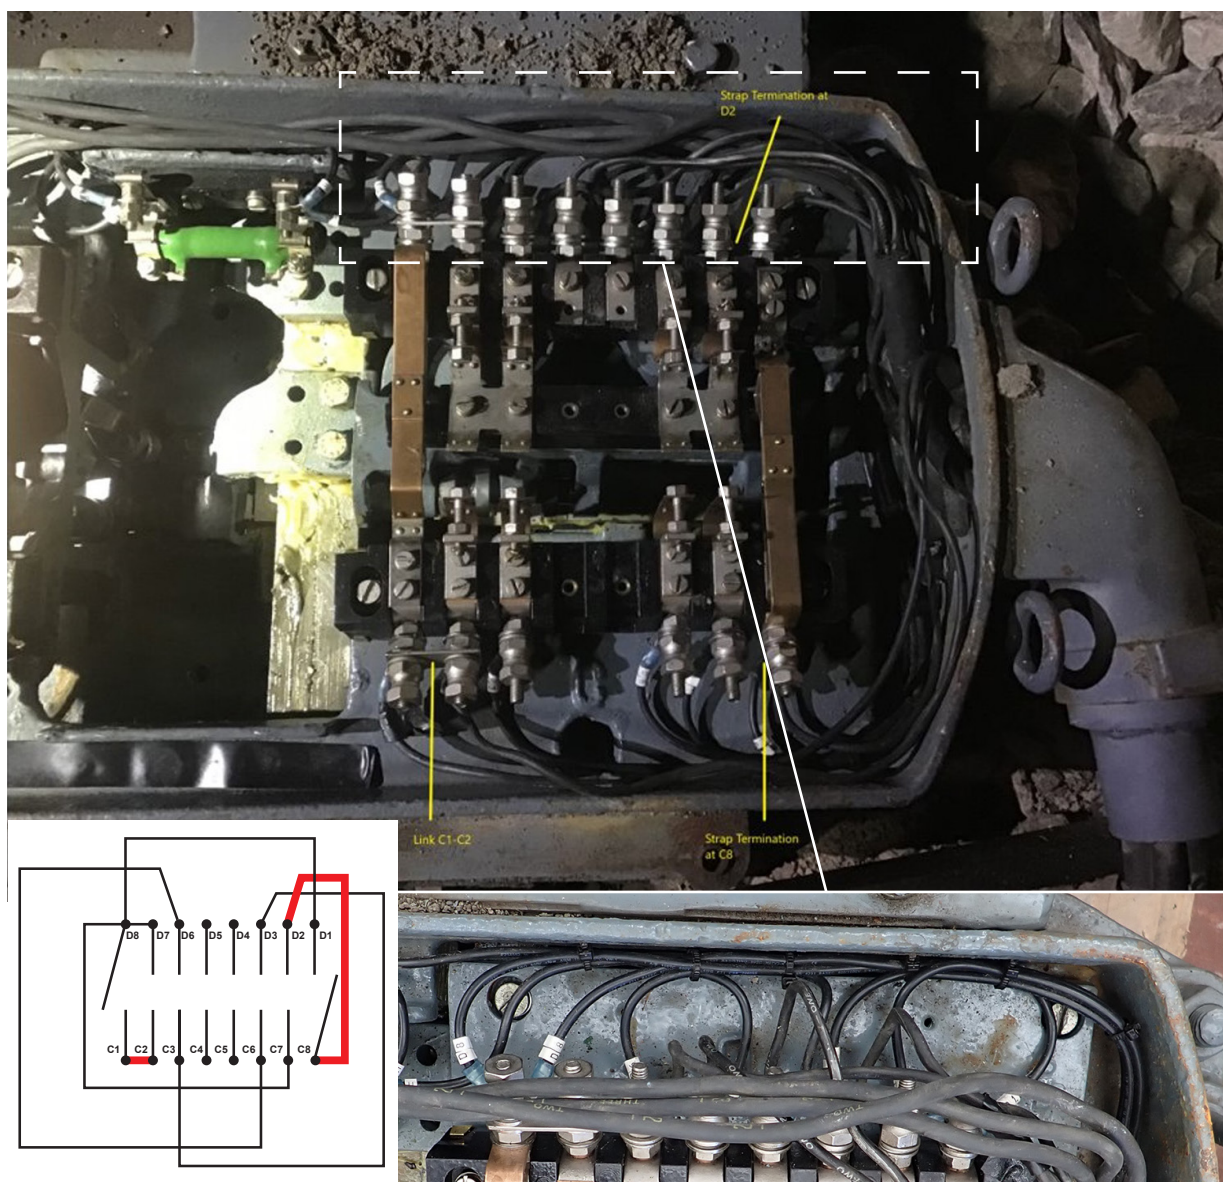
The wiring error was the result of two unwanted conductors, a wire strap and a metal link, within the replacement trailing end point machine. These conductors were only required when this type of point machine was installed at single-ended point locations. The local signalling maintenance team was responsible for installing and testing the replacement point machine. The team did not appreciate that the crossover at Dalwhinnie was unique to the area and that, because of the design of the point position detection circuit that the two point machines shared, these conductors needed to be removed from the point machine when it was installed.

### External circumstances

- 26 Witness reports indicate that it was raining at Dalwhinnie when the point machine was replaced on 28 June 2020. Around this time, the weather station near Drumochter summit, 9 km to the south, recorded rainfall of between 1 and 2 mm/h. Rainfall may be relevant to the accident (see paragraphs 111, 112 and 147). The weather station recorded an air temperature of 8°C and a wind speed of around 10 km/h.

Figure 12: Additional link and wire strap (red) found in point machine at 13B point end (main photograph courtesy of Network Rail – annotation Network Rail). Inset photograph below shows example of use of cable ties to bind wires

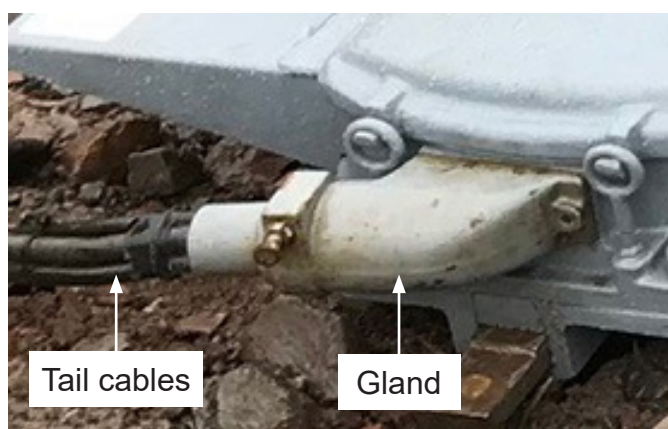
127 The condition of the gland shown on the photograph of the newly-installed point machine is consistent with the tail cables having been transferred in this way (figure 14). Witness evidence supports both this, and that installer A's focus did not extend to considering the internal detection circuit wiring. He had not considered this necessary because of the pre-installation checking work that he had done (paragraph 106).

*Figure 14: Enlargement of figure 8 showing the tail cables and gland. Paint discolouration is evidence that the gland is from the point machine that was replaced (photograph courtesy of Network Rail)*

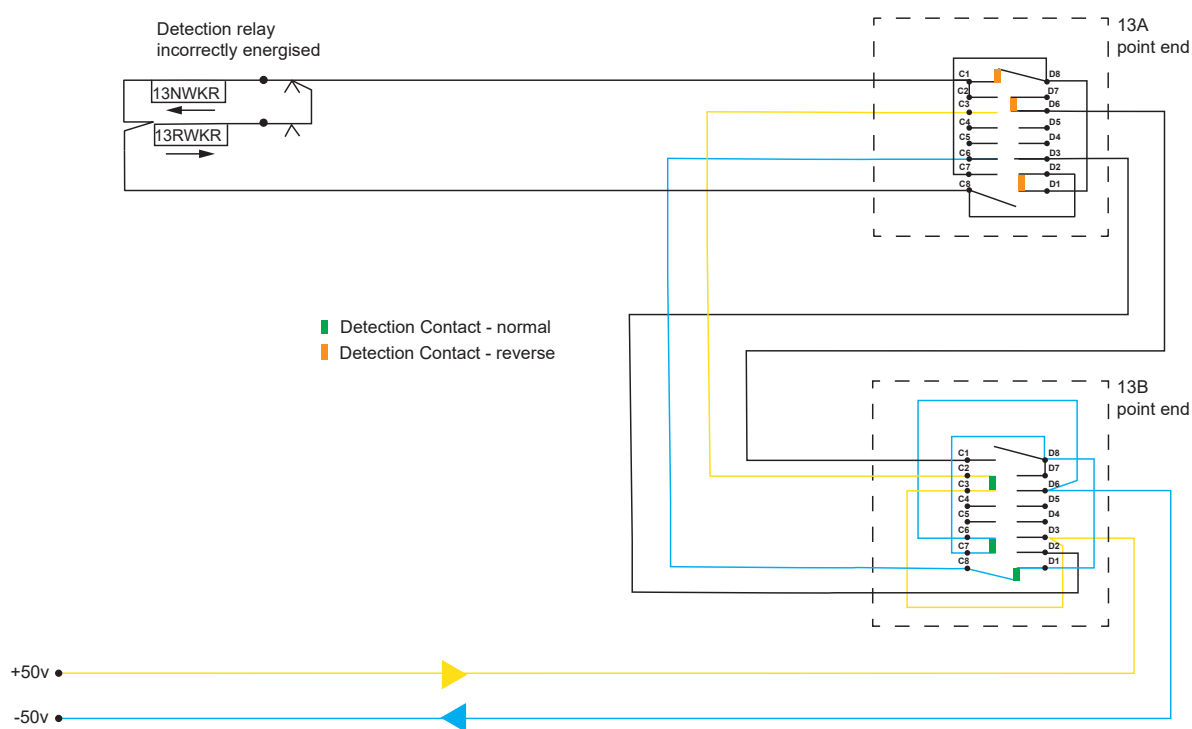
Figure B3: As-designed detection circuit for 13 points showing 13A point end reverse and 13B point end normal – neither detection relays energise

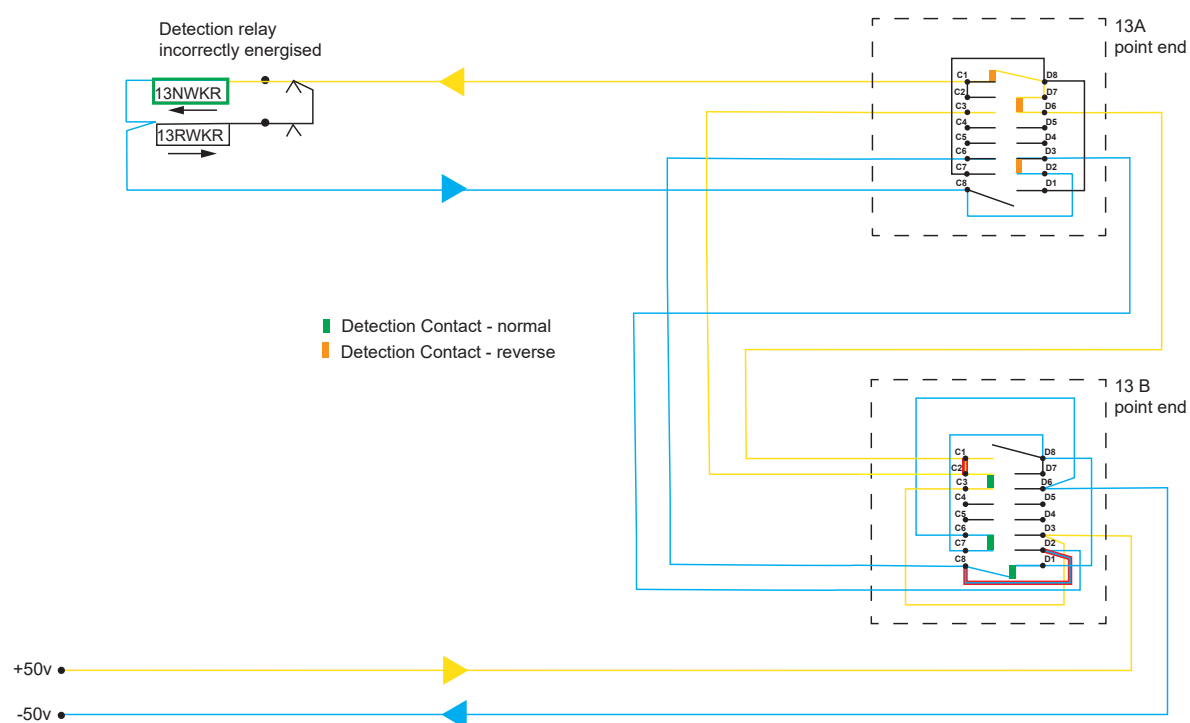
- B9 With the switch rails at 13A point end in the reverse position, and those at the 13B point end in the normal position (paragraph 81), 13 points were out-of-correspondence. For this condition, analysis of the as-designed circuit shows that neither of the detection relays should have energised (figure B3). However, with the two additional conductors in the point machine at 13B point end (between terminals C1 and C2; and C8 and D2) detection relay 13NWKR is incorrectly energised (figure B4).

Figure B4: Detection circuit for 13 points with additional conductors (red) showing 13A point end reverse and 13B point end normal – detection relay 13NWKR is incorrectly energised
