## Grounding and subsequent loss of the fishing vessel *Silver Cloud II* (WK 80) on Rubha Rodha, Lochinver, Scotland on 14 October 2025

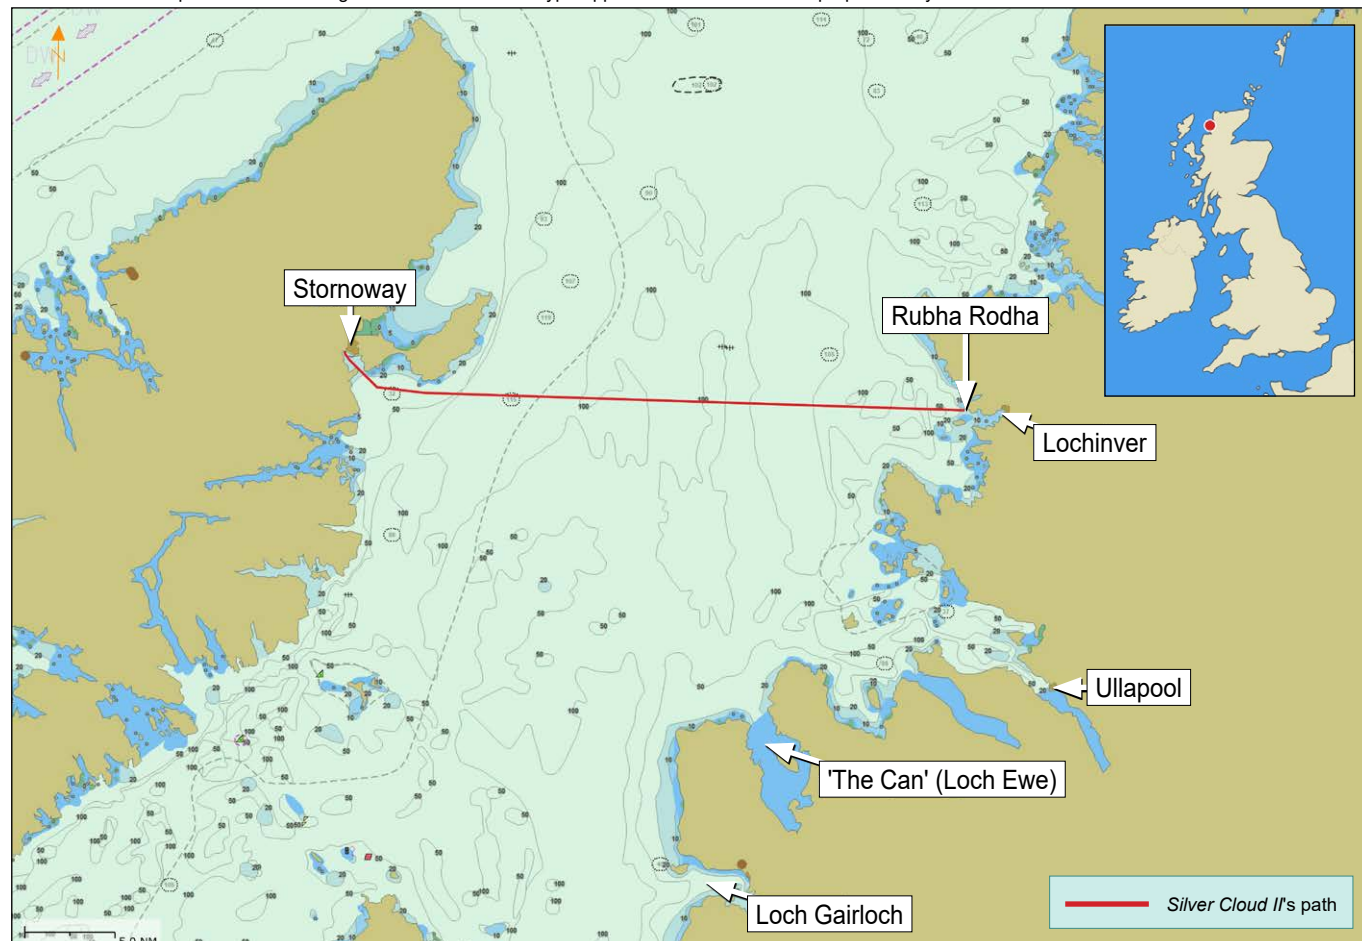
The skipper set a waypoint near the fishing ground, which had an arrival time of about 0115, and placed the vessel into autopilot. At some point between 2330 and 0115, the skipper fell asleep in the wheelhouse. The vessel passed the waypoint and continued on a course of 092° towards mainland Scotland.

**Figure 1:** Chart showing the final path of *Silver Cloud II*

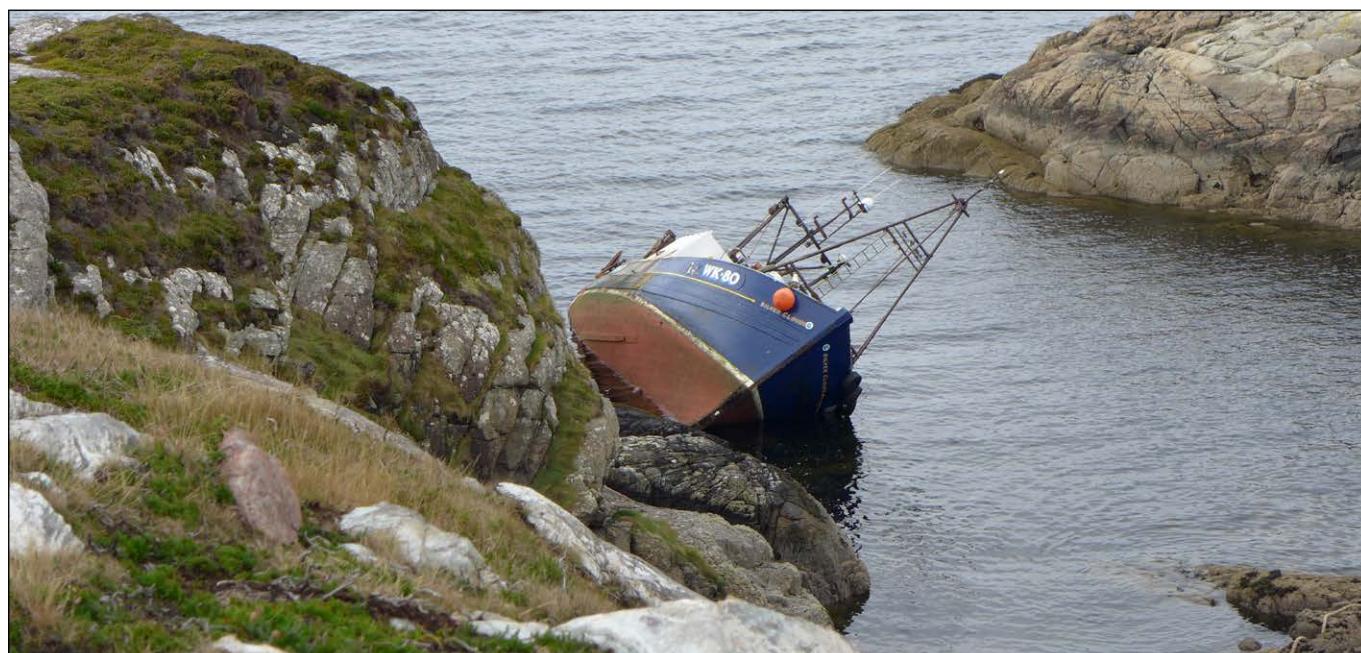
At 0238, *Silver Cloud II* grounded on rocks at Rubha Rodha (**Figure 2**). The impact and subsequent movement awoke the skipper and crew. On inspection, approximately 1m of rising water was found in the fish hold. The skipper decided to abandon the vessel.

*Silver Cloud II* remained aground, with salvors attending to remove debris and nets. The vessel subsequently broke up and sank.

**Figure 2:** *Silver Cloud II* aground on the rocks at Rubha Rodha
