Rail Accident Investigation Branch

Rail Accident Report

Near miss with track workers at Bookham Tunnel, Surrey 29 April 2025

Report 07/2026
June 2026

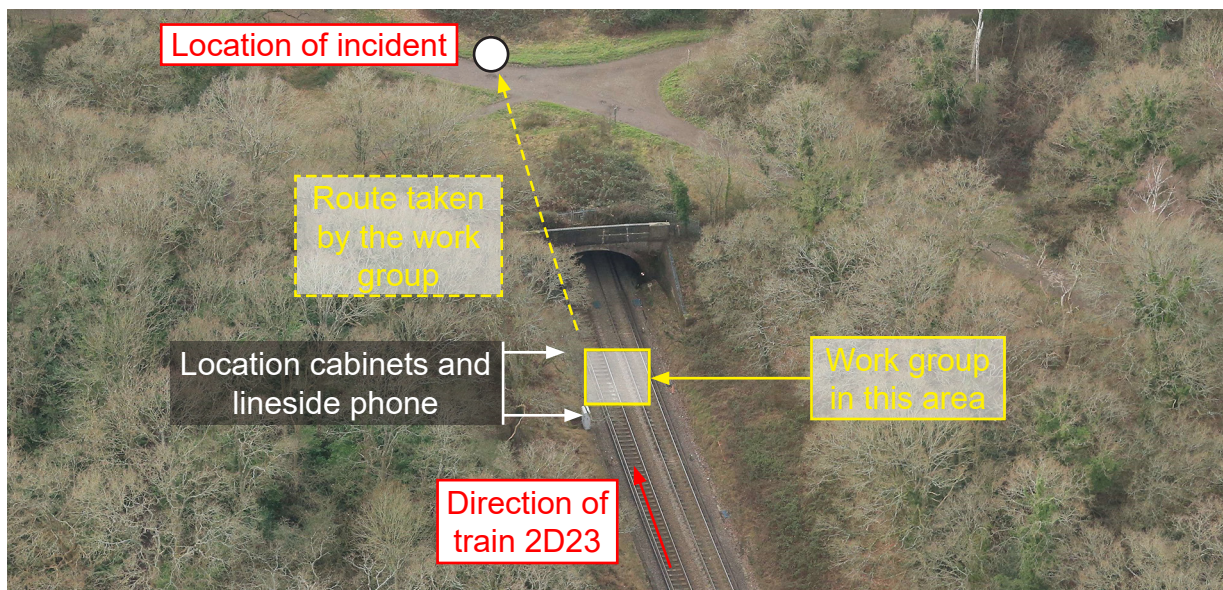
Figure 13: Track workers location after taking second line blockage and during incident (courtesy of Network Rail with RAIB annotations).

- 62 At 11:39, the signaller phoned the PIC back to confirm the line was clear for the requested line blockage. The signaller confirmed the blocking points and agreed a handback time with the PIC. This again blocked the Down Portsmouth line through Mickleham Tunnel, while the down line through Bookham Tunnel remained open. The team set off back to Bookham station with the PIC leading, followed by trackworker 2 and trackworker 1. At the same time, train 2D23 left Leatherhead station.

- 63 At approximately 11:41, while walking inside the tunnel, trackworker 1 heard a train approaching behind them and shouted a warning to the rest of the group. At around the same time, the train driver saw the group and sounded the horn. The group then moved quickly to the side of the tunnel. Once the train had passed, the group then headed toward Bookham station (figure 13).

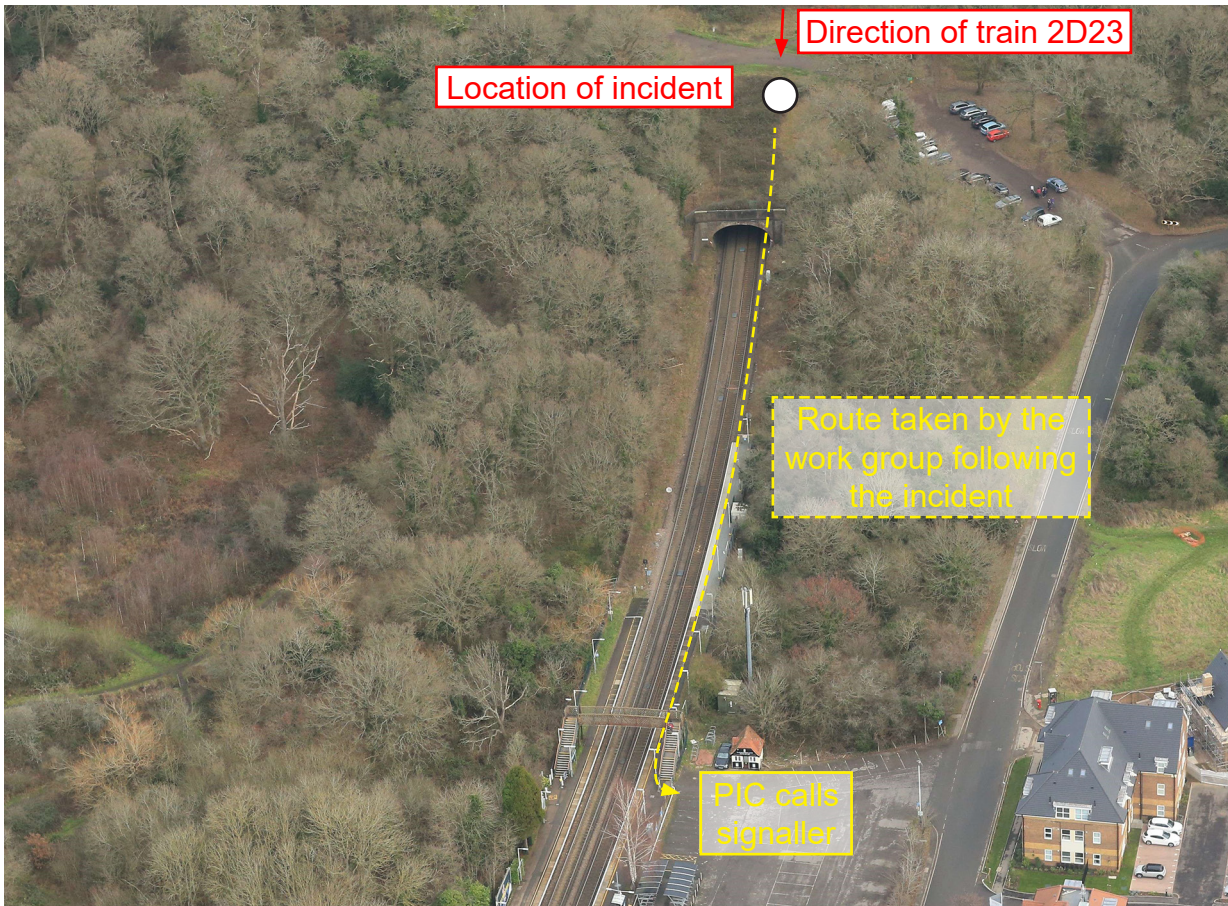
Figure 14: Track workers location post-incident (courtesy of Network Rail with RAIB annotations).

- 64 At 11:45, a relief signaller took over from the signaller at Wimbledon who had granted the line blockage. At 11:46, the PIC called to hand the line blockage back. Having done this, the PIC then mentioned that a train had passed through the blockage. The relief signaller handed the phone to the original signaller, who questioned this with the PIC. The PIC confirmed their line blockage limits and stated they were at Bookham Tunnel. The signaller replied that these were the blocking limits for Mickleham Tunnel, not Bookham Tunnel. The PIC said that they would look at their paperwork and then ended the call (figure 14).

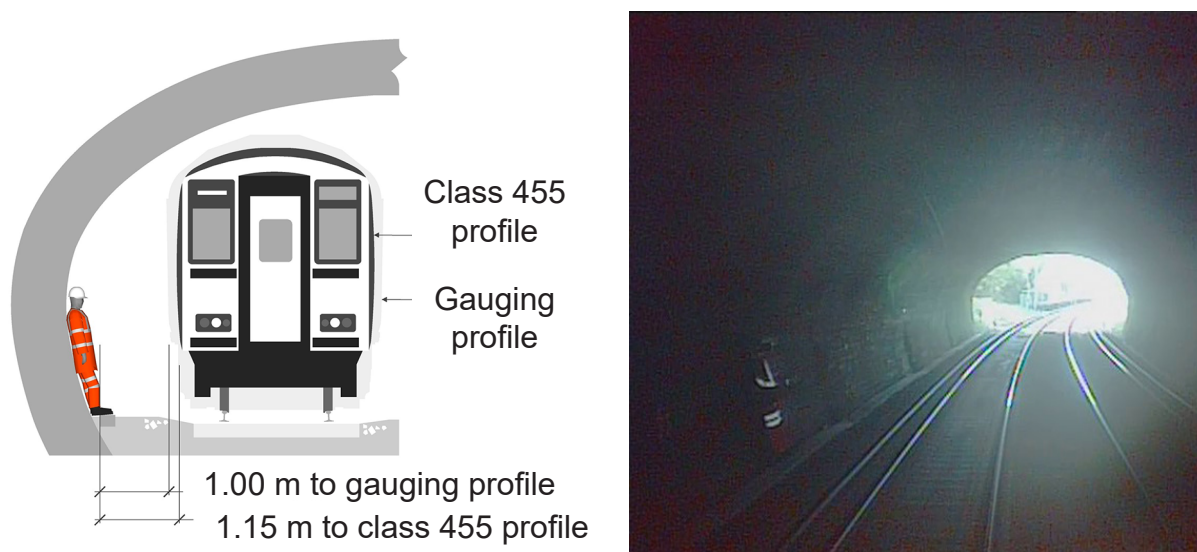
Figure 15: Position of track worker inside the tunnel as the train passed, based on gauging information from Network Rail (left-hand image) and from FFCCTV (right-hand image, courtesy of South Western Railway).

- 68 The distance between the tunnel wall and the nearest running rail of the down line where the track workers were walking is about 1.6 metres. The available space between the tunnel wall and the passing train was between 1 and 1.15 metres (figure 15).

- 69 The length of time the track workers had between becoming aware of the approaching train and positioning themselves against the tunnel wall or in the refuges is unknown from the FFCCTV footage. Witness evidence, however, indicates that, due to the track curvature and because the train approached the group from behind, the track workers only had seconds to react when they became aware of the train. Knowing that they were in a tunnel of limited clearance, the track workers moved to either put themselves against the tunnel wall (as one did) or move into a refuge before the train passed (as the other two did).
