**Potential fire hazards from flexible hose installations
identified following a fire on board
the roll-on/roll-off cargo ship
Finnmaster
in Hull, England
on 19 September 2021**

MAIB SAFETY BULLETIN 1/2023

The Marine Accident Investigation Branch is carrying out an investigation into the fire on board the roll-on/roll-off cargo ship *Finnmaster* in Hull, England, on 19 September 2021.

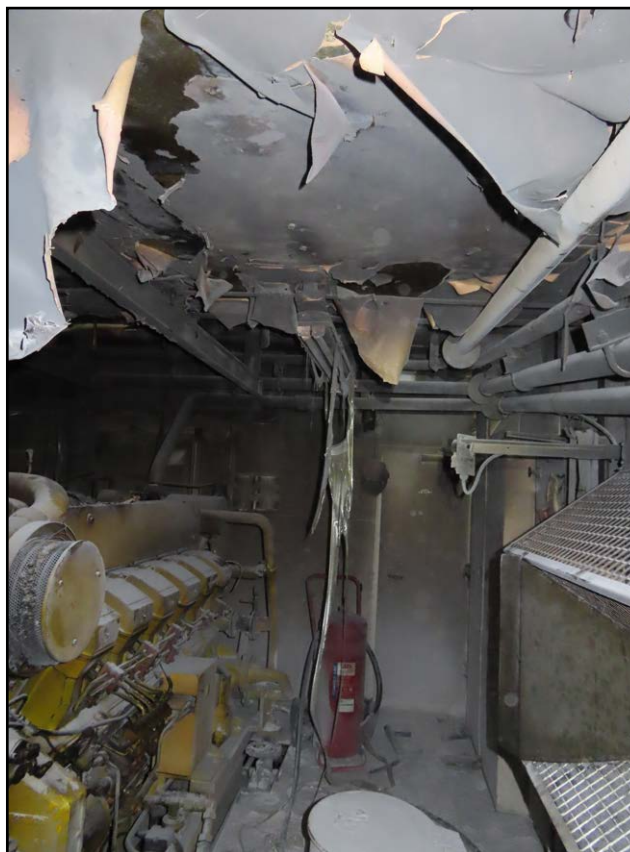
Finnmaster's fire-damaged compartment

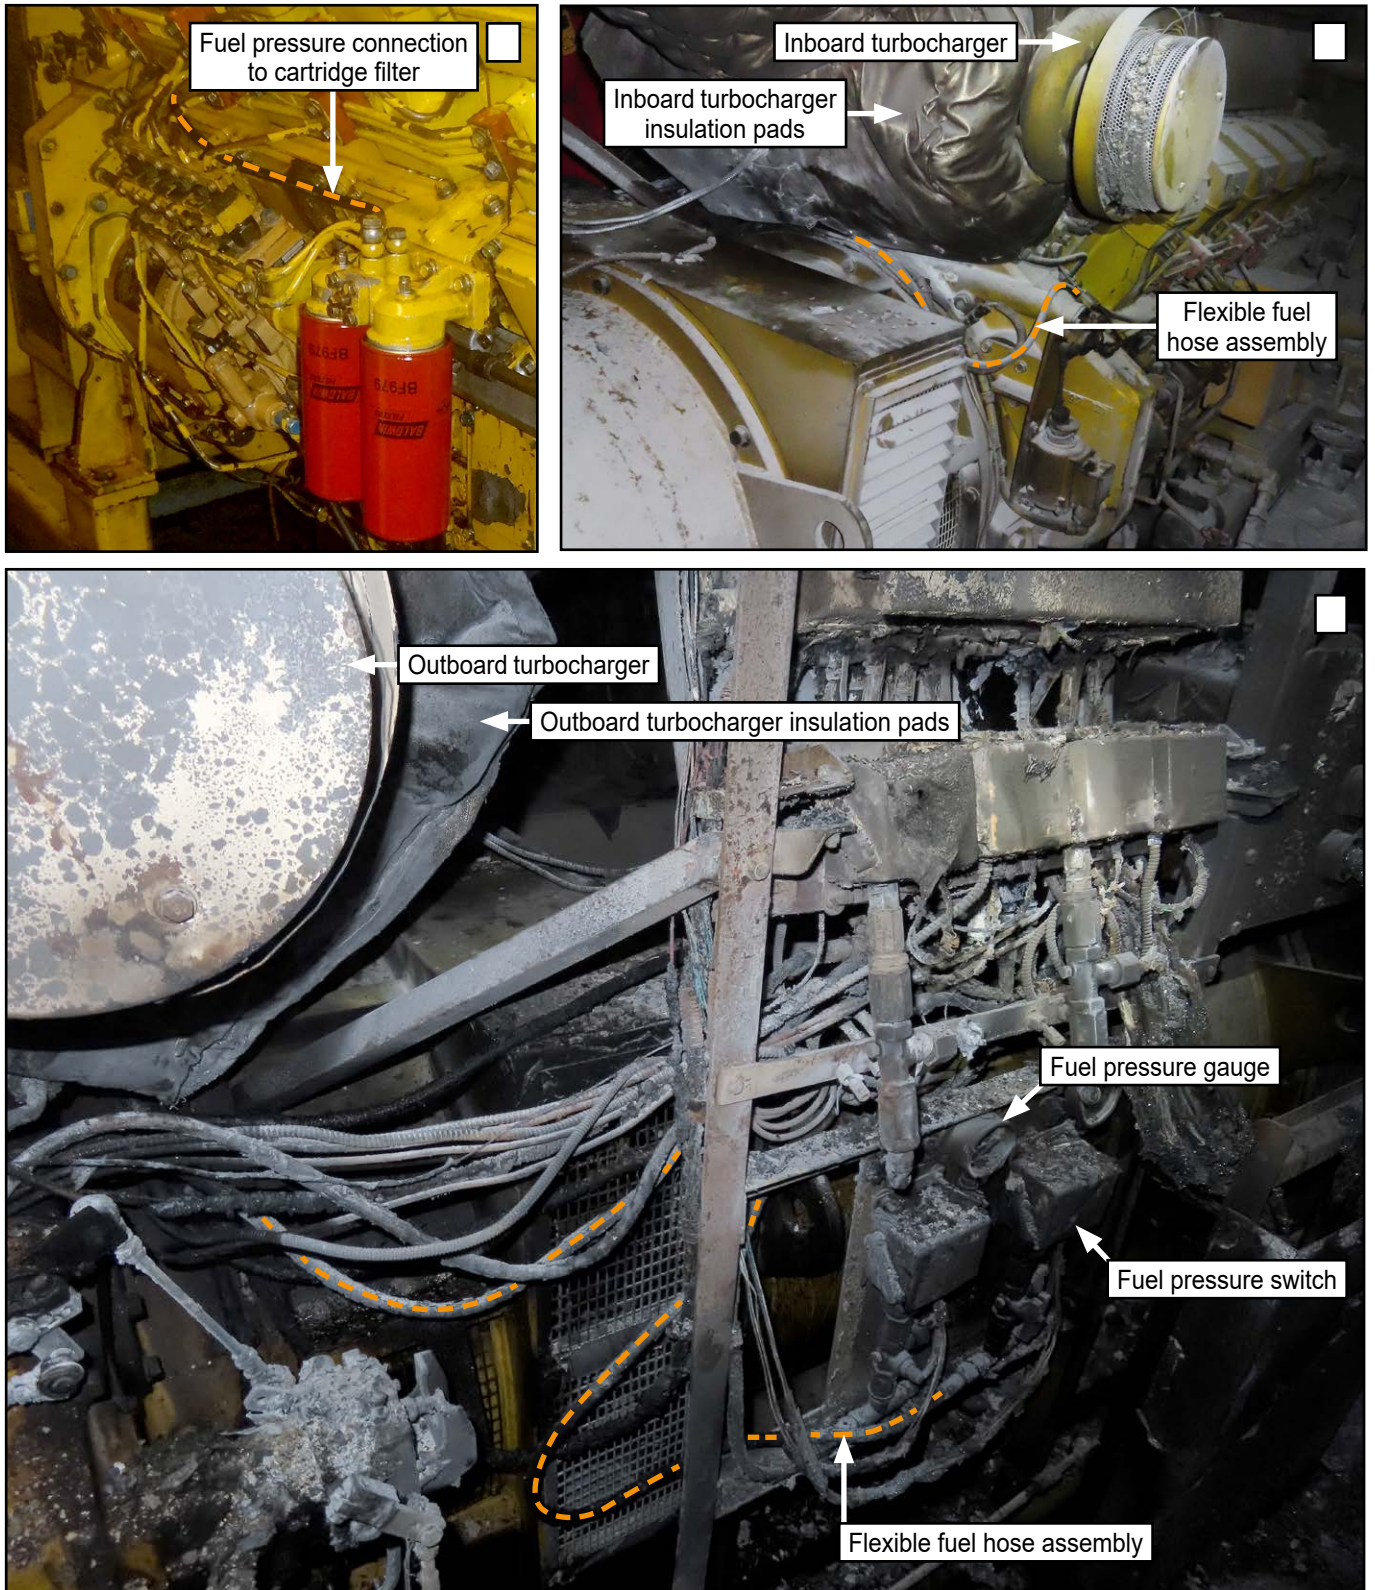
The MAIB investigation identified that the fire started below the outboard turbocharger of AE2 when a small-bore flexible fuel hose failed. Exhaust gas had leaked from the outlet of the turbocharger and caused the fuel hose to overheat and fail allowing MGO to spray onto a high temperature surface, where it ignited and a significant fire developed.

The flexible fuel hose that failed in the accident was connected to the outlet from the inboard set of AE2 cartridge filters (**Figure 3a**); the hose was routed aft along the engine and passed over the top of the flywheel cover under the turbochargers (**Figures 3b** and **3c**). It then connected to a pressure sensor on an instrument panel mounted outboard of the AE2 alternator. Both this hose and the matching hose on AE1 were 3.4m in length. No isolation valve was installed at the connection to the cartridge filters.

The thermal insulation that covered the auxiliary engine turbochargers had also been modified by the installation of bespoke insulation pads over the existing insulated box structure. The flexible fuel hose from the AE2 inboard fuel cartridge filters was routed under these insulation pads.

Figure 3: Small-bore flexible fuel hose assembly on AE2, as indicated by dashed orange line

In this case, the flexible hose assemblies were not needed to accommodate relative movement between fixed piping and machinery parts over their entire length between the cartridge filters and the instrument panel. Furthermore, the routing of the hoses under the turbochargers covered by the insulation pads exposed them to the risk of contact with high temperatures and also made them difficult to inspect.

- The risks associated with a modification on safety critical equipment should be considered before and during the work being completed. In this case, the positioning of the fuel pressure gauges and pressure switches required the pressure signal to be transferred from one side of the engine to the other. The relocation of the pressure switch closer to the cartridge filters would have removed the need for a long hose; if this was not possible, a rigid metal pipe secured with clamps and routed at an appropriate distance from the engine's exhaust might have been a safer option.

- Flexible hoses are recognised as having a higher risk of failure than a properly fitted metal pipe. An isolation valve fitted at the point of supply allows a flexible hose to be safely isolated in the event of leakage.
