ACCIDENT

Aircraft Type and Registration:	SB-5E glider, G-DEJH
No & Type of Engines:	None
Year of Manufacture:	1970 (Serial no: 5041A)
Date & Time (UTC):	7 August 2019 at 1303 hrs
Location:	Summit of Cross Fell, Pennines, Cumbria
Type of Flight:	Private
Persons on Board:	Crew - 1 Passengers - None
Injuries:	Crew - 1 (Serious) Passengers - N/A
Nature of Damage:	Destroyed
Commander's Licence:	BGA Glider Certificate with Bronze endorsement
Commander's Age:	15 years
Commander's Flying Experience:	69 hours (of which 2 hours were on type) Last 90 days - 21 hours Last 28 days - 9 hours
Information Source:	AAIB Field Investigation

Synopsis

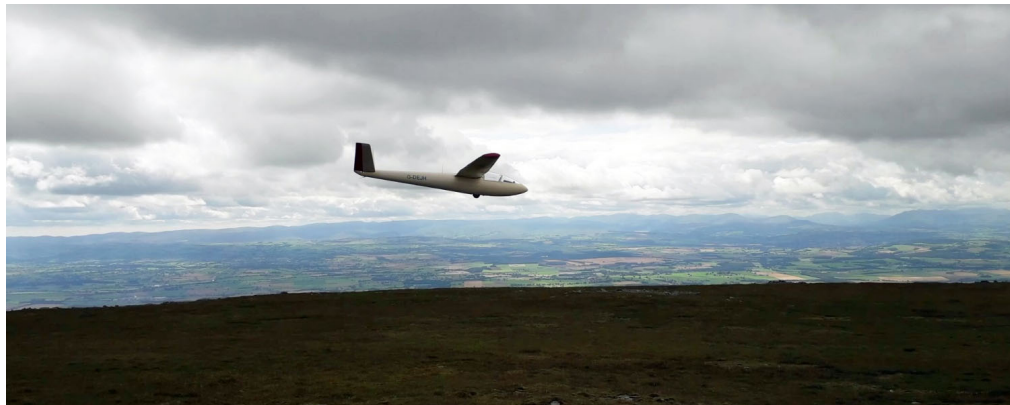
Figure 2

Still taken from video of the second pass (Image used with permission)

Analysis using specialist video software showed that shortly after the glider passed the camera position, both surfaces of the V-tail began to oscillate laterally. When viewed frame by frame the ruddervators on each side of the V-tail were seen to lag the motion of the fixed tail structure. The oscillation continued to increase in amplitude until approximately three seconds later when the whole tail section broke away from the fuselage and continued to rotate clockwise (viewed from behind) attached only by the control rods. Immediately after the structural failure, the aircraft nose and right wingtip dropped to point at the ground and the glider fell vertically until it passed below the level of the summit and hit the ground.

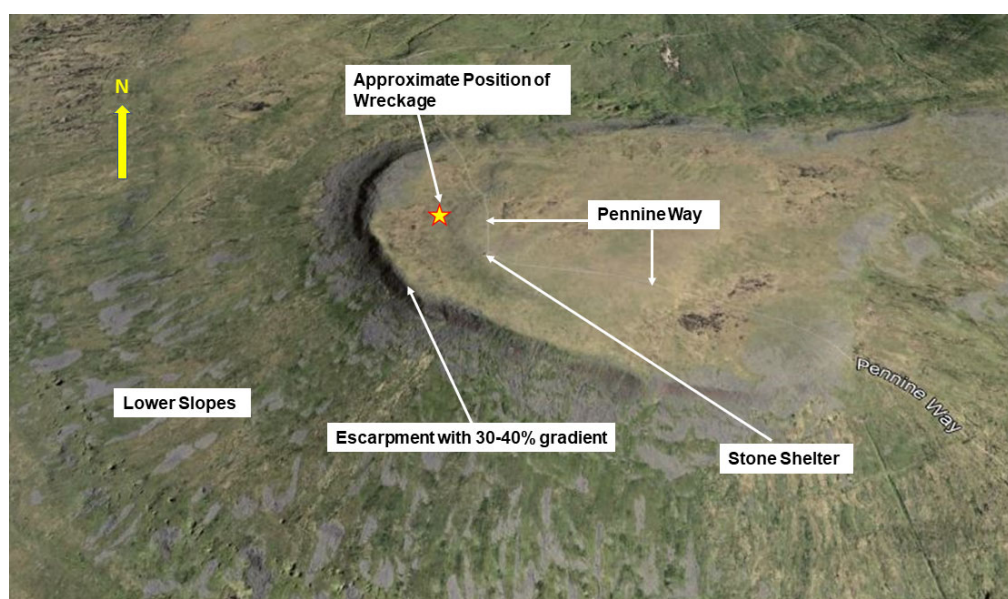
Figure 3

The plateau of Cross Fell Summit, with approximate position of wreckage (Google Earth)

The main wreckage was on an area of relatively flat ground approximately 170 m north-west of the trig point on the summit plateau of Cross Fell. This was approximately 80 m west of the Pennine Way path. The accident site was compact with the main sections of the aircraft located together. Deep impact marks were present in the ground from the nose, right wingtip and wing leading edge. However, the fuselage of the glider had largely disintegrated in the impact, and lightweight sections of plywood skin had been blown by the wind across a large area.

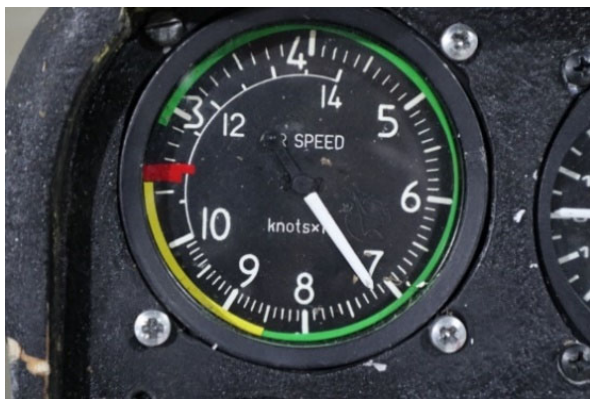
Figure 5

The ASI had been annotated with a green band around the outside of the dial, transitioning to amber at 85 kt and with a broad red line between approximately 108 kt and 110 kt (Figure 5).⁷

ASI from G-DEJH showing speed range markings

The ASI and cockpit placard had been incorrectly annotated with a Rough Air speed limit of 85 kt since at least 1992, and possibly since the glider was imported to the UK in 1981. This discrepancy had not been detected when the limitations placard in the cockpit and ASI markers were replaced at the 2016 annual maintenance check. It is, therefore, likely that the glider had operated above the actual certified Rough Air speed limit of 75 kt on previous occasions in rough air.

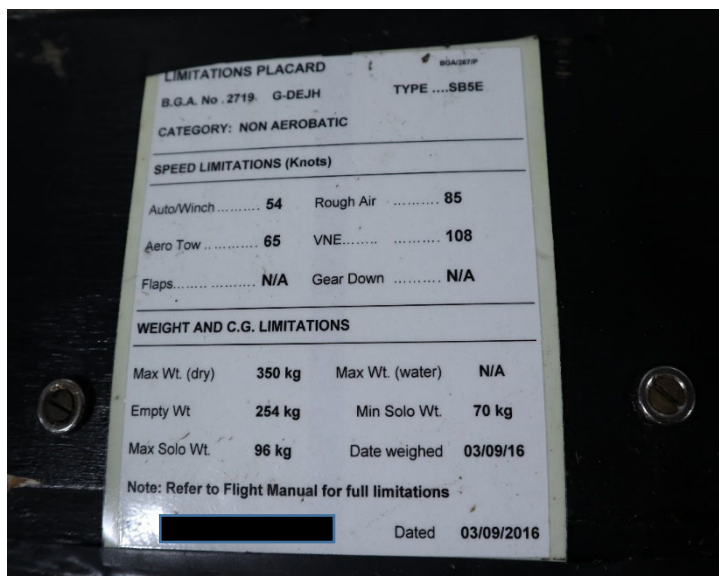
Figure 6

The limitations placard in the cockpit had a section entitled '*Speed Limitations (Knots)*' and indicated that the maximum operating speed (V_{NE}) was 108 kt and the Rough Air speed limit was 85 kt (Figure 6). The placard was dated 03/09/2016 and had been issued by a BGA Inspector.

Cockpit placard from G-DEJH

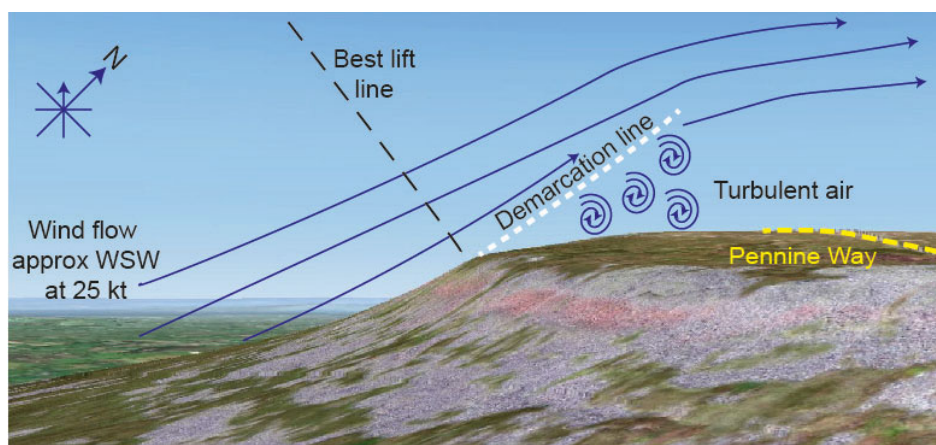
Figure 8

A view of the plateau (Figure 8) in the approximate direction that the glider was flying immediately prior to the accident, shows the wind effects that the glider likely encountered. It illustrates the area of best lift in the smoother uplifting air on the windward side of the ridge (left of the demarcation line) and the more turbulent air behind (right of the demarcation line). On the north-western edge, where the ridge curved round to the east, the turbulence would have been greater as the wind direction became less perpendicular to the ridge. The direction of the wind is also likely to have been affected as it flowed around the plateau, possibly resulting in a slightly more south-westerly flow. The plateau at the summit of Cross Fell, sitting above the main ridge, would likely have experienced stronger winds than the ambient wind at the same level.

Likely effect of the wind on the summit of Cross Fell where the accident occurred
