**ACCIDENT**

<b>Aircraft Type and Registration:</b>	Skyranger Swift 912S(1), G-SKSW	
<b>No &amp; Type of Engines:</b>	1 Rotax 912ULS piston engine	
<b>Year of Manufacture:</b>	2007 (Serial no: BMAA/HB/553)	
<b>Date &amp; Time (UTC):</b>	15 September 2019 at 1040 hrs	
<b>Location:</b>	High Cross airstrip, Hertfordshire	
<b>Type of Flight:</b>	Private	
<b>Persons on Board:</b>	Crew - 1	Passengers - 1
<b>Injuries:</b>	Crew - None	Passengers - None
<b>Nature of Damage:</b>	Damage to nose landing gear, engine cowling, engine, propeller, cockpit windscreen, left and right wings	
<b>Commander's Licence:</b>	Airline Transport Pilot's Licence	
<b>Commander's Age:</b>	61 years	
<b>Commander's Flying Experience:</b>	10,300 hours (of which 160 were on type) Last 90 days - 14 hours Last 28 days - 8 hours	
<b>Information Source:</b>	AAIB Field Investigation

**Synopsis**

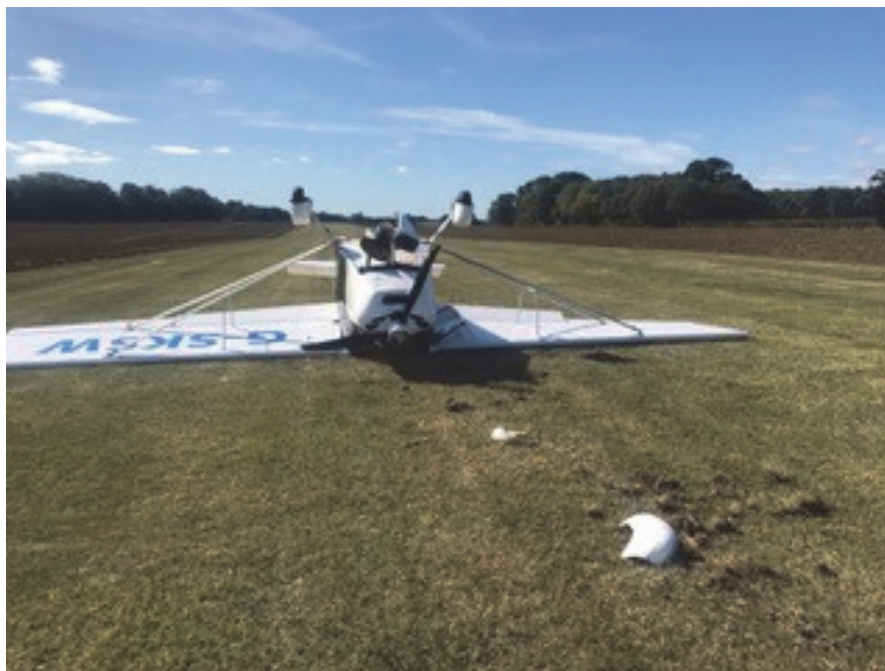
**Figure 1**

The pilot returned to High Cross airstrip from Clacton airfield after a 30-minute flight in fine weather conditions. An uneventful approach to Runway 22 was flown, followed by a normal touchdown on the main landing gear. As the nose was lowered during the landing roll, the nose landing gear fork failed, causing the nose leg to dig into the surface of the grass runway. This caused the aircraft to decelerate suddenly and to pitch forward, coming to rest inverted (Figure 1). The pilot and passenger, who were wearing four-point harnesses, were uninjured and able to unfasten their harnesses and vacate the aircraft without assistance.

G-SKSW following the nose landing gear failure

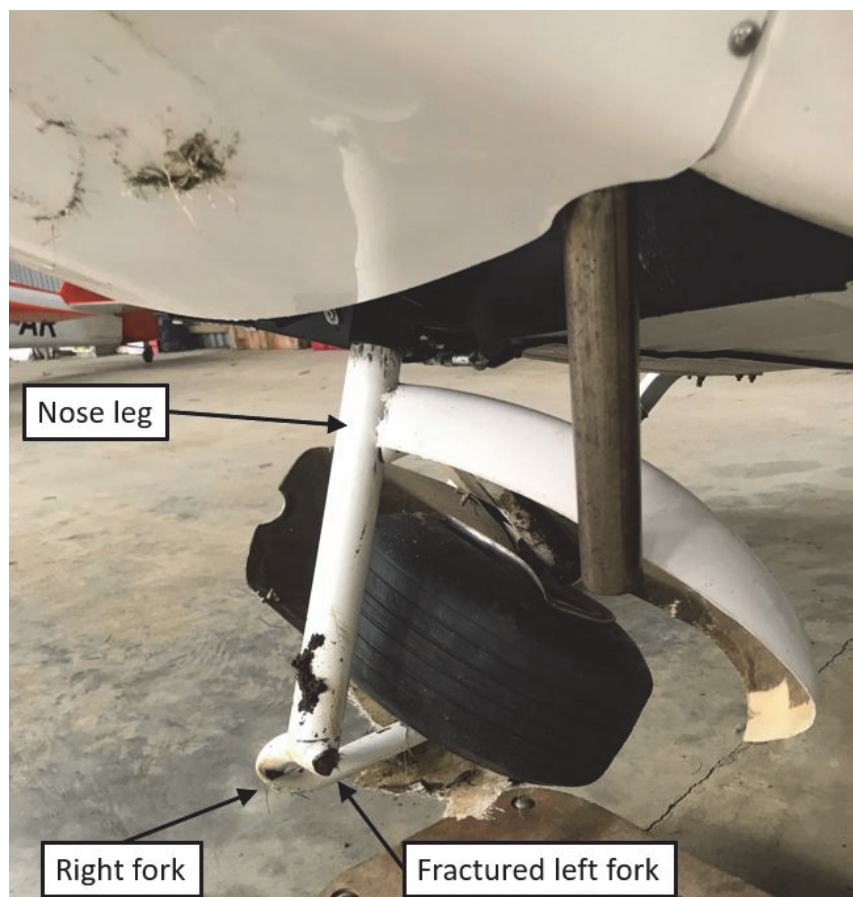
**Figure 2**

The left leg of the nose landing gear fork had failed at its welded joint with the nose landing gear down tube (Figure 2). The right leg of the fork remained attached to the down tube and had folded rearwards, with the nosewheel remaining attached to it. The nosewheel tyre was in good condition and no pre-accident defects were evident when it was examined.

Fractured nose landing gear left fork
