Rail Accident Investigation Branch

Rail Accident Report

Serious injury to a passenger alighting from a train at Loughborough Central station 14 January 2023

Report 13/2023
October 2023

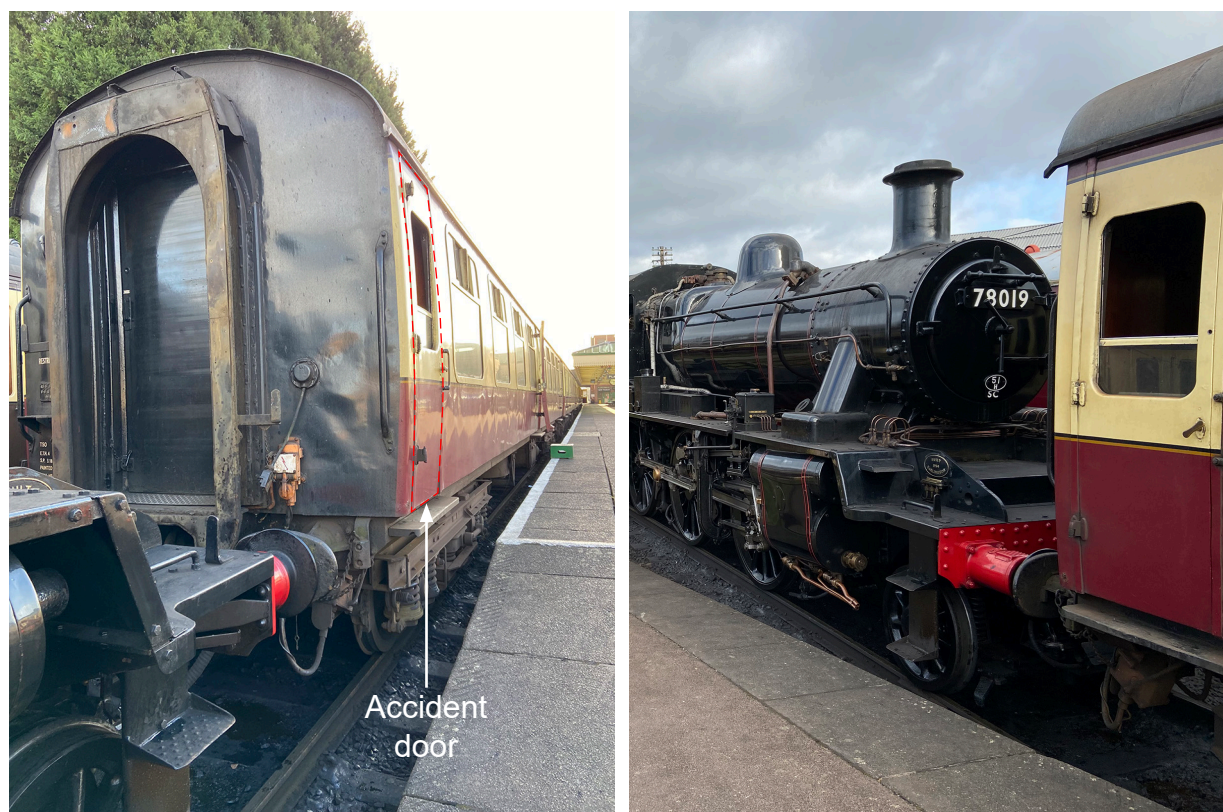
Figure 6: The north end platform ramp.

8 The north end of platform 1 at Loughborough Central was in generally good condition with the coping stones at the platform edge made from a coarse dressed stone. The area intended for use by passengers was level with no identified trip hazards. The condition of the platform surface and the level of grip it offered are not considered to be factors in this accident.

- 55 Loughborough Central station has two platforms, numbers 1 and 2, located between the Up and Down Main lines (a configuration referred to as an 'island platform' (figure 3)). Platform 1 runs along the east side of the station. The horizontal length of each platform, between the ramps at each end, is 122 metres.
- 56 At the north end of the island, a ramp is provided which slopes from platform height to ground level. This ramp runs across the whole width of the platform island. Visitors can use a path down the middle of the ramp to access a walkway that leads to the Locomotive Shed and a picnic area. The level part of the platform is marked out by white lines painted on the platform edge. At each end, where the platform end ramp starts, there is a short white line perpendicular to the platform edge (figures 6 and 11).

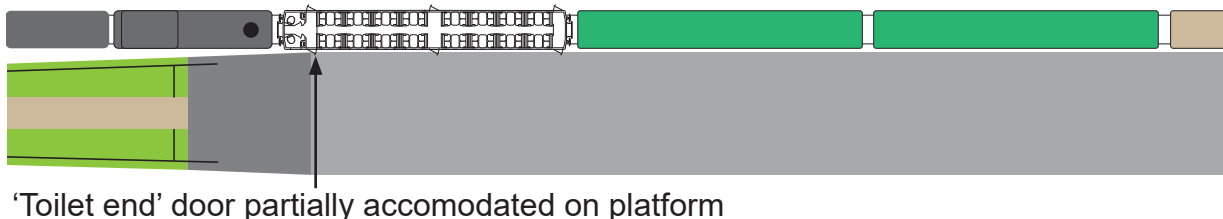
Figure 8: Stopping positions of the train involved in the accident.

51 Witness accounts, corroborated by photographs taken after the accident, show that the train stopped with the front edge of the leading door on coach 4857 approximately 1.6 metres beyond the end of the level part of the platform.

57 The train involved was formed of a locomotive, tender and six coaches (paragraph 12 and figure 7). The distance between the rear edge of the trailing end door of the trailing coach and the front edge of the leading door of the leading coach was 119.9 metres. This means that platform 1 was just over 2 metres longer than the distance between the extreme end doors of the train involved. If the train had stopped centrally along the available level platform length, then there would have been just over 1 metre of level platform beyond each door at both ends (figure 8).

58 Coach 4857 had a pair of toilets at one end with the vestibule inboard of them (paragraph 14, figure 5). Consequently, the passenger doors at that end are around 1.36 metres further inboard than the leading end doors. When the train travelled north from Leicester North station, the toilets were at the trailing end of coach 4857. If the coach had been orientated with the ‘toilet end’ leading, the external door at that end would have been adjacent to the start of the platform end ramp.
