## Grounding and loss of the motor vessel *Channel Queen* near the Needles, Isle of Wight, England on 20 July 2023

## SUMMARY

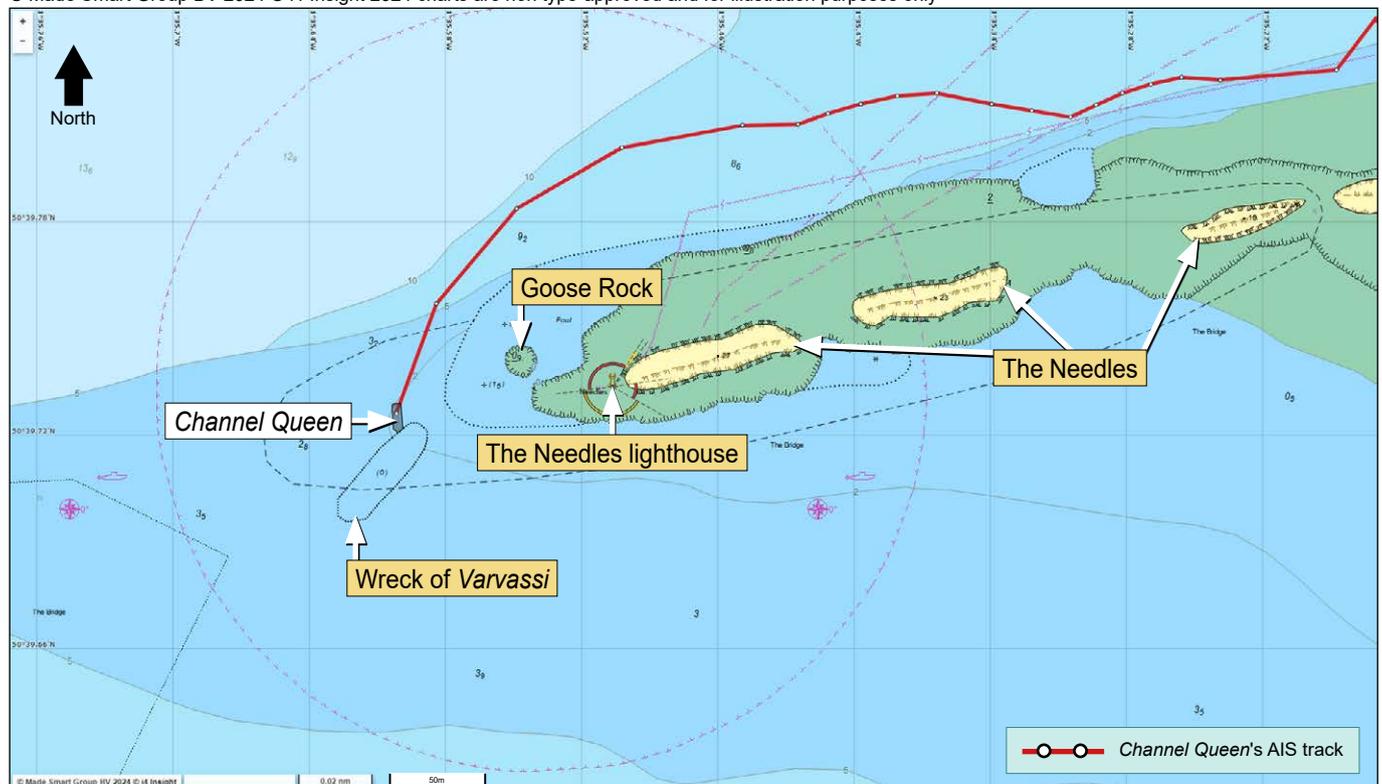
**Figure 2:** *Channel Queen's* AIS position as it approached the wreck of *Varvassi*

At 0559, *Channel Queen* shuddered noticeably as it passed over the charted wreck of *Varvassi* at a speed of less than 5kts and the port engine stopped (**Figure 2**). The owner immediately contacted the skipper by VHF radio to report that the vessel had struck an object. The deckhand who had been resting in the forward cabin alerted the owner that the hull had been breached and the vessel was flooding. Aware of the loss of power in the port engine, the owner immediately requested the skipper to return to *Channel Queen* for assistance. The skipper promptly reboarded the vessel, assessed the damage and decided to beach *Channel Queen* in Scratchell's Bay to prevent it from foundering.

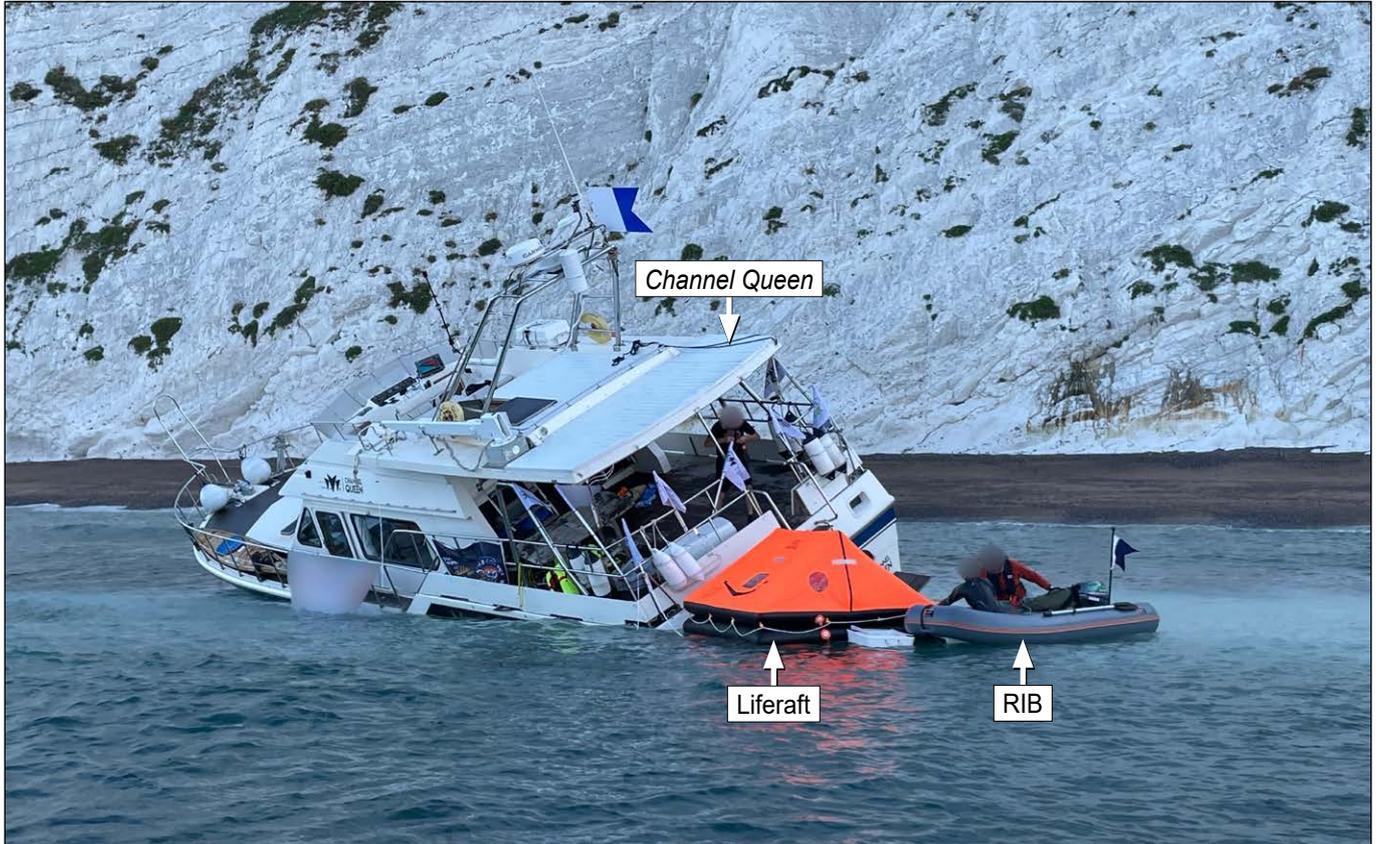
**Figure 3:** *Channel Queen* beached in Scratchell's Bay

At 0559<sup>1</sup> on 20 July 2023, the UK registered motor vessel *Channel Queen* grounded while passing over the wreck of the steam ship *Varvassi* near the Needles lighthouse, Isle of Wight, England, while escorting a relay swim event around the island. *Channel Queen* was then deliberately beached in nearby Scratchell's Bay.

By 0646, all of *Channel Queen's* passengers and crew had safely abandoned the vessel to its RIB and one of its two liferafts. They were transferred to an RNLI lifeboat a short distance away that subsequently landed them ashore in Lymington Harbour. Some passengers had suffered minor injuries, which were tended to locally.

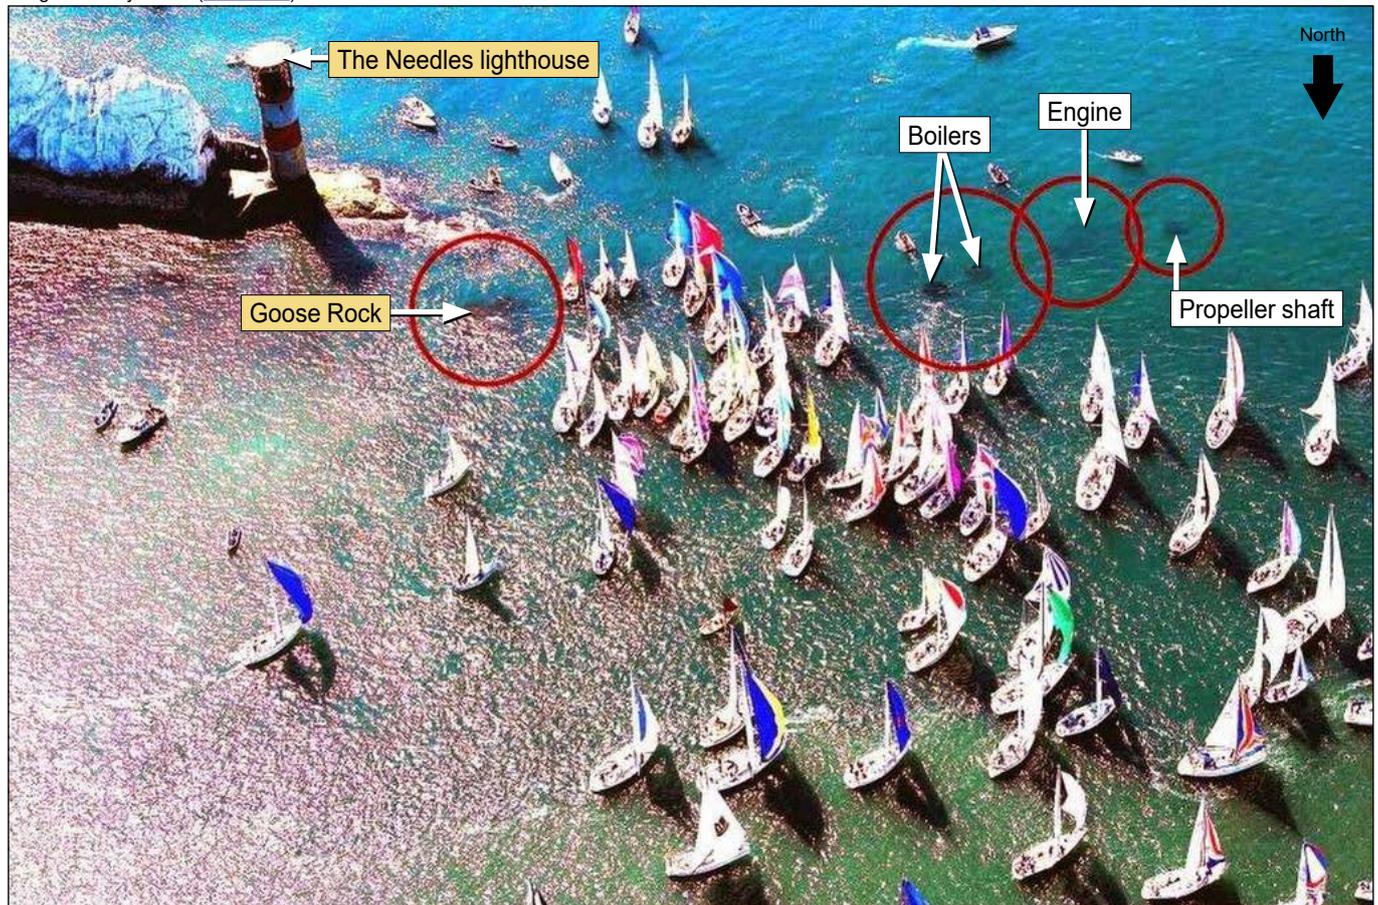
**Figure 4:** Round the Island Race competitors passing the remains of *Varvassi*

A high volume of inshore traffic frequently passed the *Varvassi* wreck (**Figure 4**).

There have been numerous groundings on the wreck of *Varvassi*. These have frequently occurred during the Round the Island Race<sup>6</sup>, when competitors have attempted to make the passage between the wreck and the Needles lighthouse (**Figure 4**).
