Rail Accident Investigation Branch

Rail Accident Report

Fatal accident at Stratford London Underground station 26 December 2023

Report 01/2025
January 2025

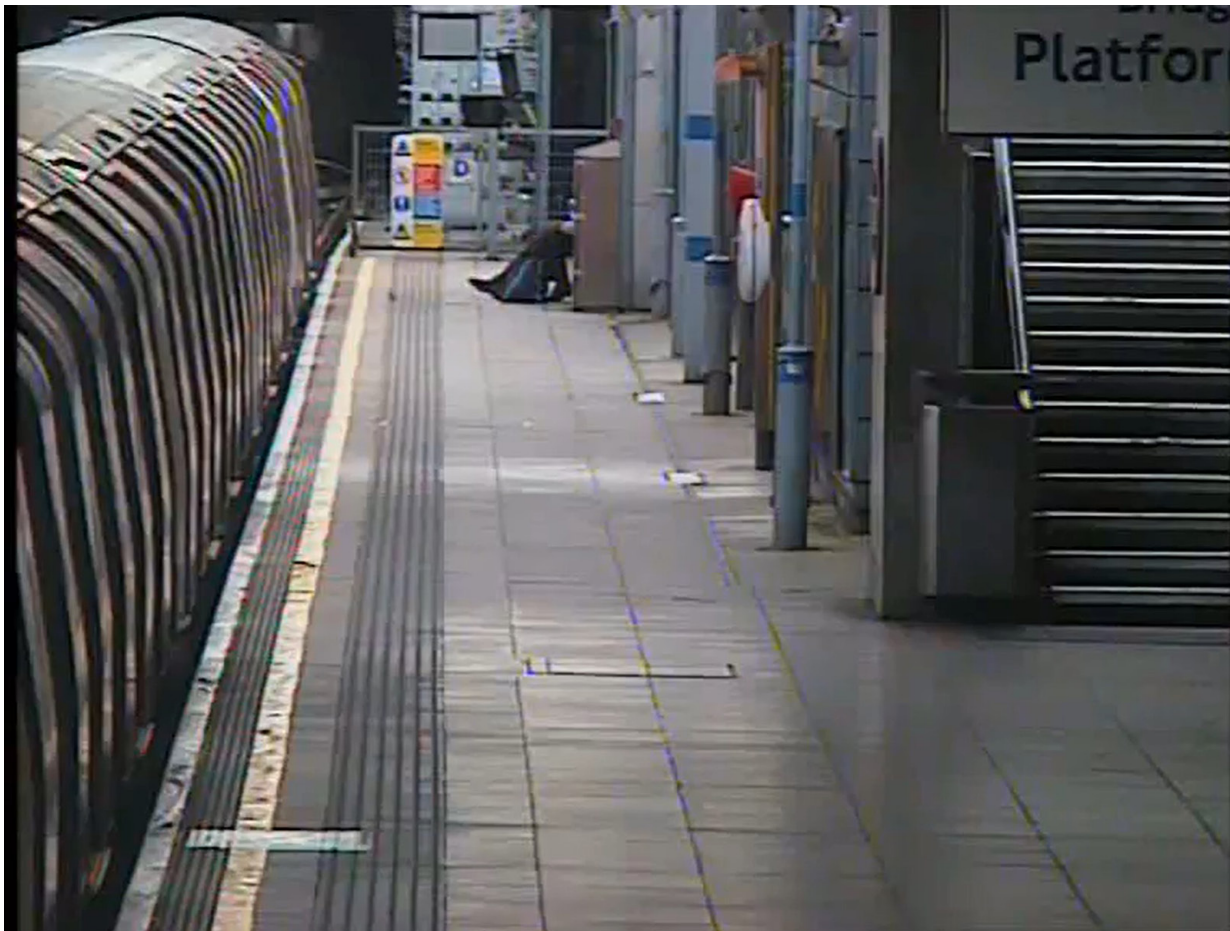
4: 2023/12/26 13:57:02.544

Figure 4: CCTV image of the passenger sat on the bench (courtesy of LUL).

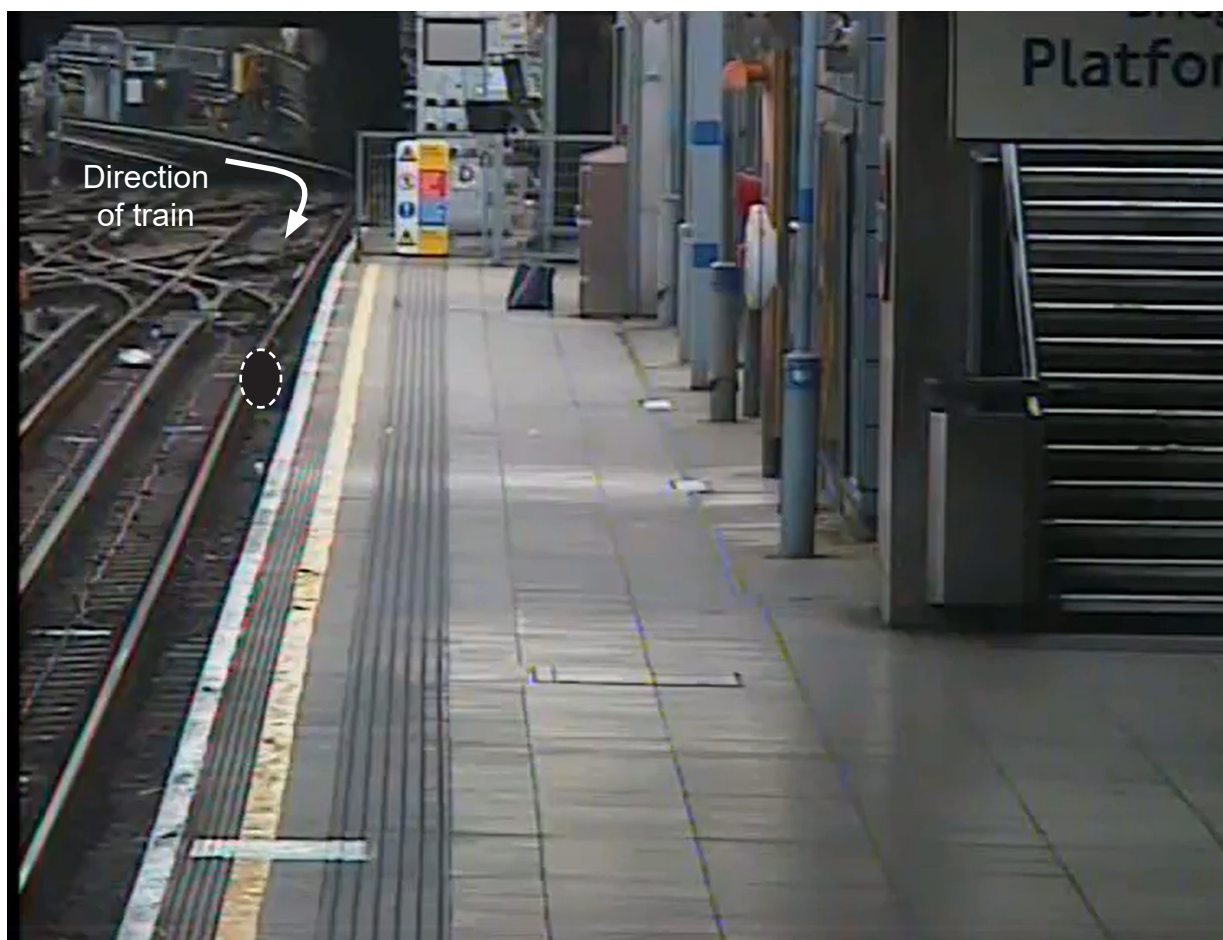
4: 2023/12/26 14:49:57.569

- 35 At 14:44:54, station CCTV shows that the passenger stood up from sitting on the bench and immediately stumbled forward, falling a distance of around 0.7 metres from the platform surface and onto the track. The bag remained on the platform in front of the bench.
- 36 Between approximately 14:45 and 14:46, station CCTV images show the passenger sitting up and making attempts to get back onto the platform. They then lie down on the track, parallel to the rails, on the part of the track between the platform and the nearest running rail (figure 5).

Figure 5: CCTV image of the passenger's position on the track, with an oval outlined in white depicting location of the passenger (courtesy of LUL, with RAIB annotations).

- 70 Station CCTV images show that the passenger was lying alongside the rail closest to the platform edge once they had fallen onto the track. They were wearing dark outer clothing with their lighter shirt also being partly visible (paragraphs 33 and 36).

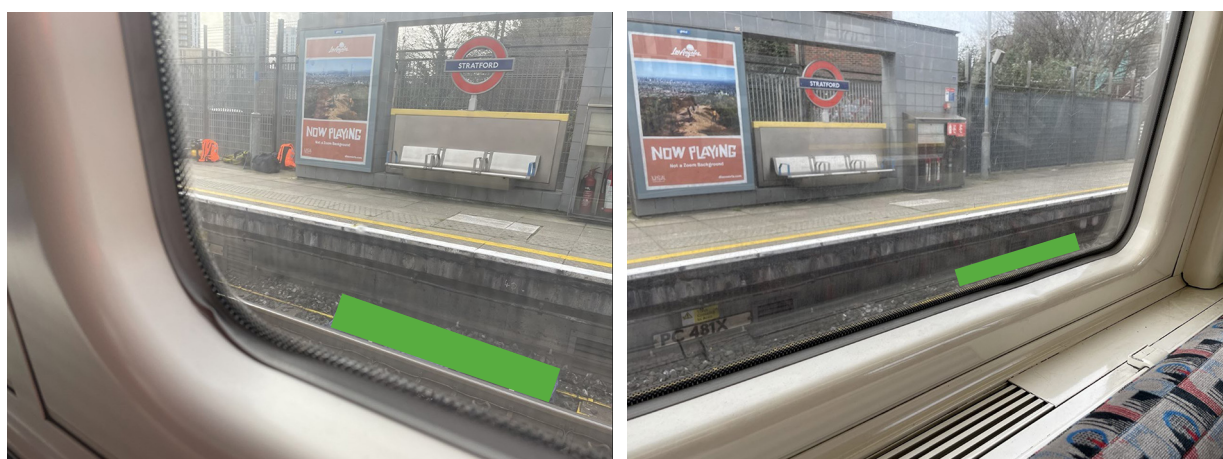
- 62 CCTV shows that there was a train in platform 14 when the passenger fell on to the track. There is no evidence that anyone on this train reported seeing the fallen passenger on the track. RAIB established that the TO of the train in platform 14, when in their normal seated driving position, would not have been able to see the passenger either when they were sitting on the bench, or after they had fallen on to the track.

- 63 It cannot be determined from the available evidence if any passengers were in the car of the train on platform 14 which was opposite the location where the passenger fell. Evidence from the RAIB reconstruction found it is possible to see the location of the fallen passenger from a train in platform 14 if someone is positioned very close to the window on the side of the train nearest platform 13 or standing up in the middle of the leading end car and looking through a window in the correct direction (figure 10). The passenger on the track would not be visible to anyone sitting down on the opposite side of the car (the side furthest from platform 13).

Figure 7: View of platform 13 from inside a carriage of a train in platform 14. The green rectangles represent the position of the passenger on the track.

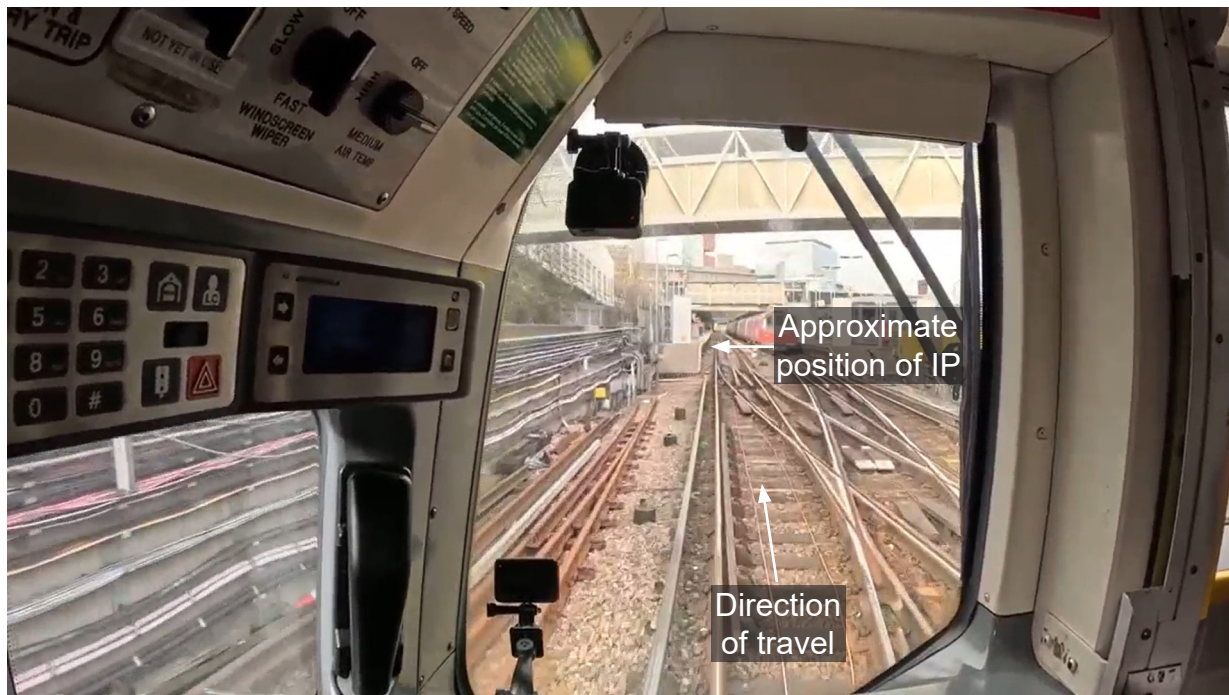
- 72 As the train approached the station during the reconstruction, the TO reported first seeing the test object from approximately 112 metres away (figure 8). For the reconstruction, LUL sprayed a yellow line across the track at a distance of 40 metres on approach to the passenger's location. This yellow line was positioned at what LUL had calculated to have been the latest point at which the emergency brake could have been applied to stop the train before reaching the passenger, taking into account the deceleration rate of the train and the decision time of the TO. When the TO could see this yellow line, they were able to discern the nature of the obstruction on the track, and to judge that there was a clear safety risk. Therefore, RAIB has concluded that the train could have been stopped before reaching the passenger, had the passenger been seen and the brakes applied before or at this point (figure 9).

Figure 9: The moment that the reconstruction TO stated they would have recognised the obstruction as a safety risk and applied the emergency brake, approximately 40 metres from the object.
