Report on the investigation of  
the flooding and foundering of the stern trawler  
***Opportune (LK 209)***

approximately 36 nautical miles east of Lerwick, Shetland  
Islands, Scotland

on 24 March 2024

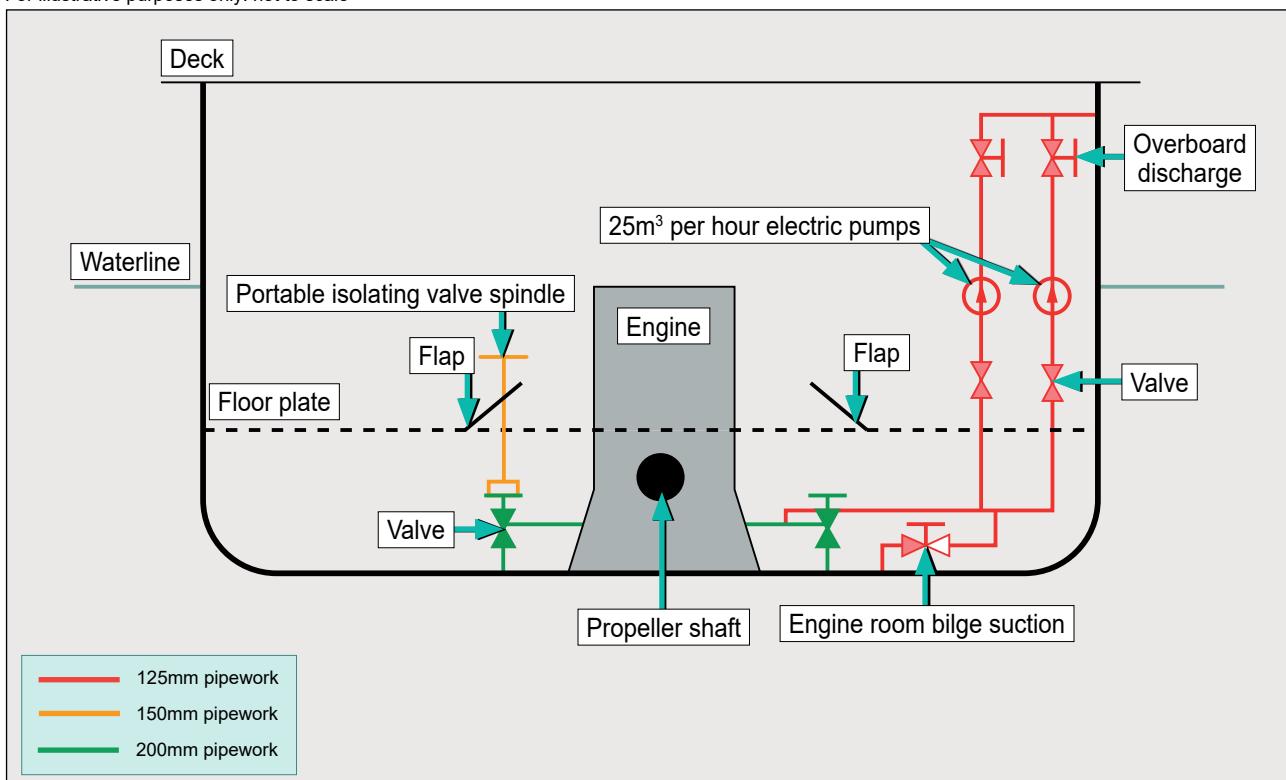
**Figure 3:** Simplified diagram of *Opportune*'s seawater pipework and bilge arrangements

*Opportune*'s sea inlet valves were opened and closed by hand wheels located below the engine room floor plates. The hand wheels were operated with portable extension spindles inserted through flaps in the floor plates (**Figure 4**). The handles were stowed close to the port and starboard generators when not in use. The floor plates above the sea inlet valve positions were not marked to show the position of the valves below. No plans of the space were located close to *Opportune*'s engine room entrances to show the positions of the bilge pump controls or sea inlet valves.

- Require owners of fishing vessels that are more than 10 years old to identify ferrous pipework and provide a seawater pipework diagram for their vessel that shows the age of each section of pipework.
- Revise the *Report of Hull Condition of a Fishing Vessel* to include a report on the condition of the vessel's seawater pipework.

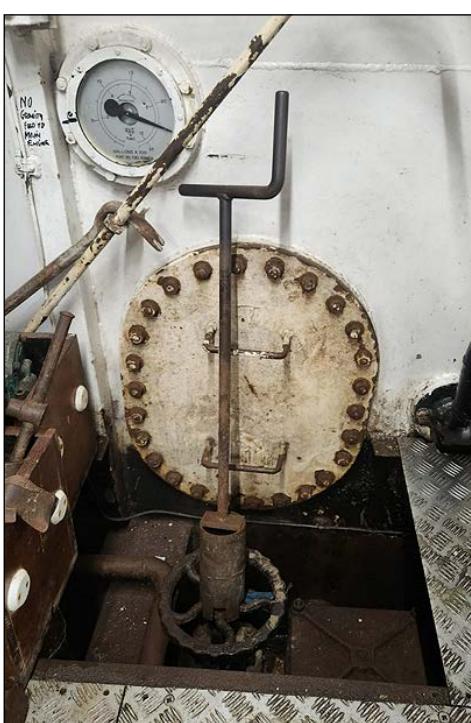
**Figure 4:** Example of portable extension spindle fitted to the sea inlet valve below the engine room floor plate
