Rail Accident Investigation Branch

# Rail Accident Report

## **Freight train derailment at Sheffield station 11 November 2020**

Report 07/2021  
October 2021

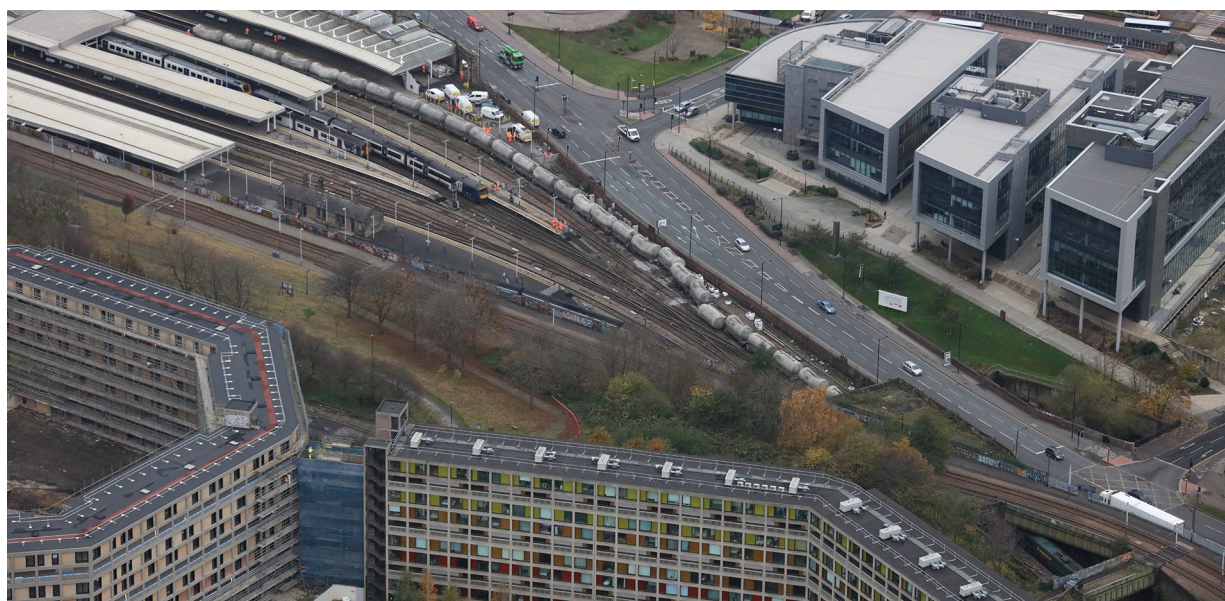
Figure 2: Aerial overview of the derailed train (image courtesy of Network Rail Air Operations team)

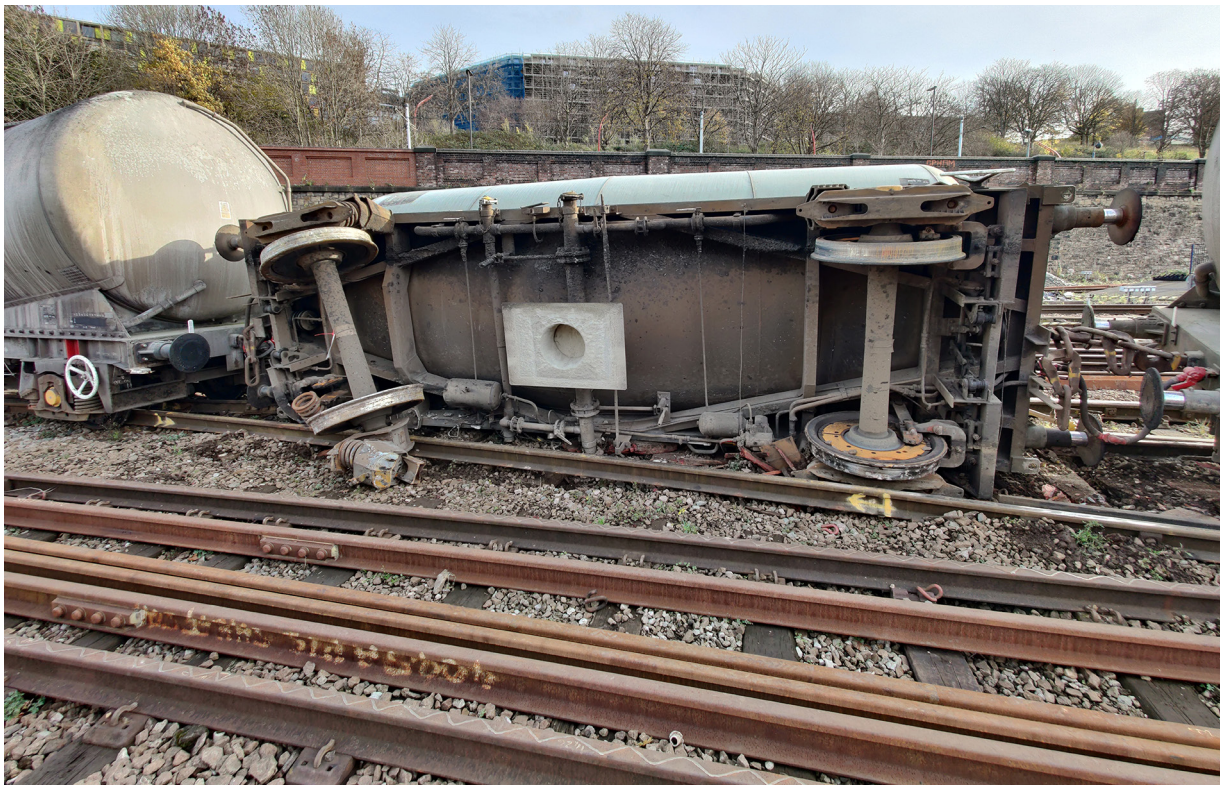
Figure 3: Wagon BCC10756 toppled on its side

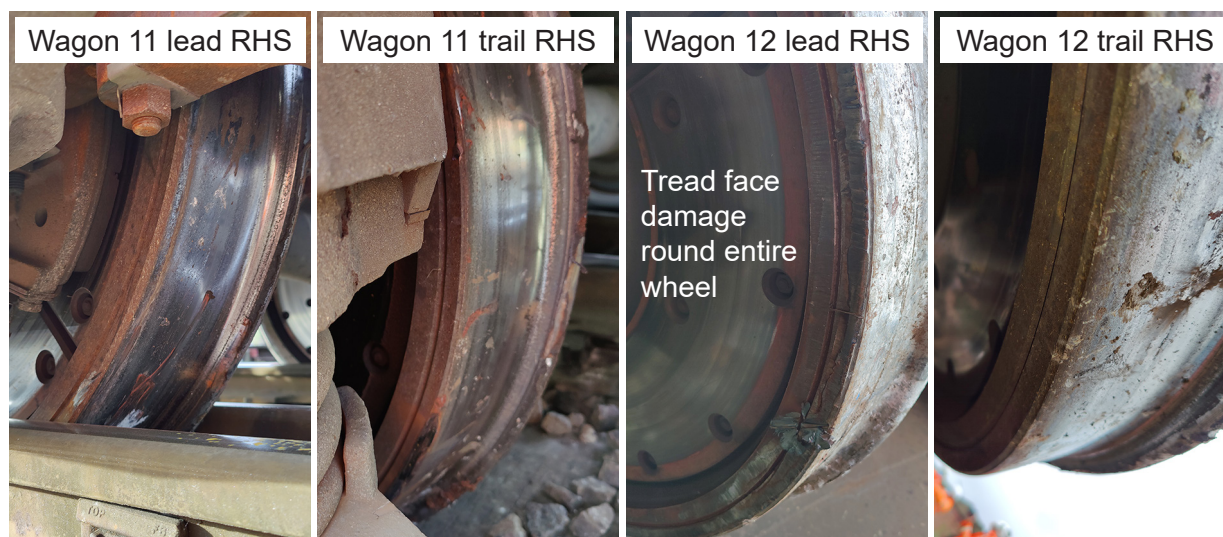
- 29 Examination of the derailed wagons showed damage on the outside face of the wheels consistent with several right-hand wheels having dropped into the four-foot (figure 9). The leading right-hand wheel of wagon 12 suffered the worst damage, indicating that it is likely to have been the first to derail into the wide gauge. Subsequent wheels also dropped into the wide gauge, but the damage was less severe. Their derailment was made more likely by the gauge having been further widened by the derailed leading wheelset on wagon 12 dropping in ahead of them.

Figure 9: Tread face damage on the right-hand leading wheel of wagon 11 compared to wagon 12

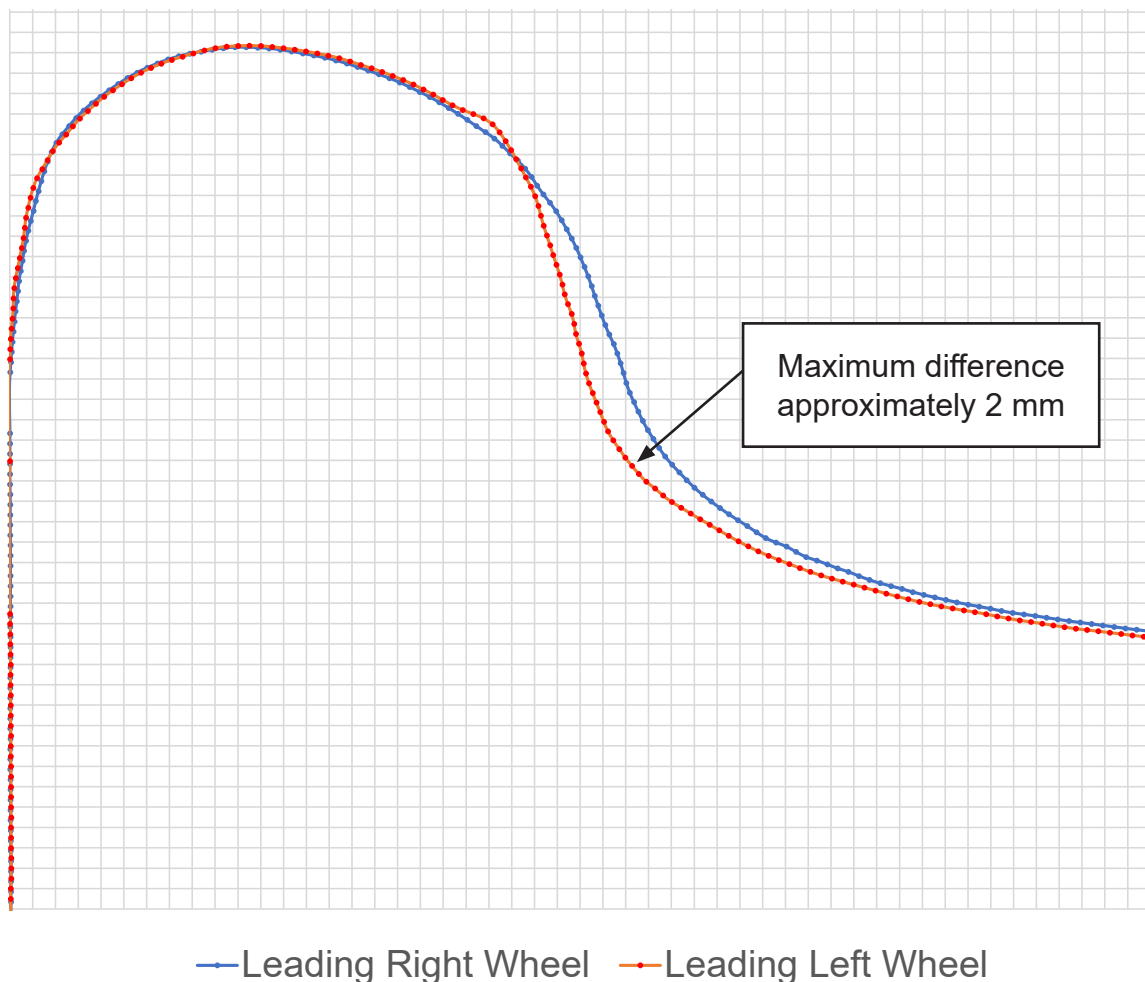
- 35 It was noted that the wheel flanges on the left-hand wheels on both wheelsets were slightly thinner than those on the right-hand wheels (figure 10). However, they were all well within the acceptable maintenance specification limits. It is possible that a thinner left-hand wheel flange could result in the wheelset being positioned slightly further to the outside rail on a right-hand curve, such as at the point of derailment. This means that the associated wheel tread corner on the right-hand wheel would also be positioned slightly closer to the four-foot on the right-hand rail, and so be fractionally more at risk of derailment (figure 11). The estimated difference in position on the twelfth wagon is only about 1-2 mm.

Figure 10: Comparison of wheel flange thicknesses on wagon 12

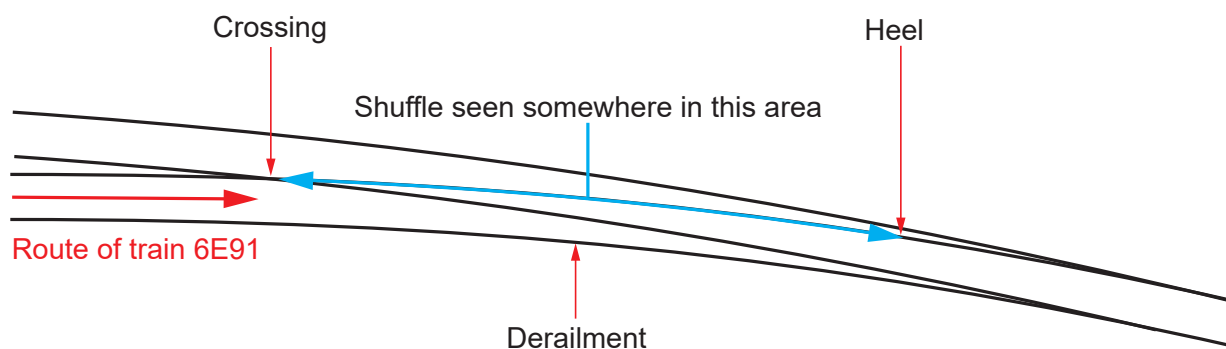
- 59 On the last four BVI record sheets, no defects were recorded as having been found at 4062 points. These were undertaken on 4 November and on 28, 21 and 14 October. However, the BVI patroller's record for 7 October noted that there was 'baseplate shuffle at the heel of 4062 points'. Baseplate shuffle is a term used to describe the wear marks on a timber bearer that indicate that a baseplate has been moving relative to the bearer it is fastened to. Witness evidence indicated that the note referred to shuffle located between the heel of the points (at the fixed end of the movable switch rail) and the crossing (figure 16). However, from the evidence available, RAIB has not been able to determine the exact location of the shuffle within this 15 to 20 metre distance, or the amount of shuffle, although this was likely to have been less than 10 mm. It is worth observing that the BVI on 7 October was undertaken by a patroller who does not routinely patrol Sheffield station, and was therefore perhaps more likely to record all defects and not omit any minor defects that were repeatedly present during previous inspections.

Figure 16: Approximate location of the identified shuffle in 4062 points on 7 October 2020

- 60 This BVI record was reviewed by a supervisor, and a maintenance intervention to address the observed shuffle was entered into the depot's list of forthcoming work. This intervention was due to be completed within a period of three months from the BVI on 7 October 2020.

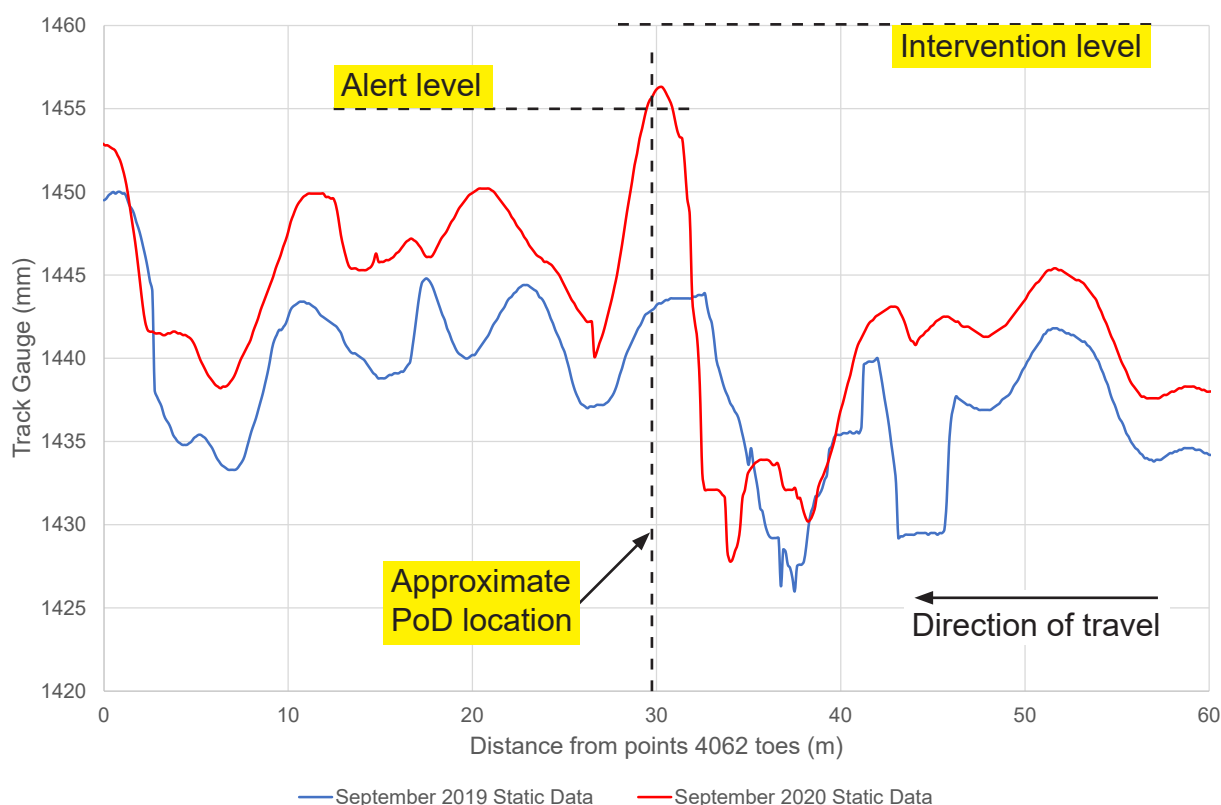
70 There was a slight exceedance of the alert limit (1455 mm) in the vicinity of the point of derailment in September 2020. Alert limit faults are not allocated a timescale by which they need to be repaired, but they are intended to be corrected as part of the planned maintenance activities. Sheffield depot had not undertaken any corrective action in response to this alarm notification prior to the derailment.

Figure 17: Static geometry measurements at 4062 points

- 71 The September 2020 gauge at the point of derailment was approximately 13 mm wider than that recorded at the same location in September 2019. However, this would only have been apparent to the TME if he had carried out a detailed comparison of the data from the two dates. The TME only undertook such comparisons to identify trends where he recognised that there was a risk of deterioration, but this was not recognised as being such a location.
