Report on the investigation into
the loss of propulsion in heavy weather experienced by
the passenger vessel
Spirit of Discovery
while crossing the Bay of Biscay, leading to over
100 injuries and one fatality
on 4 November 2023

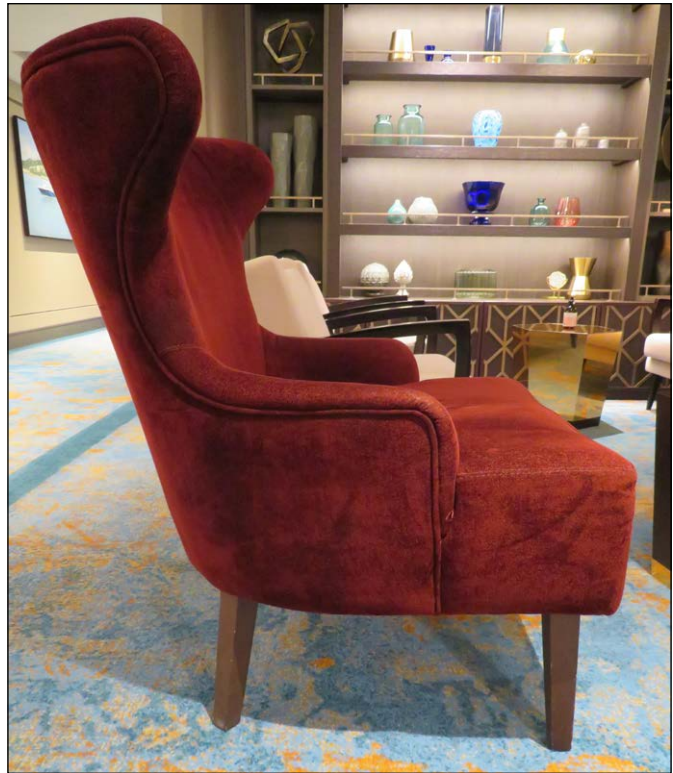
Figure 4: Example of the high-backed chair used by passenger 1

At about 1710, *Spirit of Discovery* rolled violently to approximately 10° to 13°. Passenger 1's chair toppled backwards, and he rolled backwards onto the deck. The main impact of the fall and subsequent roll was to his neck. Nearby crew saw passenger 1's fall from the chair and raised the alarm.

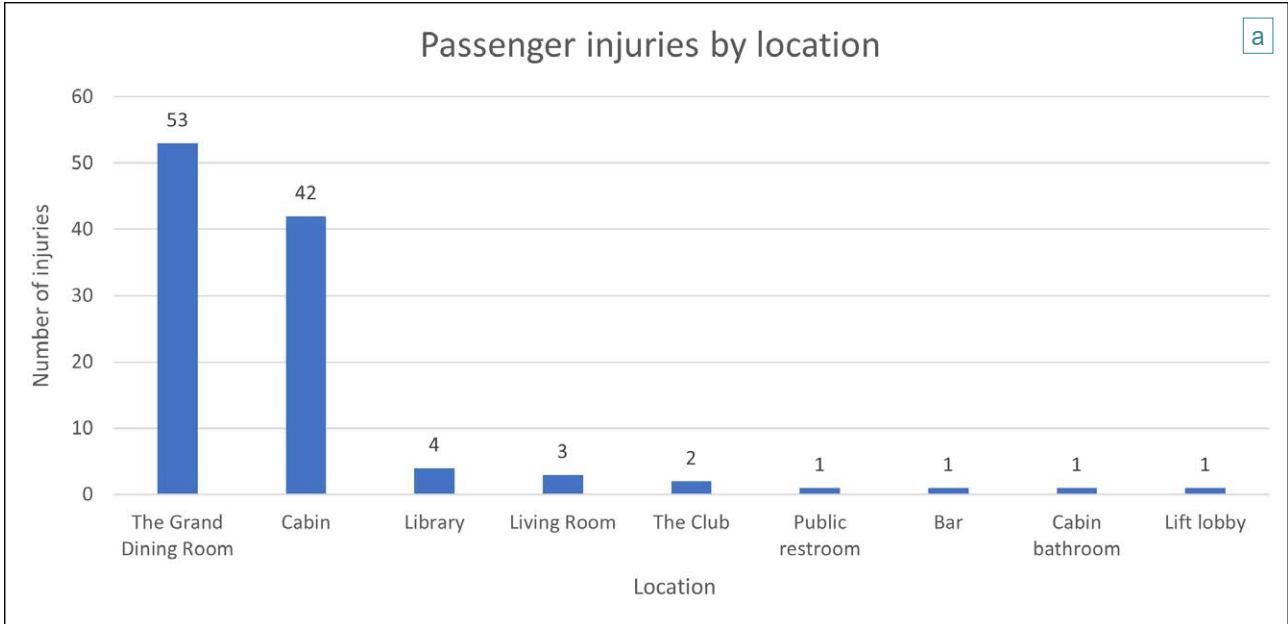
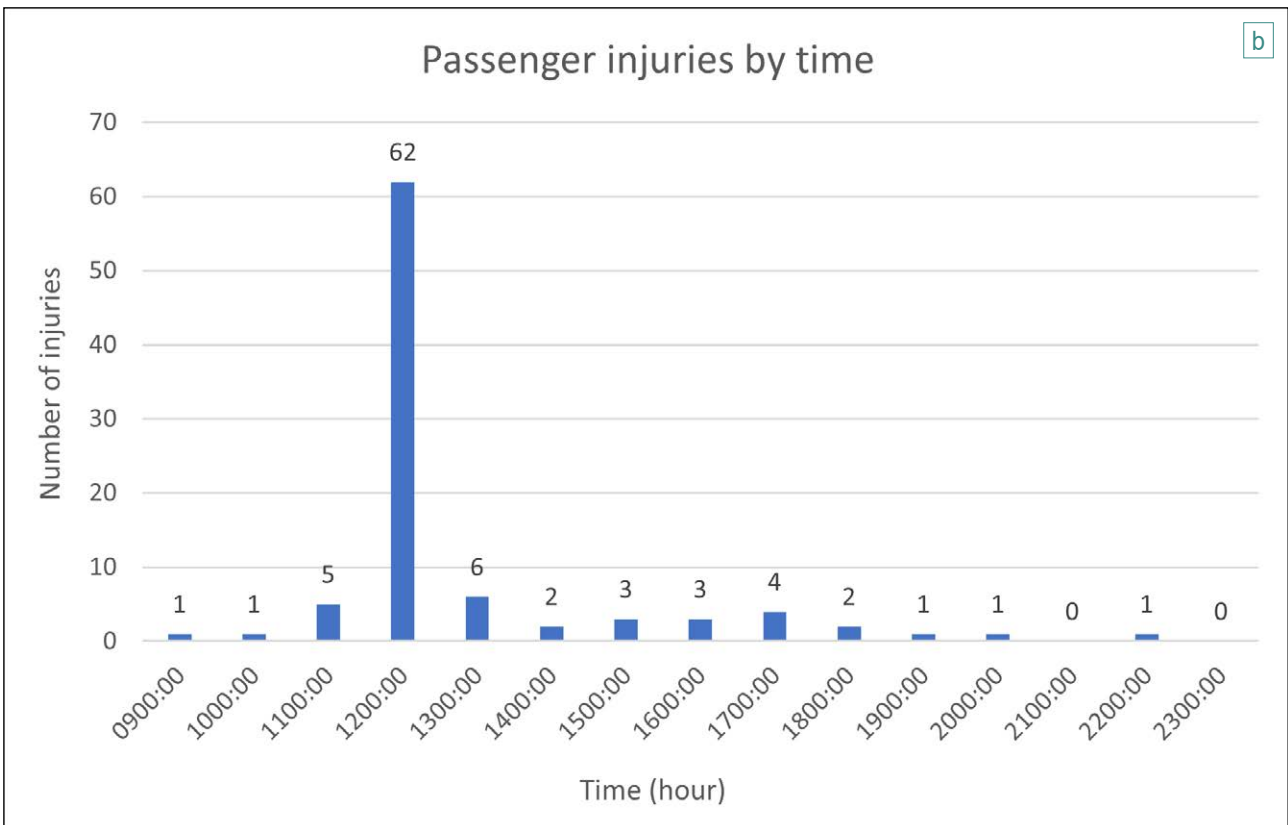
Figure 5: Passenger injuries by location (a) and time (b)

On 4 November, *Spirit of Discovery*'s medical team treated 115 passengers. While most suffered minor injuries, eight passengers were severely injured and were transferred by ambulance to hospital when the vessel berthed in Portsmouth. The severe passenger injuries had been caused by falls and included fractured hips and ribs, a shoulder injury, head trauma and spinal injury.

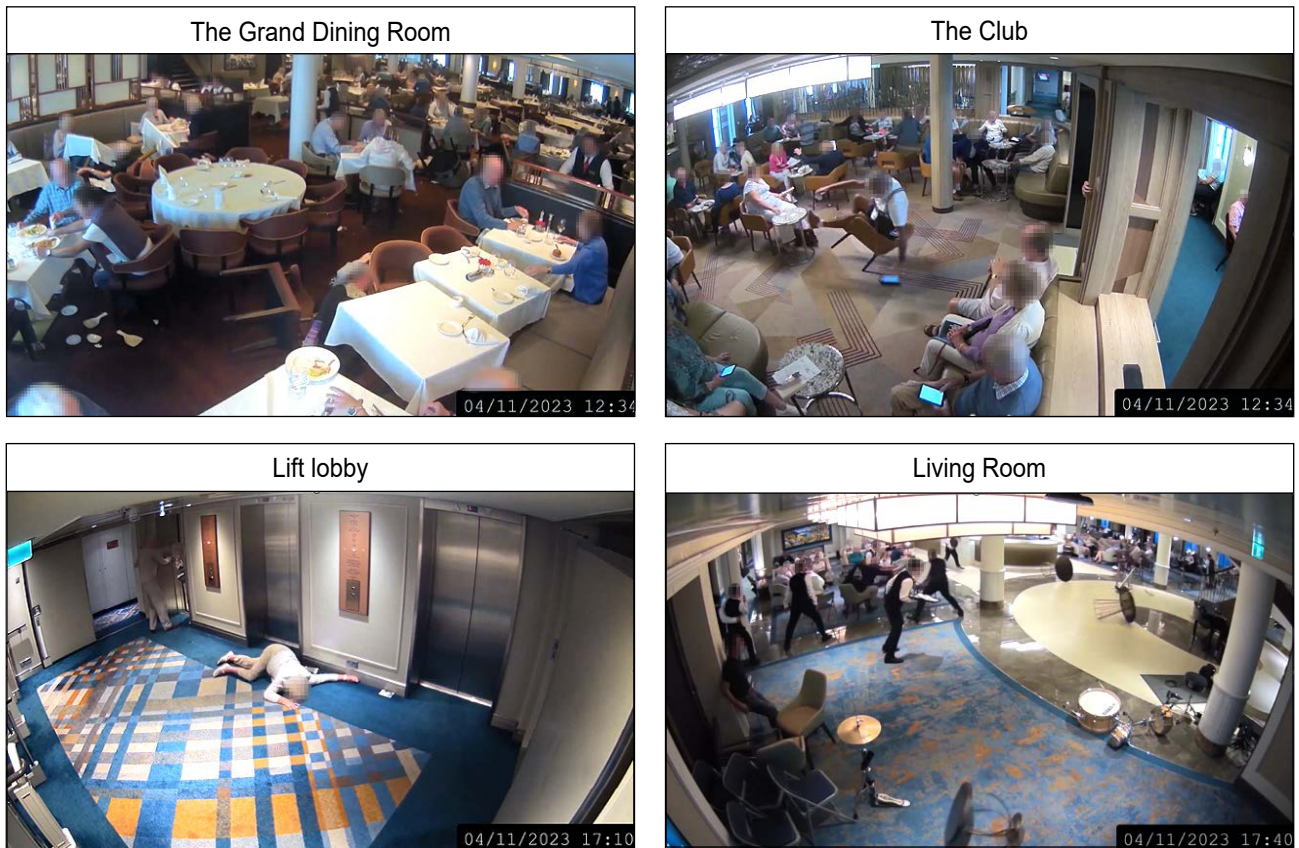
Figure 6: CCTV images of public spaces after propulsion was lost

A review of the vessel's closed-circuit television (CCTV) images showed that many passengers fell and were injured by unsecured tables, chairs and crockery in the public spaces. Not all the furniture was observed to be equally affected by the vessel's violent motion. Lighter café style tables and chairs appeared the most vulnerable and were observed to cause some chair occupants to fall to the deck or, having toppled over, slide across the deck, occasionally striking passengers. Heavier, more stable tables and chairs with a broad base and low centre of gravity appeared less affected. One passenger was injured in a lift lobby when they were unable to hold onto anything to prevent themselves falling (**Figure 6**). Of those who were injured in their cabins, 52% fell while standing; 36% fell while sitting; 10% were struck by furniture or other items; and 2% fell from their mobility aids.

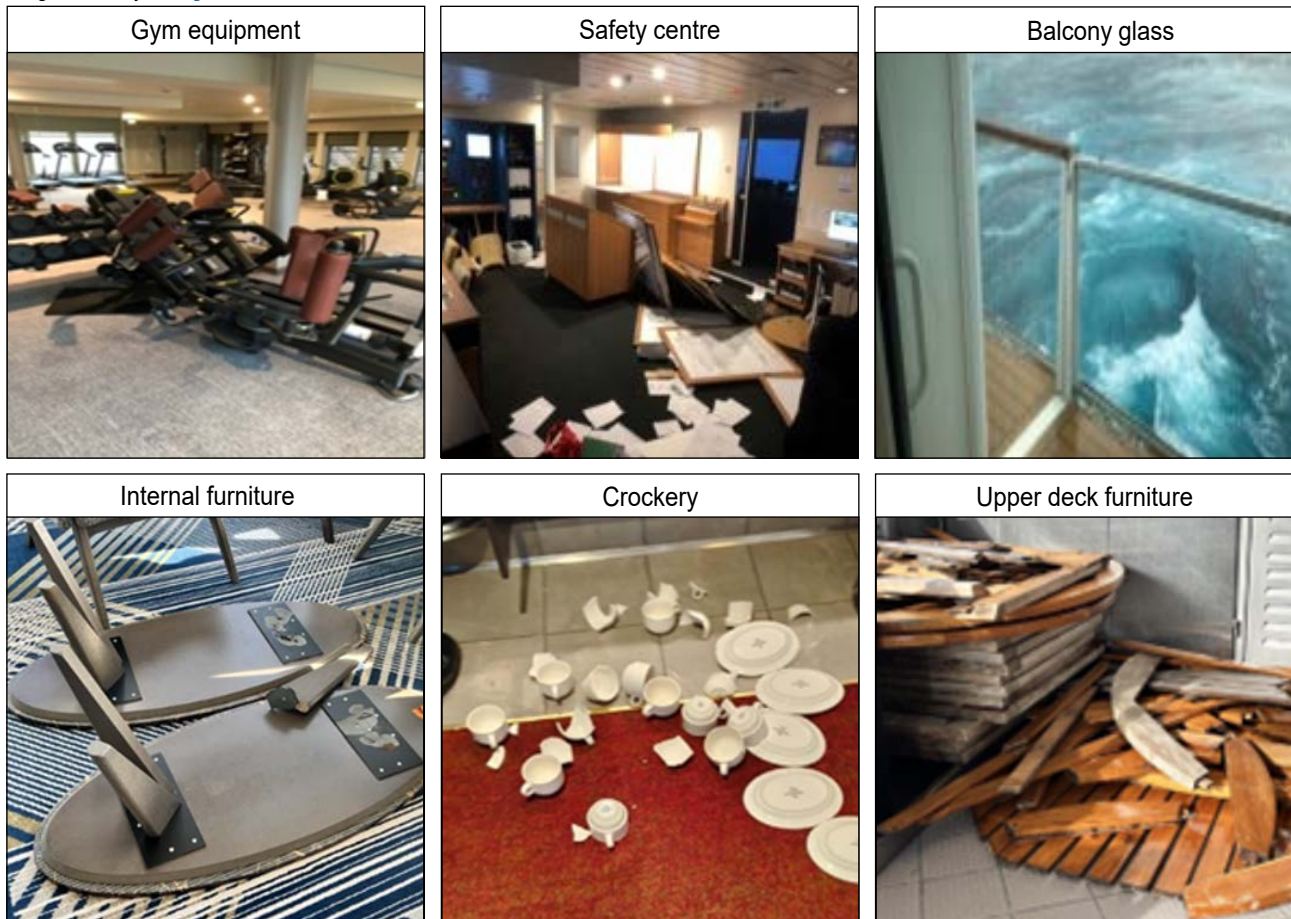
Figure 7: Examples of the damage

Spirit of Discovery sustained damage to some of its balcony glass panels, gym equipment, and furniture as well as crockery and glassware. The vessel's watertight integrity remained intact and there was no structural damage (**Figure 7**).
