# Rail Accident Report

## **Collision between passenger trains at Salisbury Tunnel Junction, Wiltshire 31 October 2021**

Report 12/2023  
October 2023

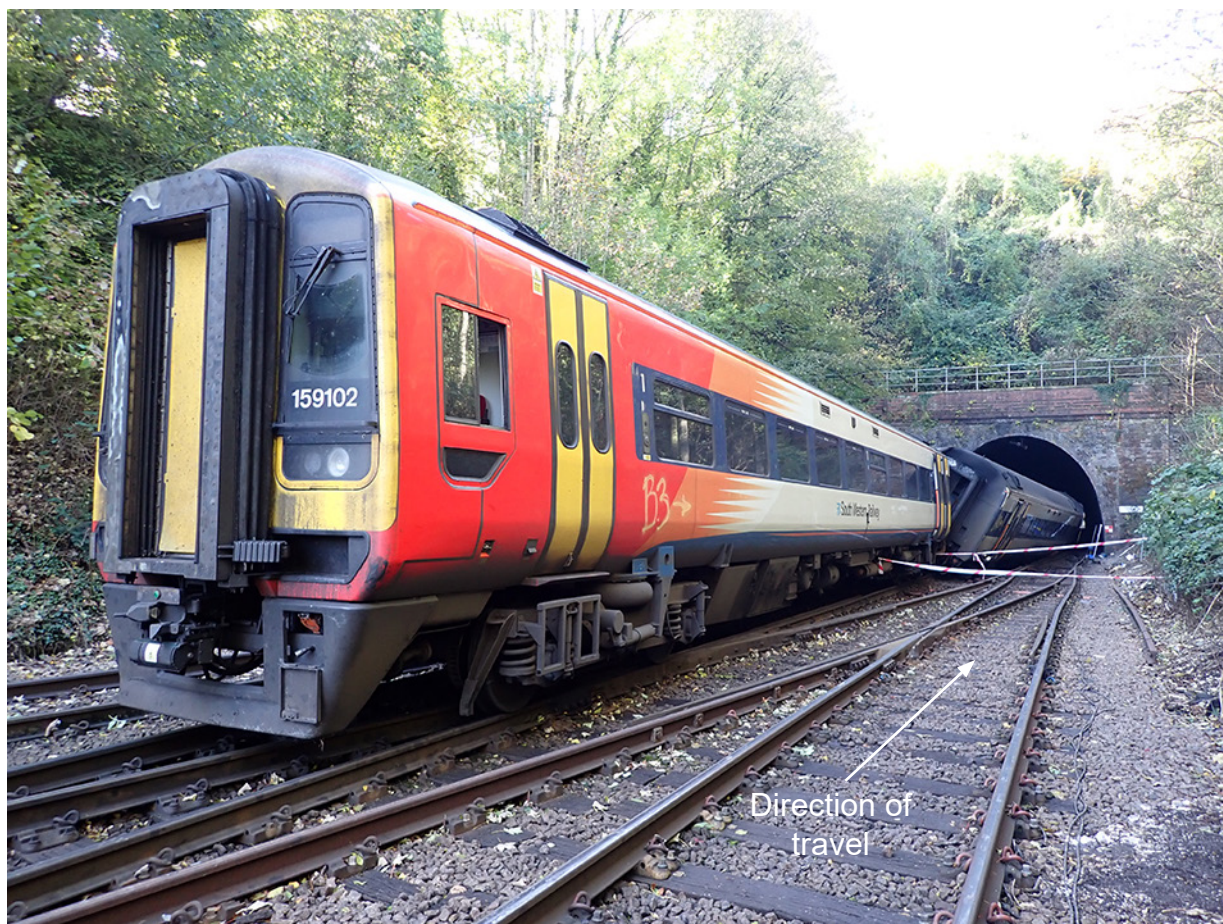
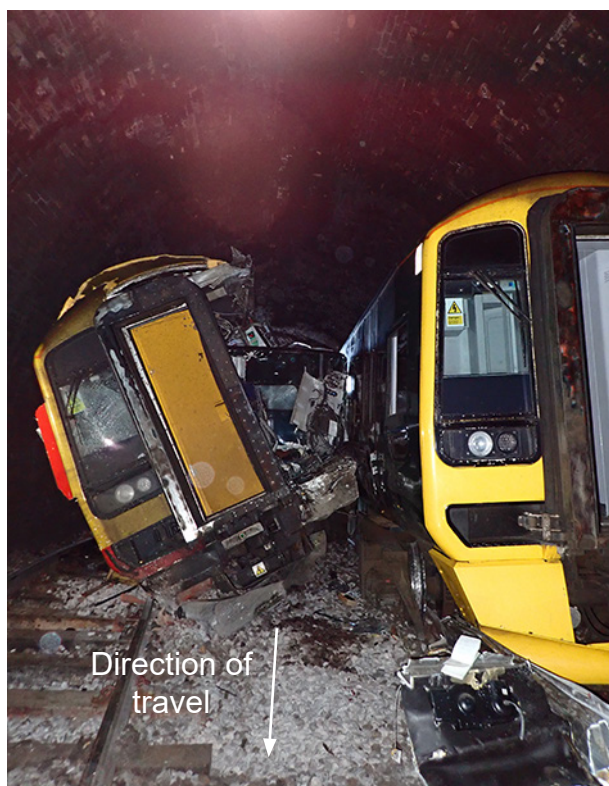
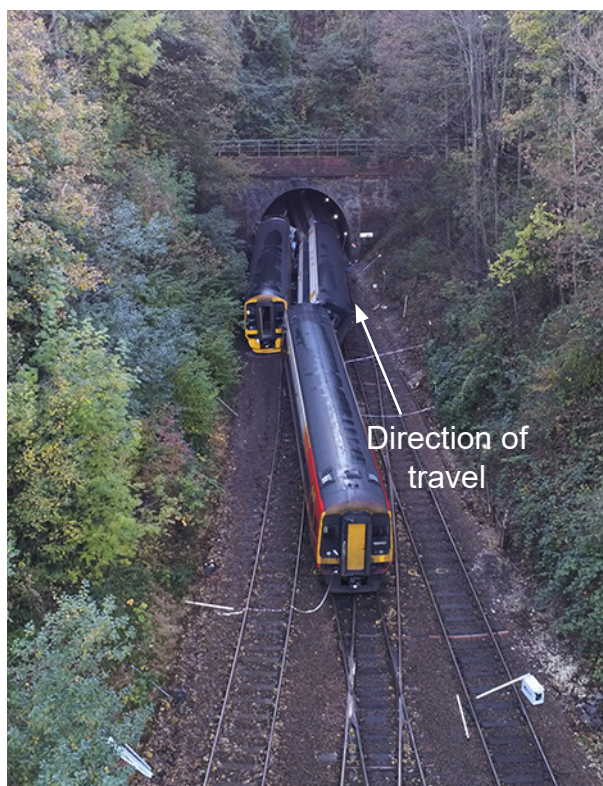
Figure 4: The aftermath of the accident.

- 7 The accident caused substantial damage to the track, the tunnel and the surrounding railway infrastructure. The leading carriage of train 1L53 and the rear two carriages of train 1F30 were damaged beyond economic repair. The rear two carriages of train 1L53 were less seriously damaged and the leading two carriages of train 1F30 were undamaged.
- 8 The driver of train 1L53 was seriously injured in the accident and spent three weeks in hospital. Thirteen passengers were also taken to hospital, with one suffering serious injuries. A further ten passengers were treated at the scene for cuts and bruises.
- 9 In total, there were 197 passengers and five members of staff on the two trains. Each train had a driver and a guard on board. There was also an on-duty driver travelling as a passenger on train 1F30 when the accident occurred.

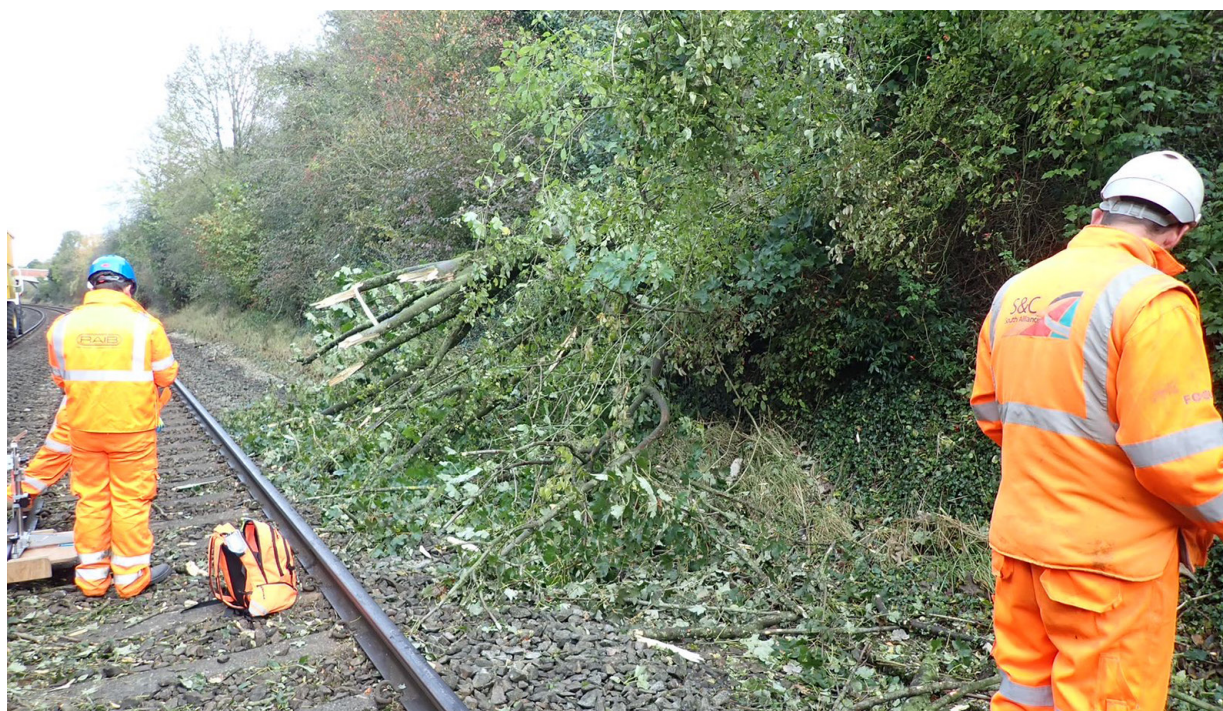
- 47 At 08:44 hrs on 31 October 2021, a train not involved in the accident, train 1L13, struck a tree<sup>4</sup> that had fallen onto the Down Main line at 80 miles 70 chains, around 250 metres west of Broken Cross bridge (80 miles 58 chains) (figure 5). The collision damaged the cab of the train, but no injuries were reported. The driver of 1L13 reported that they came to a stop in the vicinity of the AWS magnet for signal SY29, which was approximately 1350 metres beyond the fallen tree. On reporting this incident to the signaller, the driver stated that the train's braking was affected by "slipping" before colliding with the tree, but the conversation did not identify railhead contamination as a factor. There was no mobile operations manager (MOM)<sup>5</sup> available from Network Rail to attend the incident, so the train's driver and guard cut back the branches that were foul of the railway line, leaving the tree in the cress of the Down Main line (figure 7). The line was reopened at 10:44 hrs.

Figure 7: The tree struck by train 1L13 (post-collision) on the Down Main line looking east towards London with Broken Cross bridge in the background.

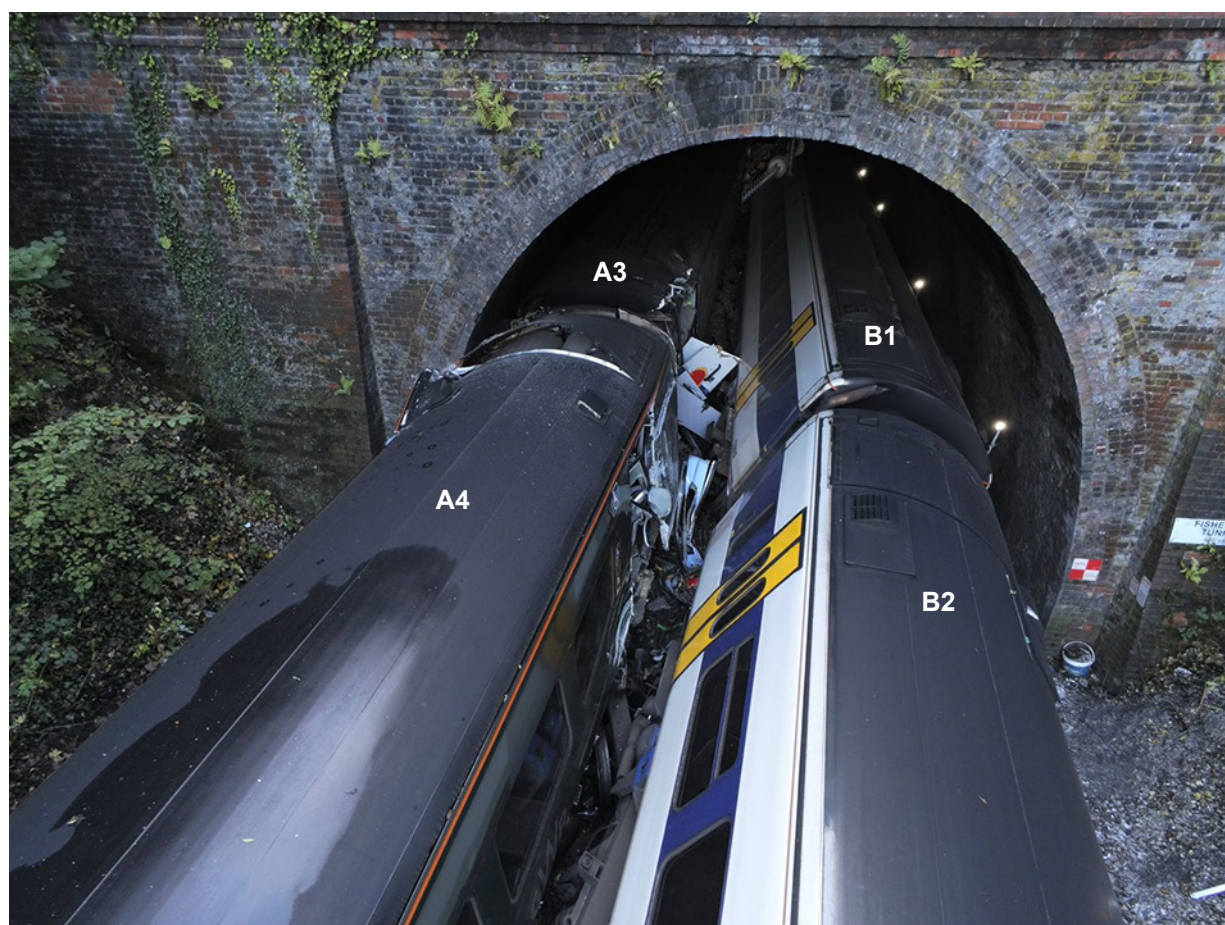
Figure 14: View from London portal of Fisherton Tunnel showing the rear carriages of train 1F30 (A3 and A4) and front carriages of train 1L53 (B1 and B2).

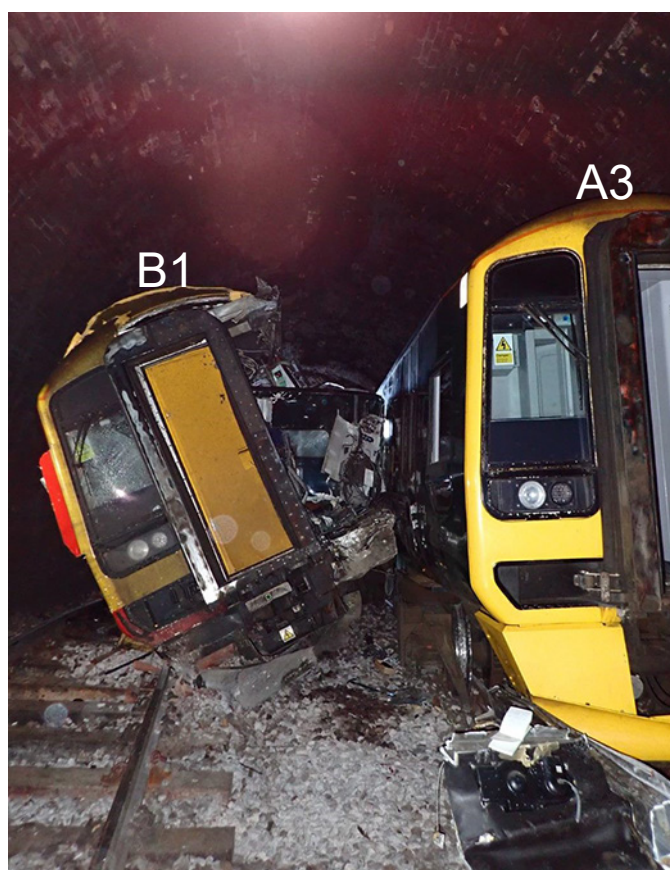
- 73 The driver of train 1L53 was injured in the collision and was trapped in the heavily damaged cab (figure 15). At around 18:46 hrs, the guard on train 1L53 attempted to contact the driver but was unsuccessful in doing so. The guard then tried to make a railway emergency call to the signaller using the GSM-R<sup>8</sup> train radio in the rear cab, but this again was unsuccessful. They then used their mobile phone to contact the emergency services and provided information from 18:45 until 19:15 hrs when they were met by responding fire and rescue personnel.

*Figure 15: View from within Fisherton Tunnel showing the front cab of train 1L53 (B1) and carriage A3, having separated from carriage A2, of train 1F30. Parts of the driving cab of train 1L53 have been cut away by the emergency services to release the trapped driver.*

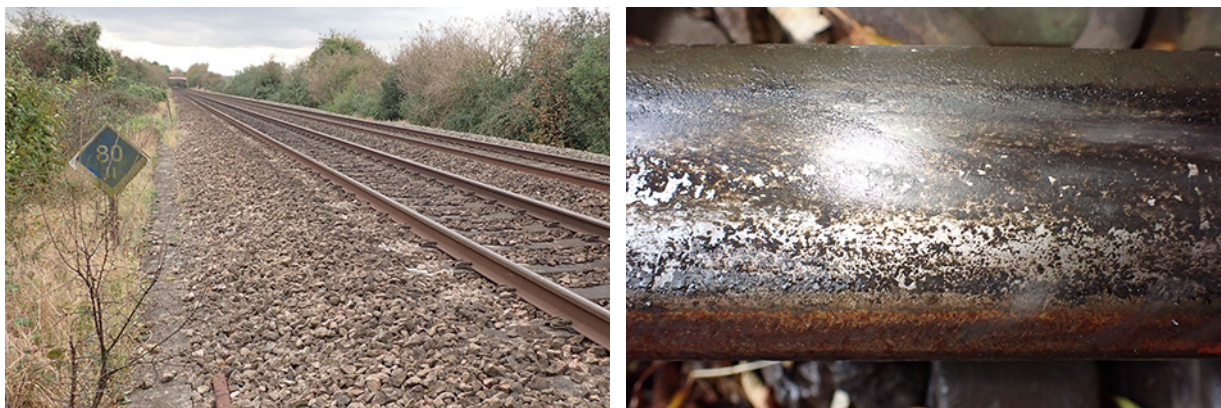
Figure 25: Location (left) and railhead condition (right) at 80 miles 40 chains.

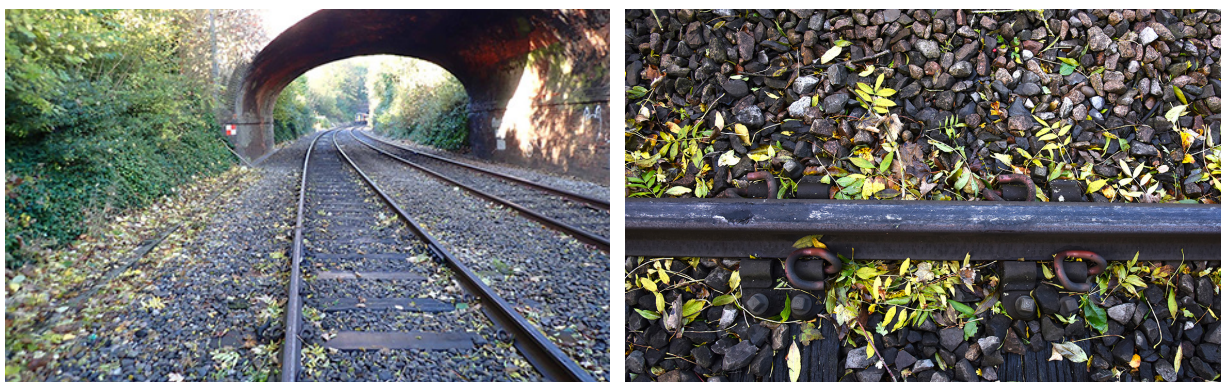
Figure 26: Location (left) and railhead condition (right) at 82 miles 27 chains beyond signal SY31 and approaching Salisbury Tunnel Junction.

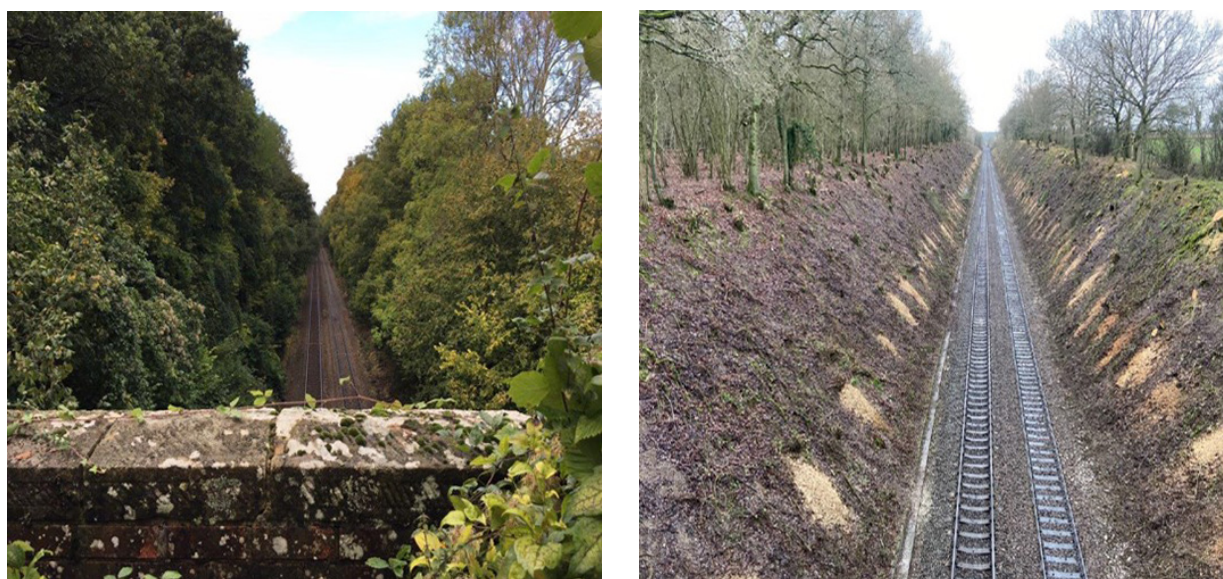
Figure 28: The main lines between Overton and Whitchurch looking towards Salisbury showing the condition of the vegetation before (taken in summer) and after (taken in winter) vegetation work was completed in 2019/20.

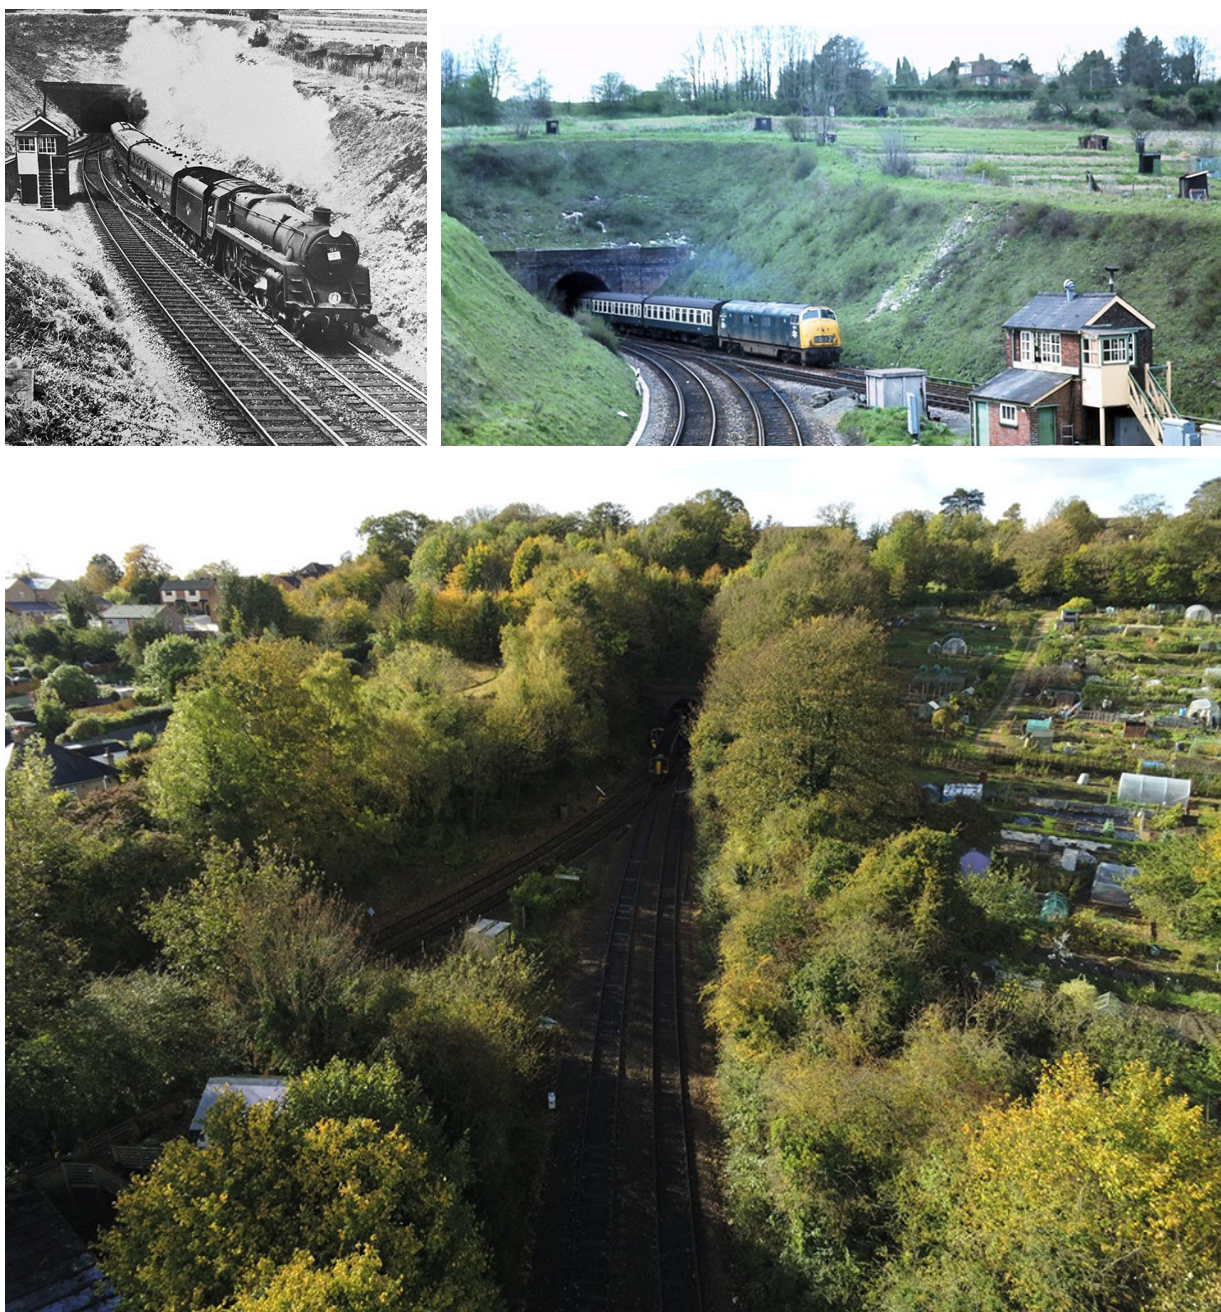
- 147 No action to manage the vegetation had been taken between 2018 and 2021 and video footage shows that vegetation continued to grow on the main lines approaching Salisbury Tunnel Junction between 2019 and 2021. A comparison between the 2021 scores and those from earlier inspections therefore brings into question the robustness of the process. It is also unclear whether classification of sites with an assessment score of between 21 and 26 as *'high risk during peak leaf fall period and wet conditions'* in NR/L2/OTK/5201/F3076 may have affected the contractors' scoring. As explained in paragraph 139, operational standard NR/L2/OPS/095 did not require any action to be taken for such sites, but the contractors were unlikely to have been aware of this. Figure 32 shows the change in the management of vegetation at Salisbury Tunnel Junction over the previous decades.

Figure 32: The Up and Down Dean and Main lines looking towards Fisherton Tunnel in 1963 (top left, courtesy of Crecy publishing), in the 1970s (top right, courtesy of Crecy publishing), and on 1 November 2021 (main image).

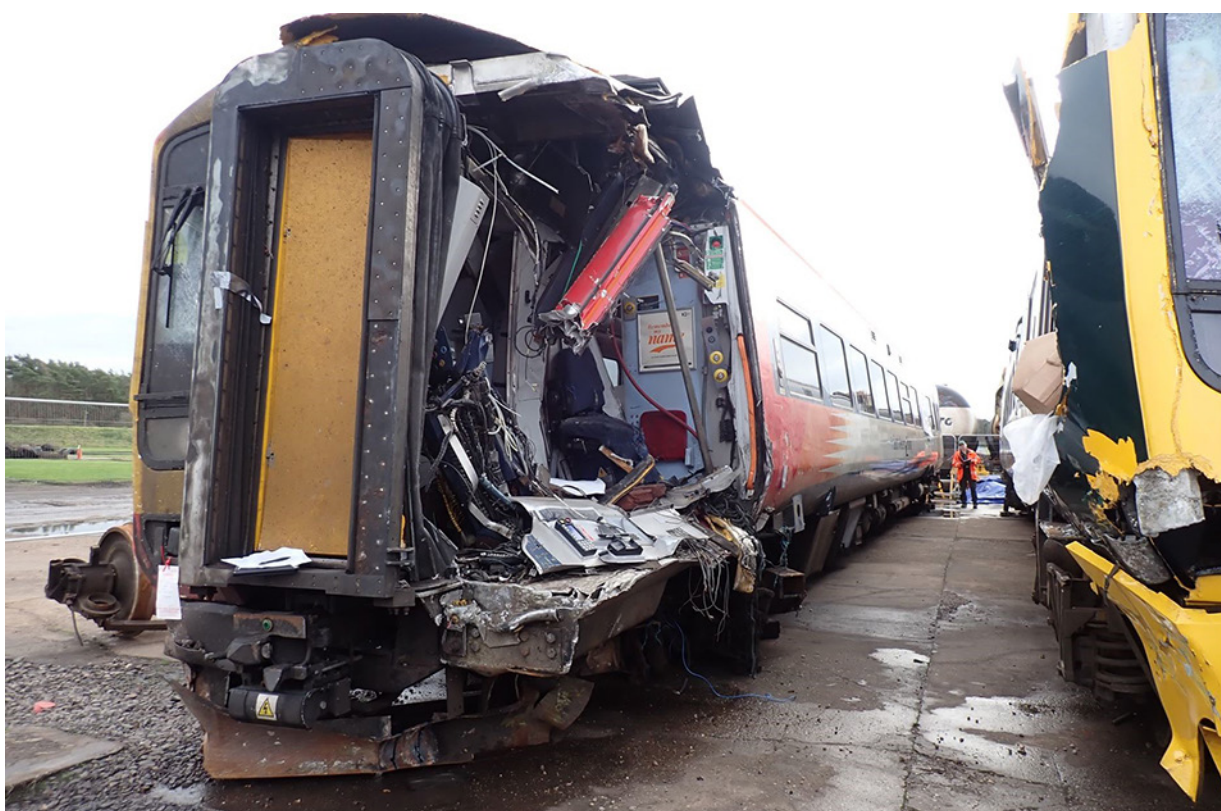
*Figure 45: Cab of train 1L53 (additional damage was caused by the fire and rescue service during the extraction of the injured train driver).*

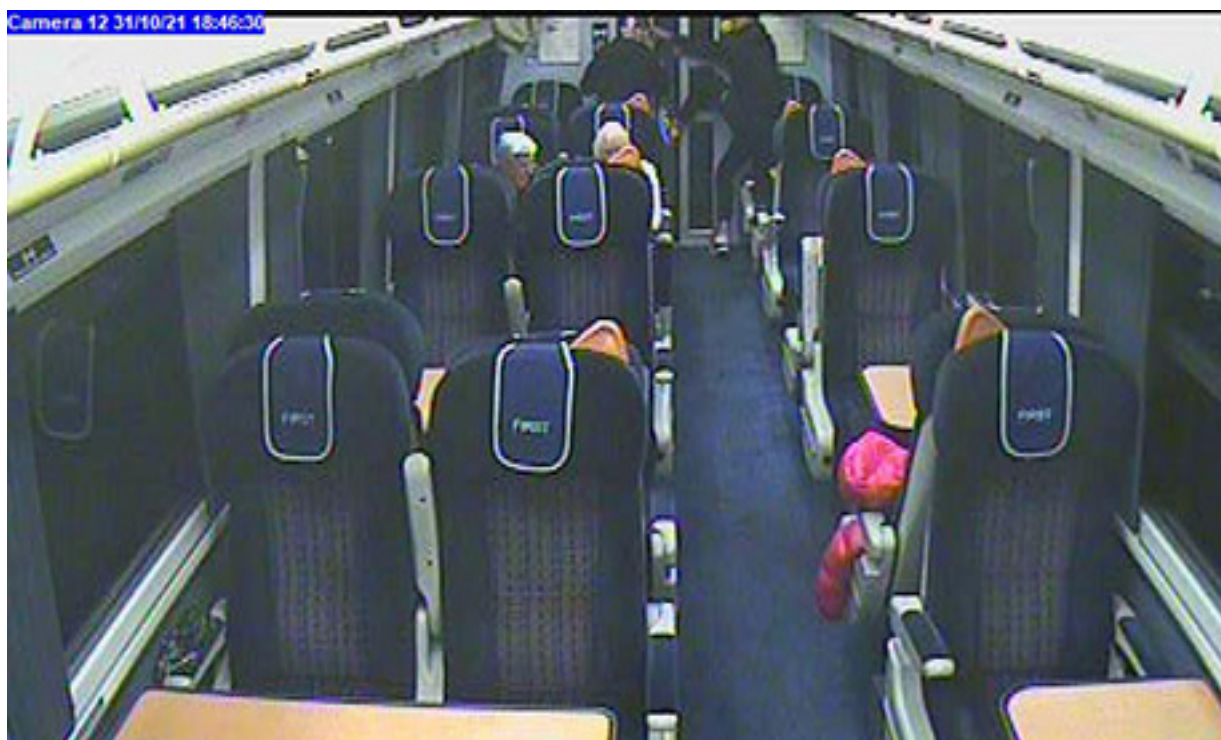
Figure 47: Internal CCTV image showing passengers trying to prise vestibule door open in the rear carriage of train 1L53.

One recommendation is made to Porterbrook, Eversholt and Angel Trains regarding the design of the internal sliding doors on class 158 and 159 carriages.
