Wightlink Ltd - Lymington Harbour Safe Operating Procedure

Event 1: number 6 connecting rod debris analysis

Subject: Volvo Penta – Wightlink Ferry
Exponent Project No.: 1808759.UK0-0870

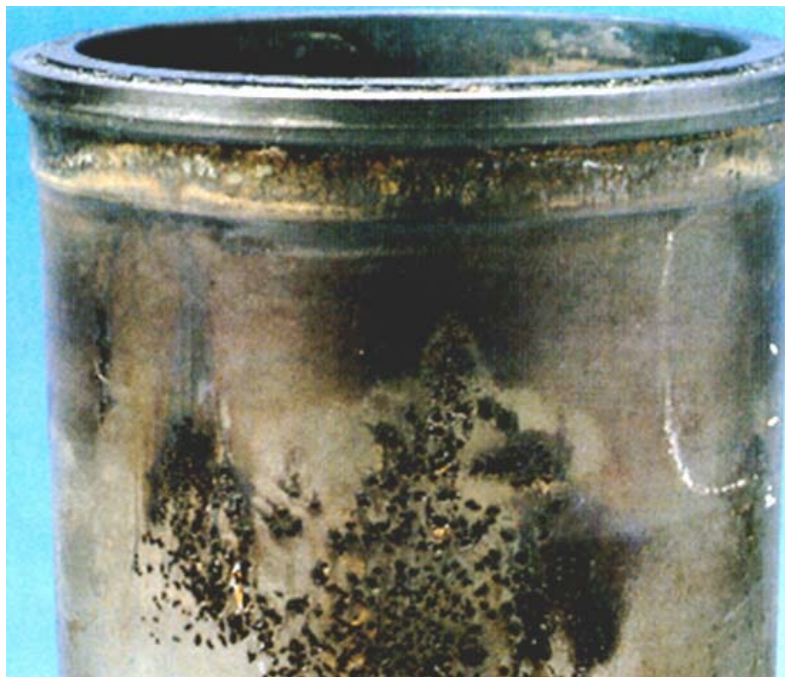
Figure 1. Severely Eroded liner

The affected areas form vertical strips or patches sometimes in alignment with the thrust face of the piston within the cylinder, or also formed immediately over the top sealing ring of the liner. The erosion can penetrate the wall of the cylinder and permit the flow of antifreeze/coolant to the oil or vice-versa.

The cavitation erosion is caused by excess in harmonic vibrations of the engine and in some cases by loose fitting liners that result in a fast formation and implosion of small vapor bubbles within the coolant which attack the cylinders' liner wall. The vibration in combination with collapsing bubbles produces an

In order to reduce or prevent cavitation, manufacturer recommendations should be followed.

In many cases, cavitation can be avoided by reducing harmonic vibrations. For example, by making sure the injection complies with the manufacturer's specifications, the engine's speed is governed according to the manufacturer's data and that the control functions. Also, do not underestimate the importance of correct clearances between liner and cylinder blocks; incorrect liner fit is a serious contributor to liner vibration resulting in cavitation erosion.

Engine manufacturers have specific additives for the coolant called SCA (supplementary cooling additive). These additives will form a protective coating over the cylinder liner, which is exposed to the coolant, therefore reducing cavitation damage. With time, additive concentration reduces in the system, consequently making it necessary to follow system maintenance recommendations in order to keep the adequate levels.

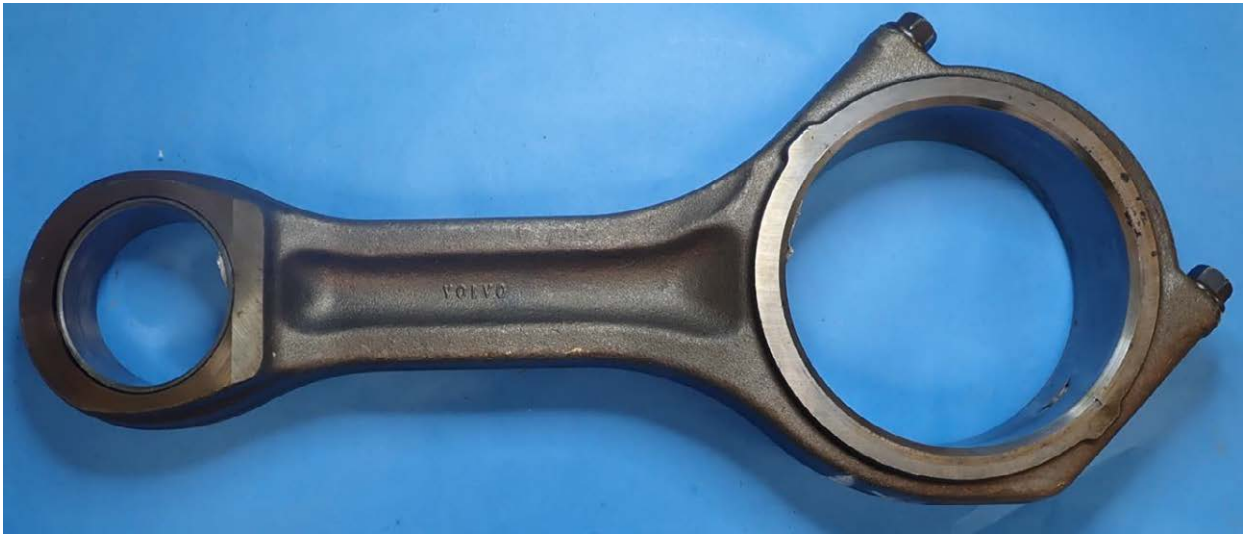
FIGURE 1. Representative photograph of the subject connecting rod.

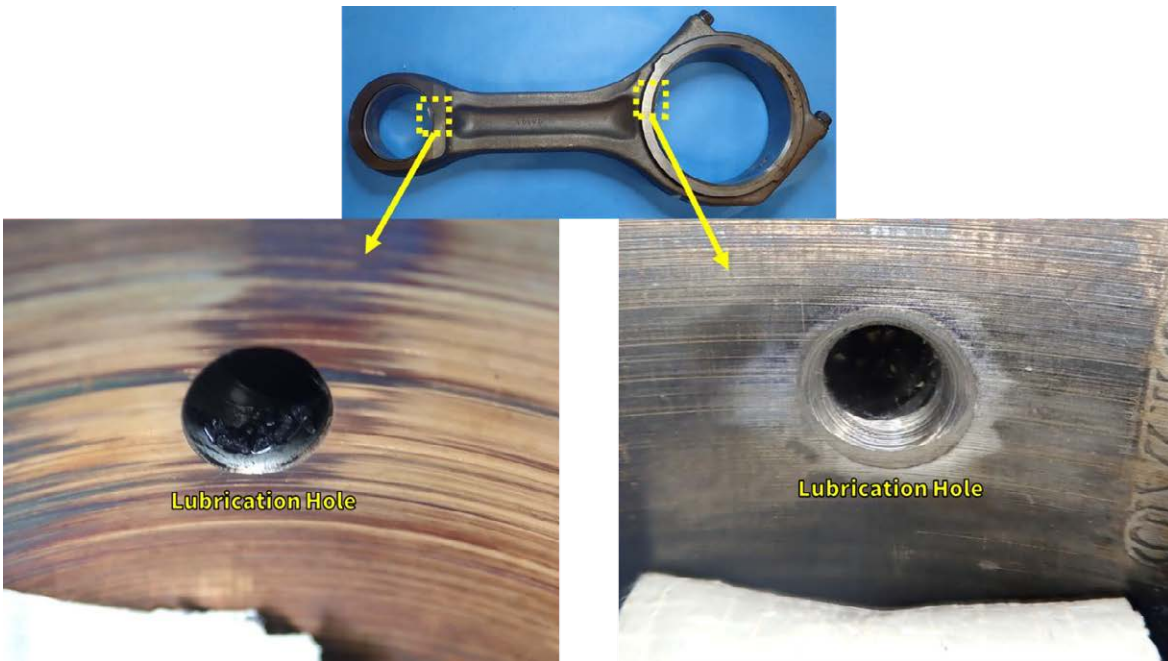
FIGURE 2. Representative photographs of the lubrication channel openings in the subject connecting rod. Particles were visible in both openings.

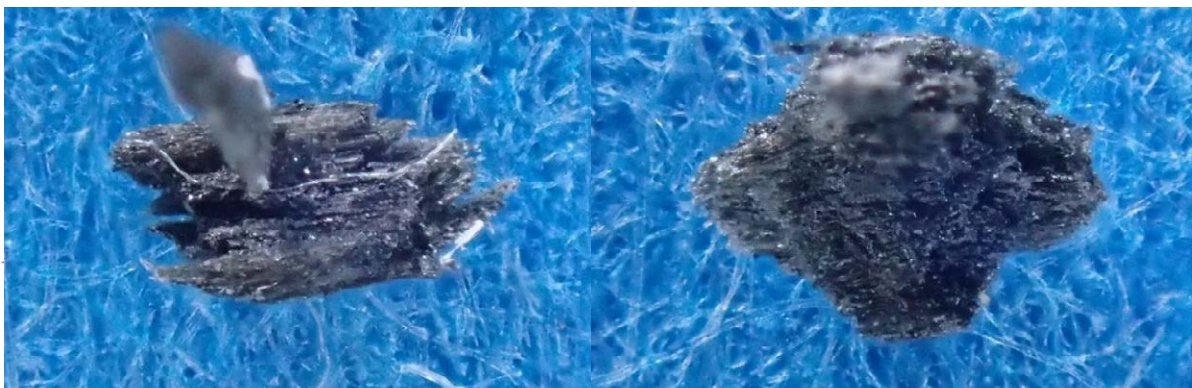
Two particles, both approximately 1 mm³, were collected from the subject connecting rod and arbitrarily named “Particle 1” and “Particle 2.” Both particles were examined via SEM/EDS. Representative SEM images of the Particles 1 and 2 are shown in **FIGURE 4** and **FIGURE 5**, respectively. The contrast in **FIGURE 4** and **FIGURE 5** represents compositional differences: brighter areas represent heavier elements (e.g., iron, Fe) while darker areas represent lighter elements (e.g., carbon, C). Note, the contrast is not uniform across all of the images, thus a particular shade of grey does not represent the same element image-to-image. Smaller, micron-scale particles were observed decorating the larger 1 mm³ particles. The larger 1 mm³ particles appear to consist mainly of carbon (C), while the smaller particles consist of a mix of aluminium (**FIGURE 6**), iron (**FIGURE 7**), nickel (**FIGURE 7**), copper (**FIGURE 7**) and lead (**FIGURE 8**). Traces of other elements, including but not limited to, phosphorus (P), calcium (Ca), sulphur (S) and silicon (Si) were also detected in various small particles decorating Particles 1 and 2.

FIGURE 3. Representative photograph of the two particles collected from the subject connecting rod.

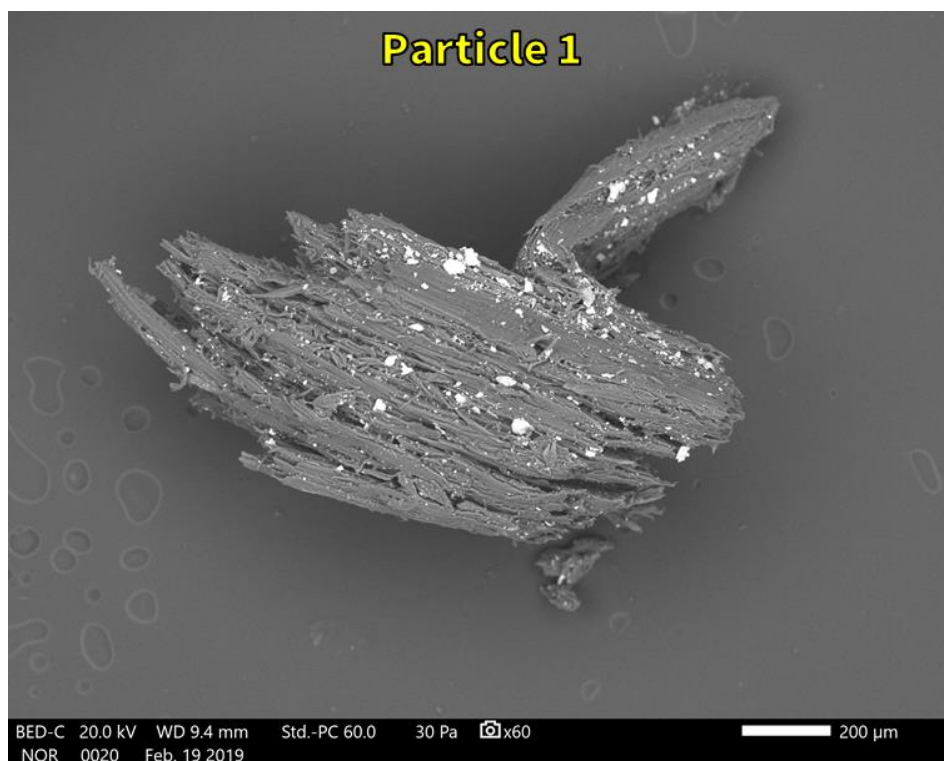
FIGURE 4. Representative SEM image of Particle 1.

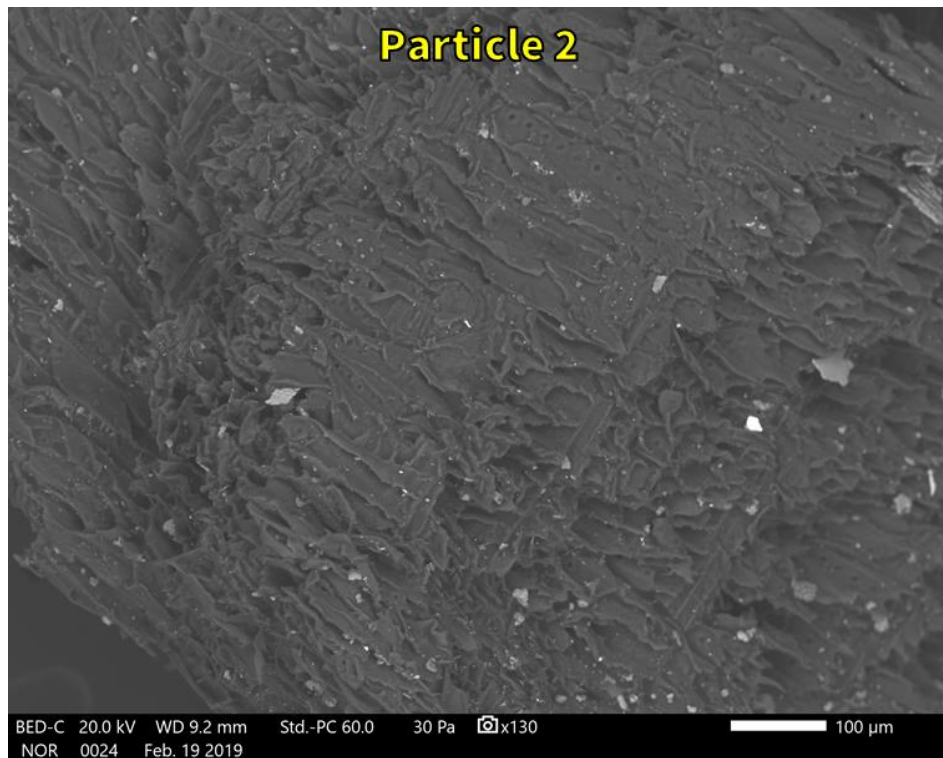
FIGURE 5. Representative SEM image of Particle 2.

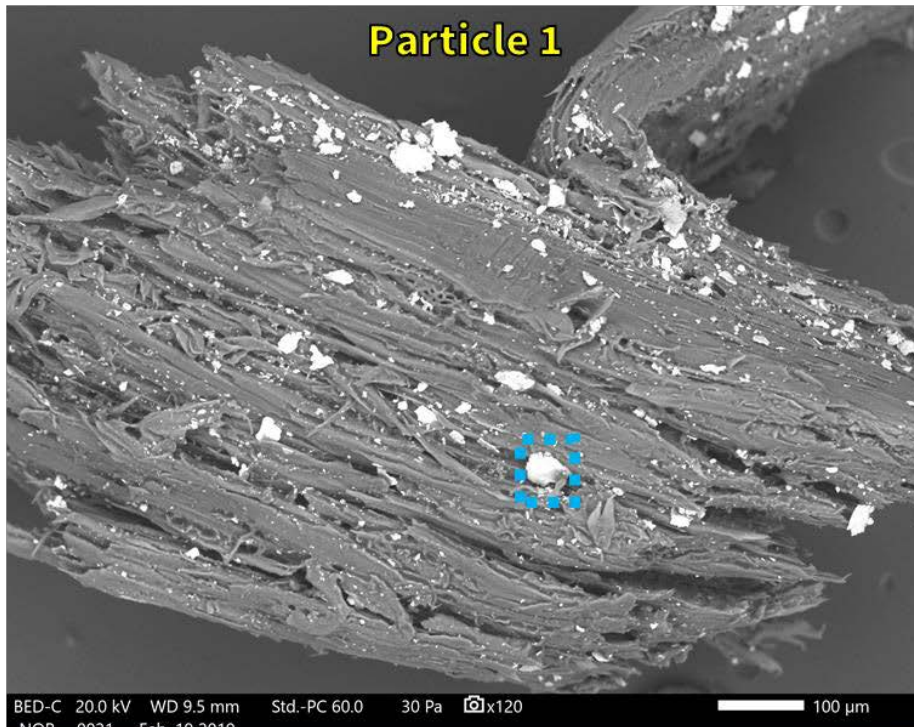
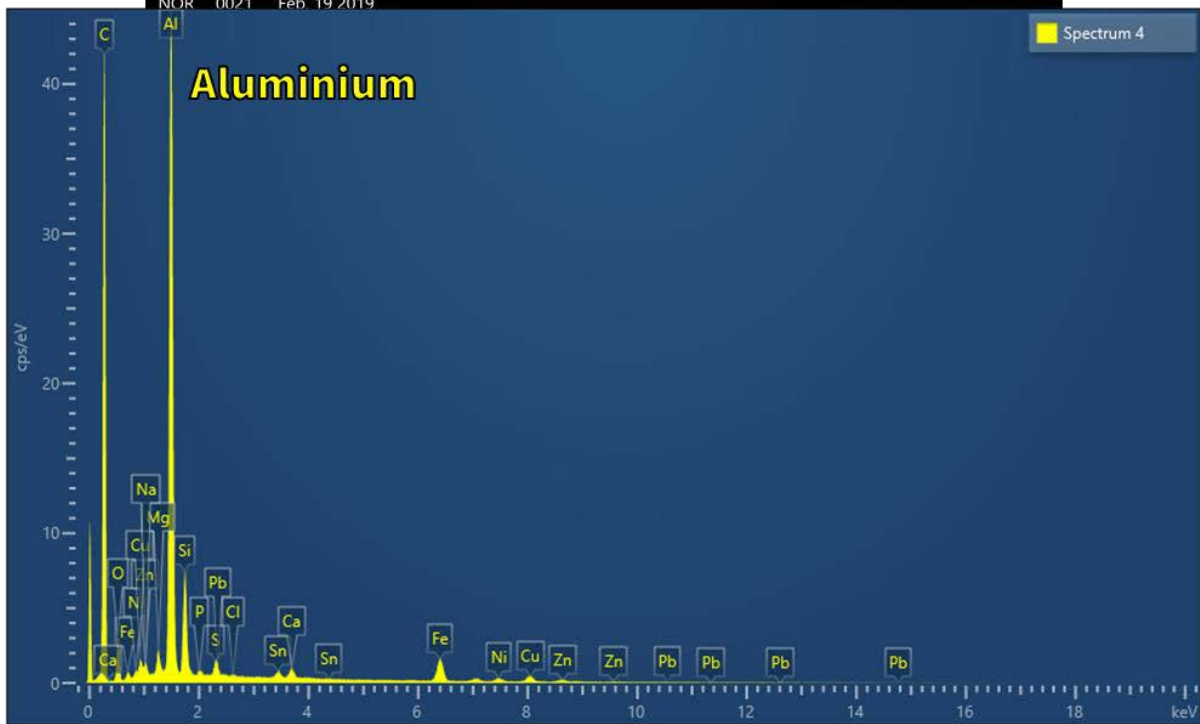
FIGURE 6. Representative EDS spectrum of a small particle decorating Particle 1. Aluminium (Al) was detected in this smaller particle.

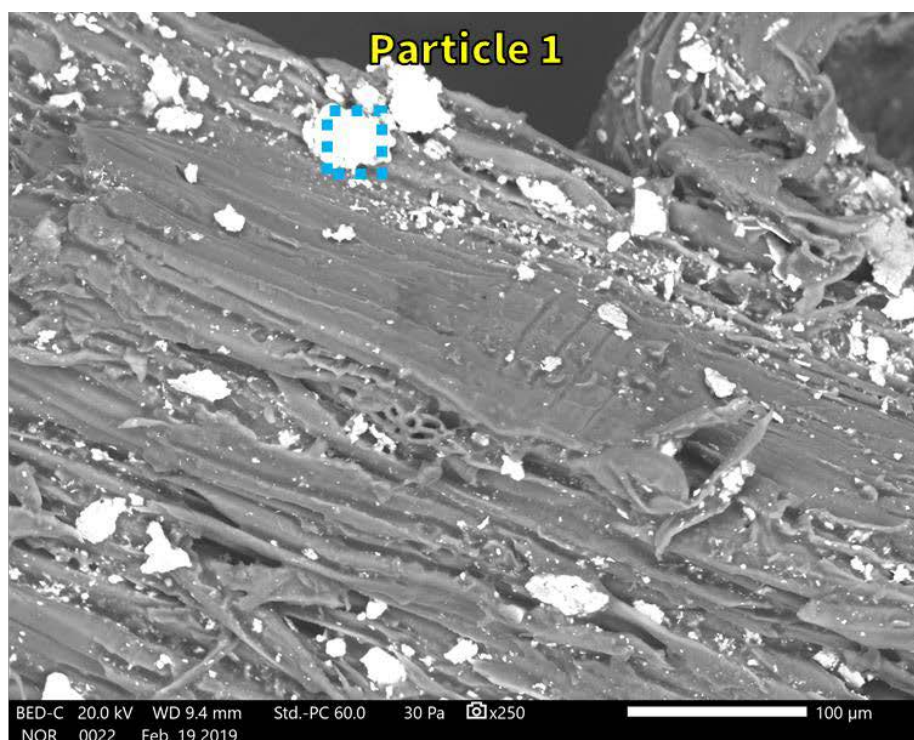
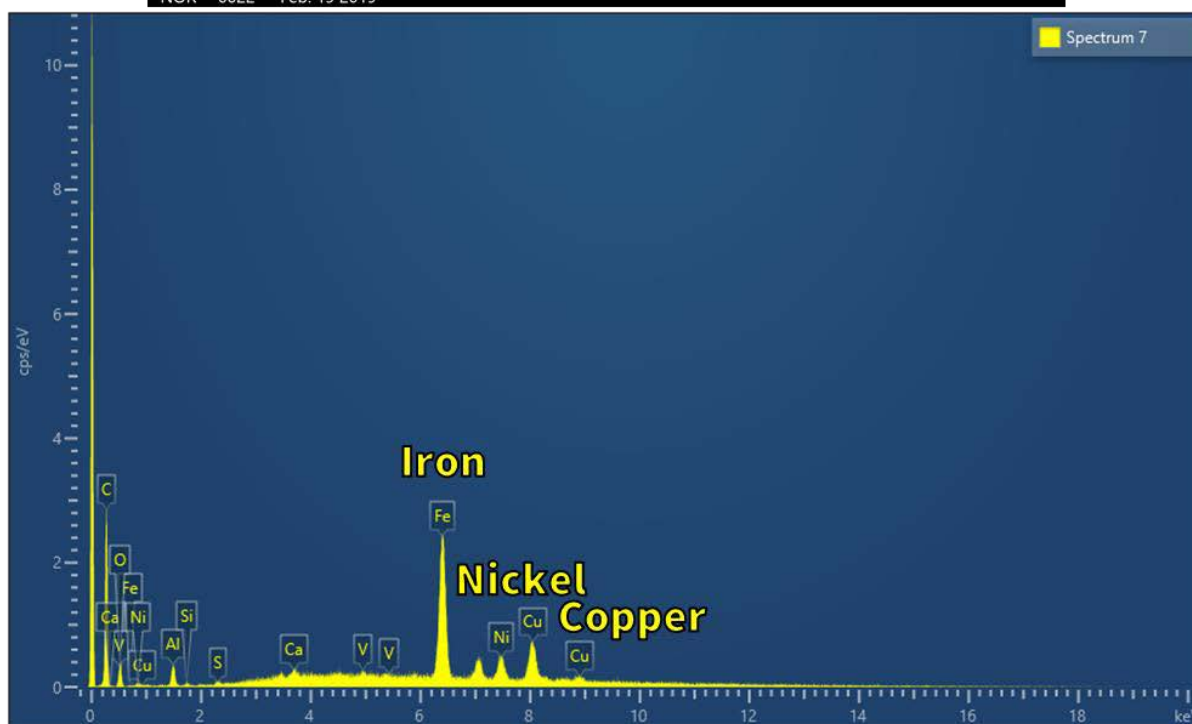
FIGURE 7. Representative EDS spectrum of a small particle decorating Particle 1. Iron (Fe), nickel (Ni) and copper (Cu) were detected in this smaller particle.

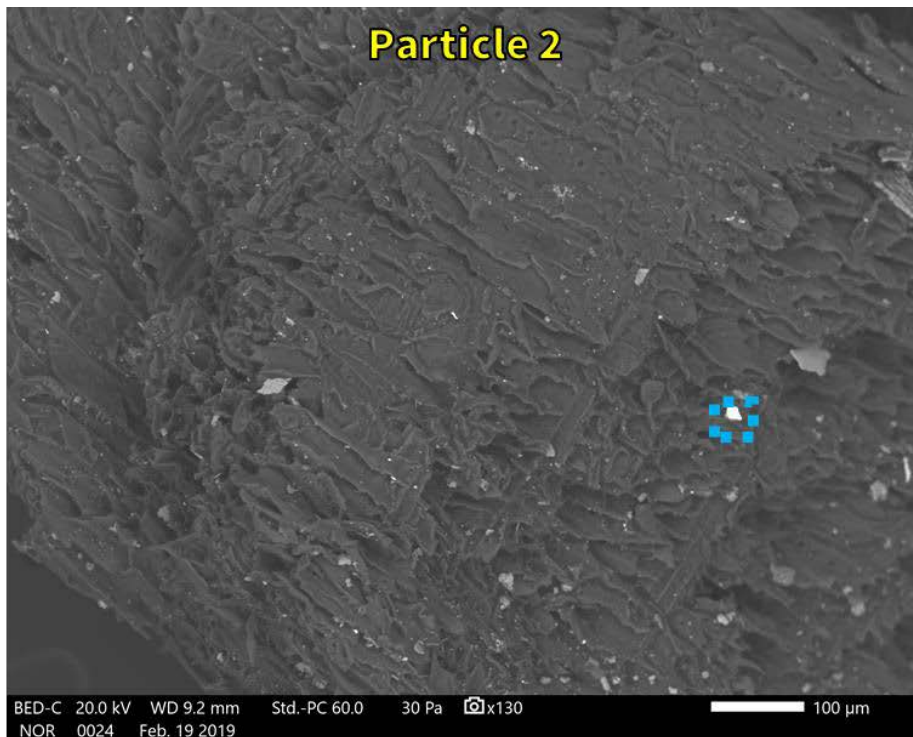
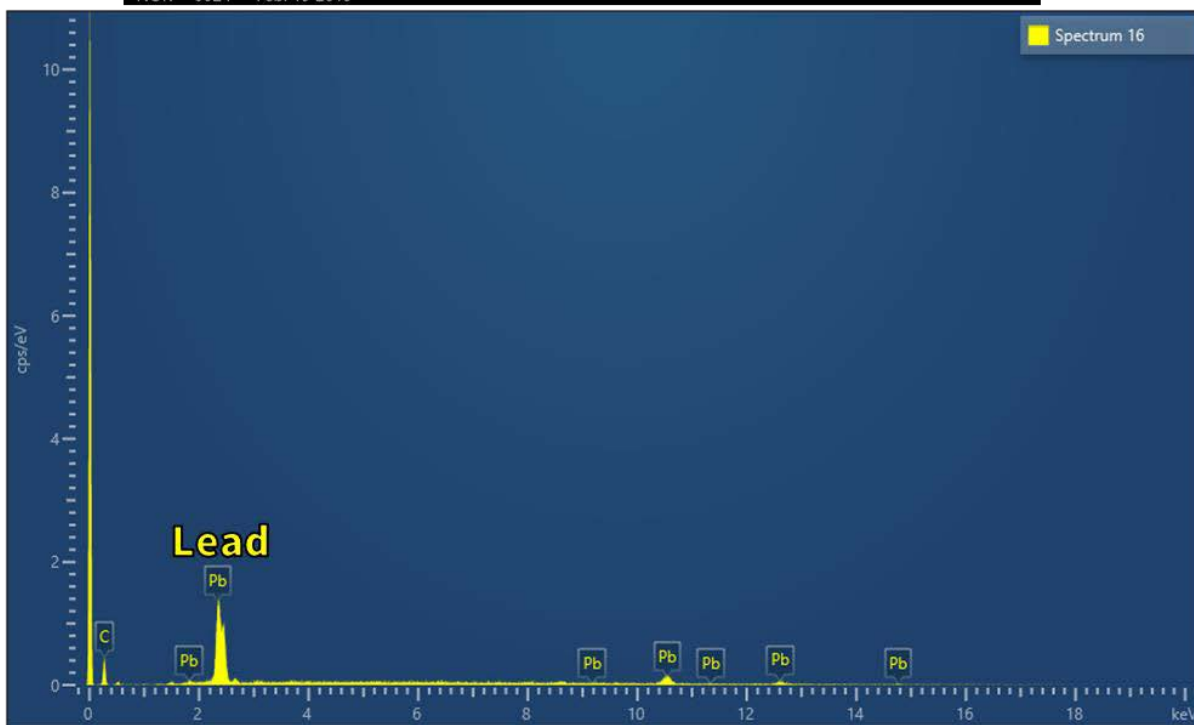
FIGURE 8. Representative EDS spectrum of a small particle decorating Particle 2. Lead (Pb) was detected in this smaller particle.
