**SERIOUS INCIDENT**

<b>Aircraft Type and Registration:</b>	MBB-BK 117 C-2, G-MPSB	
<b>No &amp; Type of Engines:</b>	2 Arriel 1E2 turboshaft engines	
<b>Year of Manufacture:</b>	2005 (Serial no: 9068)	
<b>Date &amp; Time (UTC):</b>	12 March 2021 at 1150 hrs	
<b>Location:</b>	North Weald Airfield, Essex	
<b>Type of Flight:</b>	Private	
<b>Persons on Board:</b>	Crew - 2	Passengers - None
<b>Injuries:</b>	Crew - None	Passengers - N/A
<b>Nature of Damage:</b>	Distorted aft crosstube between skids	
<b>Commander's Licence:</b>	Airline Transport Pilot's Licence (Helicopters)	
<b>Commander's Age:</b>	52 years	
<b>Commander's Flying Experience:</b>	7,170 hours (of which 2,196 were on type) Last 90 days - 28 hours Last 28 days - 14 hours	
<b>Information Source:</b>	AAIB Field Investigation

**Synopsis**

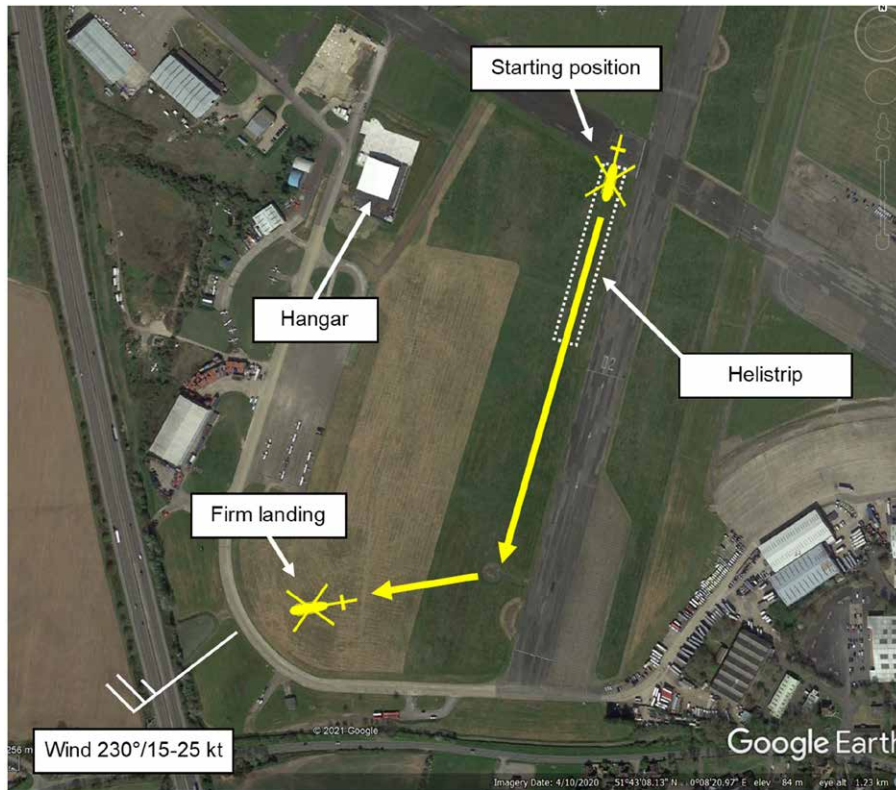
**Figure 1**

Approximate track of G-MPSB from Cat A takeoff to firm landing (satellite imagery courtesy of Google Earth ©2021 Google)

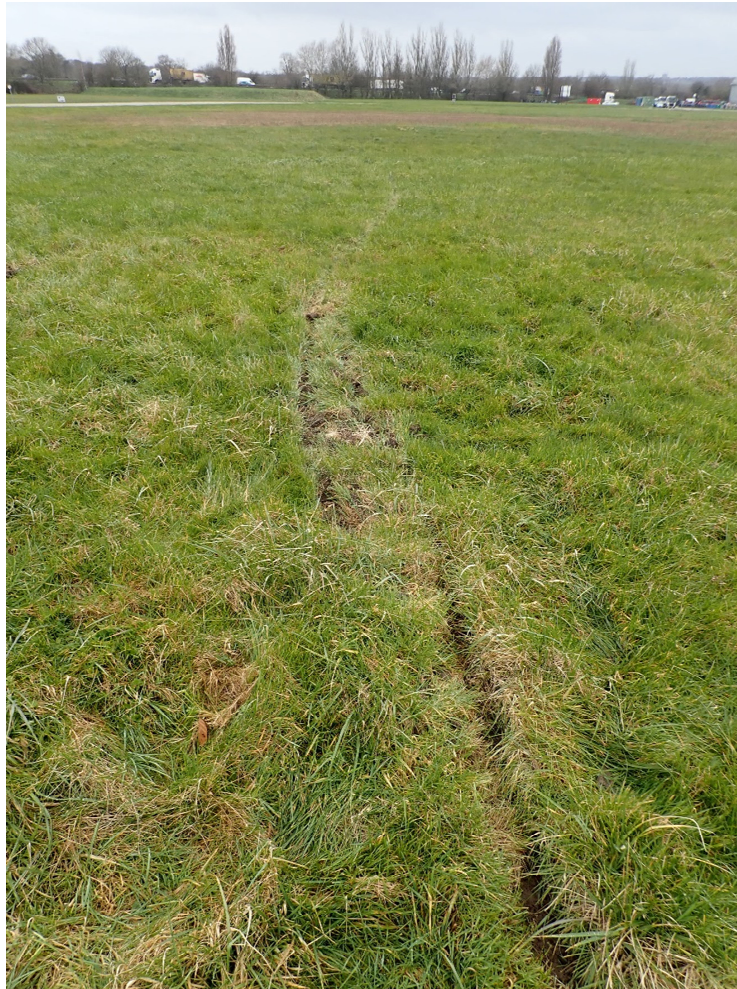
**Figure 3**

The helicopter landed on an area of grass to the north of the south-western taxiway. Ground marking caused by both skids extended for approximately 17 metres in a westerly direction. The initial landing point was identified by deep furrows which were left in the turf by the helicopter's skids. The markings indicated that the right skid bounced after the initial contact with the ground before it slid and came to rest (Figure 3). The ground marking became less visible as the ground slide progressed.

Ground markings from right skid

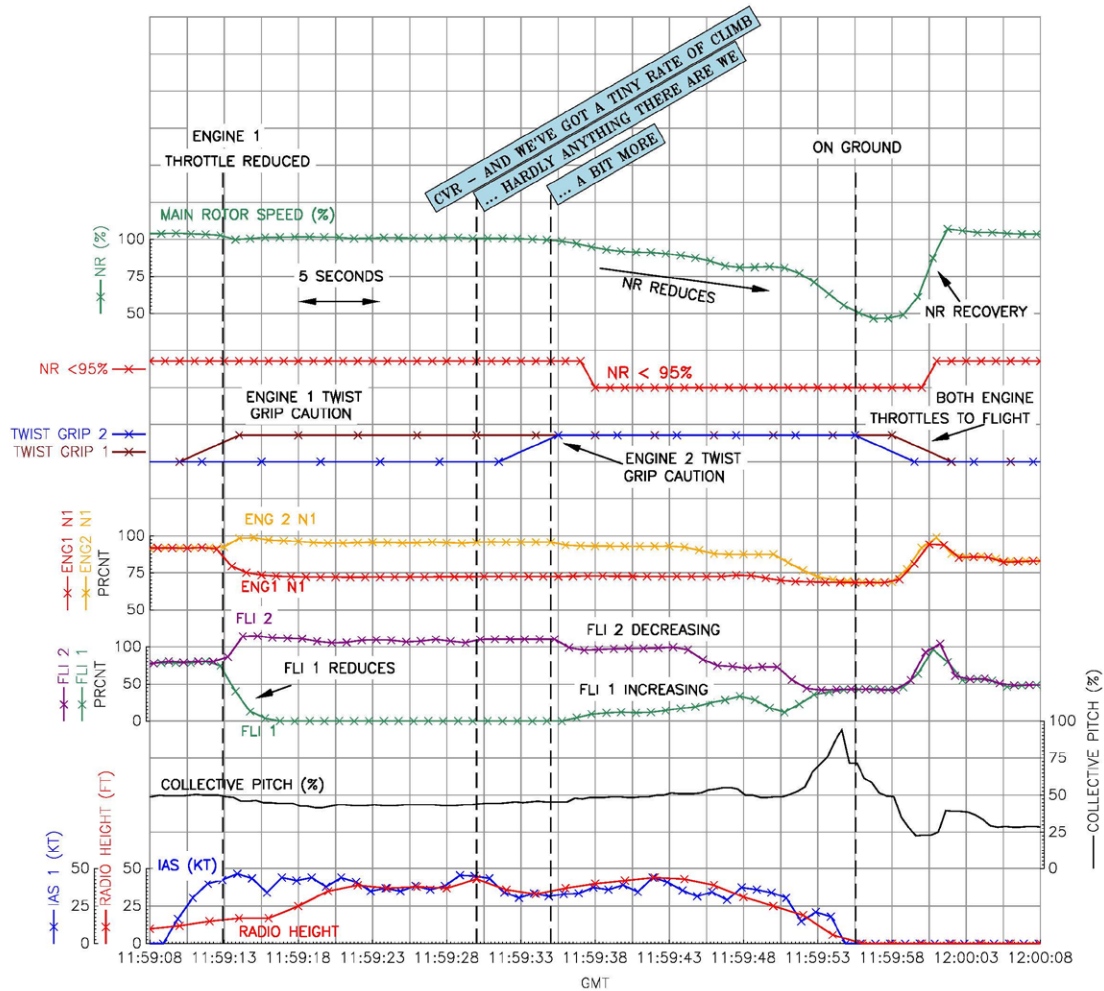
Figure 8

At 1159:13 hrs, while climbing through 16 ft agl at an IAS of 43 kt, Engine No 1 FLI began to reduce, signifying the point at which the Engine No 1 throttle was reduced. This was confirmed by the CAU TWIST GRIP parameter (Figure 8). The position of the Engine No 1 throttle was not recorded but within 3 seconds, Engine No 1 torque had reduced to less than 3%.

The IAS increased to 47 kt and the aircraft climbed to a maximum of 39 ft with the CVR recording the commander talking through the simulated engine failure. Eighteen seconds into the exercise, the CVR recorded the commander stating "AND WE'VE GOT A TINY RATE OF CLIMB... HARDLY ANYTHING THERE ARE WE". The examiner replied "NO", to which the commander stated "A BIT MORE". At this time, the FDR recorded an increase in the Engine No 1 FLI but also a decrease in the Engine No 2 FLI and the Engine No 2 CAU TWIST GRIP caution was triggered.

Two seconds later, the CVR recorded an audible low rotor rpm warning as the  $N_R$  dropped below 95%. The examiner stated "JUST WATCH YOUR  $N_R$ ", which the commander acknowledged. The examiner stated "PUT THE THROTTLE BACK IF I WERE YOU". However, as this exchange was taking place, the Engine No 2 FLI reduced further and the Engine No 1 FLI increased.

G-MPSB FDR parameters  
NOTE FLI is recorded as percentage on the FDR

At 19 ft agl and an IAS of 15 kt, the collective was raised to cushion the landing. At touchdown, both recorded FLI were the same at 43%. After landing, the collective was lowered and a few seconds later, both engine throttles were returned to the FLIGHT position. As a consequence, both engines spooled up and the main rotor rpm recovered.

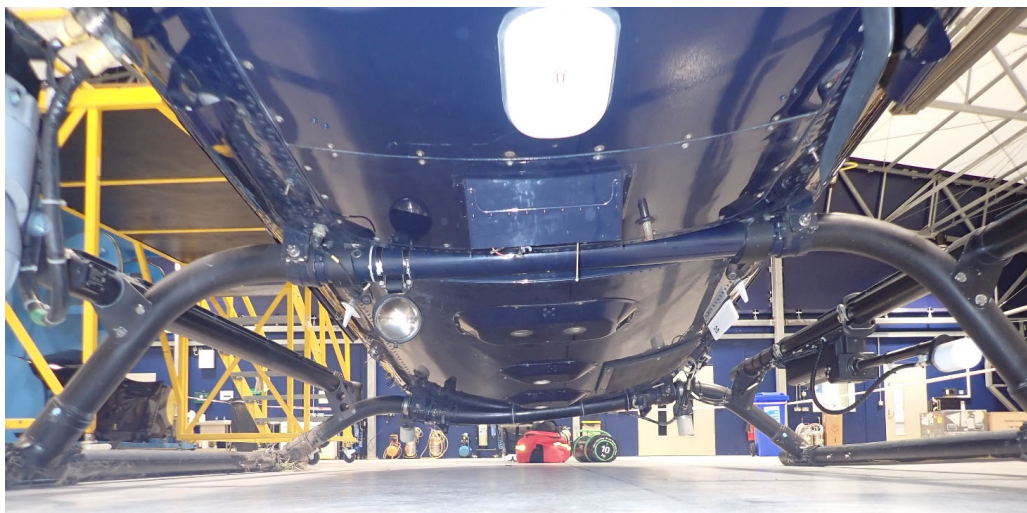
**Figure 9**

The helicopter was moved to a hangar after it had landed. External examination identified significant deformation of the aircraft landing gear (Figure 9). The aft crosstube had bowed, resulting in both skids moving outboard. The right skid had deflected further than the left. Other than the aft crosstube damage, no other physical damage was identified with the aircraft.

G-MPSB landing gear (viewed from front looking rear)

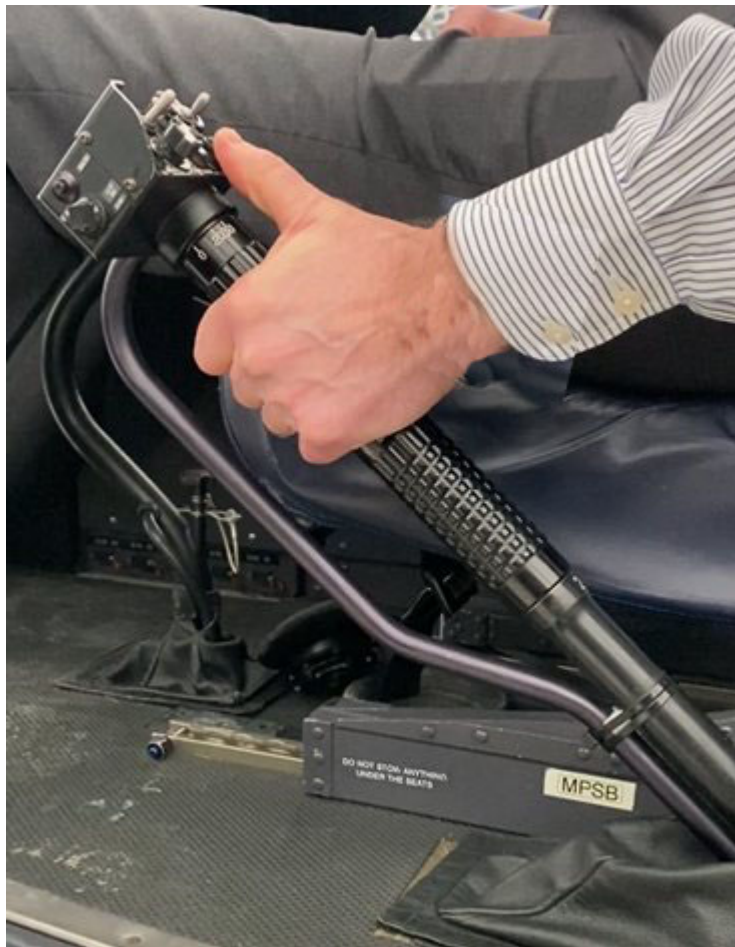
**Figure 13**

intermediate throttle setting, rather than IDLE, the encountered problems might not have occurred. The subsequent inadvertent deselection of FLIGHT on Engine No 2 probably resulted from the commander's hand accidentally overlapping its throttle as he tightened and/or moved his grip on Engine No 1's throttle while manipulating it in response to the unfolding emergency. The investigation heard that inadvertent manipulation of the throttles during high stress/workload situations was an uncommon, but not unknown occurrence on this type of helicopter. The helicopter manufacturer undertook to review their handling guidance for pilots employing the one engine to IDLE technique for simulating engine failures during Cat A Clear Heliport takeoffs.

Pilot's hand overlapping both throttle twist grips
