Rail Accident Report

Collision between a tram and a cyclist, near Audenshaw tram stop, Manchester 1 September 2021

Report 08/2022
August 2022

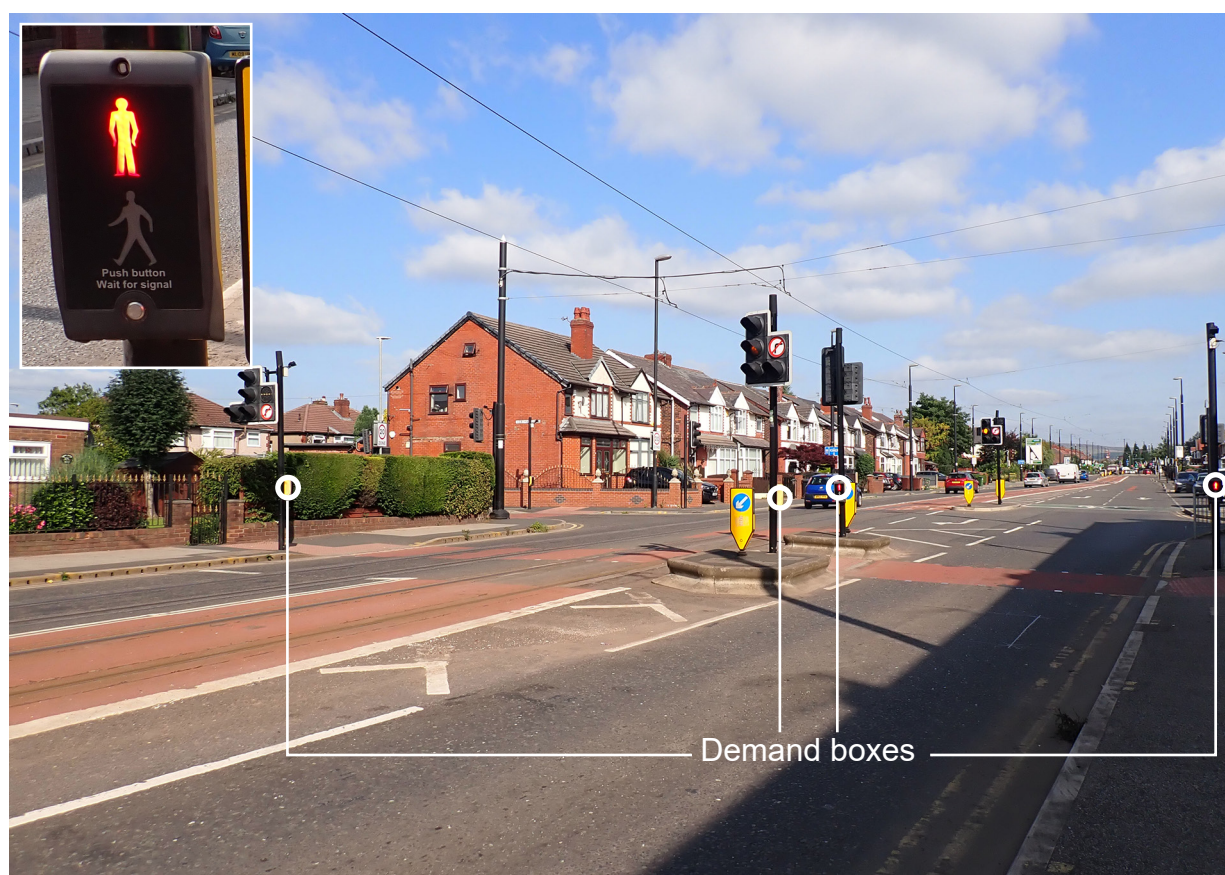
Figure 4: general view of the Puffin crossing across Droylsden Road (looking east), with (inset) demand box showing 'red standing man' indication

- 11 Although a mid-carriageway pedestrian refuge exists, the Puffin crossing covers the entire carriageway of Droylsden Road as a single crossing. Operating the demand button on either side of the crossing will cause road (and tram) signals to change, stopping traffic from both directions so that an individual may cross the complete width of Droylsden Road.

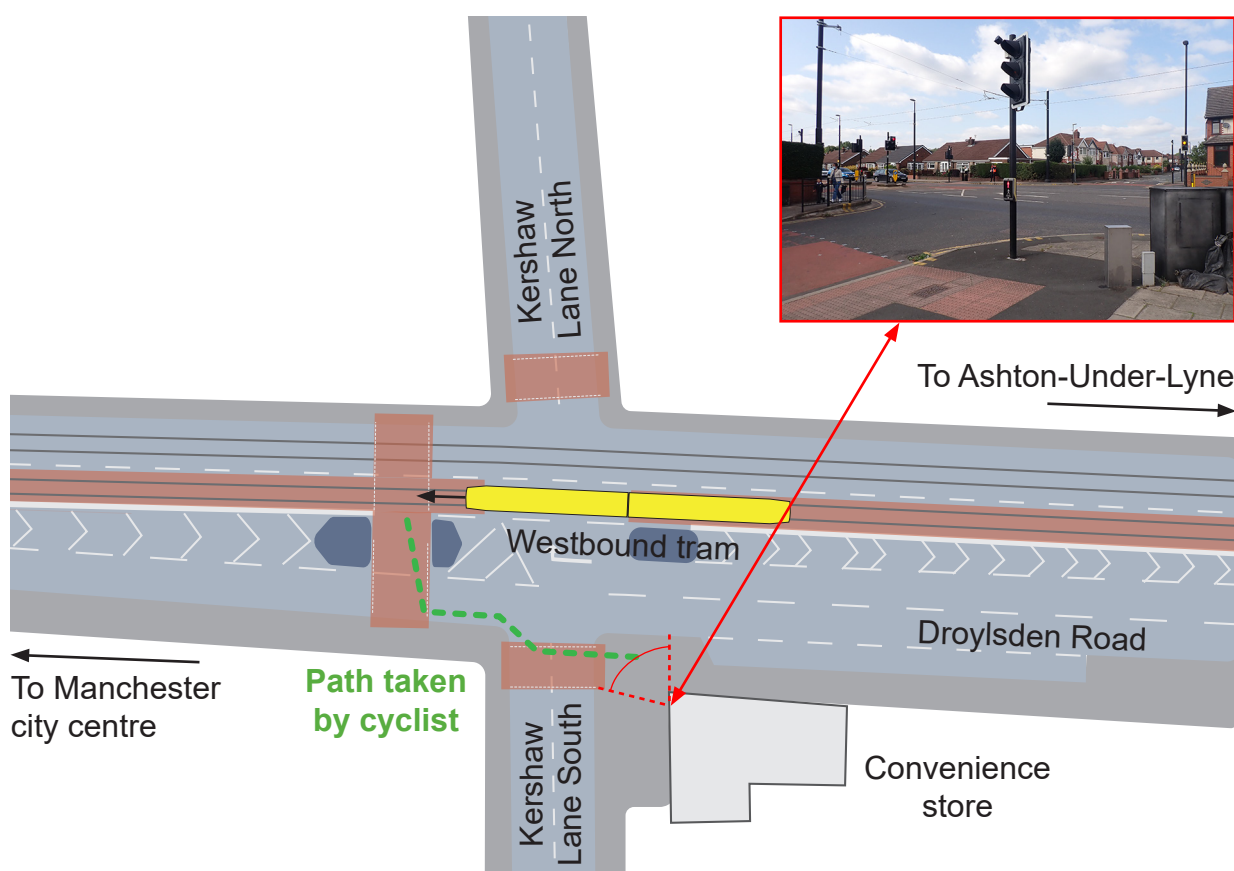
- 29 After leaving the shop, the cyclist mounted his bicycle, crossed the southern leg of Kershaw Lane, and then moved around the road side of the pavement fencing (figure 5) at the south-west corner of the junction with Droylsden Road. The cyclist then crossed Droylsden Road as far as the mid-carriageway pedestrian refuge. CCTV shows that he arrived there at 19:25:31 hrs.

Figure 5: the crossing and the path taken by the cyclist to the mid-carriageway refuge

- 90 CCTV footage (paragraph 29) shows that the cyclist rode around the road-side of the pavement edge fencing at the south-west corner of the crossing and then to the mid-carriageway pedestrian refuge. The traffic signals controlling traffic on Droylsden Road were green when he did this, and traffic was flowing in both directions. The cyclist did not approach or interact with the Puffin crossing demand buttons on the south side of the crossing.

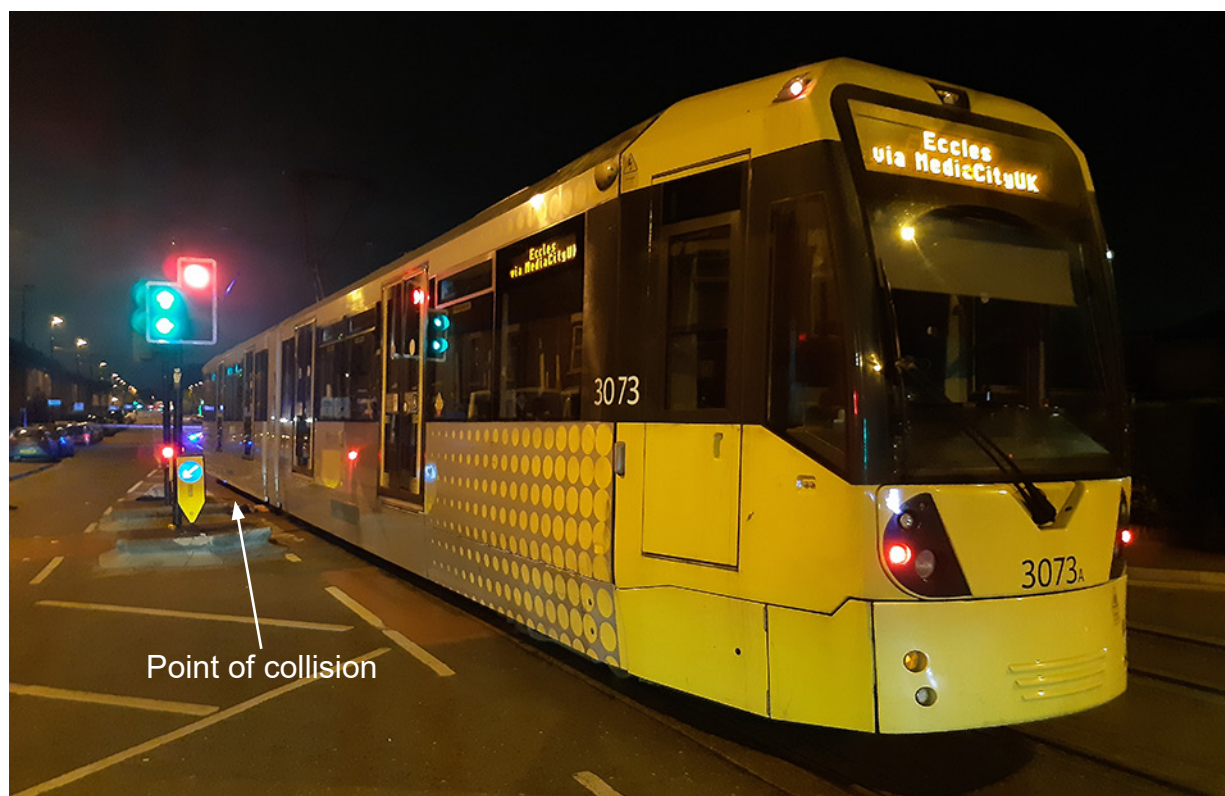
Figure 6: The tram, stopped after the accident. The point of the collision is indicated

- 33 The cyclist was knocked from his bicycle and fell partly under the left-hand side of the tram. He was found alongside the tram, with his legs in the vicinity of the tram's centre bogie, which was in line with the pedestrian refuge by the time the tram came to a stop. There was no evidence that the cyclist interacted with the tram's underrun protector, which is located immediately in front of the leading wheels of the tram. This indicates that the cyclist fell to the left of the tram's bogies and wheels.

- 34 It is possible that the high containment kerb (figures 4 and 6) around the pedestrian refuge may have deflected the cyclist towards the tram after the collision. Marks were found on the kerb after the accident showing evidence of contacts, but it cannot be determined exactly what effect the presence of the kerb had on the outcome of the collision.

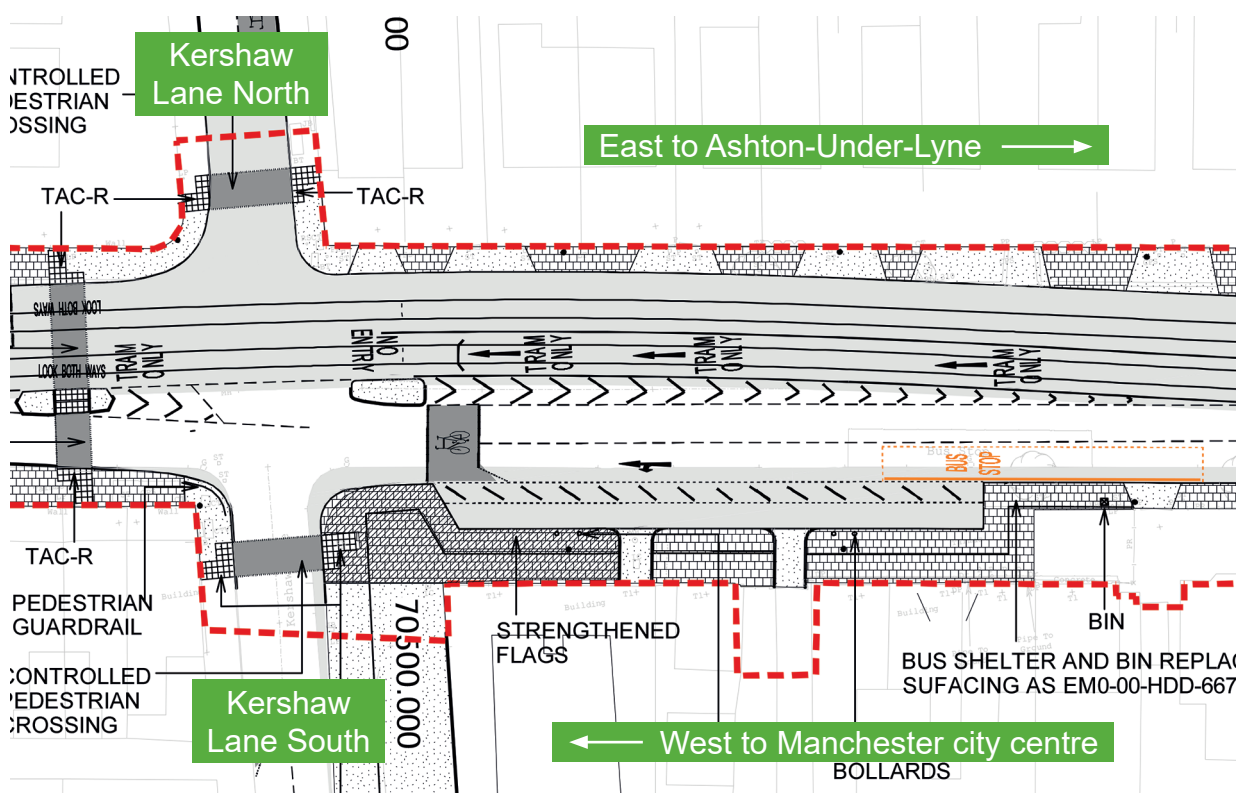
- 66 This initial design had the advantage of placing a controlled crossing at the location of the likely 'desire line' for pedestrians crossing to and from the convenience store and other businesses at the eastern side of the junction (paragraph 61). However, problems associated with the needs of property owners in the vicinity were encountered with the layout. For these reasons, this initial design was rejected. Design work then progressed with the intent of providing a controlled crossing (on Droylsden Road) solely across the western leg of the junction. By June 2010, MPT's detailed design had progressed to a point where it included the pedestrian refuge in its final position, to the south of both tram tracks. It was this configuration which was ultimately constructed, and which existed at the time of the accident (figure 12).

Figure 12: June 2010 design (courtesy of TfGM/MPT)

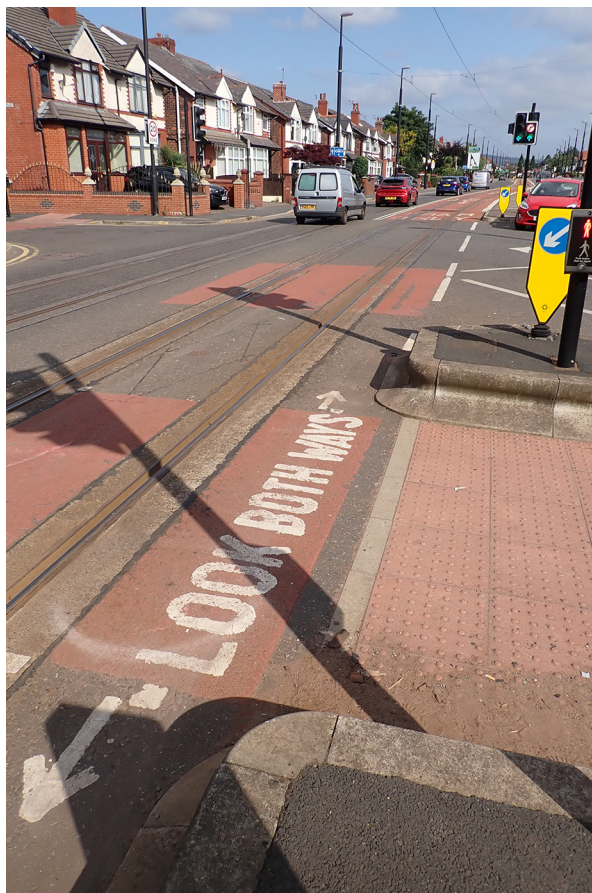
Figure 15: 'Look Both Ways' markings painted onto the road surface

The ‘look both ways’ markings were laid as recommended, and were found to be in place on the day of the accident (figure 15). However, the recommended markings to the south of the island were not in place. RAIB has been advised that these markings were never laid.

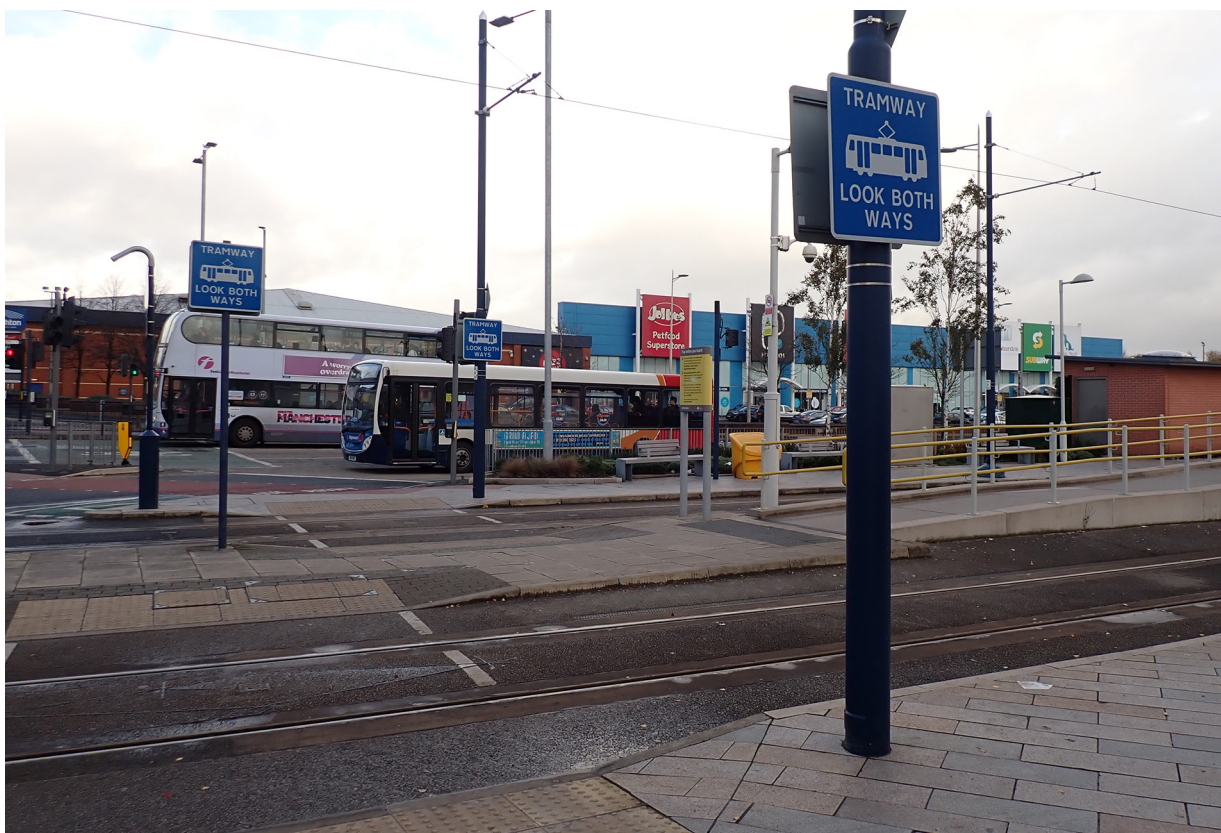
137 Section 10.3 of Chapter 3 of the TSM documents the 'Diagram 963.3' signage (figure 16). Neither TSRGD nor the TSM mandate the use of these signs at locations such as the site of the accident; they equally do not prohibit the use of such signage.

Figure 16: Diagram 963.3 signage in place elsewhere on the Metrolink network

138 LRSSB advised RAIB that the use of such signs at a crossing on a tramway which is integrated with the road would be unusual; these signs are more commonly found to warn pedestrians of a tramway crossing where the tramway is segregated from a road. Tameside MBC advised RAIB that they would not have objected to the provision of such signage, but that they have a general duty to reduce the level of 'sign clutter' on roads. TfGM advised RAIB that diagram 963.3 signs are generally not used on sections of the Metrolink network where trams share road space with other users (as at the location of the accident).
