Serious Incident

Aircraft Type and Registration:	Ikarus C42 FB80 Bravo, G-CICF	
No & Type of Engines:	1 Rotax 912-UL piston engine	
Year of Manufacture:	2013 (Serial no: 1305-7260)	
Date & Time (UTC):	8 December 2022 at 1150 hrs	
Location:	Headcorn Aerodrome, Kent	
Type of Flight:	Private	
Persons on Board:	Crew – 1	Passengers – 1
Injuries:	Crew – None	Passengers – None
Nature of Damage:	Aircraft main battery destroyed, and thermal damage to cockpit floor	
Commander's Licence:	National Private Pilot's Licence	
Commander's Age:	57 years	
Commander's Flying Experience:	107 hours (of which 101 were on type) Last 90 days – 0 hours Last 28 days – 0 hours	
Information Source:	AAIB Field Investigation

Synopsis

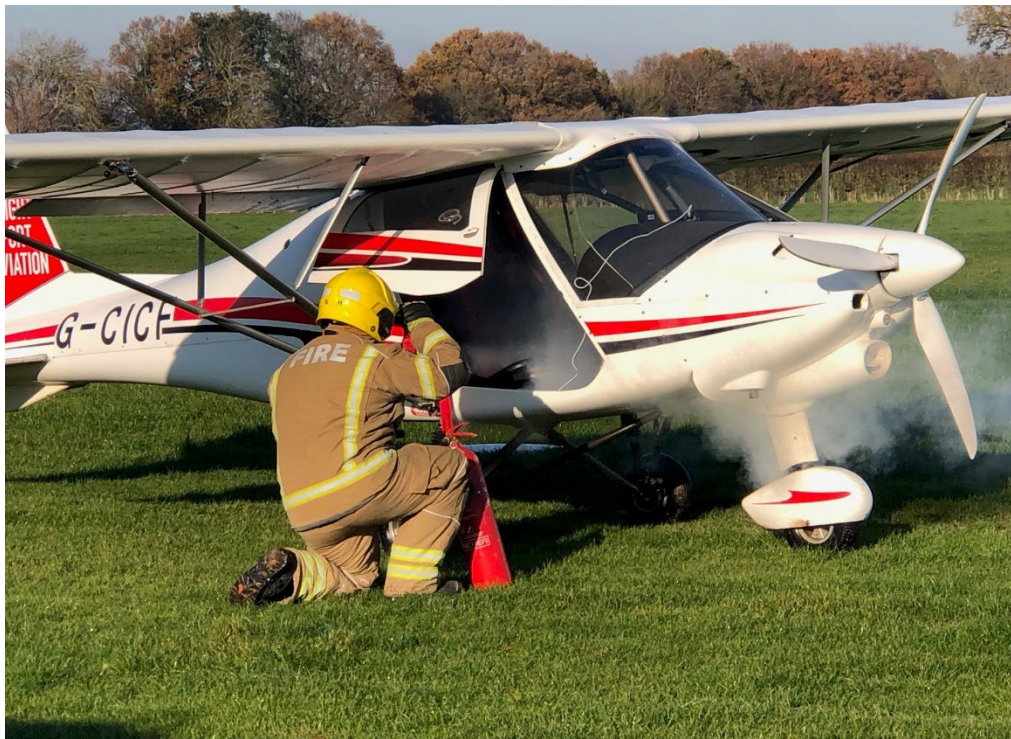
Figure 1

The aircraft landed downwind and rolled to a stop. The pilot shut the engine down and both occupants then promptly left the aircraft. The airfield RFFS arrived at the aircraft and, having been briefed by the pilot that the main battery had caught fire, discharged two CO₂ extinguishers onto the battery, which was still burning (Figure 1). They then removed the burnt battery pack from the aircraft.

RFFS discharging a CO₂ extinguisher onto G-CICF's battery

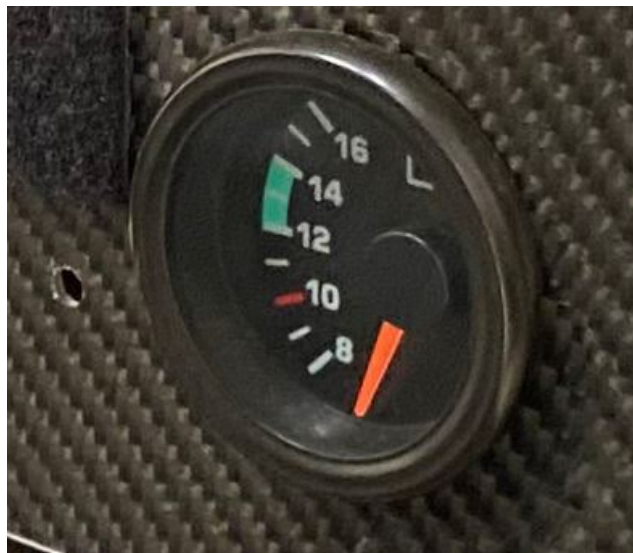
Figure 2

Voltmeter fitted to G-CICF, showing green band marking between 12.0 and 14.0 V

The lithium-ion main battery in G-CICF was installed in accordance with the requirements of BMAA Minor Modification TIL 117, with the exception that the instrument panel voltmeter was not marked with the maximum charging voltage for the new battery. The battery offered a weight saving and higher capacity than the lead-acid battery it replaced.

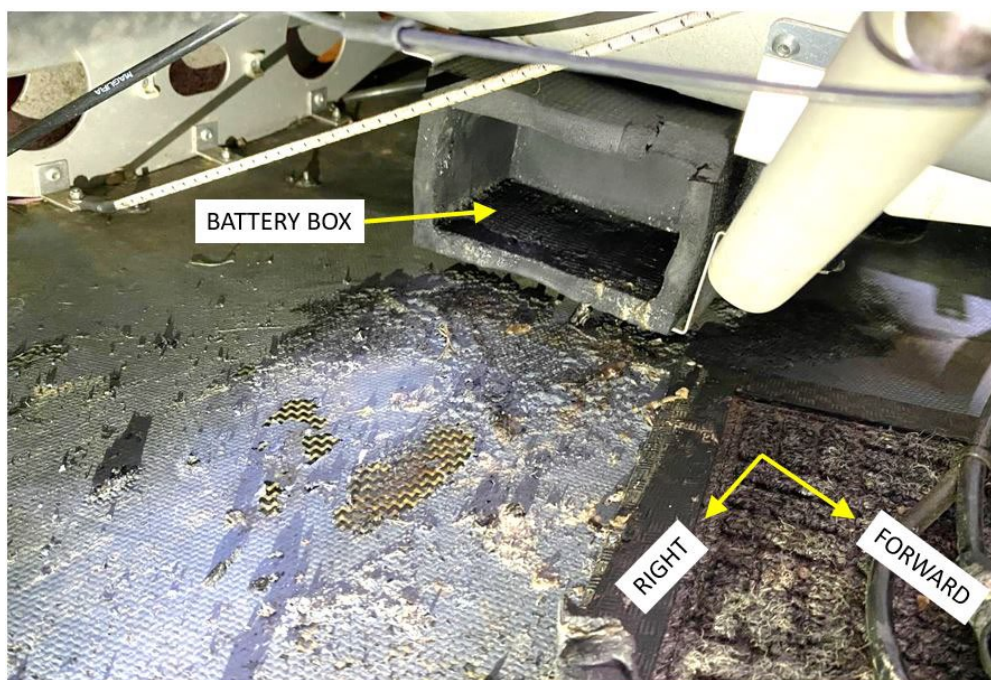
Figure 3

The damage to the aircraft was limited to charring and scorching of the composite cabin floor around the battery box (Figure 3).

Damage to the cabin floor caused by the battery fire

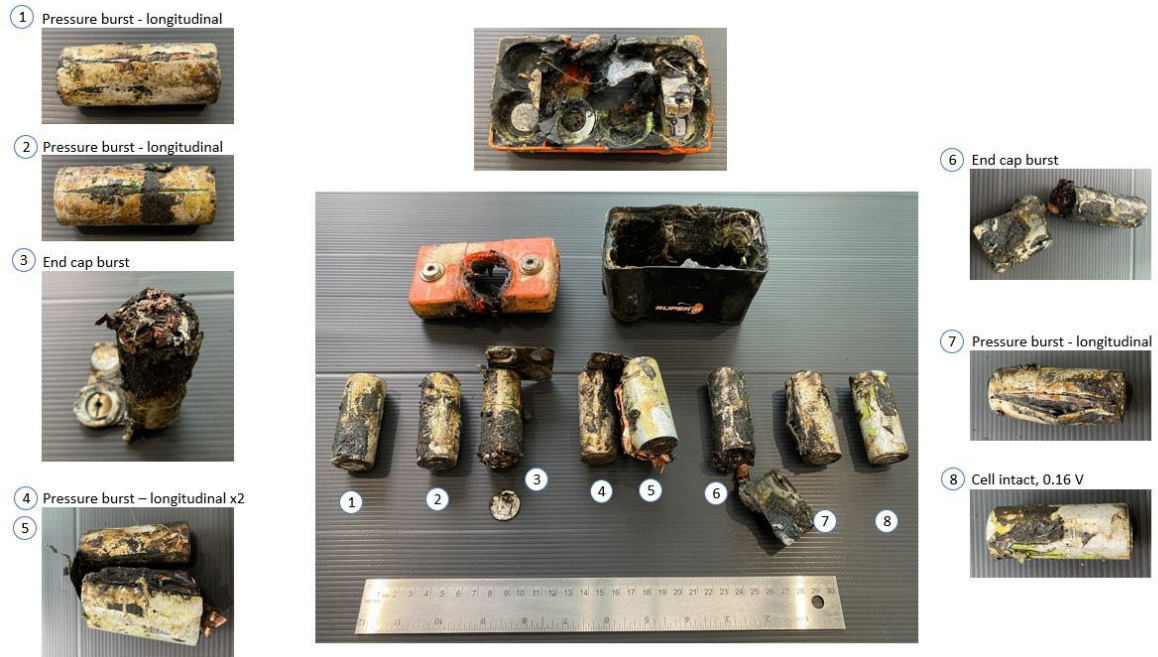
The battery's external plastic case had melted and was penetrated between the battery terminals, indicating that the final stage of the thermal runaway was located close to this position. Seven of the cells had burst, due to excessive internal pressure, and one cell was intact and still retained a low voltage level of 0.16 V. The manufacturer stated that it was not possible to identify a cause for the battery thermal runaway due to the damaged state of the battery parts.

Figure 4
Damaged parts of the battery

The cause of the battery fire was not identified due to heat damage to the battery's component parts. The centre of the battery pack, between the terminals, showed the greatest heat damage and it is likely that one of the cells in the centre of the pack was the origin of the thermal runaway.

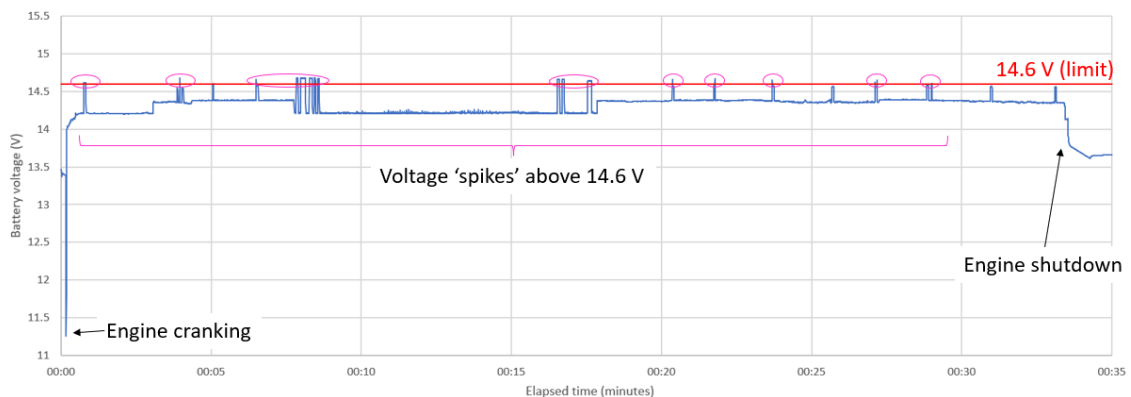
Figure 5
Battery voltage recorded during G-CICF test flight

The recorded data showed that the battery charging voltage varied during the flight, mostly between 14.2 and 14.4 V, but with numerous voltage 'spikes' up to 14.7 V, which was marginally in excess of the 14.6 V maximum permitted charging voltage specified by the battery manufacturer. The duration of the voltage 'spikes' was generally less than four seconds and were not noticeable on the analogue voltmeter fitted to the instrument panel.

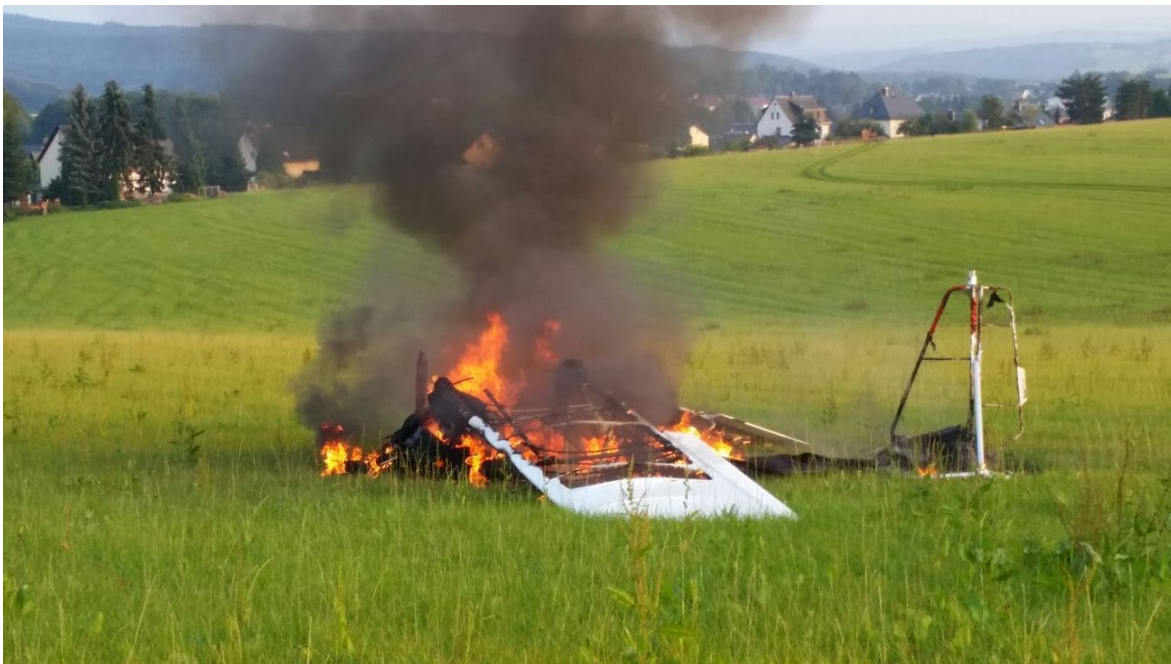
Figure 6

The AAIB is aware of a second Ikarus C42 lithium-ion battery fire that occurred in Germany. This aircraft was fitted with the same model of battery as G-CICF and was also not equipped with an OVP device in the battery charging circuit. The aircraft was being flown solo when a battery fire occurred in flight. The pilot made a forced landing in a field and was not injured. The fire continued after the aircraft landed, eventually destroying the aircraft (Figure 6).

Ikarus C42 lithium-ion battery fire in Germany (image courtesy of manufacturer)
