On 3 September 2020, the paddle steamer *Waverley* made heavy contact with the eastern pier at Brodick, Isle of Arran, Scotland while attempting to berth following a 2-hour afternoon excursion along the Isle of Arran coast. Twenty-one of the 186 passengers and three of the 27 crew on board sustained injuries because of the impact and *Waverley* suffered damage to its bow above the waterline.

1.1 PARTICULARS OF WAVERLEY AND ACCIDENT

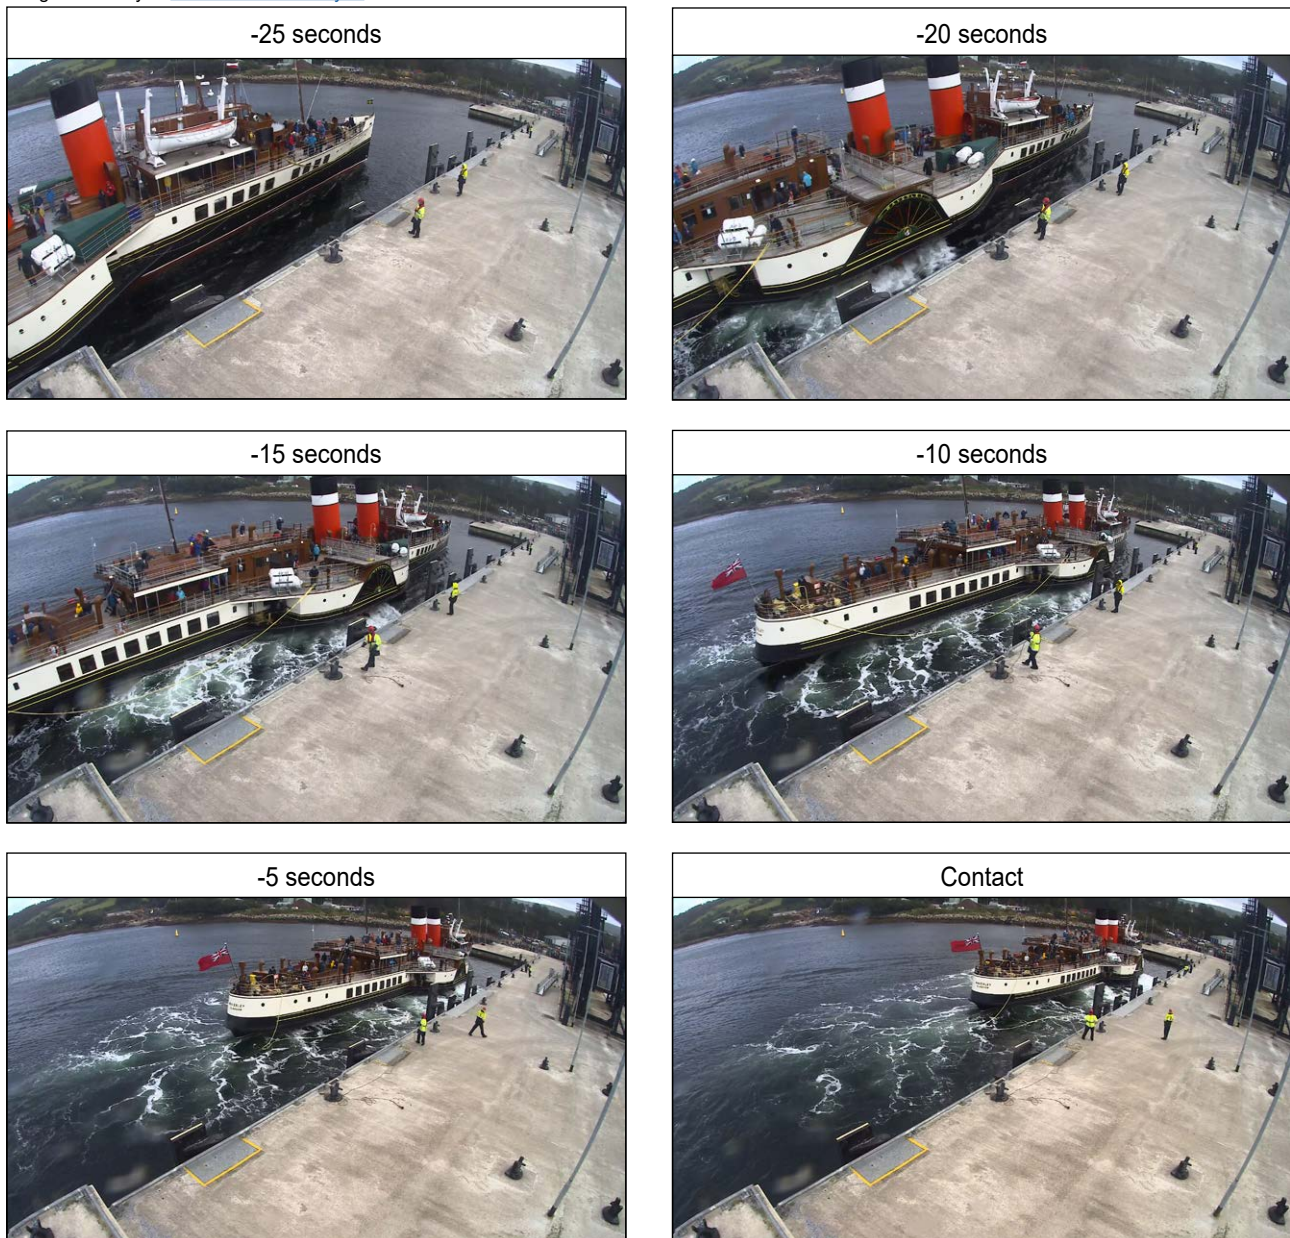
Figure 5: CCTV stills showing *Waverley* moving down the pier before making contact with the pier structure at 1646 on 3 September 2020

During the approach to the berth, the vessel's bridge team ordered astern propulsion on the engine to slow the vessel as it approached the closed end of the pier. As part of the process to achieve astern propulsion, the chief engineer stopped the engine, but it would not restart when the controls were moved to the astern position. By the time the chief engineer managed to resolve the problem and restart the engine to achieve astern propulsion it was too late to take effect; *Waverley* hit the concrete wall at the closed end of the pier at a speed of approximately 2.8 knots.

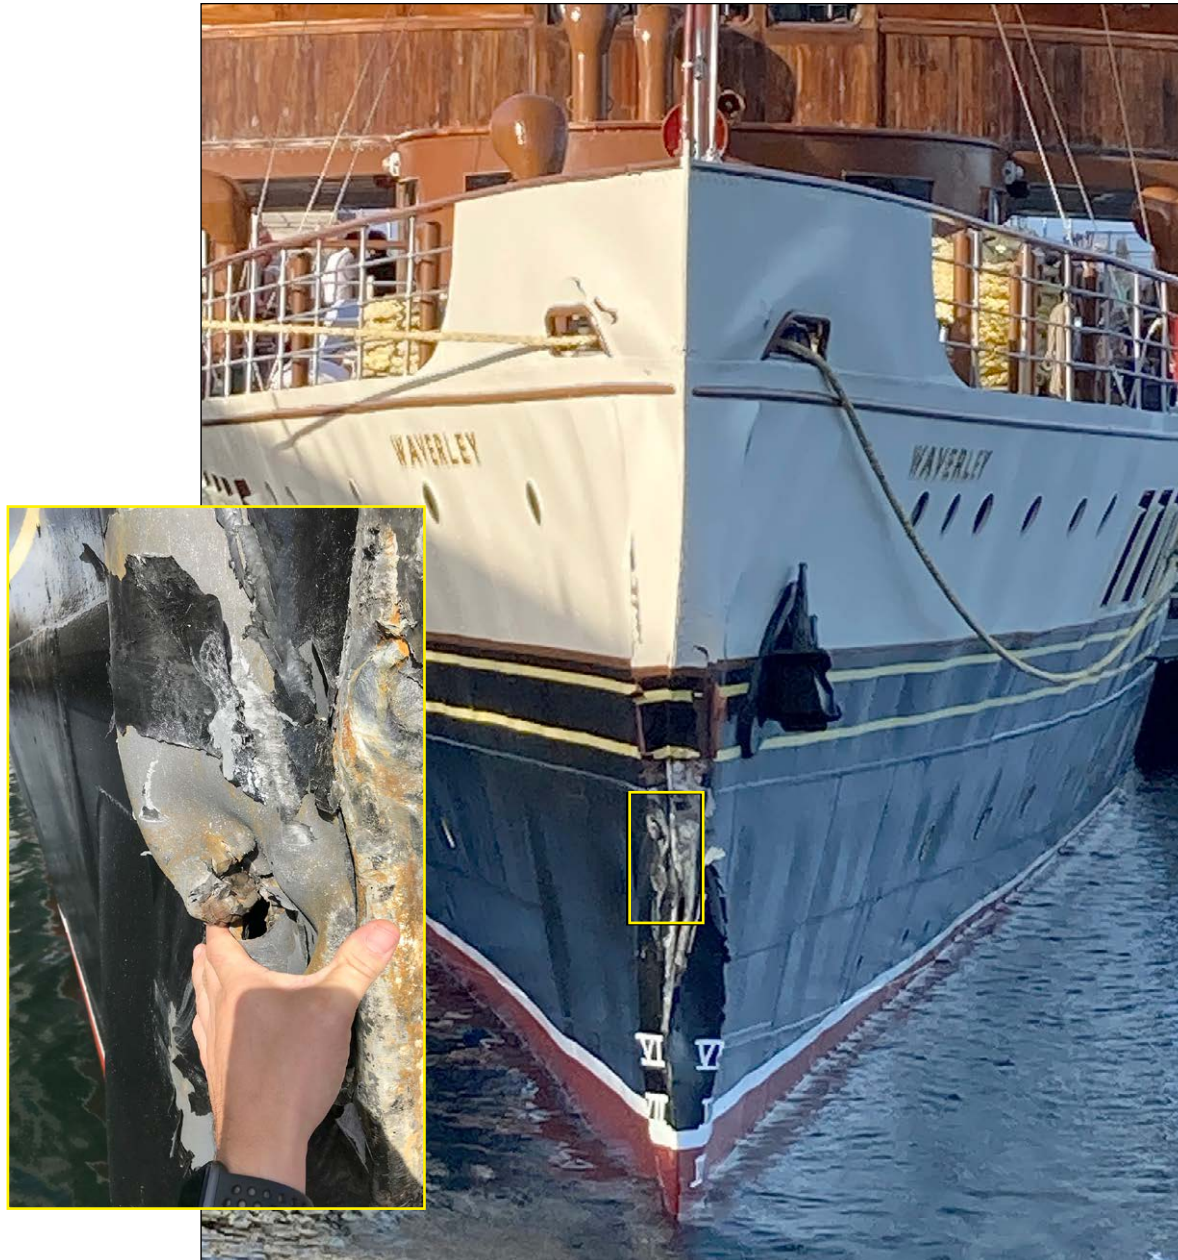
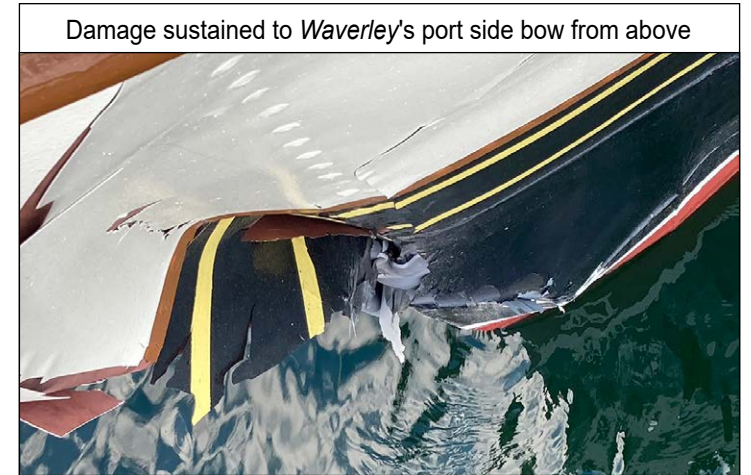
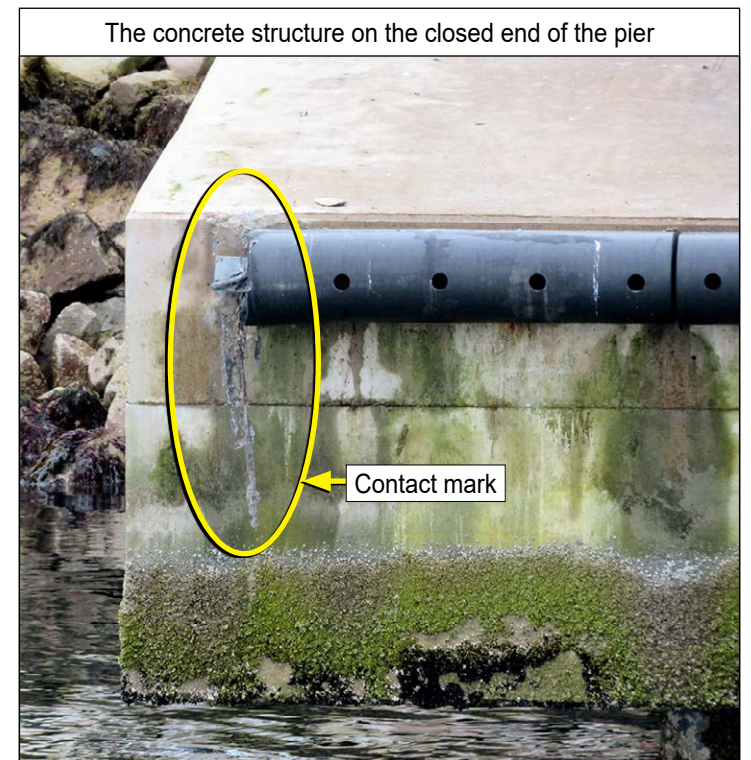
Figure 7: Damage sustained to the vessel's bow and the berth

Waverley remained at Brodick pier while temporary repairs were undertaken to the bow and approved by the Maritime and Coastguard Agency (MCA). On 9 September 2020, *Waverley* sailed from Brodick to Glasgow, Scotland for full repair to the bow and remained out of service for the remainder of the 2020 season. *Waverley* returned to service in June 2021, after the MCA had conducted a full assessment of the repairs and directed a set of sea trials.

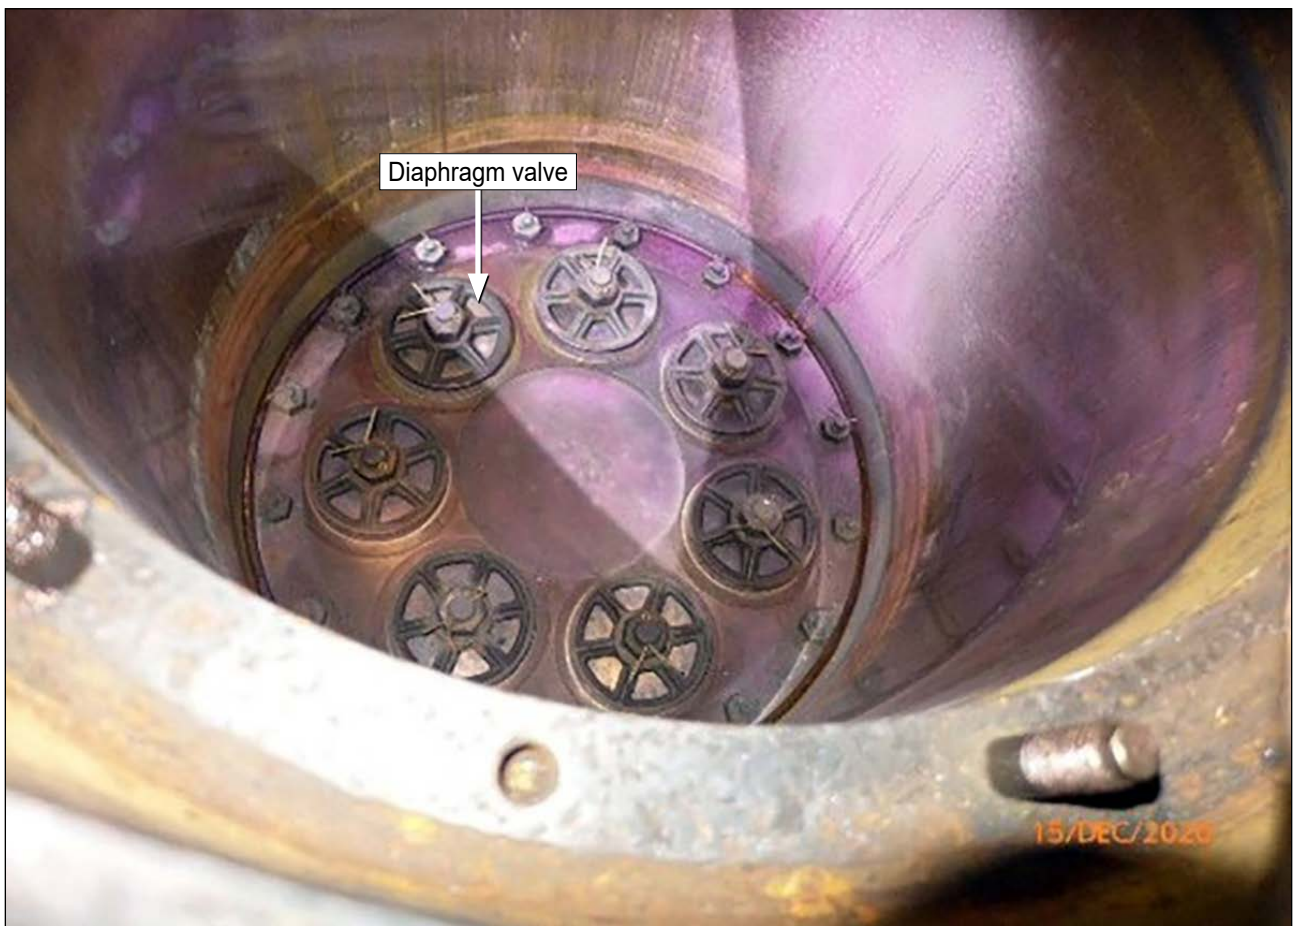
Figure 12: Vacuum pump diaphragm valves

- Three of the condenser vacuum pump's 36 diaphragm valves (**Figure 12**) were blocked. This resulted in a vacuum of 796 millibar (mb) rather than 846mb, which reduced the engine's efficiency.
- The locking nuts that secured the HP piston valve to its piston rod were loose (**Figure 13**). The washers in use were not an original design and had probably been introduced to reduce the gap between the end nut and the split pin. The fabricated nature of the washers made tightening the nuts difficult. The loose nuts extended the piston valve's travel by 5.4%, causing the piston valve to open or close prematurely and impacting the engine's timing.

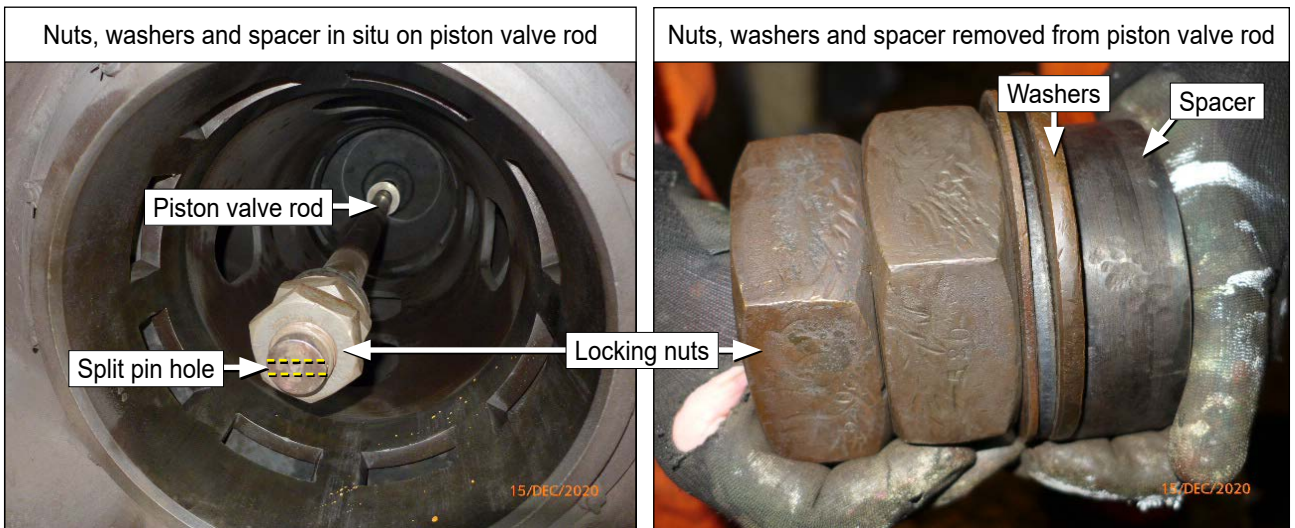
Figure 13: Piston valve rod locking nuts and washers

- The engine was slow to restart due to a steam lock at top dead centre because of an incorrectly secured piston valve, which advanced engine timing and resulted in excessive steam entering the cylinder ahead of top dead centre.

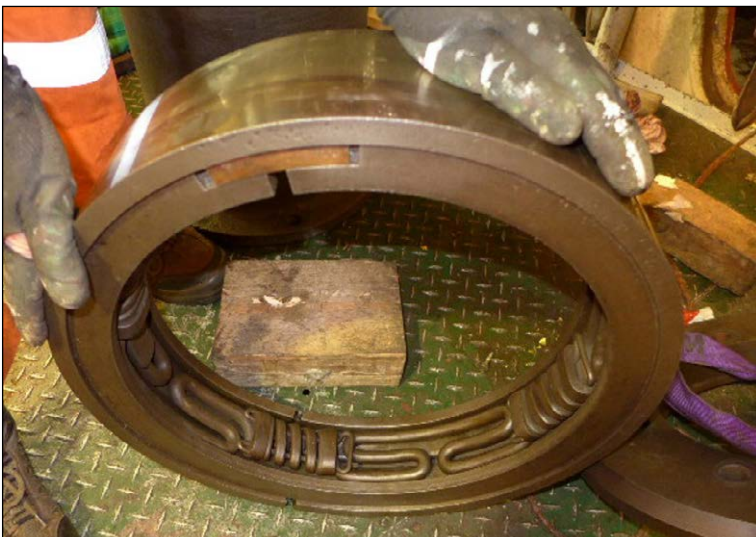
Figure 14: Piston valve ring

During the 2015 winter engine overhaul period, *Waverley's* crew had found that the HP piston valve rings (**Figure 14**) were worn and required replacement. New rings were fabricated and installed but these failed after approximately one week as they had been manufactured using an incorrect material. The original piston valve rings were subsequently reinstalled while the correct material was identified and sourced. The original HP piston valve rings were still in place at the time of the accident.
