Rail Accident Report

**Track workers struck by a train at Margam,
Neath Port Talbot
3 July 2019**

Report 11/2020
November 2020

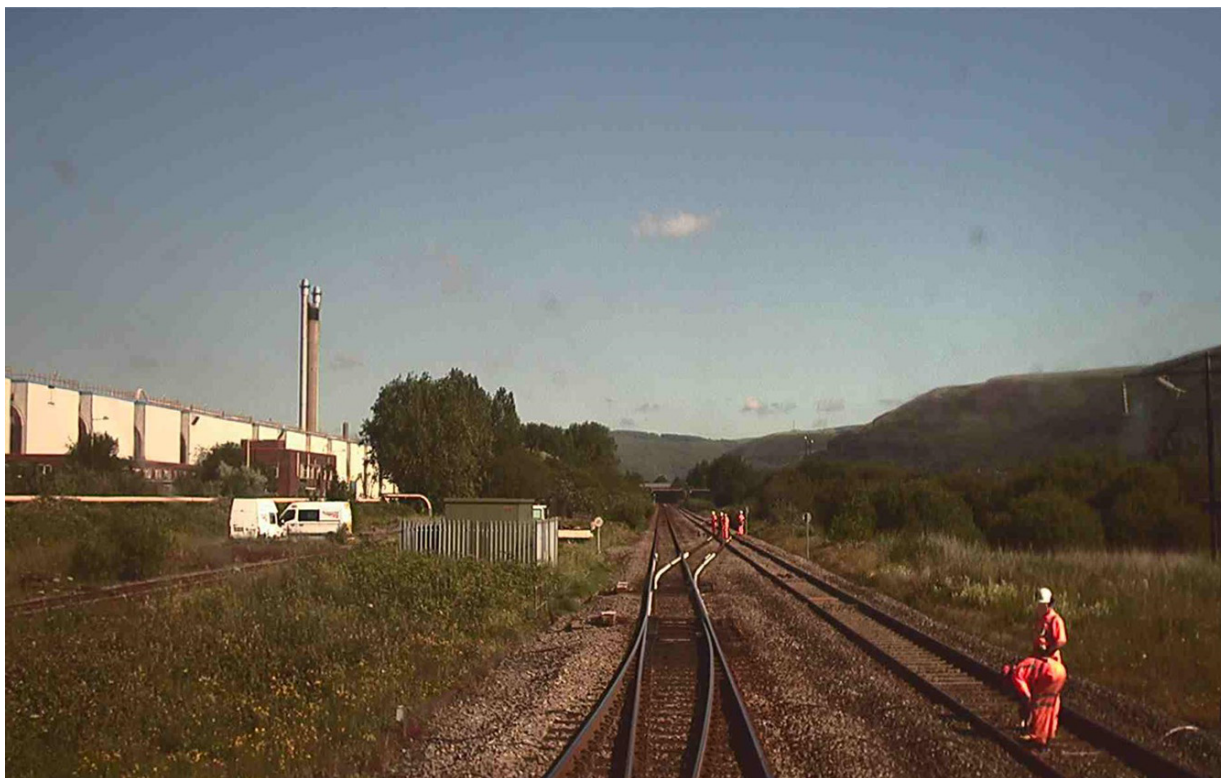
- 33 Around 08:50 hrs the six track workers split into two groups. One group, consisting of TW4 and TW6, started the additional task on the IRJs on the down main, up main and down relief crossover lines. The other group, consisting of TW1, TW2, TW3 and TW5, went to work on 9577B points (figure 3). TW5 stood clear of the line and acted as site lookout, with one of the others watching him and acting as *touch lookout* for the person with the power tool. During this period the two groups were around 100 metres apart, with TW4 and TW6 being the Cardiff side of 9577B points. TW4 and TW6 took it in turns to work while the other observed the nominated lookout TW5, who was with the other group at the points, for warning of approaching trains on the up main line.

Figure 3: Forward-facing CCTV image looking towards Port Talbot from a train on the down main line at approximately 09:24 hrs, showing the two groups working on the open up main line approximately 100 metres apart

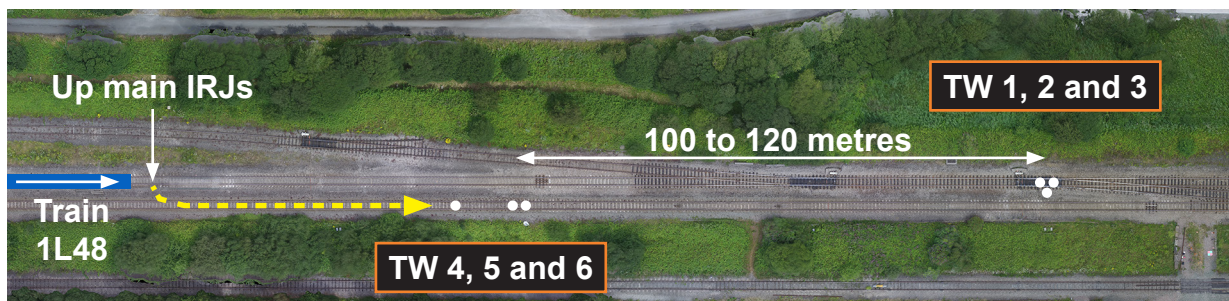
- 38 When they had completed their work on the IRJs, they crossed from the up main line to the down main line and walked back along the down main line towards the access point. They were walking facing the direction of traffic on that line, and therefore had no need to look out for trains approaching from behind them on the other line. Train 1L48 approached from behind them on the up main line travelling towards Cardiff. At this time they could see the other three track workers about 100 to 120 metres ahead, and they have stated that they were surprised to see them working on 9577B points on the up main line with a train so close (figures 4 and 5).

Figure 4: Position of workers immediately before the accident

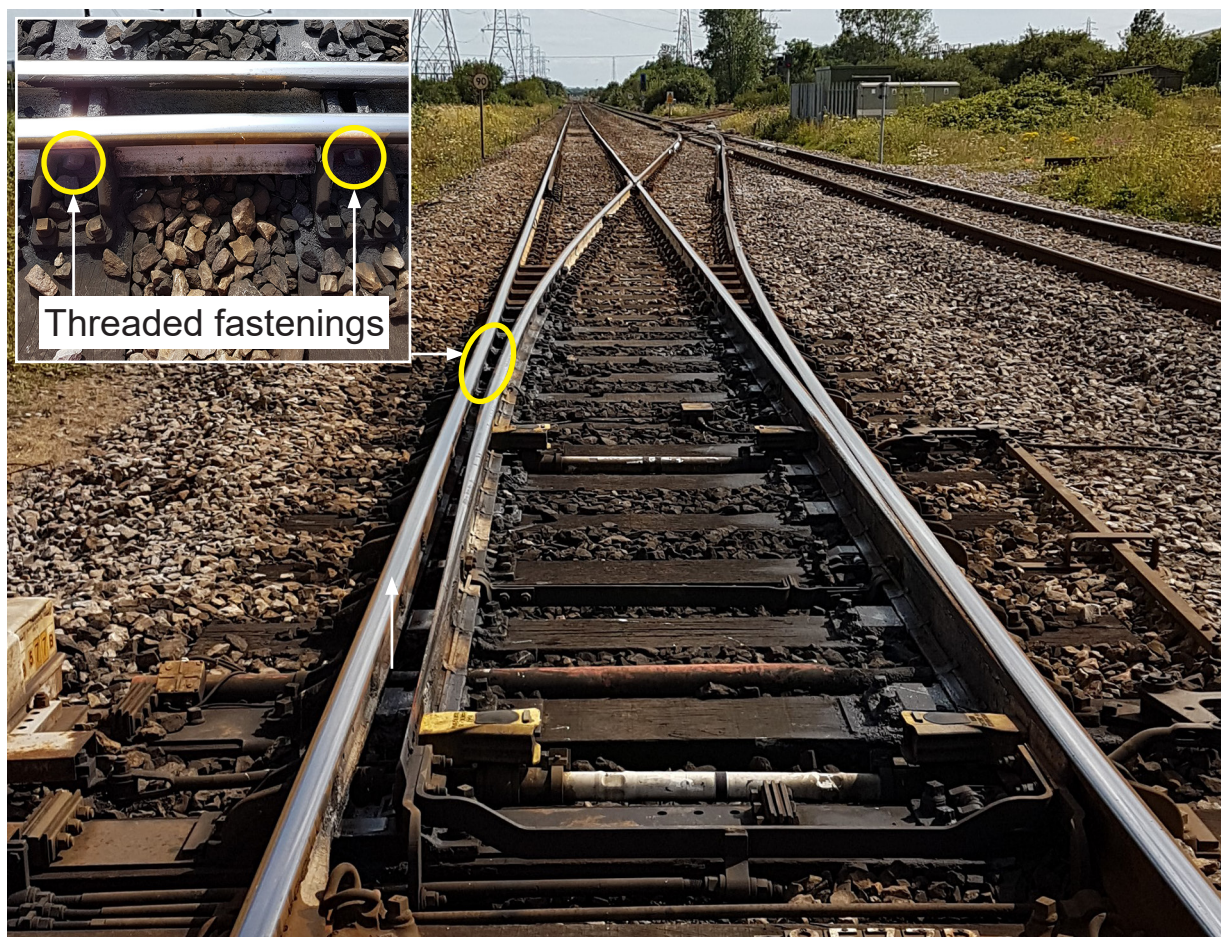
³ Insulated rail joints are used to separate sections of rail from each other electrically, for signalling purposes. Rail wear, damage and contamination can lead to the insulation becoming ineffective. This can usually be rectified relatively easily by maintenance staff.

Figure 7: Switch slide baseplate and distance blocks

- 84 There are no Network Rail track engineering standards, track work instructions or other guidance notes which require the loosening, lubricating and retightening of these fastenings (figure 7) as a scheduled maintenance activity. Network Rail's professional head of track was unable to think of any reason why this should be carried out as a scheduled task, and other engineers whom RAIB has consulted agree.

- 86 Many of the depot staff, due to their long service on the railway, would be familiar with the maintenance of older designs of S&C. These required greater maintenance attention than the more modern types, such as 9577B points. The component parts on older designs, including the rails, were often replaced individually, but the practice with the more modern types is to replace complete sub-assemblies. It was noted that some of the depot managers, also with a long service on the railway and with responsibilities for checking the technical quality of work, viewed the practice of loosening, lubricating and retightening threaded fasteners as normal.

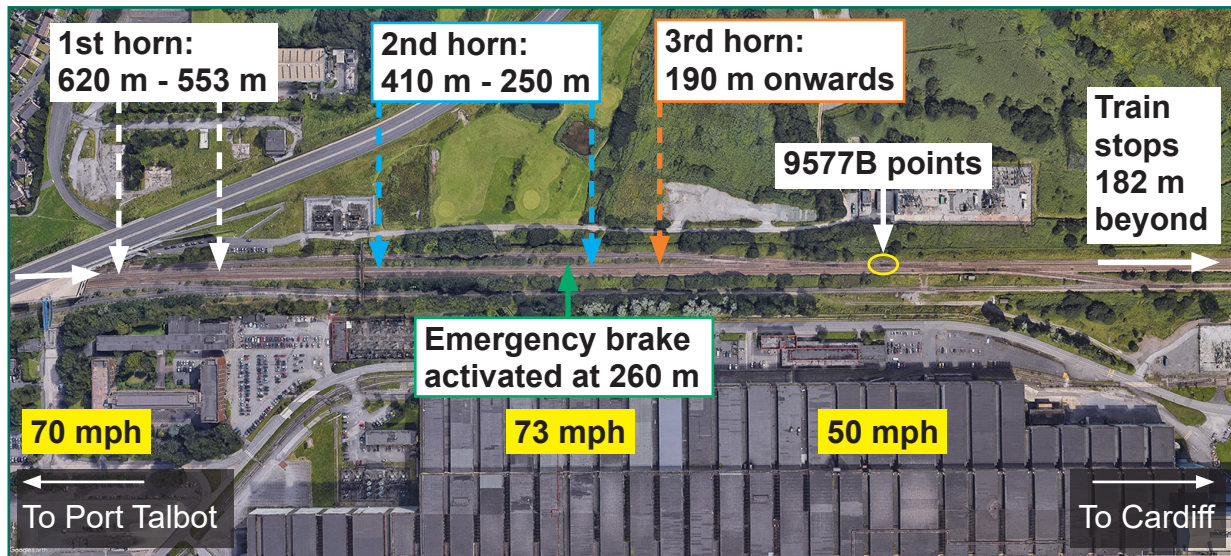
- 148 The train's data recorder shows that the driver sounded the train's warning horn three times on the approach to the group working on 9577B points (paragraph 40, figure 8). The driver sounded these repeated warnings, and applied the emergency brake during the second of them, because he saw no response from the group of three to the initial warning.

Figure 8: Driver actions and train speeds on the approach to 9577B points

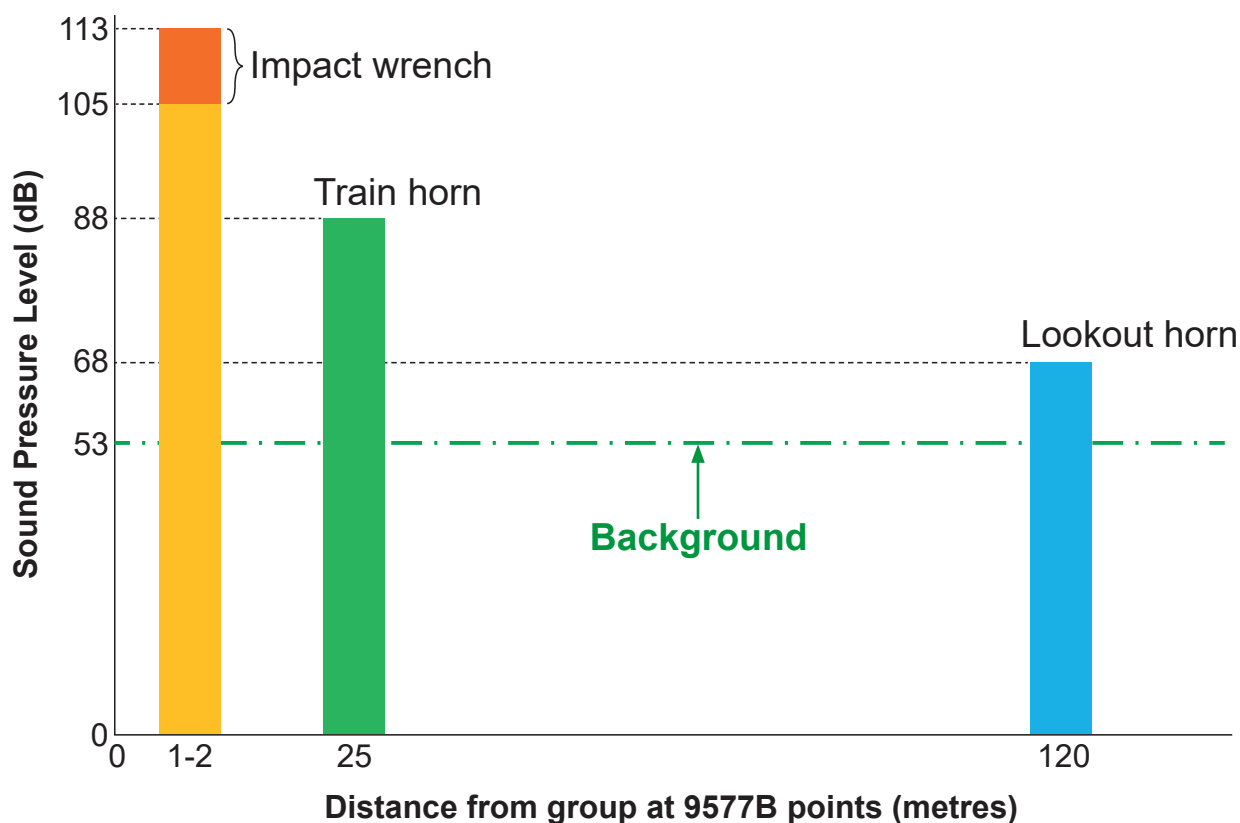
151 Measurements undertaken by RAIB of the sound pressure levels¹¹ from the impact wrench (measured in similar conditions to those at the time of the accident, but on a different day) showed that at distances of between 1 and 2 metres it produced a sound pressure level between 105 and 113 dB(C)¹² (figure 9). This was greater than the sound pressure level of the low tone warning from the approaching train horn (paragraph 40), which was measured as 88 dB(C) at 25 metres, the approximate distance the train was from the group around one second before it reached them. The sound pressure level of the lookout's warning horn was measured as 68 dB(A)¹³ at a distance of 120 metres, which is the approximate distance that the lookout was from the three track workers at the points.

Figure 9: Comparative sound pressure levels of different sources at distances relative to the group working at 9577B points
