Rail Accident Report

Collision and derailment at Neville Hill 13 November 2019

Report 13/2020
November 2020

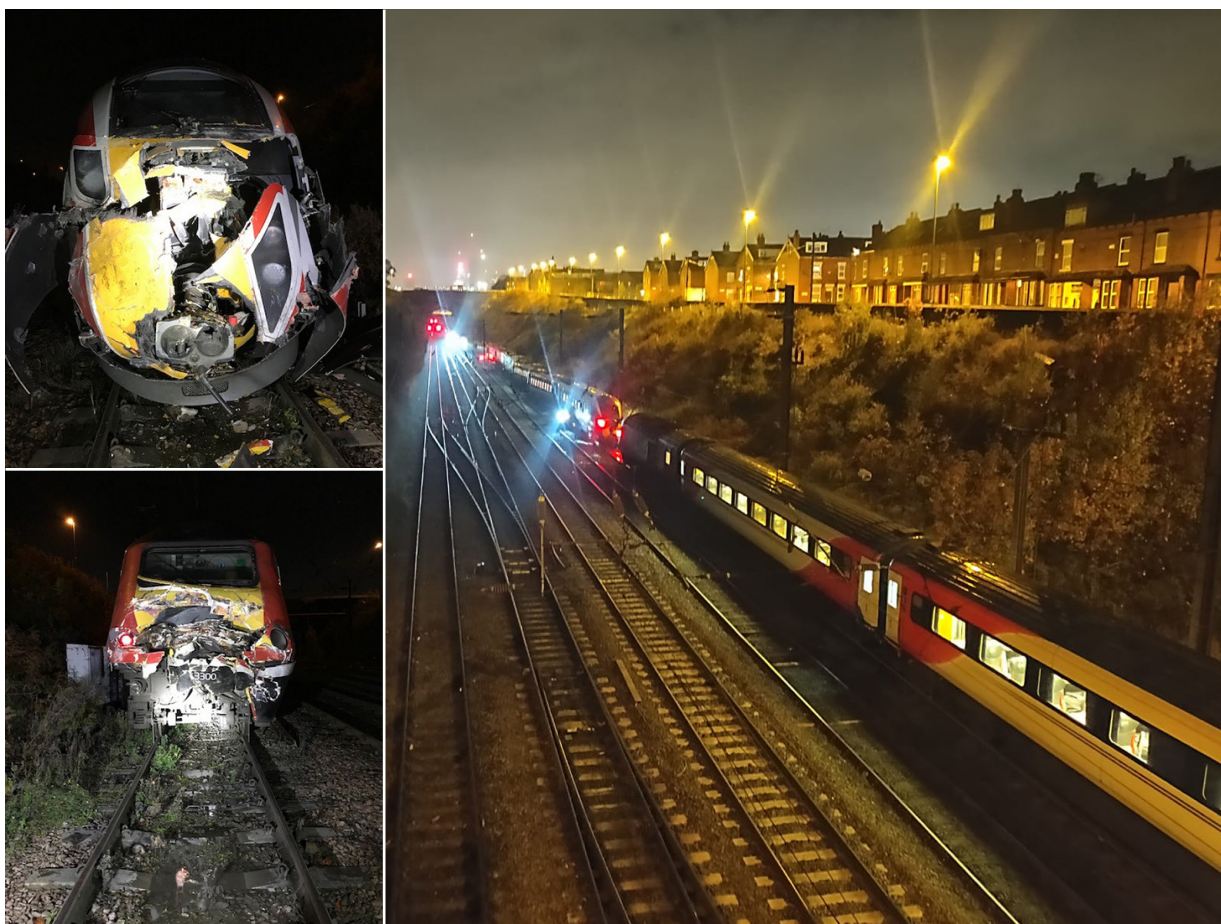
- 5 The colliding train was a 9-coach class 800 set, part of the Intercity Express Programme, operated by London North Eastern Railway (LNER). Its leading end suffered significant damage during the collision (figure 2). The second train was a High Speed Train (HST) set comprising 9 coaches and a class 43 locomotive at each end. It was also operated by LNER. The trailing class 43 locomotive also suffered significant damage (figure 2).

Figure 2: The class 800 train (top) and HST set (bottom) involved in the accident and the crash scene to the right (images courtesy of Network Rail)

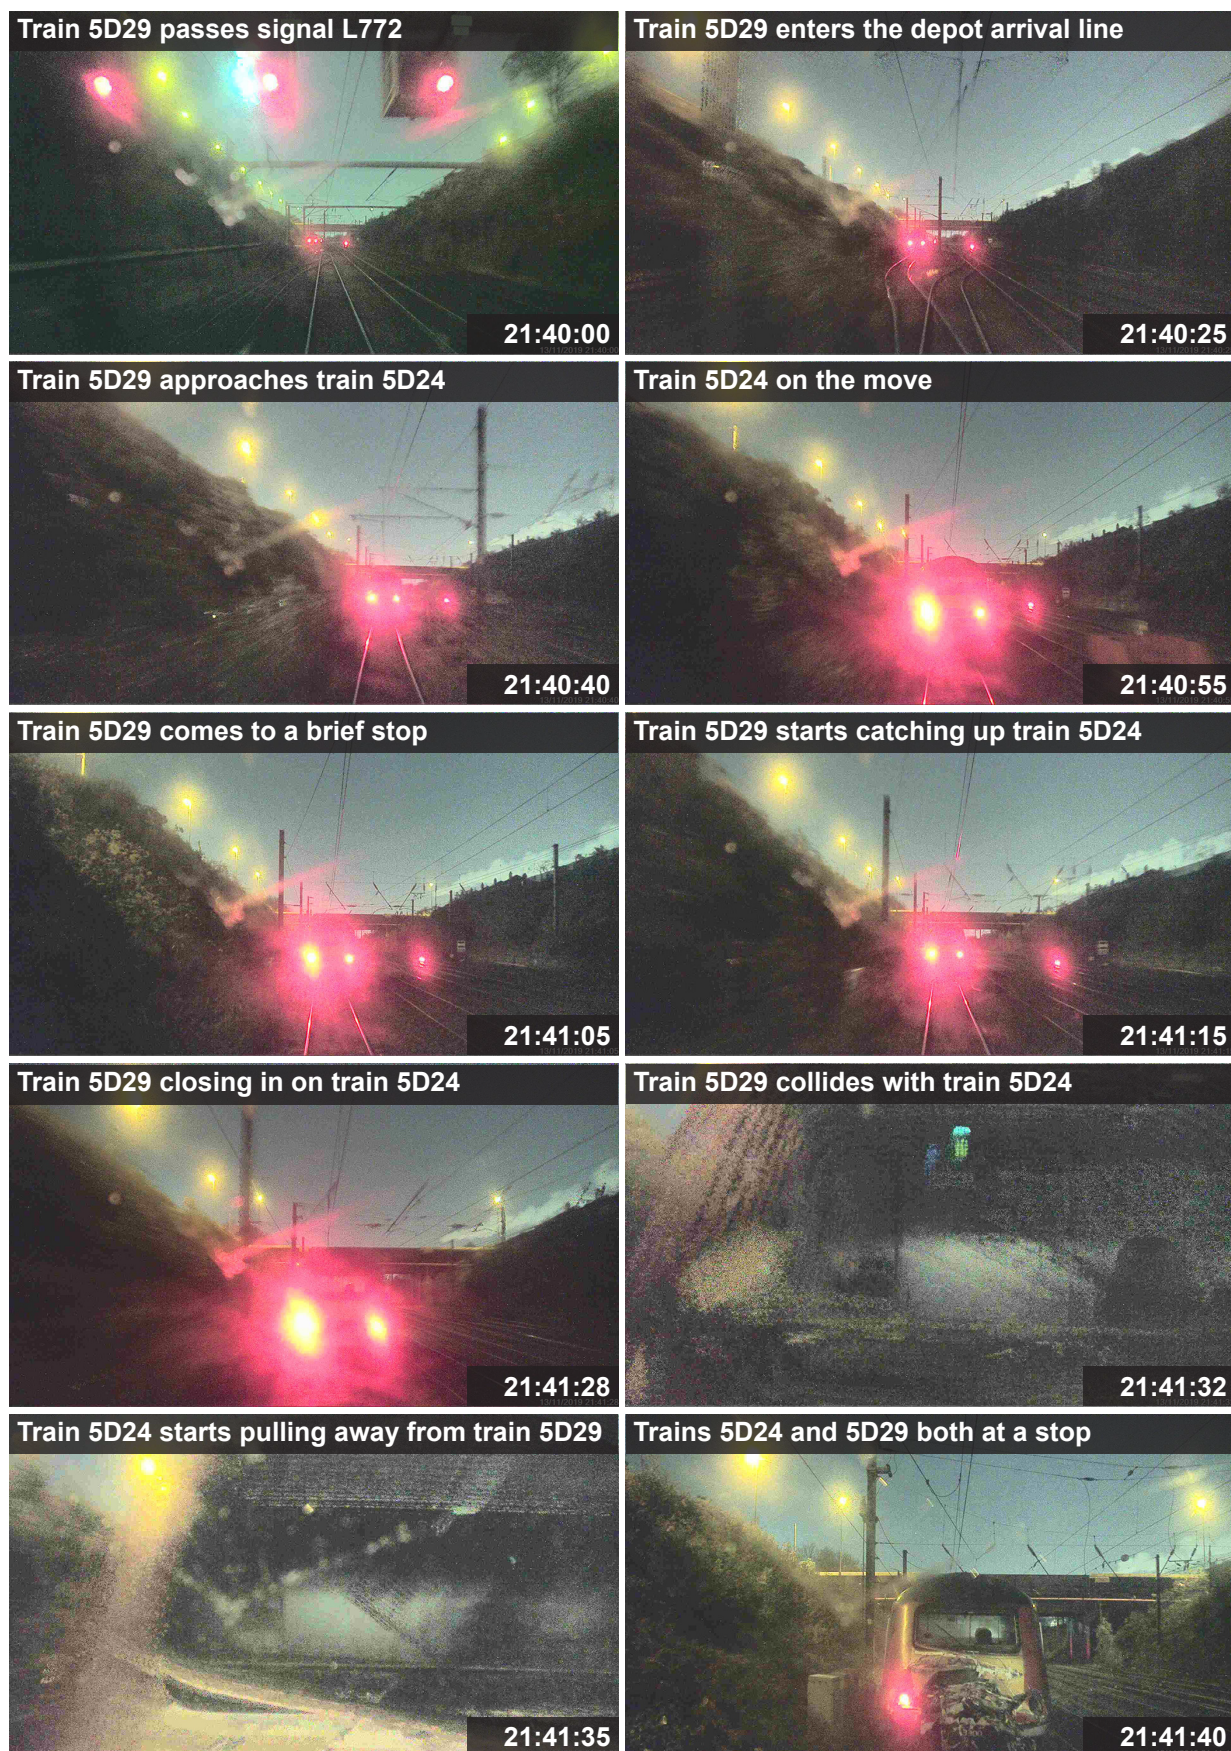
Figure 5: FFCCTV footage from unit 800109

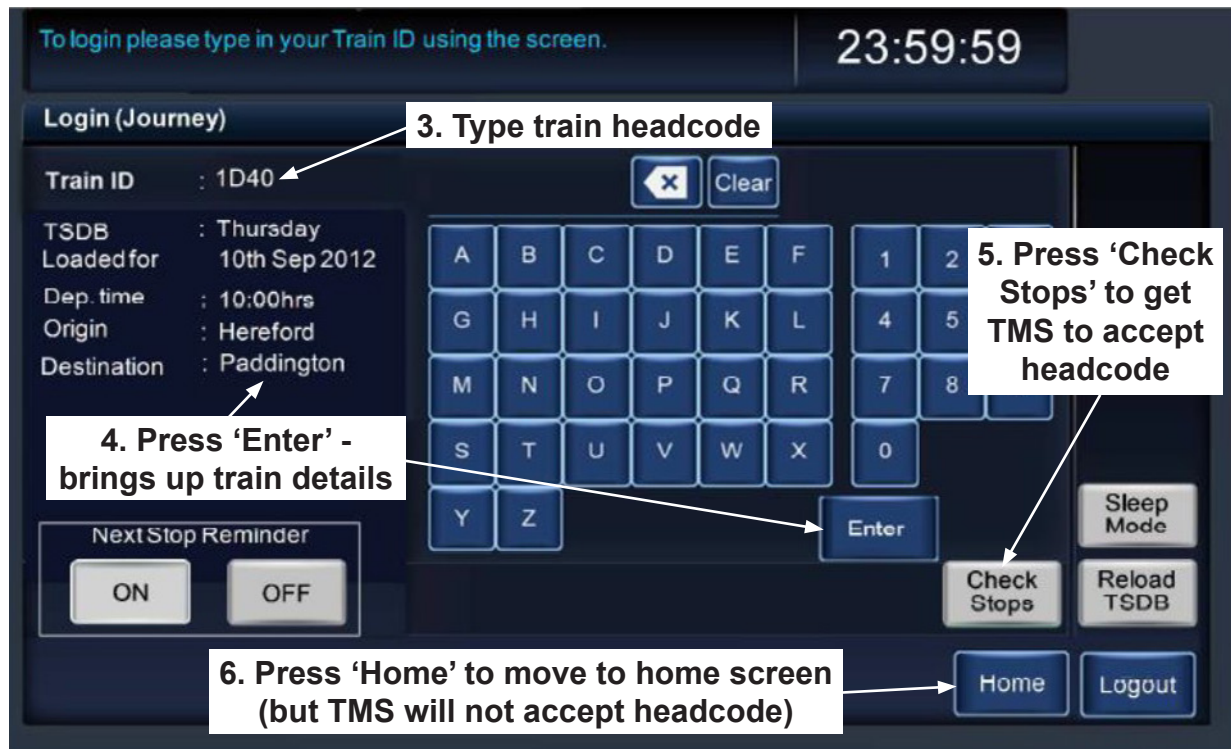
- 65 When satisfied that the correct headcode has been entered, a driver has the choice between two buttons to take the TMS to the home screen, which is the default screen during a journey. The HOME button takes the TMS to the home screen but does not cause the TMS to accept the entered headcode. The CHECK STOPS button takes the TMS to a screen where the driver can check the stops for the intended journey, before reaching the home screen. It is the pressing of this CHECK STOPS button which causes the TMS to accept the entered headcode.

Figure 7: TMS headcode screen

- 66 LNER trained its drivers that pressing CHECK STOPS would allow a driver to check the station stops for the journey ahead. The driver operating instructions identified this as a step in the cab setup process. LNER also trained its drivers that pressing HOME on the headcode screen would take the TMS to the home screen with the headcode having been accepted. This was the method used by the driver on the night at Leeds station. LNER did not understand that CHECK STOPS had to be pressed for the headcode to be accepted.

LNER should review, and make any necessary changes to, its procedures, training, and associated materials and aids (including the TMS app and simulator) to confirm that they prepare drivers to correctly interact with the TMS on its IETs. It should also review the TMS touch screen displays to make sure that they clearly reinforce the correct processes. In particular, these activities should include consideration of the method of entering a headcode and any issues raised by Recommendation 1 (paragraph 141.2.a).i).

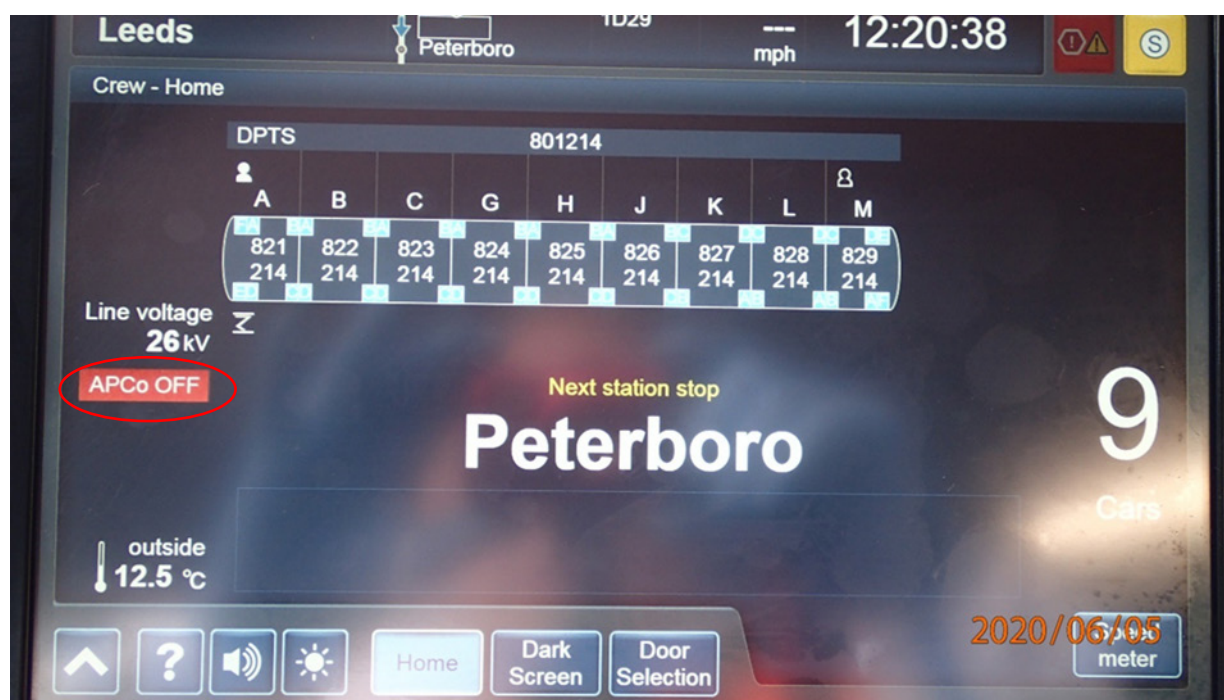
- 75 However, at the start of November 2019, the TMS software was updated to provide an indication of an APCO isolation on the home screen (figure 8). As part of the update, a driver also received a warning that APCO was isolated when starting a train using the master switch.

Figure 8: APCO isolation on TMS home screen

- 76 The driver was unaware of this new feature because he had not been briefed by LNER on the introduction of the software update. LNER and Hitachi have an engineering change process for managing and briefing such changes, which normally results in briefing updates being provided to drivers. However, in this instance, it appears that the importance of this information was lost in the vast array of changes introduced in this particular software update. It is possible that, if a more thorough description of the change had been included in Hitachi's engineering change pack, its relevance would have been more easily identified.

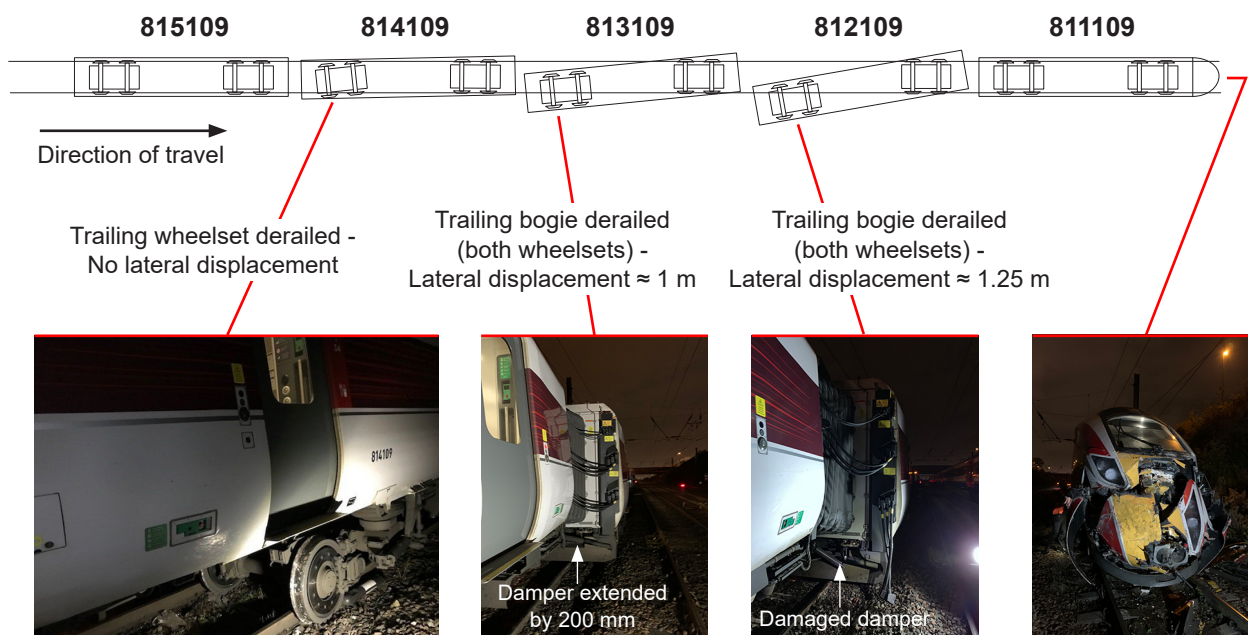
- 89 The trailing bogie of the second and third vehicles and the trailing wheelset of the fourth vehicle on the IET, derailed to the right in the direction of travel as a result of the collision. Figure 9 shows the lateral movement of the vehicles during the collision as witnessed by the marks left by the couplers on the vehicle structures. The extent of the derailment (up to 1.25 metre of lateral displacement on the second vehicle) would have been sufficient to significantly infringe the swept path of a vehicle travelling on an adjacent line, assuming a typical gap between adjacent running lines (known as the 'six-foot'), as shown in figure 10.

Figure 9: Schematic showing extent of derailment during collision (not to scale)

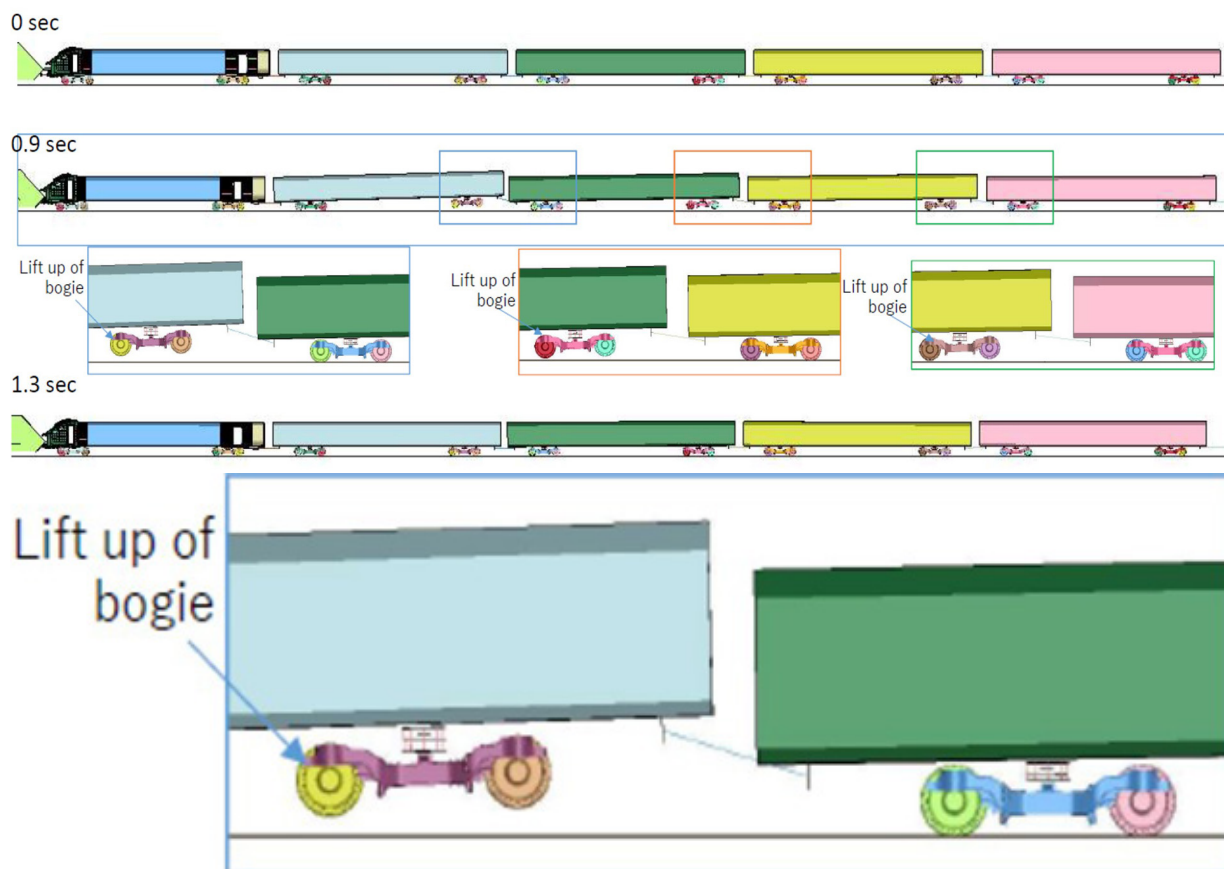
- 98 Figure 13 shows the results from the 3D simulation at the relative collision speed of 10 mph (16 km/h). The amount of deformation on the class 43 power car and at the leading end of the IET was checked to ensure that it was representative of what had been experienced during the accident. As shown on figure 13, the trailing bogies of vehicles 2, 3 and 4 on the IET were predicted in the simulation to lift up above the railhead during the collision.
- 99 Figure 14 shows the predicted lateral displacement on the first five vehicles. The trailing bogies of vehicles 2, 3 and 4 were predicted in the simulation to derail to the right during the collision. Vehicle 5 was predicted to remain guided by the rails.

Figure 13: Output from collision and derailment simulation – sequence of events (courtesy of Hitachi)

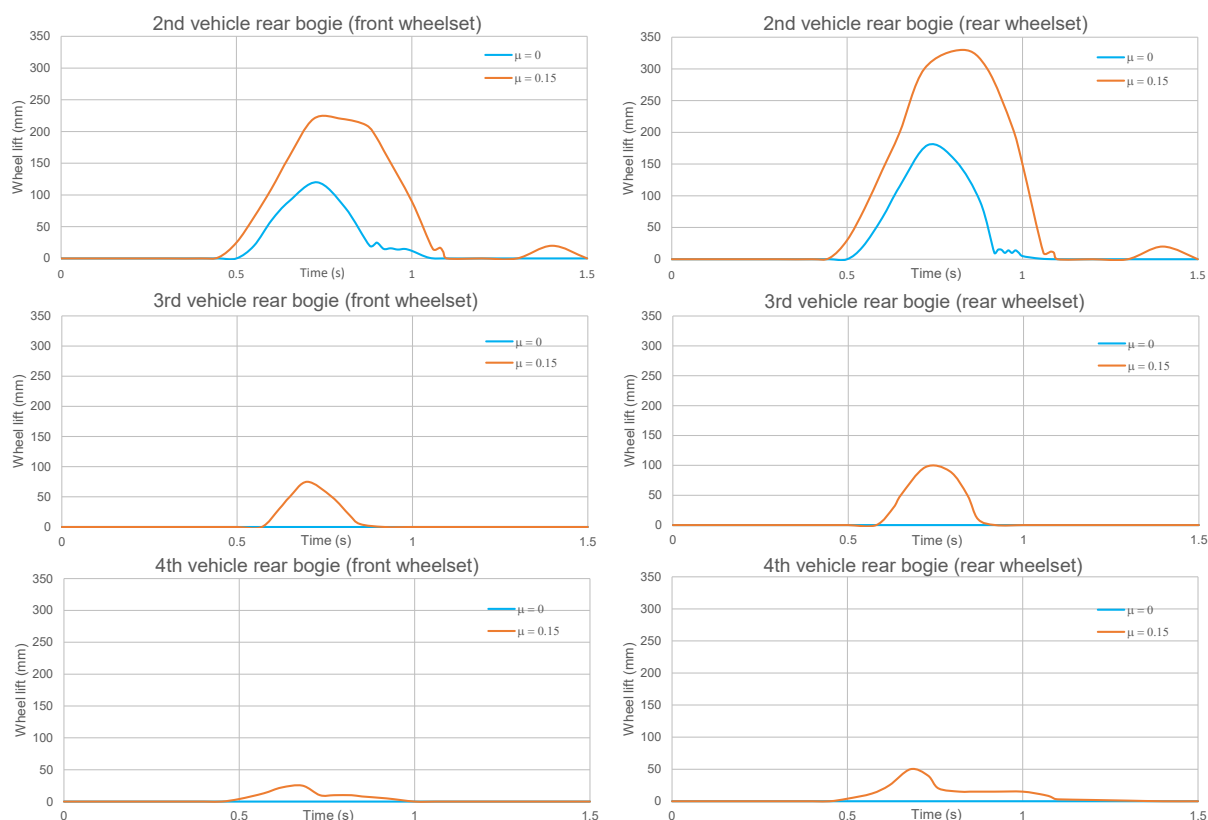
- 106 Figure 15 shows the predicted amount of wheel lift for the leading and trailing wheelset of the trailing bogie of vehicles 2, 3 and 4 for different coefficients of friction at the wheel-rail interface. These results show that the amount of wheel lift predicted in the 3D model was dependent on the amount of friction at the wheel-rail interface in the model (representing the amount of braking). In the case of zero friction (representing an unbraked train), only the trailing bogie of vehicle 2 was predicted to lift vertically. As modelled friction was increased, so did the amount of wheel lift on vehicles 2, 3 and 4. This is due to the additional vehicle body pitching introduced by braking.
- 107 The effect of braking on the degree of lateral displacement was not investigated.

Figure 15: Output from collision and derailment simulation – wheelset vertical lift (courtesy of Hitachi)

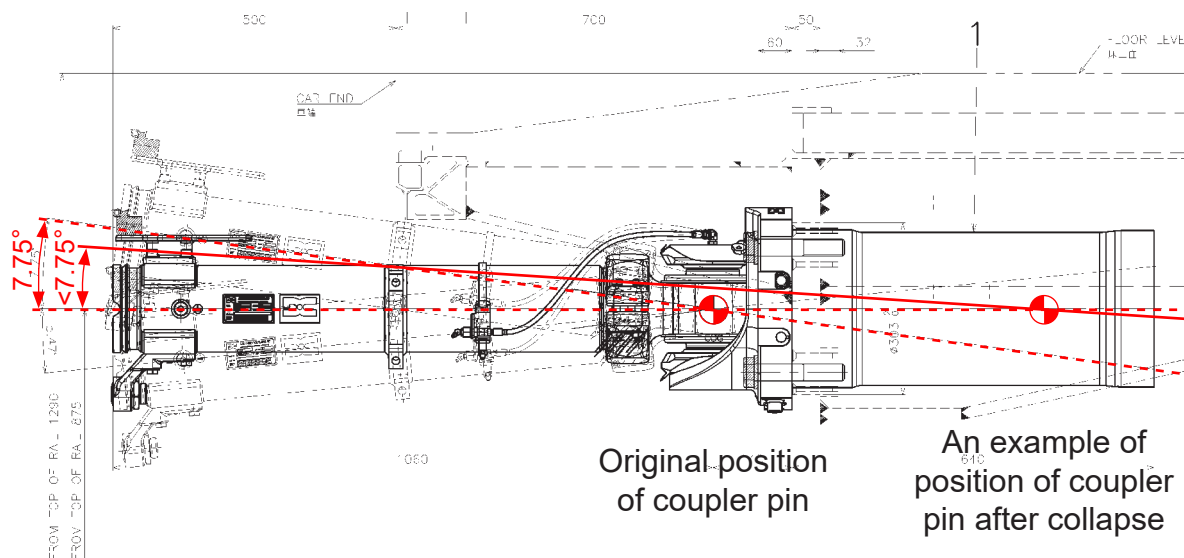
110 At 22.5 mph (36 km/h), the inter-vehicle couplers were predicted to collapse significantly, which reduced the angle that the couplers can freely pitch and yaw (figure 16). The original 1D models had been set with a constant $\pm 8^\circ$ pitch limit (and $\pm 24^\circ$ yaw limit) which was only accurate for the cases where the couplers did not collapse. The model with the 22.5 mph (36 km/h) collision speed was rerun initially with a constant pitch limit of $\pm 6^\circ$ (and $\pm 6^\circ$ yaw limit) and then with a constant pitch limit of $\pm 5^\circ$ (and $\pm 5^\circ$ yaw limit) representing increasing levels of coupler collapse.

Figure 16: Effect of coupler collapse on pitch freedom

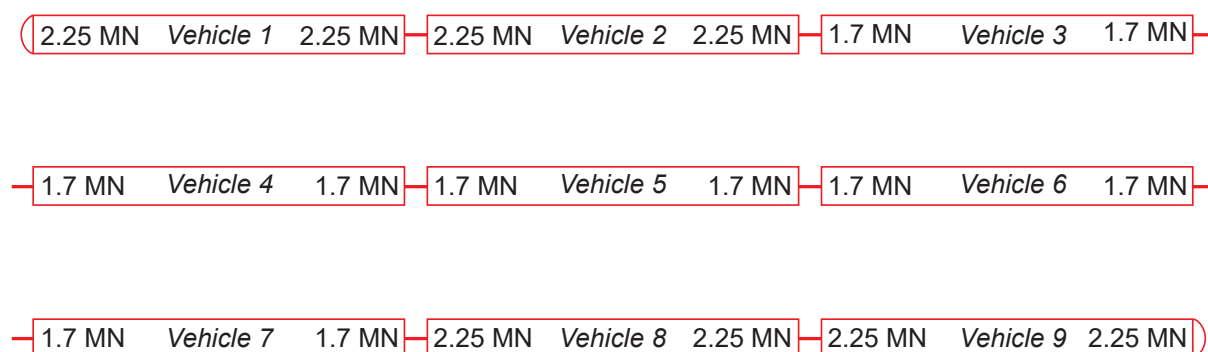
114 The couplers fitted to an IET are all designed to collapse in the event of a collision. However, the load at which they will collapse is not the same throughout the train. Figure 17 shows the distribution of coupler collapsing strength along the train.

Figure 17: Distribution of coupler collapsing strength along the IET rake

- 115 The IET coupler collapsing strengths of 2.25 MN and 1.7 MN are high compared to those of other trains on the UK network. The requirement in EN 12663¹³ is to design the carbody of trains to withstand a compressive 1.5 MN load at the coupler attachment. The coupler collapsing strength tends to be designed to be the same or less than 1.5 MN to ensure that the coupler will collapse before the carbody starts deforming permanently.
