**Accident**

| <b>Aircraft Type and Registration:</b> | Piper PA-18-150, G-CUBX | |
| <b>Location:</b> | Croft Farm Airstrip (Defford Airfield), Worcester | |

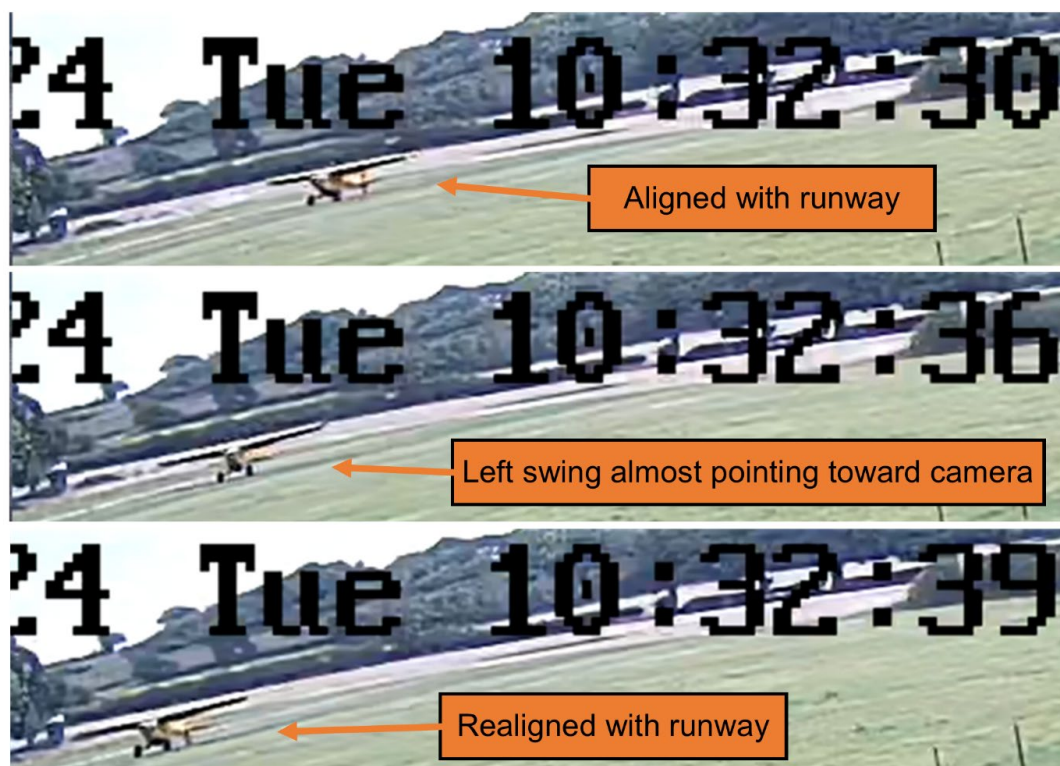
**Figure 2**

Captured on CCTV, while at low speed during the initial phase of the takeoff roll, the aircraft swung to the left before being re-aligned to the runway by the pilot (Figure 2).

CCTV snapshots of G-CUBX at the start of its takeoff roll  
(CCTV shows approximate local time)

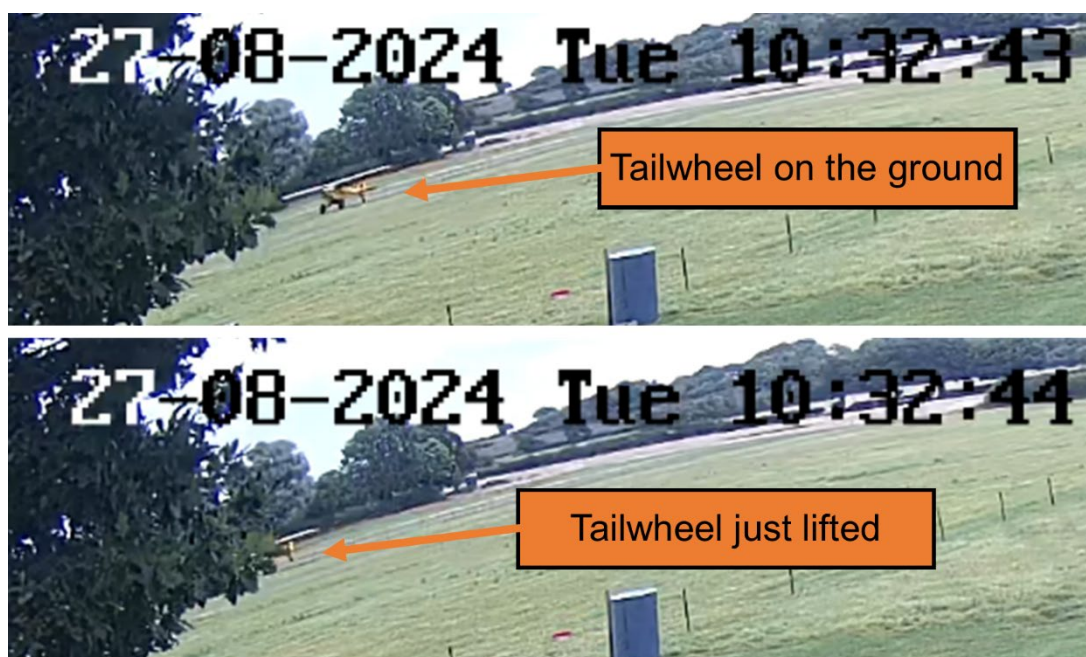
**Figure 3**

After this early yaw divergence, the remainder of the takeoff roll captured on CCTV appeared to progress normally, with the aircraft's tailwheel lifting off just before the aircraft went out of view (Figure 3). Approximately nine seconds later the aircraft reappeared in the CCTV image, close to the camera and in a steep nose down attitude just before it struck the ground. While the CCTV footage was not of a sufficiently high definition to reach a definitive conclusion, it appeared to show G-CUBX's wing flaps in the retracted position before it struck the ground.

CCTV snapshots of G-CUBX showing its tailwheel being lifted from the runway

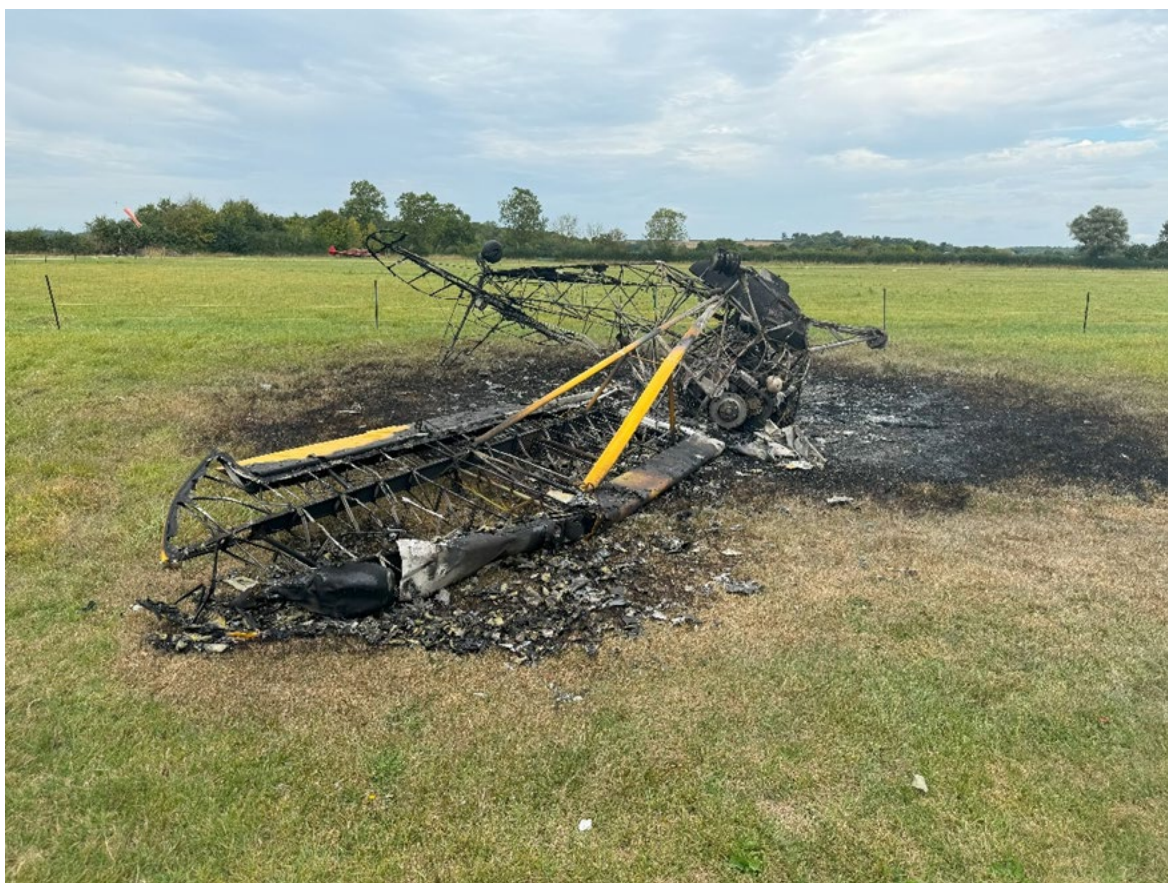
**Figure 4**

While video footage of the accident shows the aircraft initially coming to rest on its nose with the tail almost vertically above it, during the subsequent post-accident fire the tail settled to the ground with the top of the vertical stabilizer resting on the floor. The fuselage was inverted and there was significant damage to the structure (Figure 4).

G-CUBX showing significant post impact fire damage

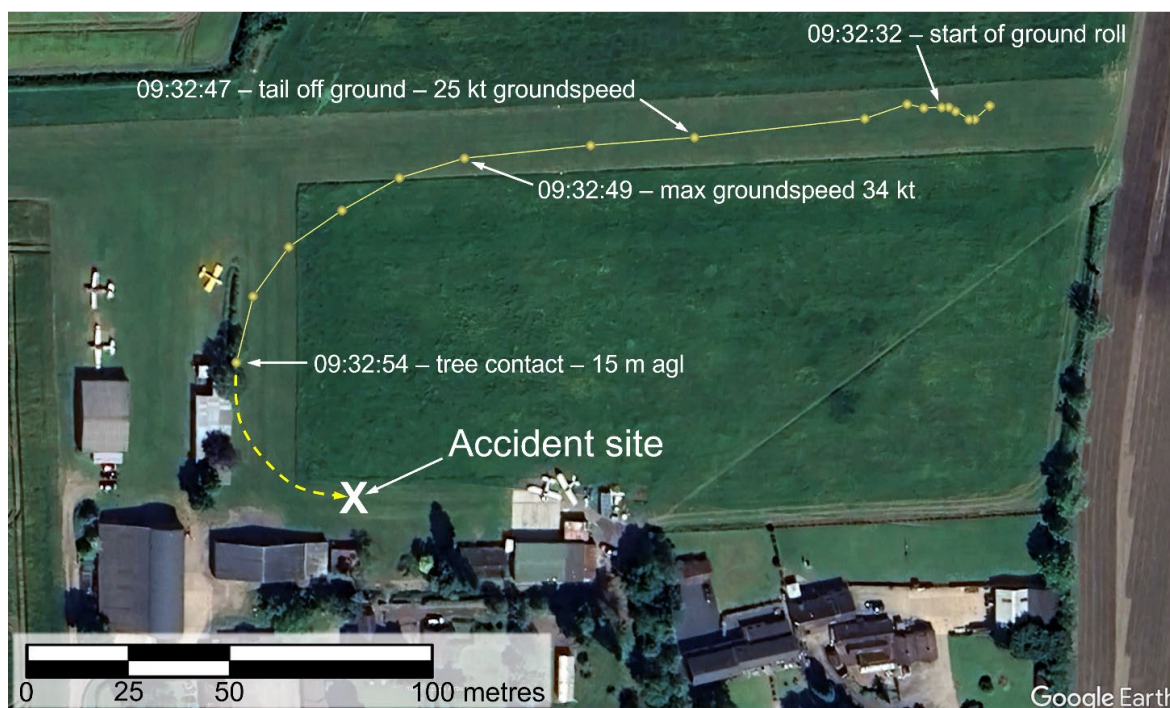
**Figure 5**

The pilot was using a flight-planning and navigation app on a tablet device which recorded the aircraft's GPS flight path. The ground track is shown in Figure 5. Note that the path stops short of the accident site by about three seconds as the recorded positions during this period were unreliable, probably as a result of the aircraft's banked attitude limiting the tablet's view of the GPS satellites.

GPS derived ground track of the flight  
(© 2025 Google, Image © 2025 Airbus)

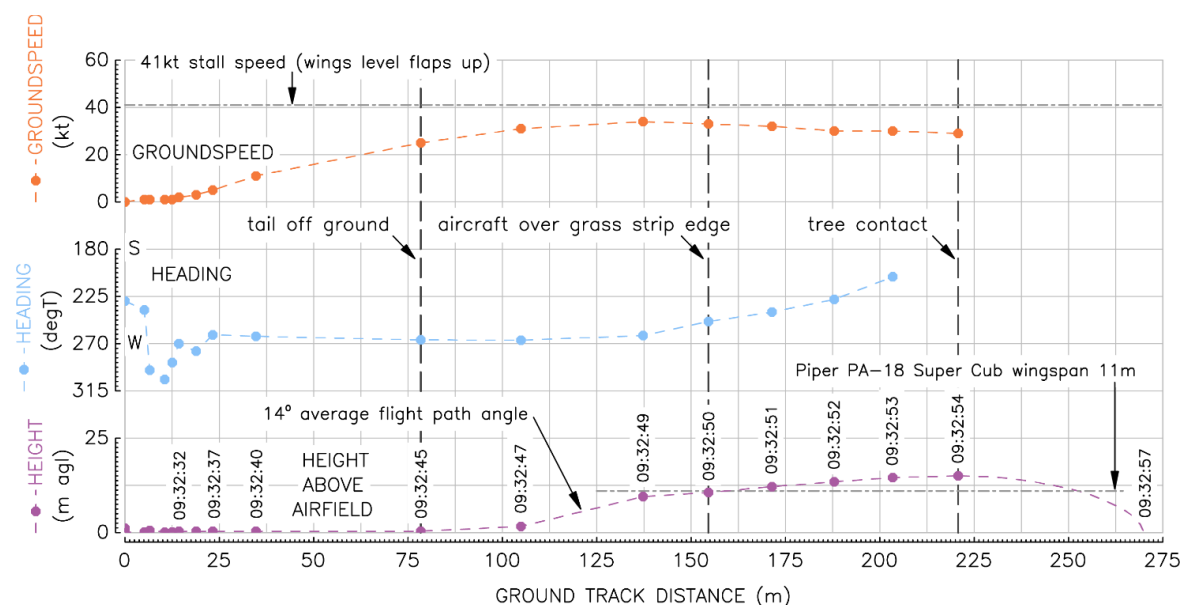
**Figure 6**

After five seconds of gentle manoeuvring right, left and right again, the aircraft accelerated down the grass strip, veering slightly left, with the tail of the aircraft coming off the ground 10 seconds later (before going out of view of the CCTV). Within two seconds, the aircraft was airborne, after which it climbed at an average flight path angle of  $14^\circ$  and reached the maximum recorded groundspeed of 34 kt. Now turning left, the rate of climb reduced with the aircraft flying over the left edge of the grass strip at just over 10 m height.

The last recorded reliable position was four seconds later when the aircraft contacted a tree, 40 m to the left of the grass strip edge, at a height of about 15 m. Continuing to turn, and roll left, the aircraft came back into CCTV view descending vertically in a nose-down attitude, wings aligned with the grass strip, left wing first.

GPS derived data of flight  
(PA-18 clean stall speed and wingspan indicated for reference)

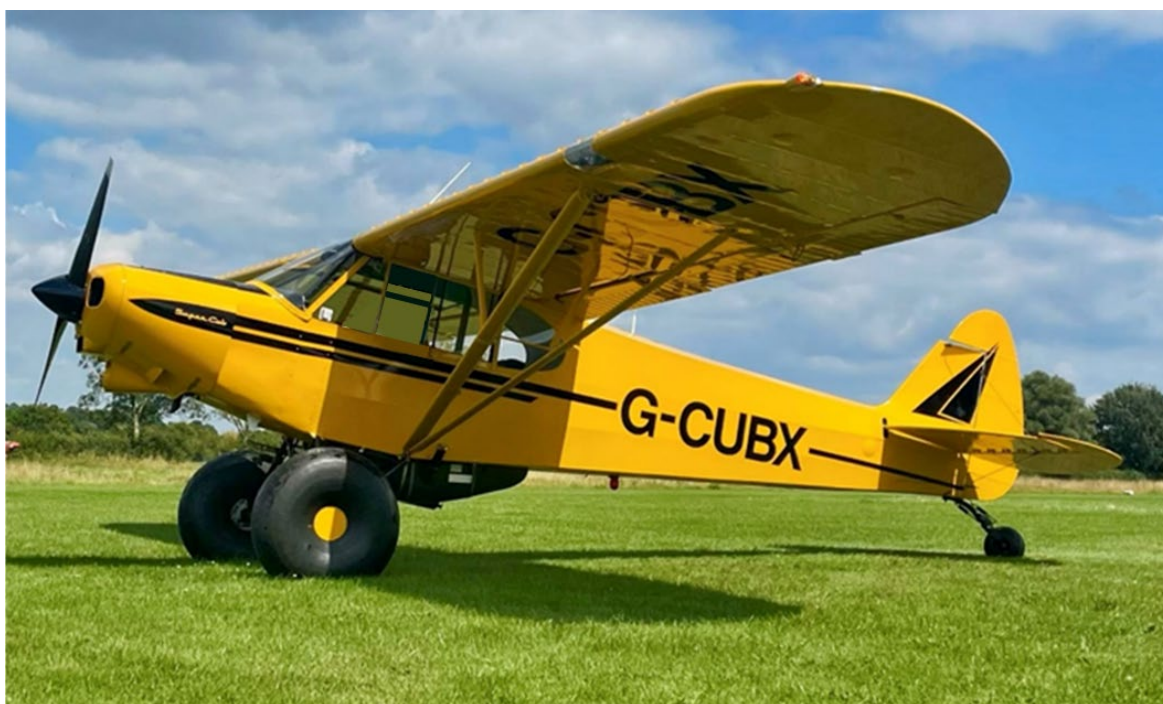
**Figure 7**

G-CLYI was involved in a landing accident in May 2023<sup>2</sup> where it flipped over onto its back whilst braking shortly after touching down on a grass landing strip. The aircraft spent 13 months undergoing repairs during which it was re-registered as G-CUBX in June 2024 (Figure 7). The engine was shock load tested by an approved engine workshop and refitted during the repairs. To improve stall performance and enhance the short takeoff and landing capability of the aircraft, vortex generators had been fitted just aft of the wings' upper leading edges and on the lower surfaces of the horizontal stabilizer, forward of the elevator hinges. These were also replaced during the repair process. G-CUBX received a CAA UK Airworthiness Review Certificate (ARC) on 11 July 2024.

G-CUBX after repair showing features of the Alaskan Bush fit

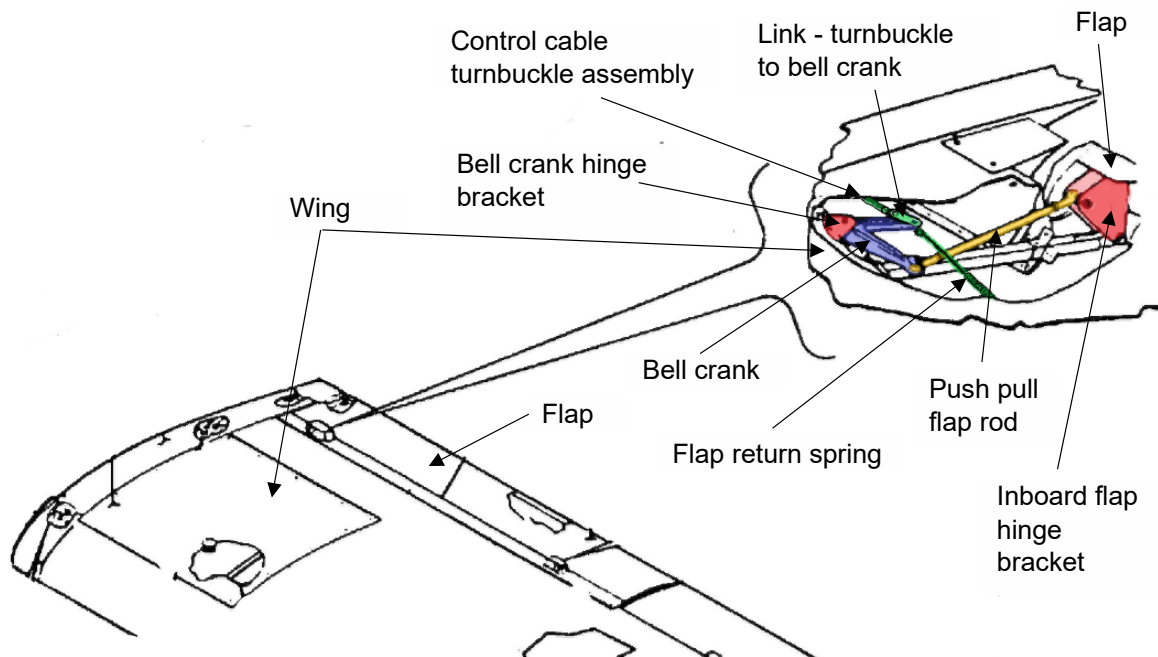
**Figure 8**

Whilst the right flap bell crank was missing (Figure 8), the turnbuckle that should have attached the flap control cable to the bell crank was intact and still attached to the control cable, link and return spring. The bell crank hinge bracket remained in place and attached to the wing. The push pull flap rod, which should have connected the bell crank to the inboard flap hinge bracket, remained attached to the bracket but the bracket had separated from the flap. The left flap control assembly was still connected to the left bell crank and flap although the wing spar section that held bell crank hinge bracket had melted releasing the bracket and bell crank.

Flap control assembly diagram

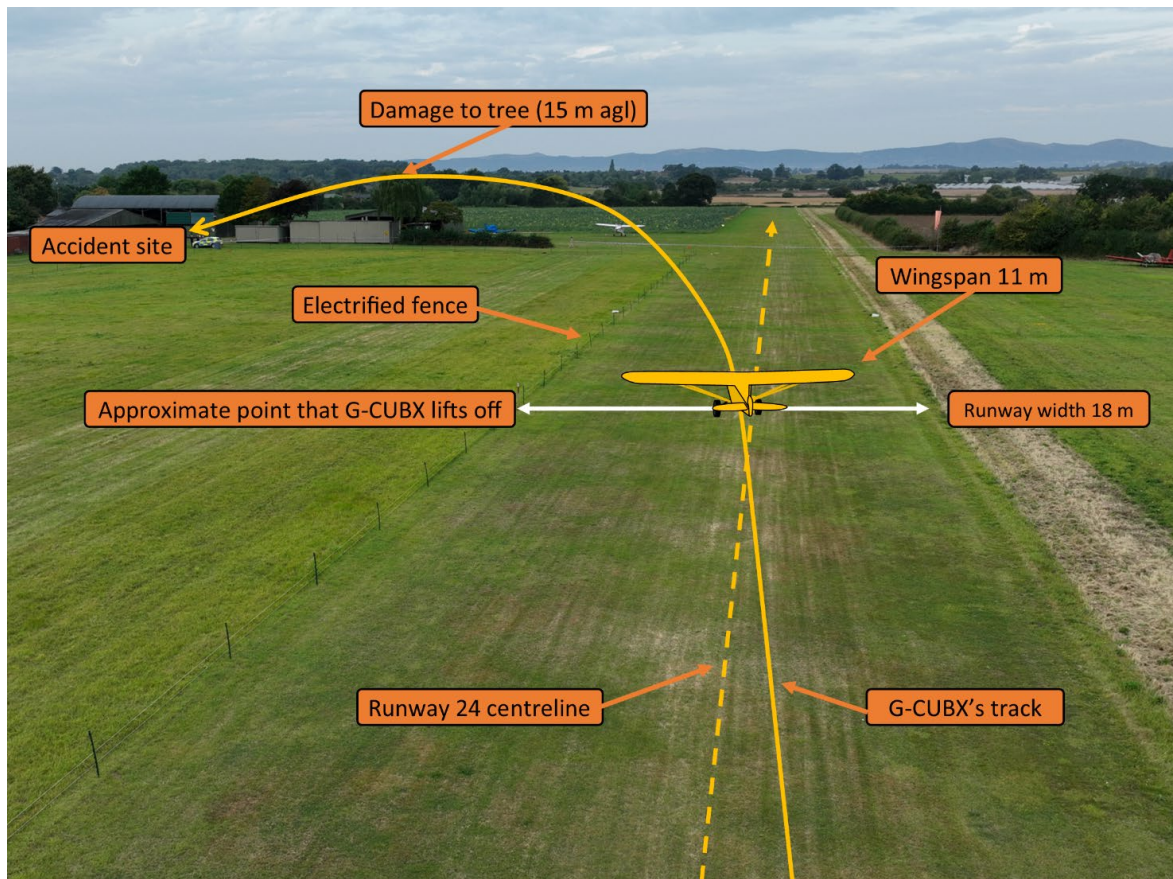
**Figure 11**

The investigation did not find conclusive evidence to explain why the pilot lifted off at 34 kt groundspeed or for the steep climb and apparent loss of effective control. The investigation considered the aircraft's ground roll track converging with the electrified fence bordering the southern edge of the runway (Figure 11) could have been a contributory factor if the pilot decided to lift off earlier than perhaps he originally intended.

G-CUBX's approximate ground track and flightpath (aircraft drawn to scale)
