Report on the investigation of  
the fatal contact between the dive workboat

***Karin***

and a recreational diver  
in Scapa Flow, Orkney Islands, Scotland  
on 28 September 2023

REPORT NO 16/2025

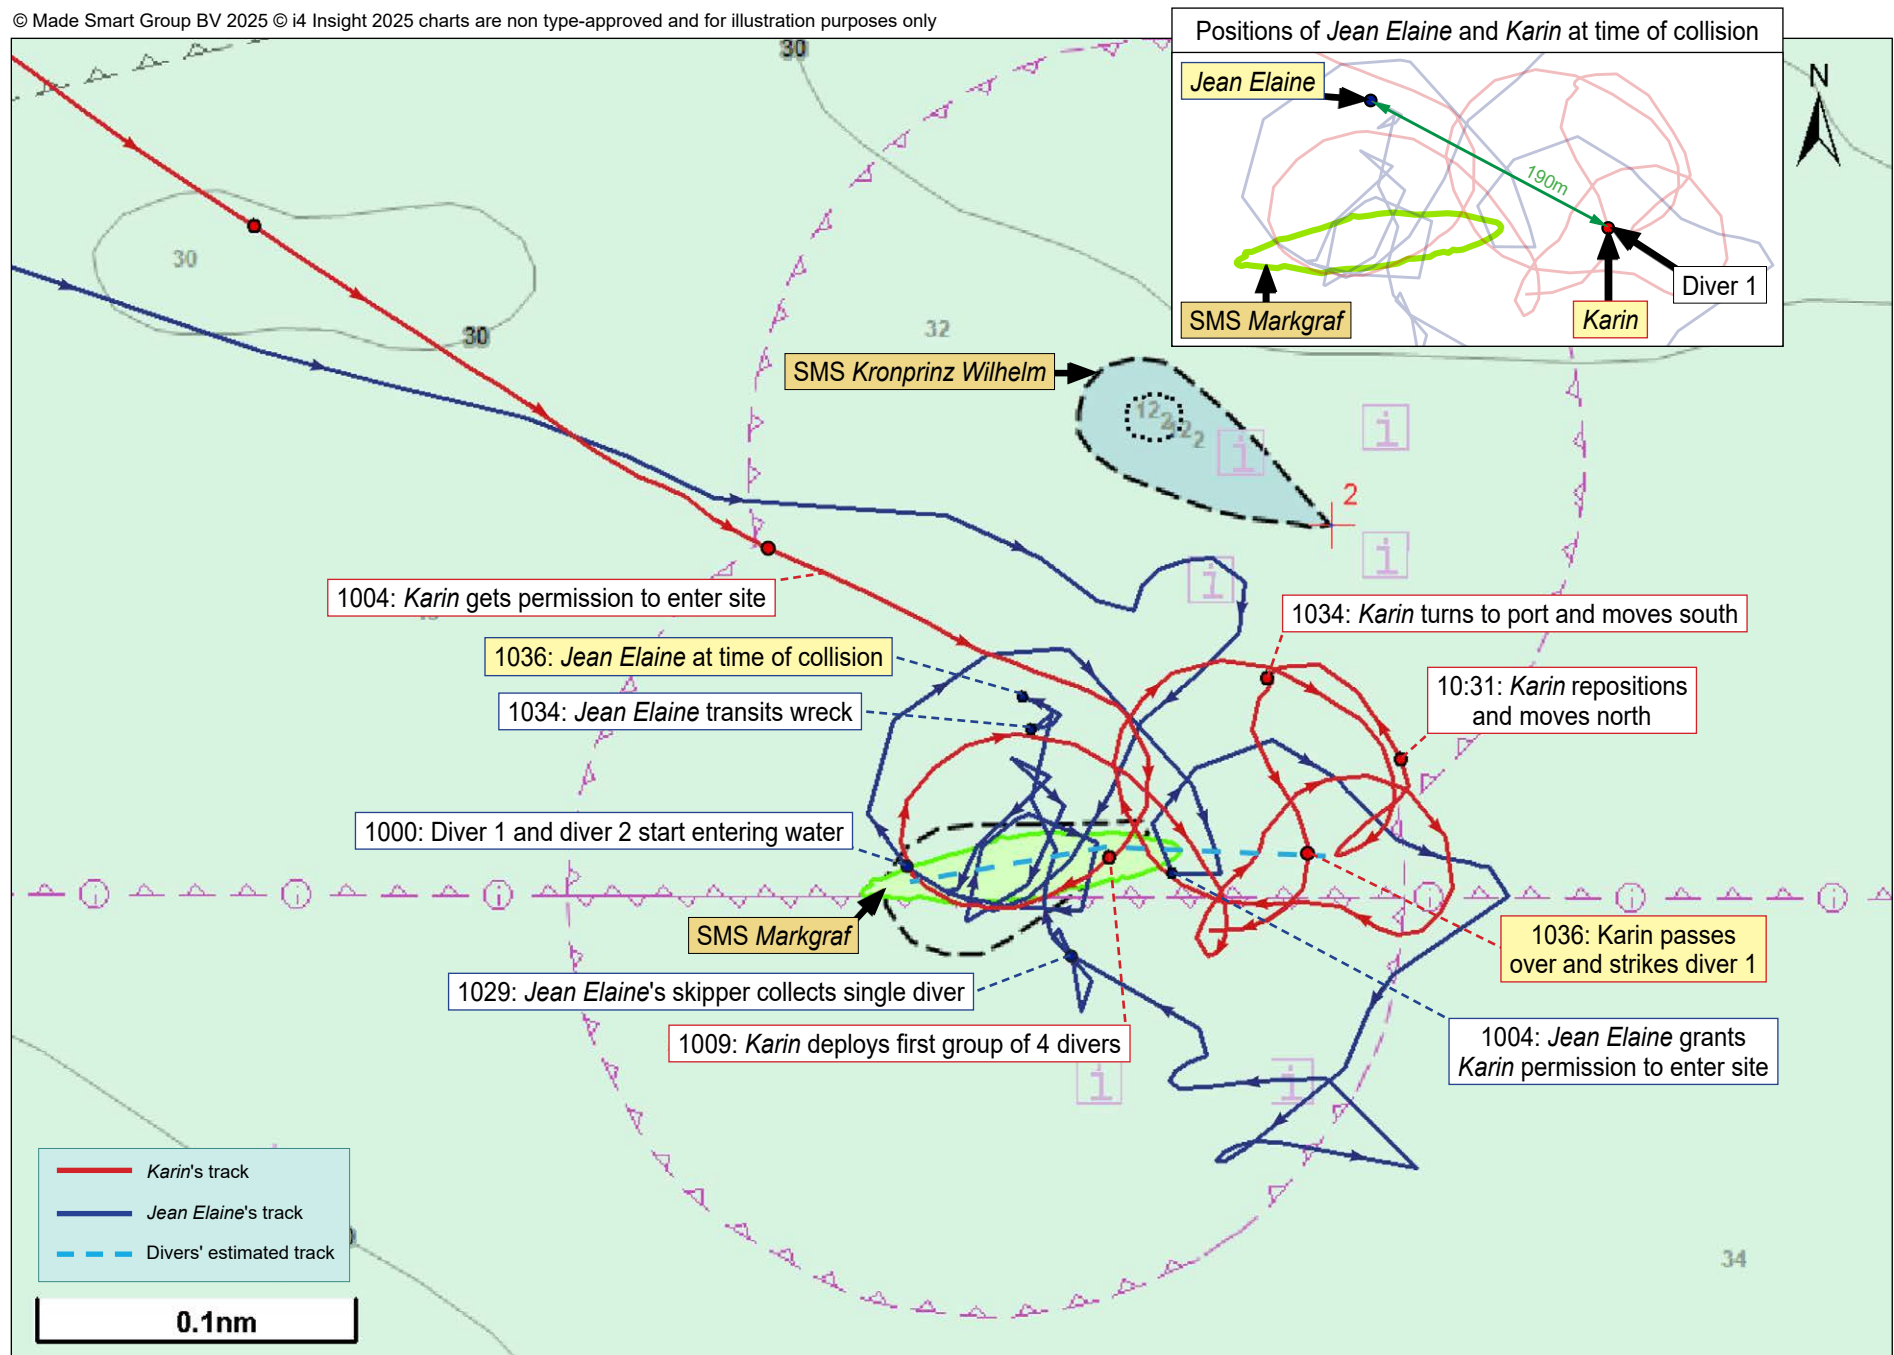
**Figure 3:** *Karin* and *Jean Elaine*'s navigational history with estimated track for diver 1 and diver 2

At 1004, *Karin* arrived at the wreck site of *Markgraf*. When the vessel was about 200m from the shot lines (**Figure 3**), *Karin's* skipper noticed *Jean Elaine* drifting approximately 50m to the east of the wreck location. *Karin's* skipper called *Jean Elaine* on the very high frequency (VHF) radio and requested permission to enter the site and deploy divers. *Jean Elaine's* skipper checked for signs of divers and/or bubbles at the shot lines and was satisfied that they were clear. *Jean Elaine's* skipper granted access to enter and briefed *Karin's* skipper that they had nine divers on the wreck.

At 1009, *Karin*'s skipper manoeuvred the vessel into position at the stern shot line and, assisted by the deckhand, deployed four of its divers (**Figure 3**). *Karin* then passed over *Jean Elaine*'s nine submerged divers as it crossed to the wreck's bow shot line, where a further four divers were deployed. Two passengers remained on board. *Karin*'s deckhand then went to the galley to prepare lunch for the divers' return. There were now 17 divers in the water, nine from *Jean Elaine* and eight from *Karin*.
