Report on the investigation of the grounding  
and recovery of the container feeder vessel

***Thea II***

***Svitzer Josephine***

in the approaches to the Humber Estuary

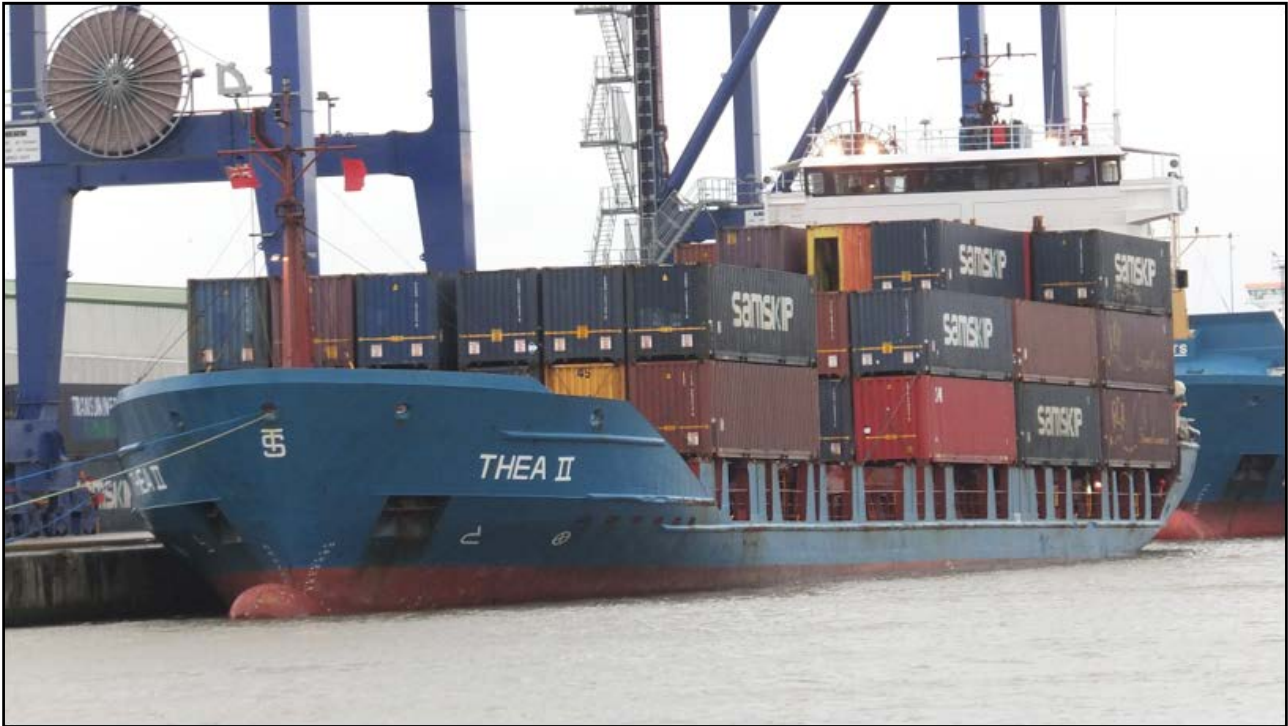
**Figure 1:** *Thea II*, post-grounding, alongside in Hull

- The rudder and steering gear were damaged, but operational.
- The vessel's hull was intact, but the hull bottom paintwork was damaged.
- There was minor damage to the propeller blades.
- Two quarter deck ventilation pipes had been broken by the tug's towline.

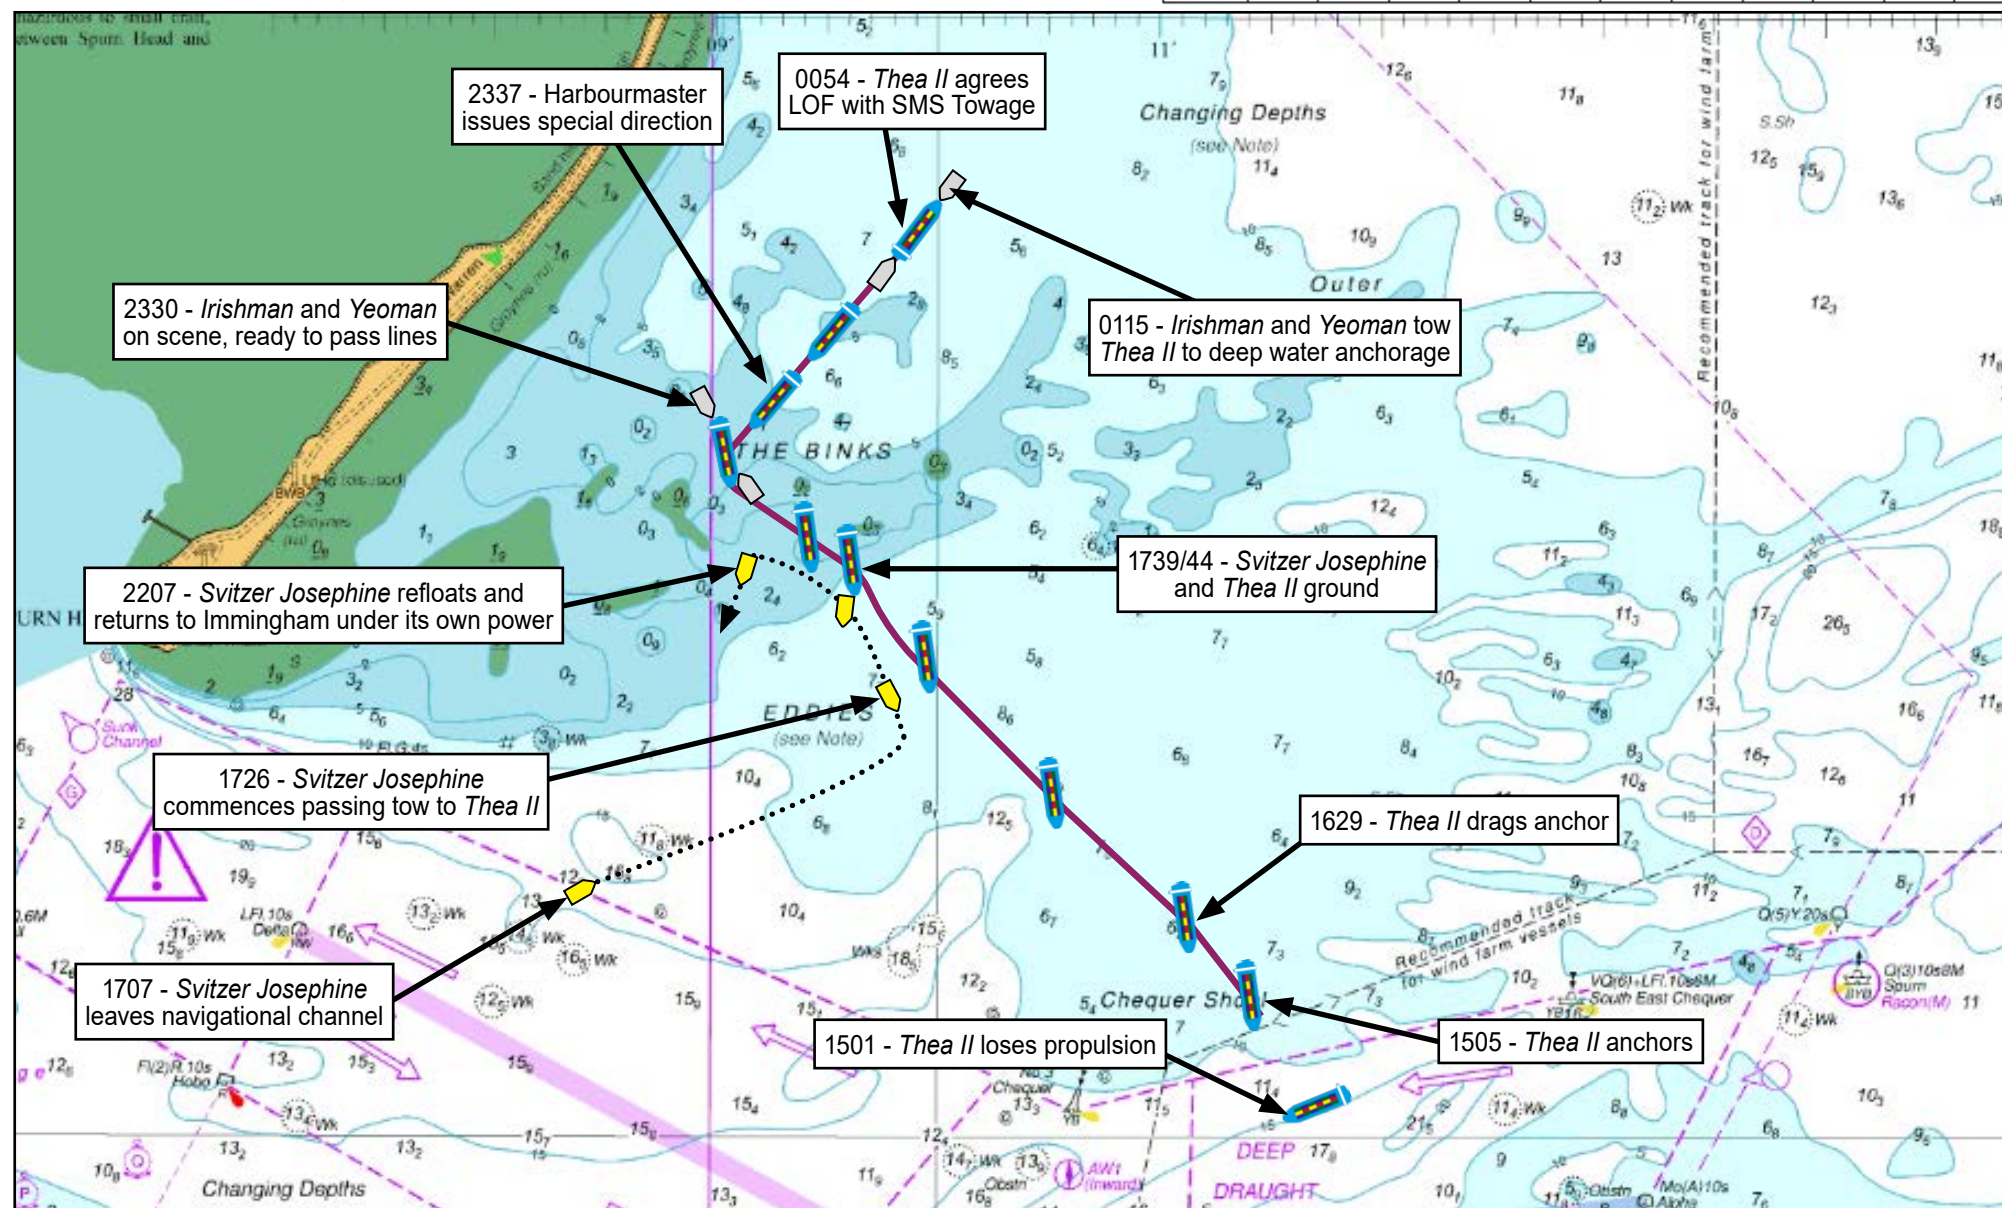
At 1633, just before low water Spurn Head<sup>2</sup>, the VTSO observed *Thea II* drifting north-west at 1.7kts (knots) (**Figure 3**). He called the vessel and enquired if *Thea II* was dragging its anchor. The master confirmed that this was the case and reported that he was deploying a further shackle of anchor cable. However, this did not stop the vessel's drift.

Figure 3: Overview of the accident track from 1501 on 15 December until 0115 on 16 December

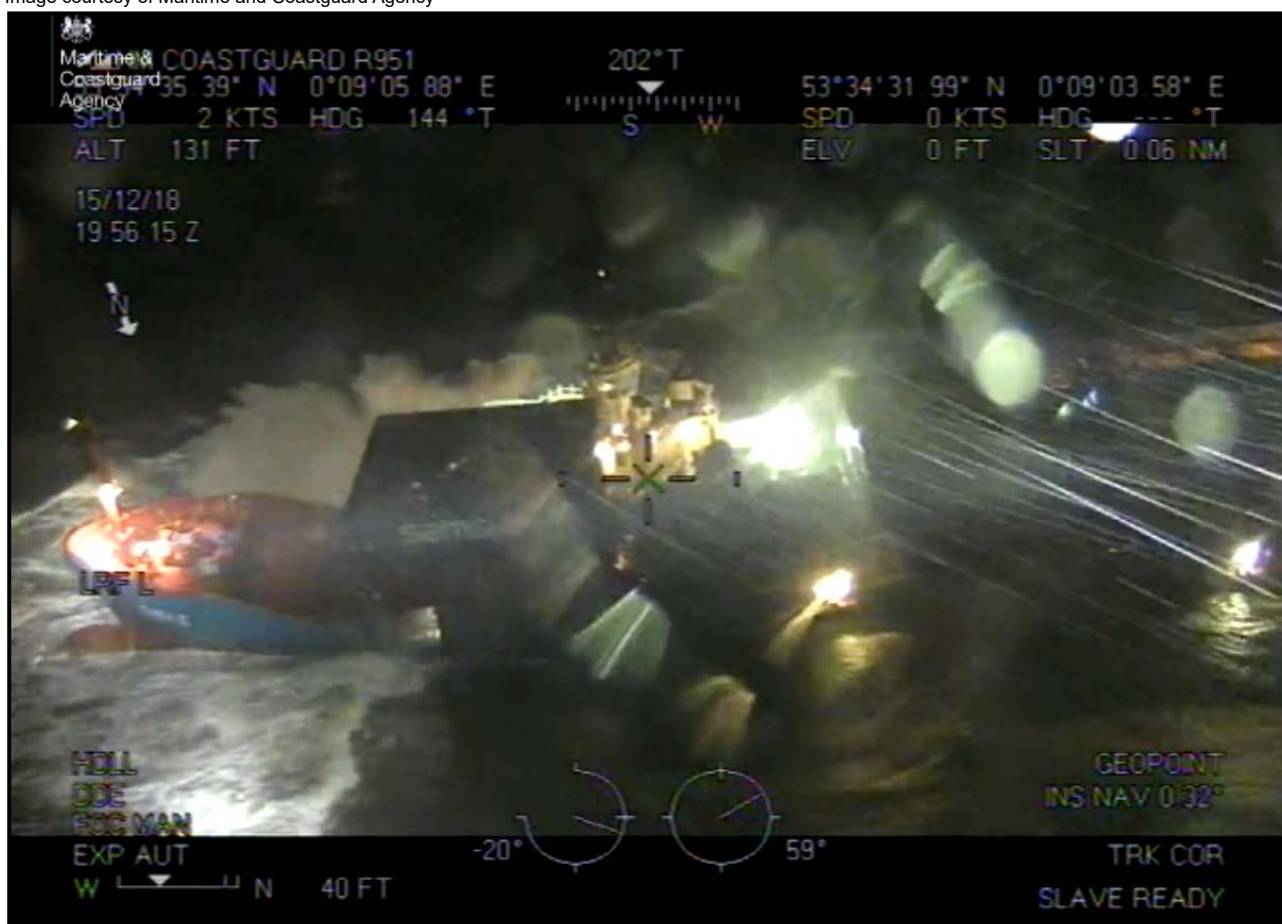
At 1739, as *Svitzer Josephine*'s master tried to tow *Thea II*, he found his tug was aground. He reported this to VTS Humber, who in turn contacted *Thea II*'s master, who responded that his vessel was also aground.

**Figure 4:** *Thea II* and *Svitzer Josephine* viewed from the search and rescue helicopter, aground on the Binks Shoal

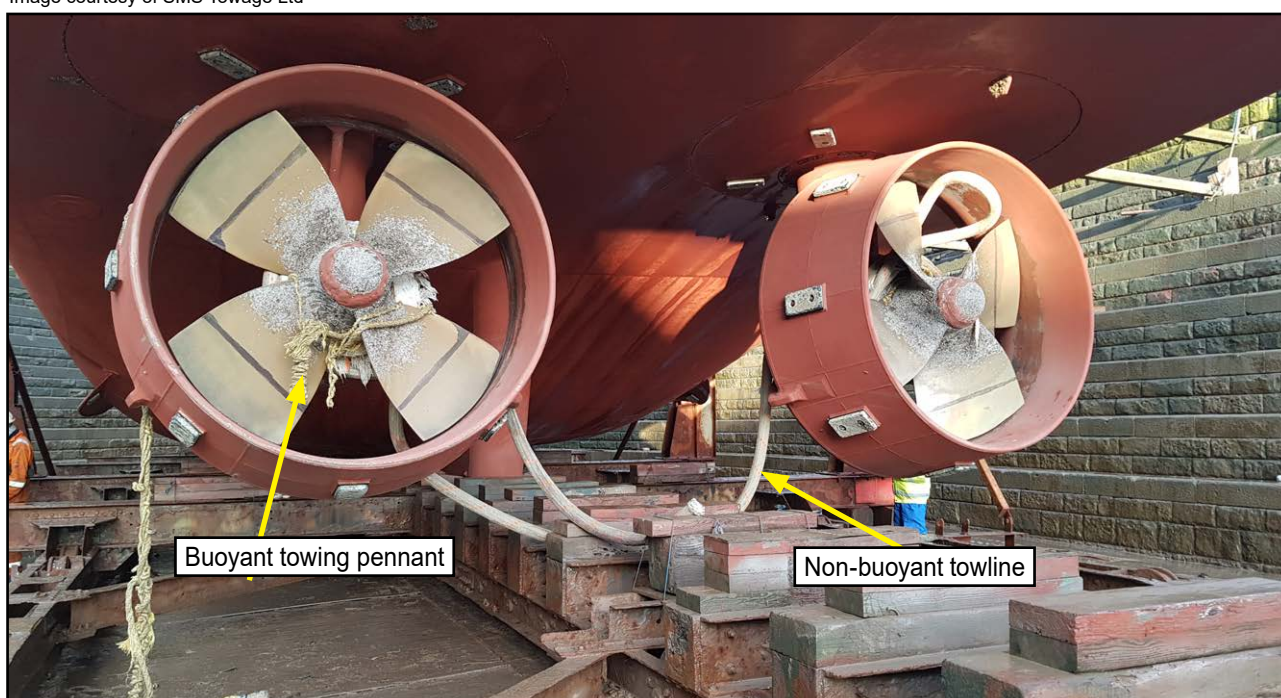
assumed that its propellers had been fouled by fishing gear. However, when *Yeoman* was in dry dock it was discovered that the port and starboard azimuth units had been fouled by a towline (**Figure 7**). The following damage was also discovered:

- The internal engine room mountings were out of tolerance.
- The starboard bilge keel and starboard side of the hull were damaged.

Post-accident inspection of the rope recovered from *Yeoman*'s azimuth units suggests that it was an 80mm, 3-strand 'Strongline' polyester, Langhorst towing hawser, attached to a 15m yellow/orange towing pennant. This was similar to *Svitzer Josephine*'s towline, which had been discarded by *Thea II*'s crew.

**Figure 7:** *Yeoman*'s propellers fouled by *Svitzer Josephine*'s towline

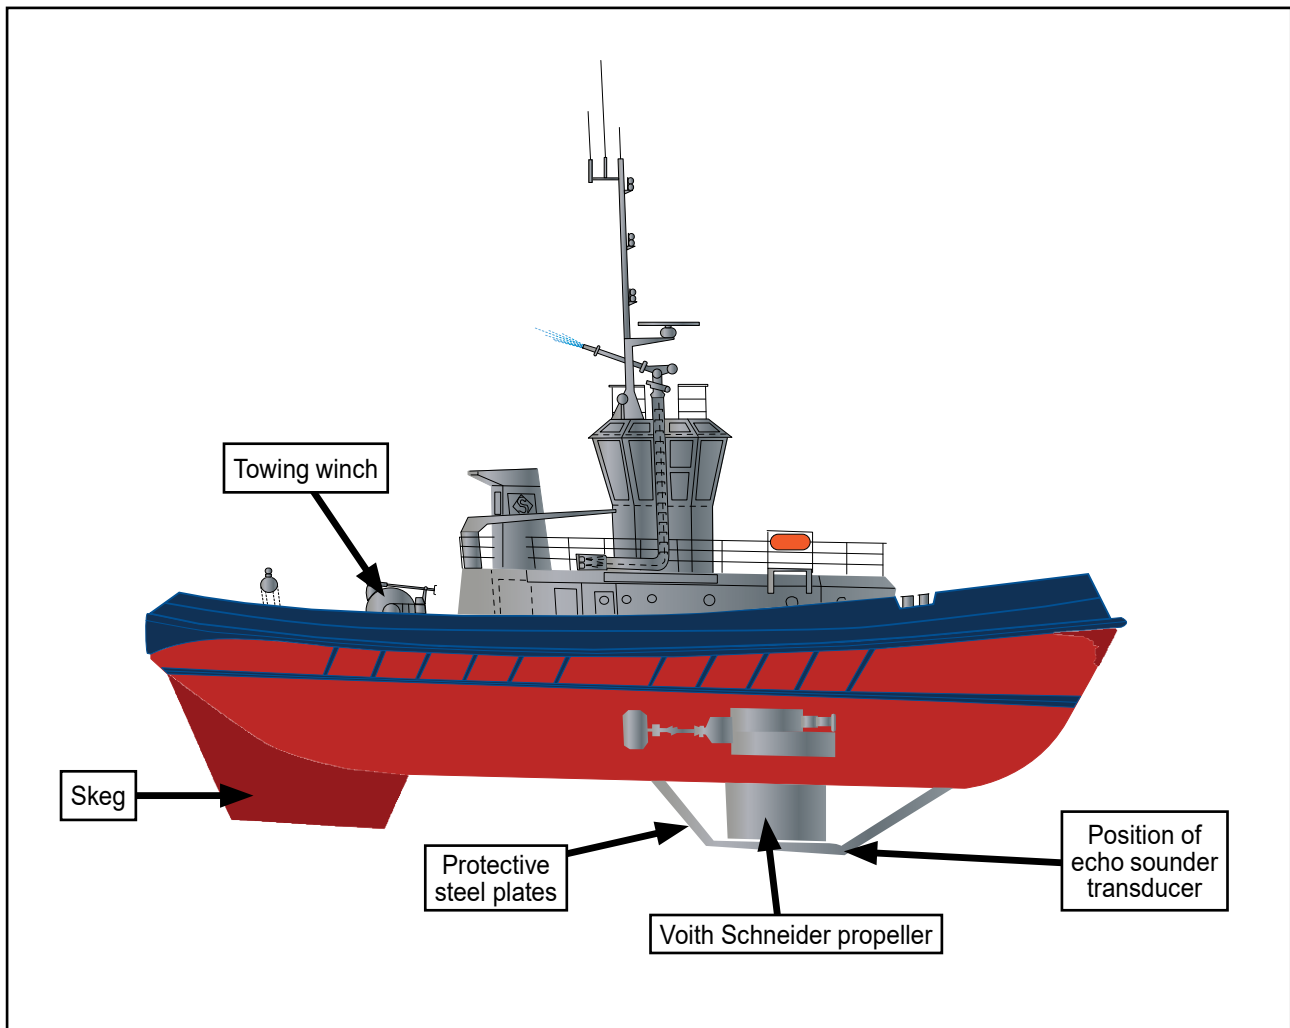
Post-accident in-water survey of *Svitzer Josephine* revealed that the void space containing the starboard engine room vent fan had flooded. This had shorted the fan motor and probably triggered the fire alarm. The starboard weather deck door had also vibrated open during the grounding, causing water damage to the tug's accommodation and recreational spaces. Initially it was thought that the tug's hull and Voith Schneider propellers (VSP) were undamaged. However, during the dry-docking of the vessel in June 2019, extensive cracking was identified along the skeg and adjoining keel plating, which had not been detected during the in-water survey.

*Svitzer Josephine's* echo sounder transducer was fitted in front of its VSPs. The echo sounder's minimum depth alarm was set at 1m. However, the position of its transducer, like many tugs, meant that it was prone to false alarm due to VSP wash and, on the day of the accident, the echo sounder's audible warning alarm had been silenced.

**Figure 9:** *Svitzer Josephine's* underwater arrangements

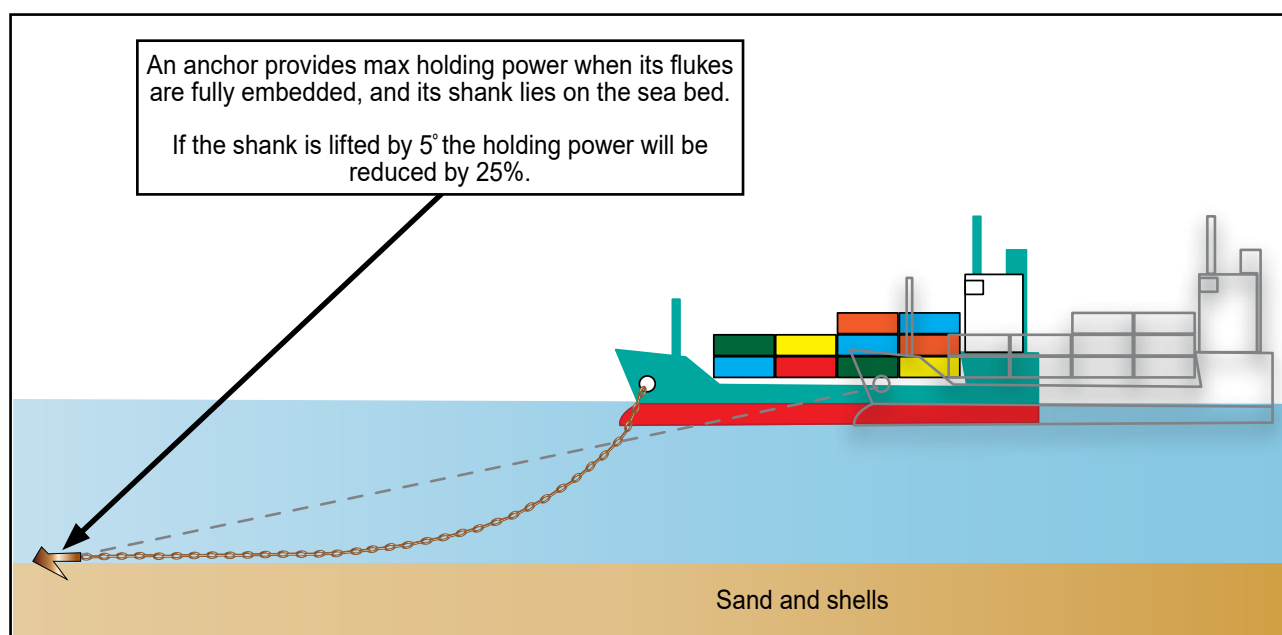
Using a charted depth of 12m these guidelines indicate that *Thea II*'s master should have deployed between 2.6 and 5.2 shackles of cable. When *Thea II* initially anchored, 5 shackles of cable were deployed, which was increased to 6 shackles once the vessel started to drag its anchor.

These guidelines recommend that in bad weather additional anchor cable be deployed. Furthermore, in strong winds, high-sided vessels like *Thea II*, with containers stowed on deck, can be prone to yaw either side of their anchor cable. At the extremity of each yaw, the vessel would snatch at the cable, placing it under

**Figure 12:** Scope of deployed anchor

considerable load and increasing the risk of the anchor breaking free and dragging. *Thea II* was yawing approximately 35° either side of its cable immediately prior to dragging its anchor.
