Rail Accident Investigation Branch

Rail Accident Report

**Track worker near miss at Chiltern Green,
between Harpenden and Luton
23 April 2024**

Report 06/2025
April 2025

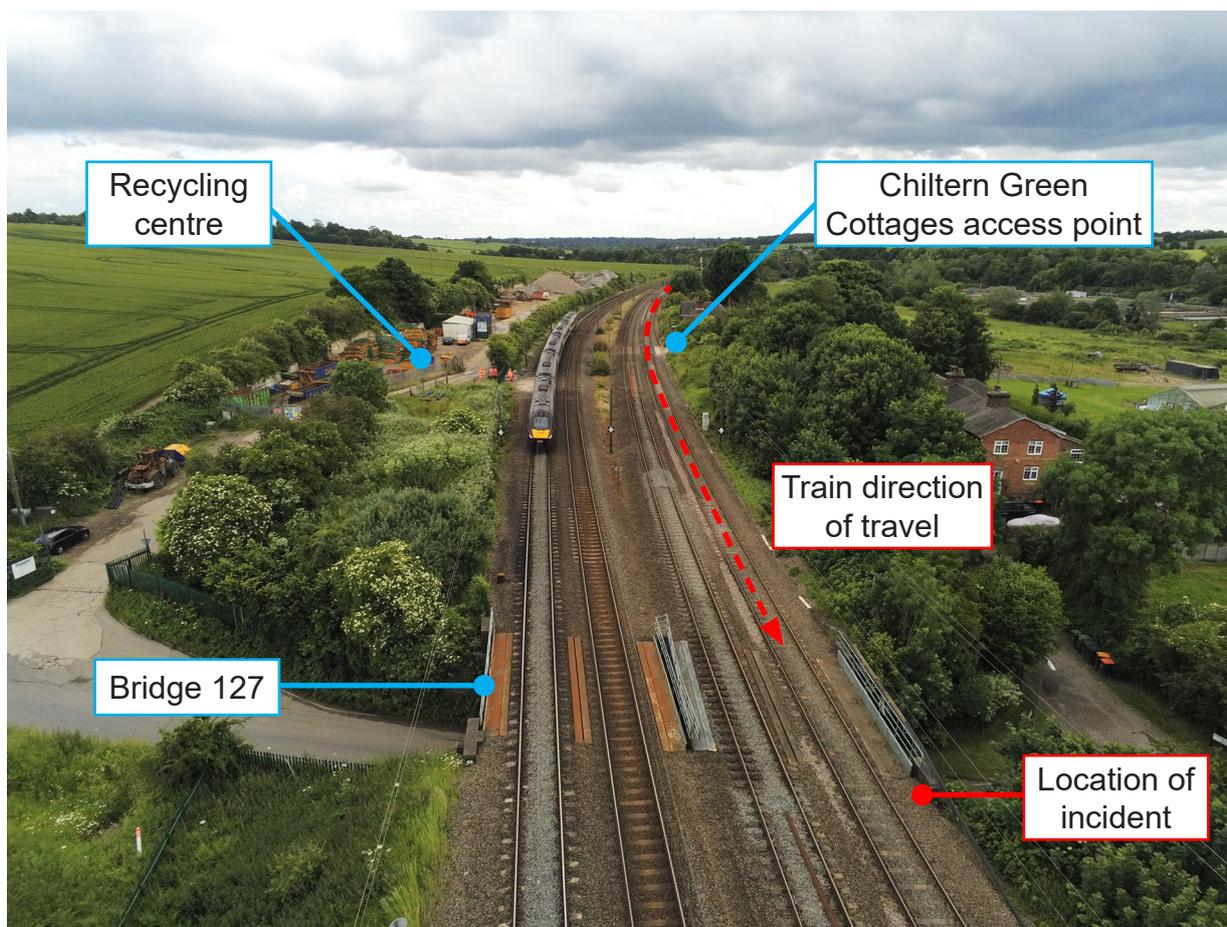
- 3 At about 09:53 on 23 April 2024, a train travelling at 104 mph (167 km/h) came very close to striking a track worker who was crossing an underbridge at Chiltern Green, between Harpenden and Luton Airport Parkway stations (figure 1).

Figure 2: View of the bridge where the near miss happened.

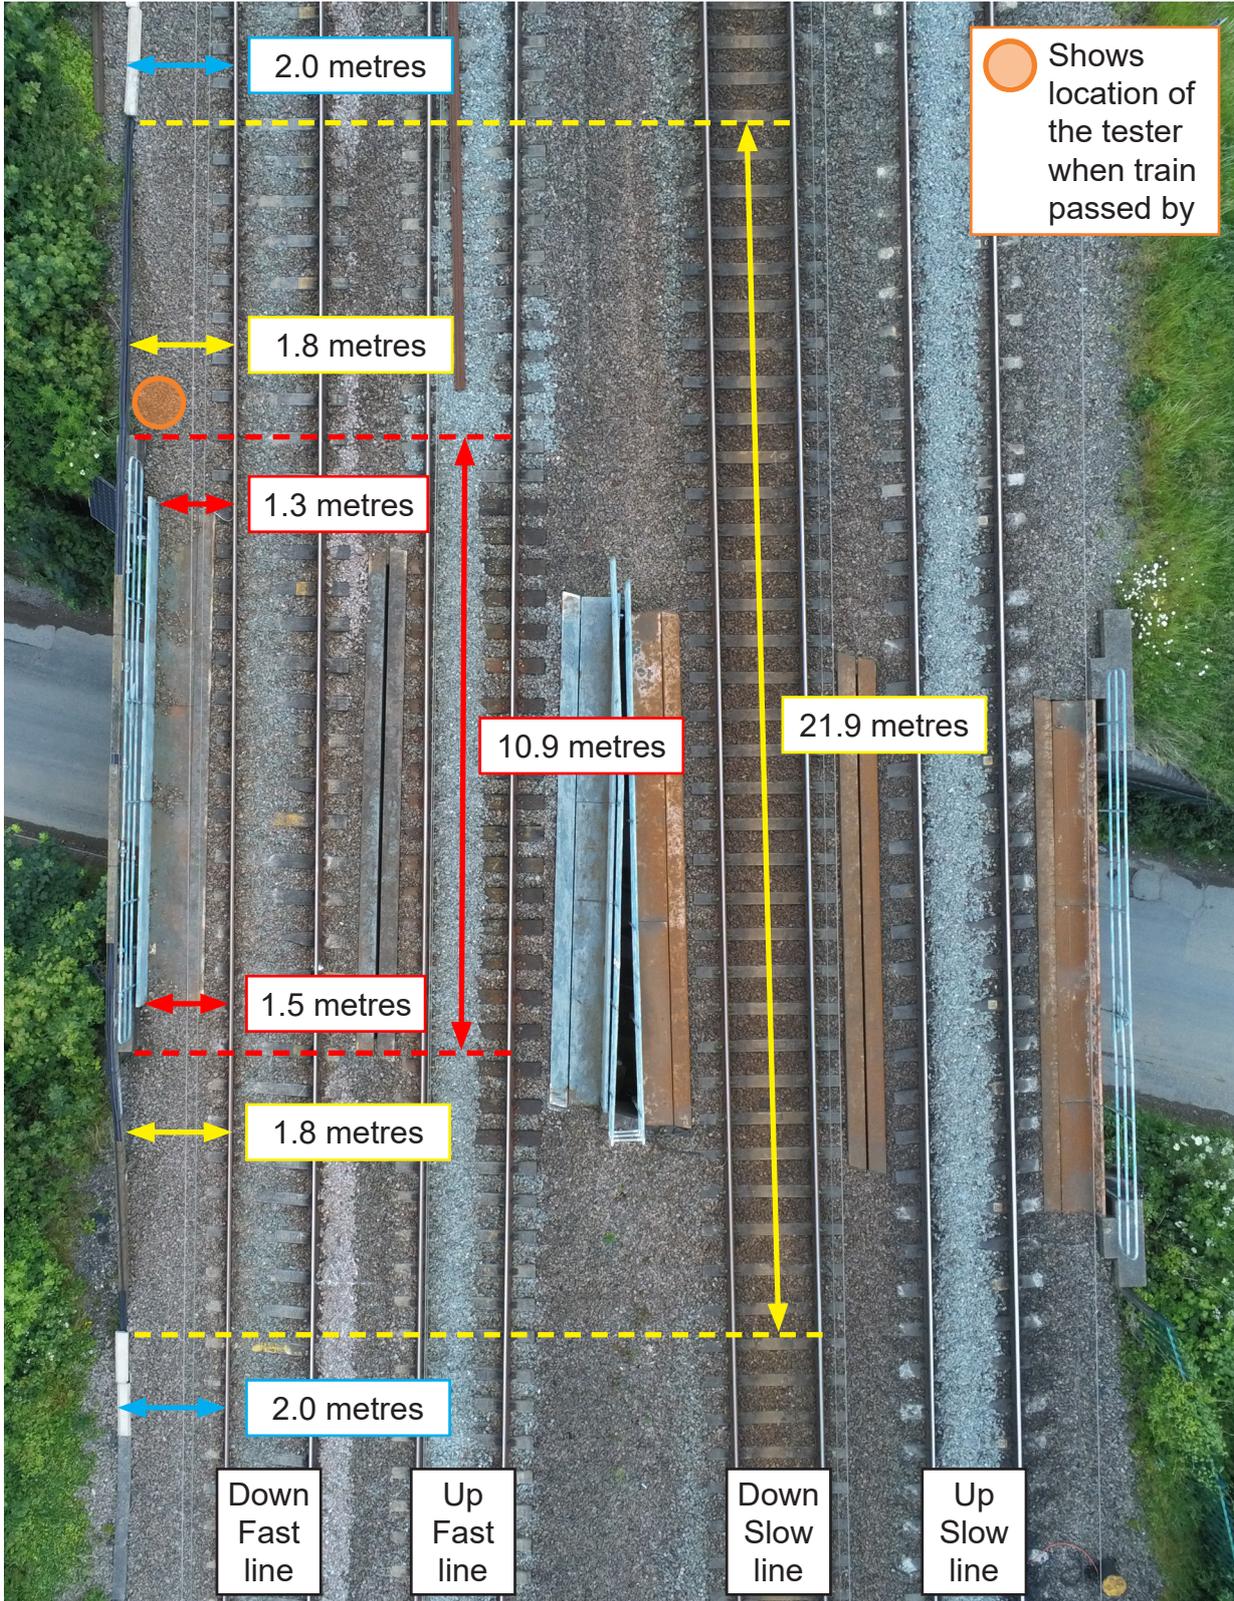
53 The tester was in an unsafe position on a bridge with restricted clearance as the train approached.

- 57 The train passed the tester just as they were stepping off the bridge (paragraph 46). Here the available space is still restricted due to a cable run. However, the available space between the cable run and nearest running rail is increased, being about 1.8 metres (figure 12). This gave about 1.2 metres of space between the train and cable run for the tester to occupy.

Figure 12: Bridge 127 dimensions.

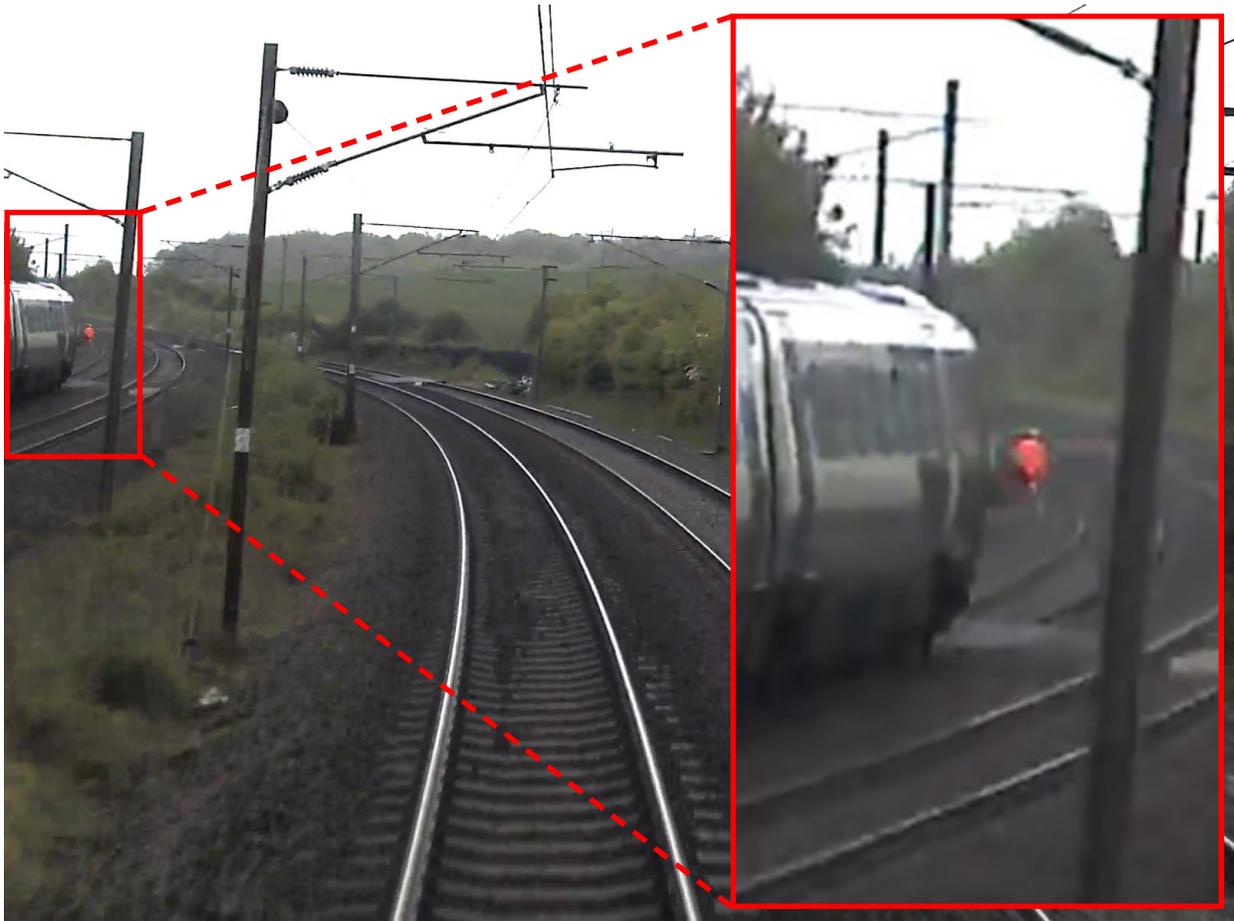
- 56 Due to a hardware fault, the CCTV equipment fitted to train 1F20 did not record any footage showing the incident. However, forward-facing CCTV footage from a train on the Down Slow line showed the tester was about halfway across the bridge as train 1F20 approached them (figure 13). It also showed that the tester was already moving quickly by this time.

Figure 13: Image from forward-facing CCTV footage recorded by a train on the Down Slow line (courtesy of Govia Thameslink Railway).

- 149 When CCTV footage recorded by the train on the Down Slow line (paragraph 56) was reviewed, it showed that other structures in the vicinity of bridge 127 were also not fitted with any warning signs. This was despite these structures being listed in the national hazard directory as having restricted clearance.

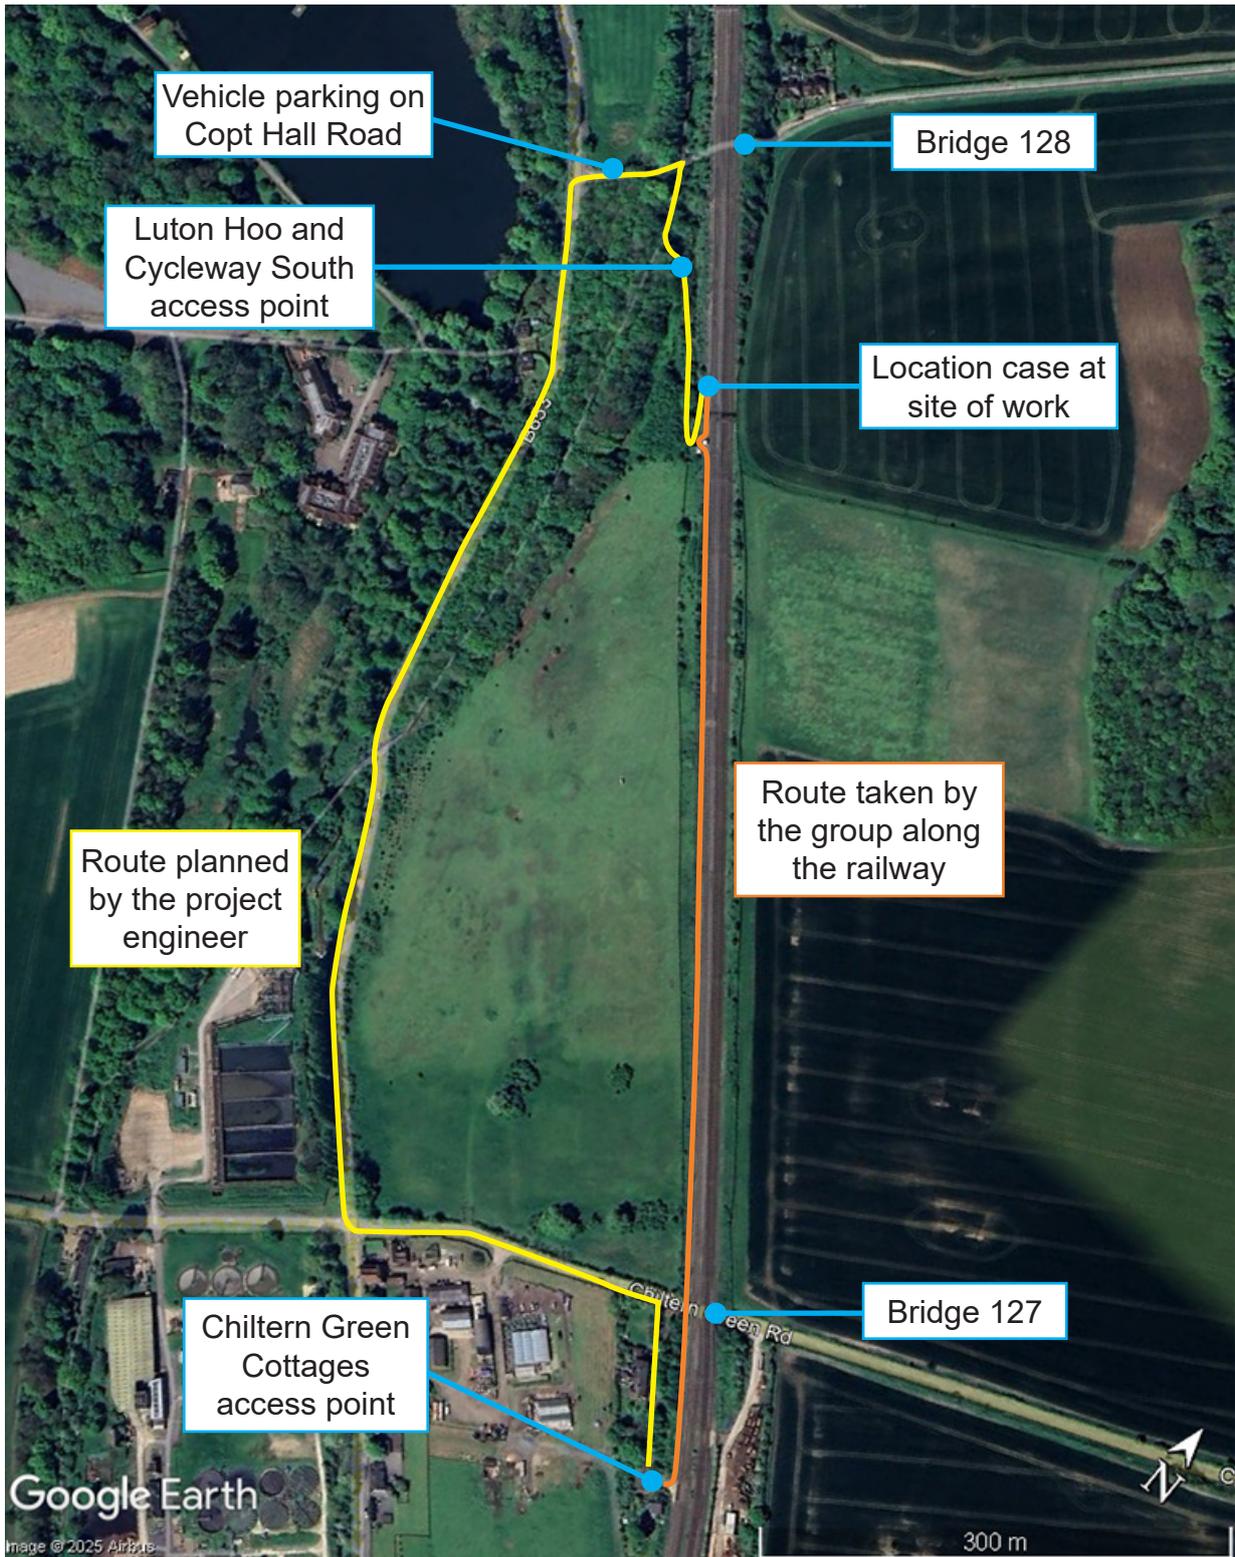
- 63 The route taken by the PIC to get to the location case meant the group had to cross bridge 127 and then walk a further 595 metres along the cess. Had the project engineer planned for the group to cross bridge 127, because of the restricted clearance over it, the project engineer could have planned for the PIC to take a line blockage. This involves a signaller preventing trains from moving on a section of a railway line, by placing or maintaining signals at red (danger). That section of line is then blocked, according to defined rules, which then allows a COSS and their group to either carry out work that affects the safety of the line, or to gain access to or work in a place which otherwise would be unsafe to go into while trains are running.

Figure 14: The route the project engineer had planned for the group to take versus the route taken by the group (courtesy of Google with RAIB annotations).

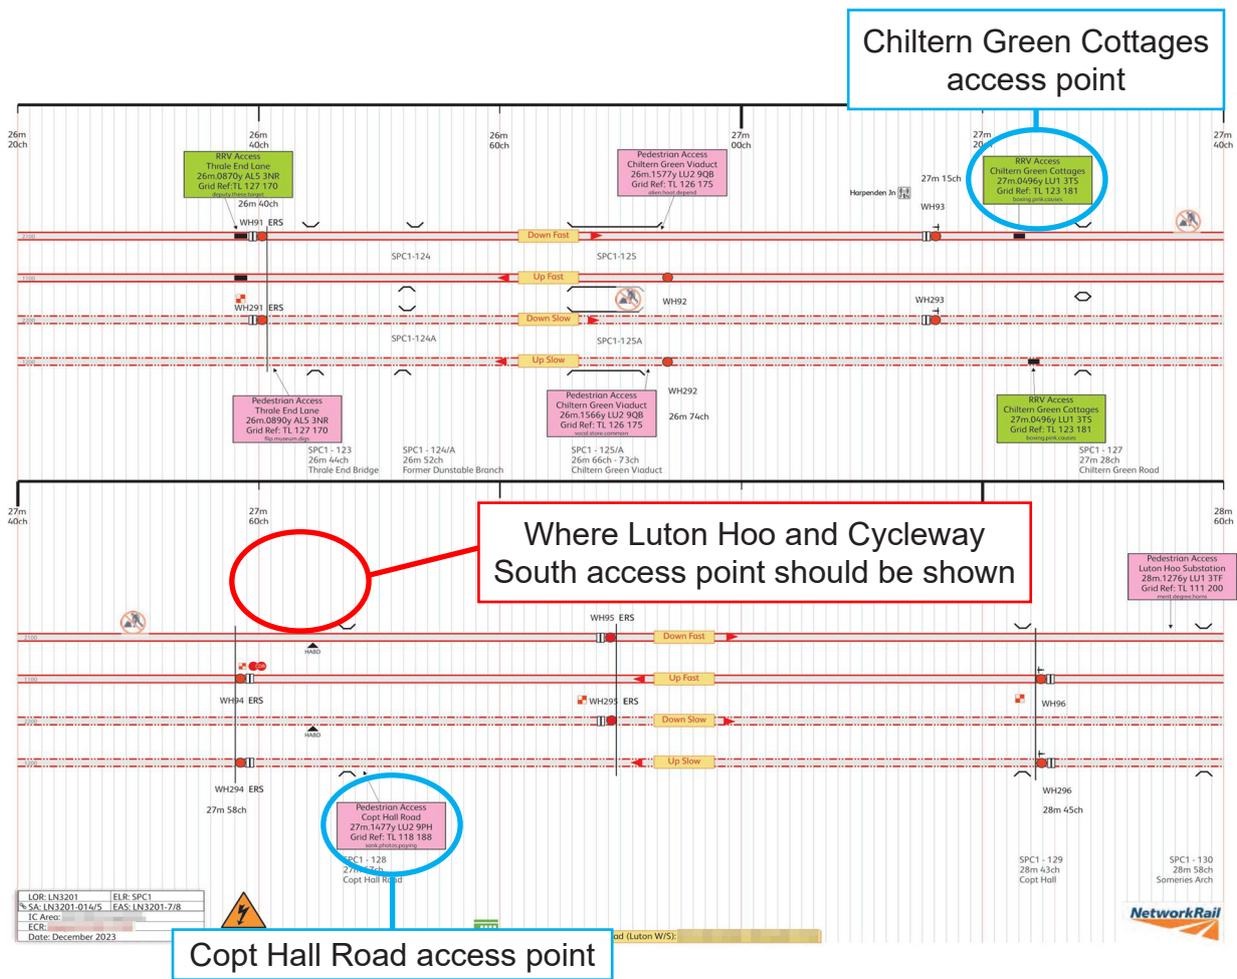
- 102 As the PIC did not know the whereabouts of the location case they needed to go to, and with no clear information in the SWP to guide them, they decided to walk to the location case from the Chiltern Green Cottages access point. The logic used was that the group would get to the correct location case at some point. This decision was also influenced by the PIC discounting Copt Hall Road as the second designated access point.

Figure 19: The line diagram extract in the SWP (courtesy of Linbrooke with annotations by RAIB).

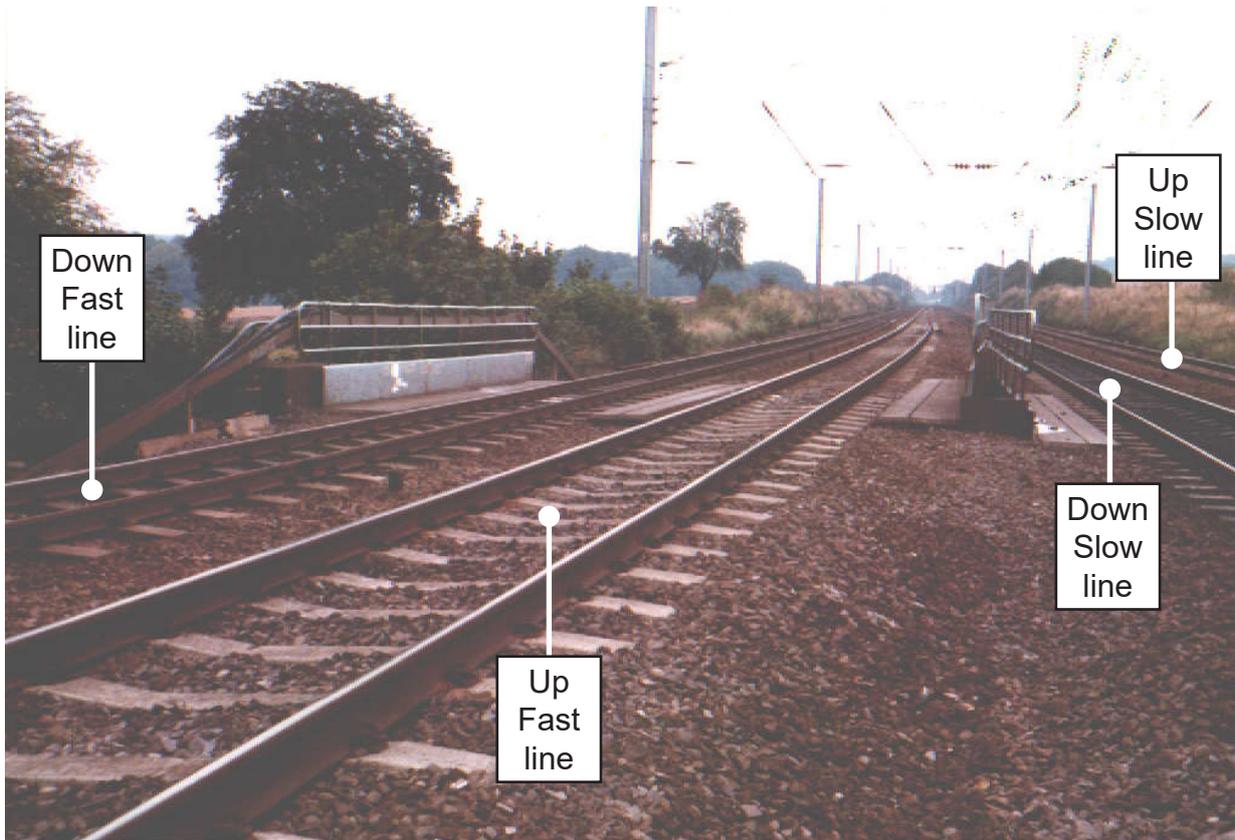
133 Bridge 127 is listed in the national hazard directory as a hazard due to it being a structure that has restricted clearance (paragraph 54). The date for this entry is recorded as December 1999. However, no limited clearance signage was fitted to the bridge to indicate this. Photographic records for the bridge, going back as far as 1981 (figure 21), show no limited clearance signage fitted to the bridge, so it is unlikely that these signs have ever been fitted to it.

Figure 21: Photograph of bridge 127 taken in 1981 (courtesy of Network Rail with annotations by RAIB).

137 RIS-3413-TOM requires Network Rail to provide limited clearance signage where a position of safety is interrupted for more than 2 metres, and the criteria for no refuges or prohibition warning signage are not applicable. The type of sign that should have been provided at bridge 127 is dependent on how these criteria are interpreted (see paragraph 154). However, no signage was fitted to the bridge.
