Rail Accident Investigation Branch

Rail Accident Investigation: Interim Report

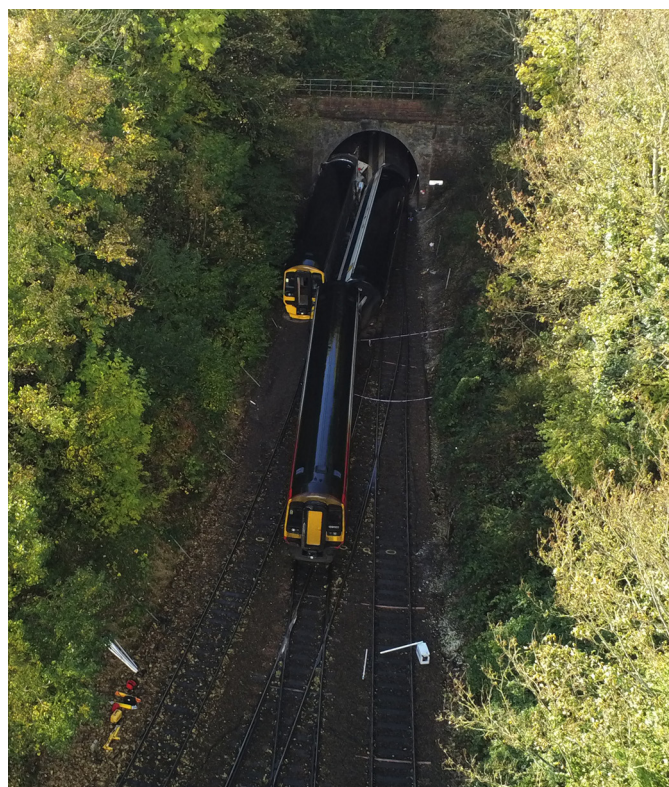
Figure 1: Aerial view of the trains involved once they came to a stand following the collision, showing the junction and tunnel mouth

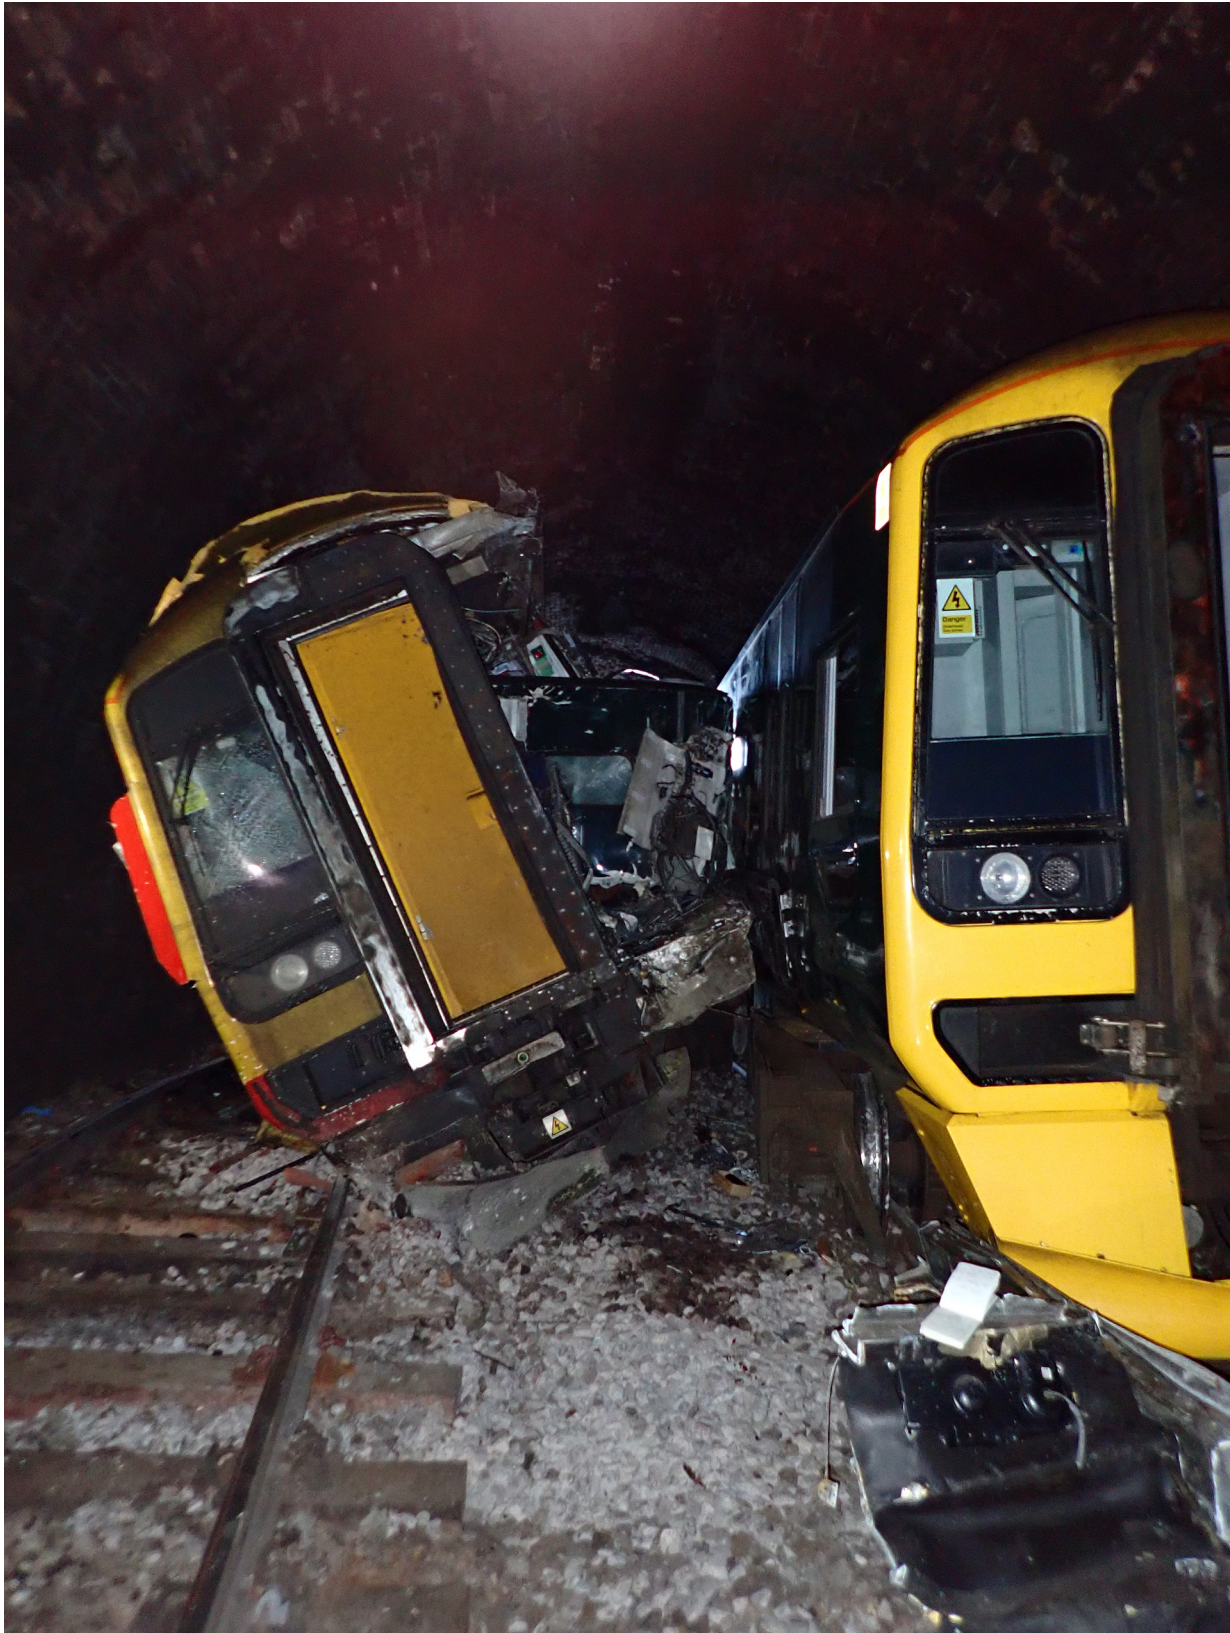
Figure 5: The scene inside the tunnel, showing the third coach of train 1F30 (right) and the leading coach of train 1L53 (left). Parts of the driving cab of train 1L53 have been cut away by the emergency services to release the trapped driver

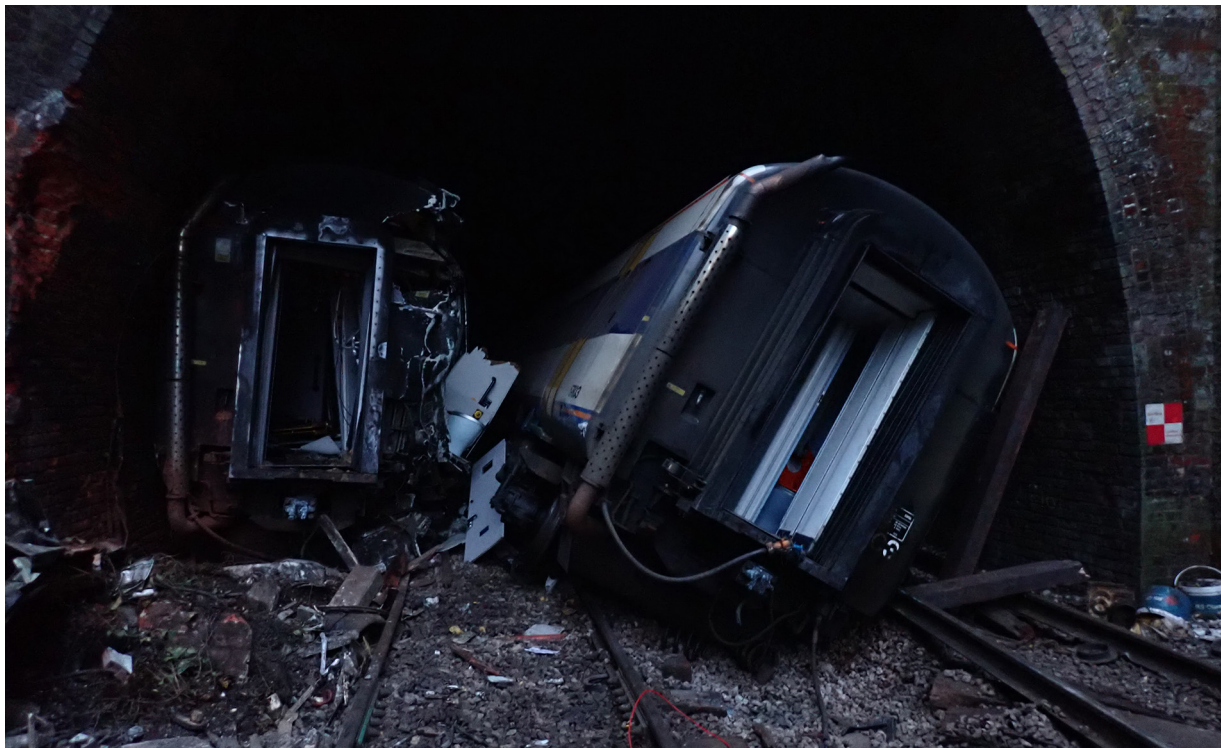
Figure 6: The scene during recovery of the damaged vehicles, showing the rear of the third coach of train 1F30 (left) and the first coach of train 1L53 (right), after the removal of the vehicles that had been behind them

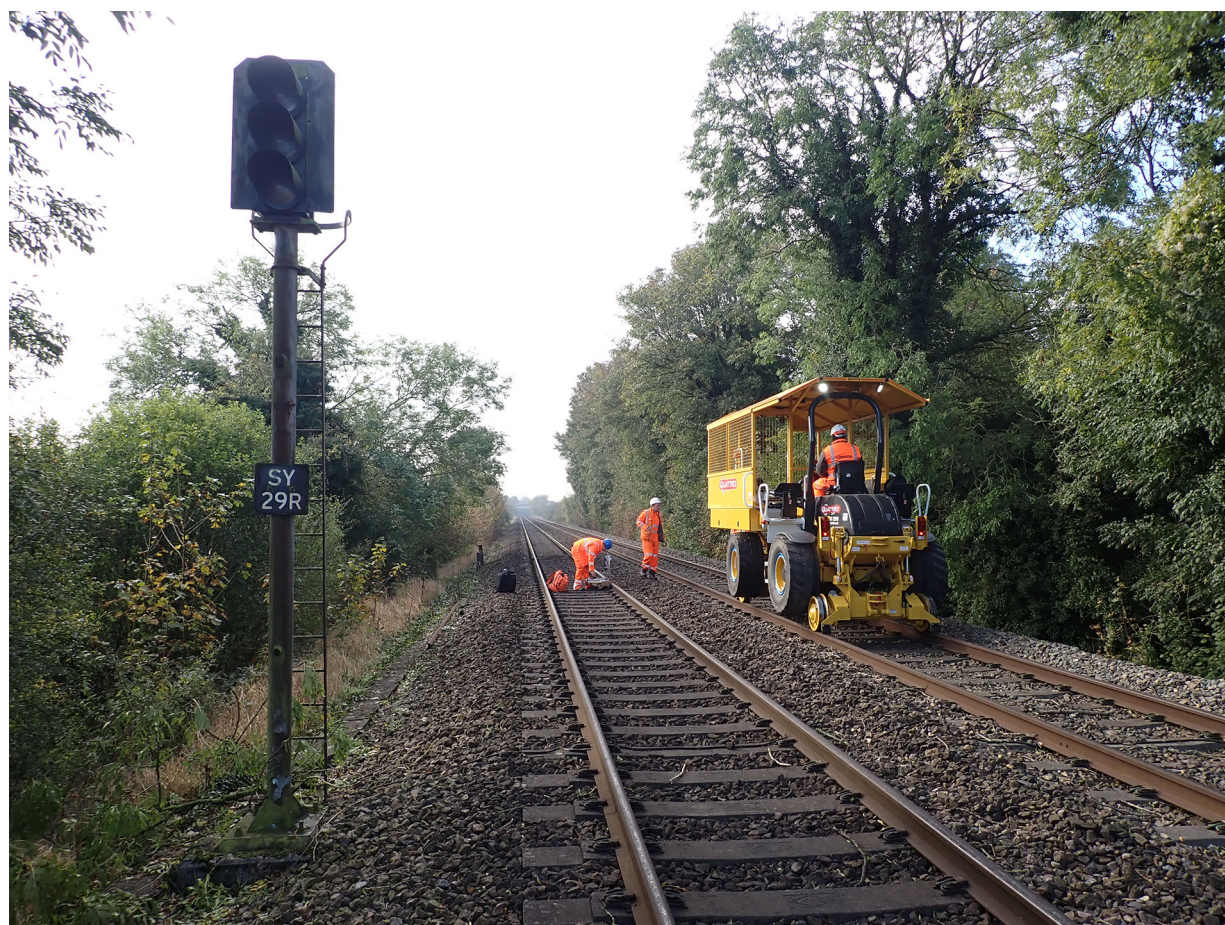
Figure 7: The railway at signal SY29R, looking towards Salisbury
