INTERIM REPORT

VERY SERIOUS MARINE CASUALTY

Interim report on the investigation into the foundering of the yacht *Bayesian*, with the loss of seven lives, 0.5 nautical miles south-east of Porticello, Italy on 19 August 2024

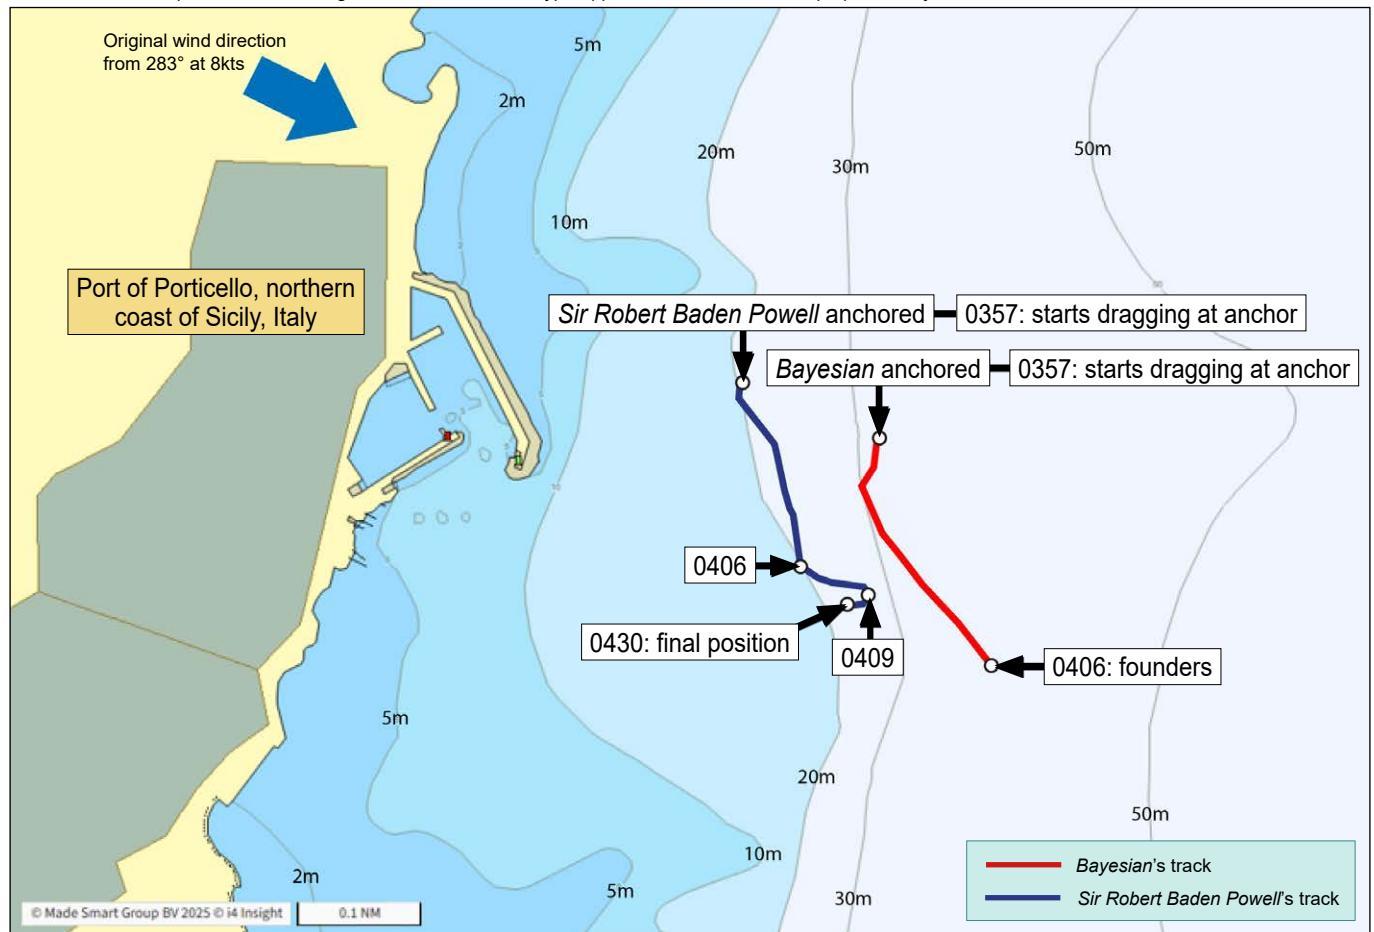
Figure 2: Location and tracks for Bayesian and Sir Robert Baden Powell on 19 August 2024

At around 0357, both *Bayesian* and *Sir Robert Baden Powell* started dragging their anchors in the rapidly worsening weather.

Bayesian was lying with the wind about 60° off the port bow and moving at 1.8kts south-south-east of its original position (**Figure 2**). *Sir Robert Baden Powell* was also dragging its anchor at a similar rate in a similar direction.

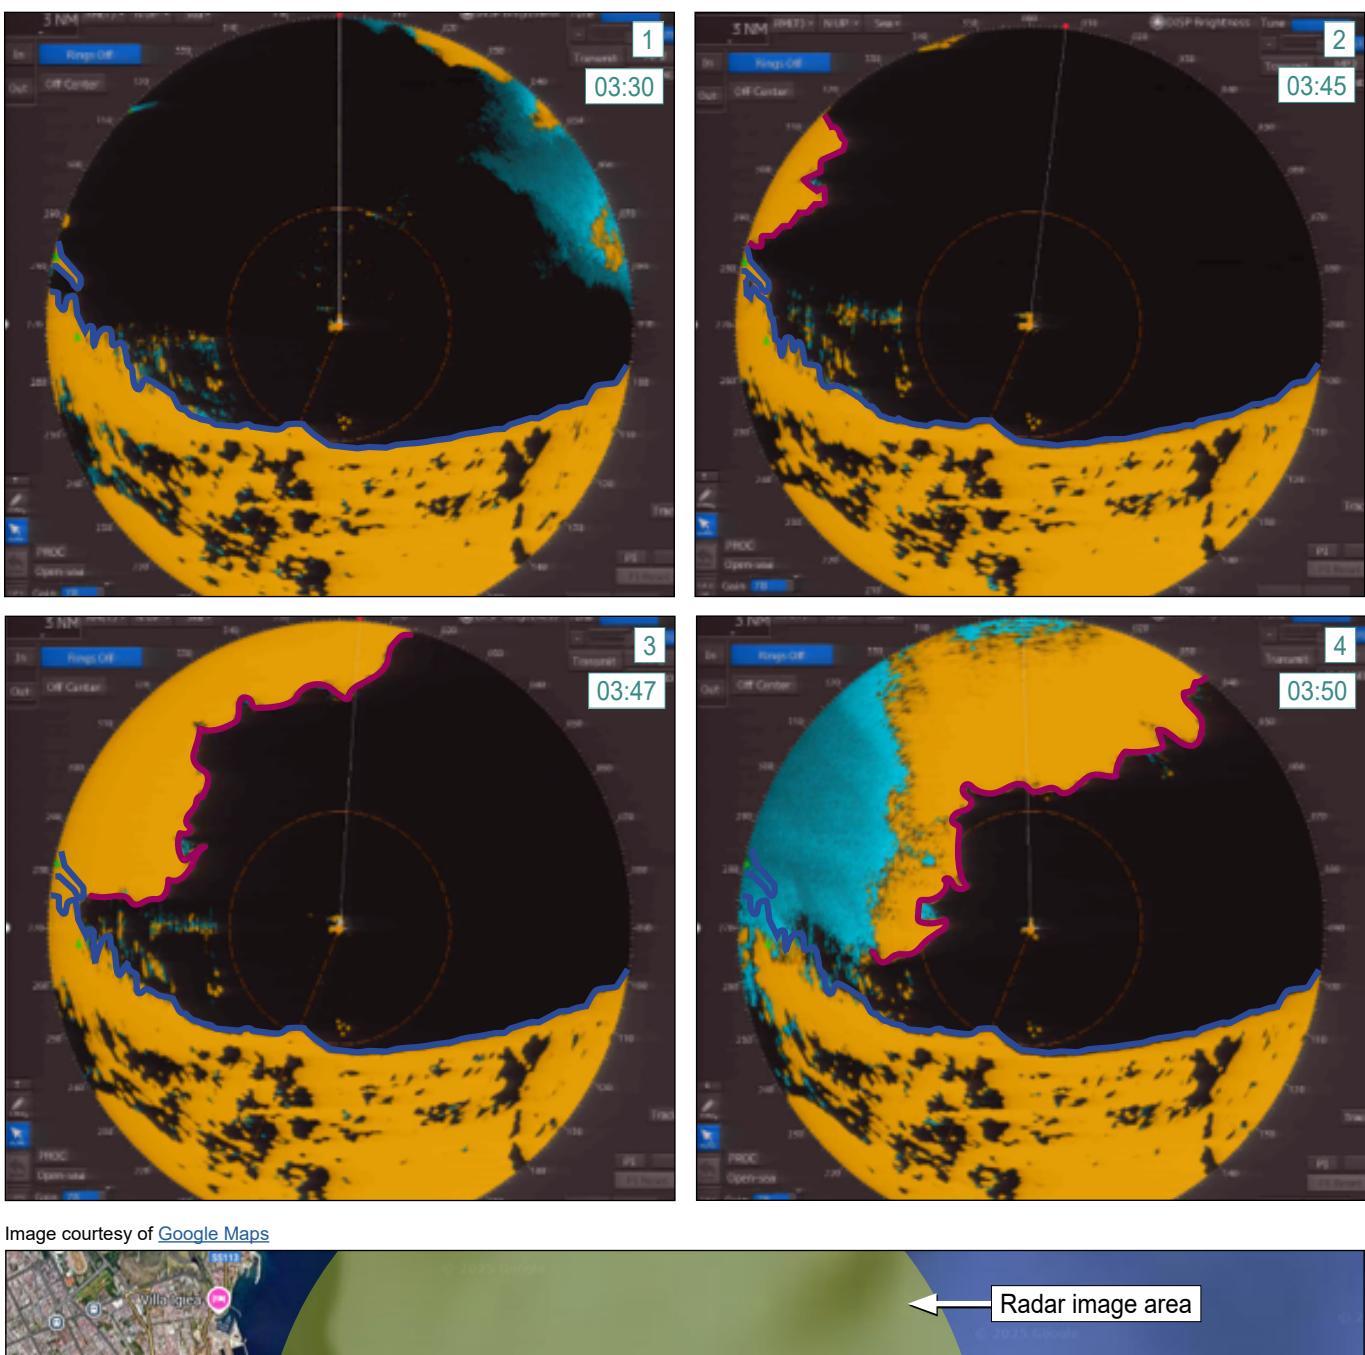
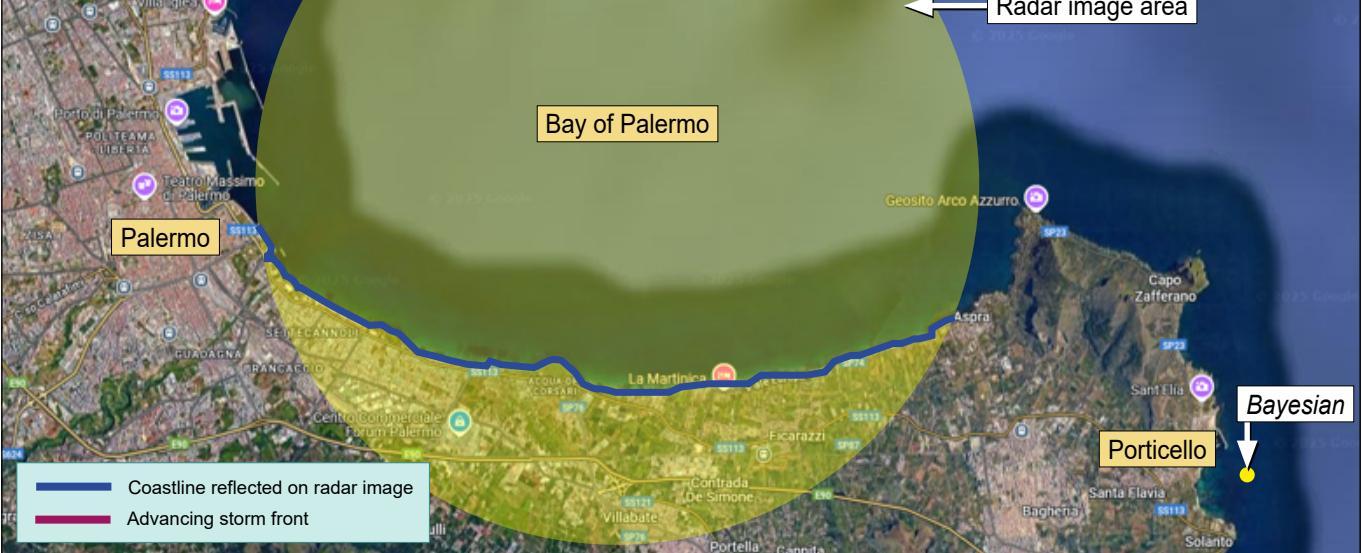
Figure 3: Radar images, showing passage of rain across the Bay of Palermo on 19 August 2024

At 0352 on 19 August 2024, around 5nm to the north-west of the Porticello anchorage, winds were recorded to have suddenly increased from around 5kts to 41kts from the north-west. These strong winds were associated with a storm front that passed quickly towards the rugged coastline near Bagheria and Porticello. This was observed on a nearby vessel's navigational radar (**Figure 3**). Several CCTV cameras in Porticello showed an intense squall of wind and heavy rain arriving, throwing debris around violently before moving on. This intense squall was associated with lightning strikes, thunder and very poor visibility. Land weather readings (recorded at 5-minute or hourly intervals) captured a peaking of wind strength as the intense squall passed.

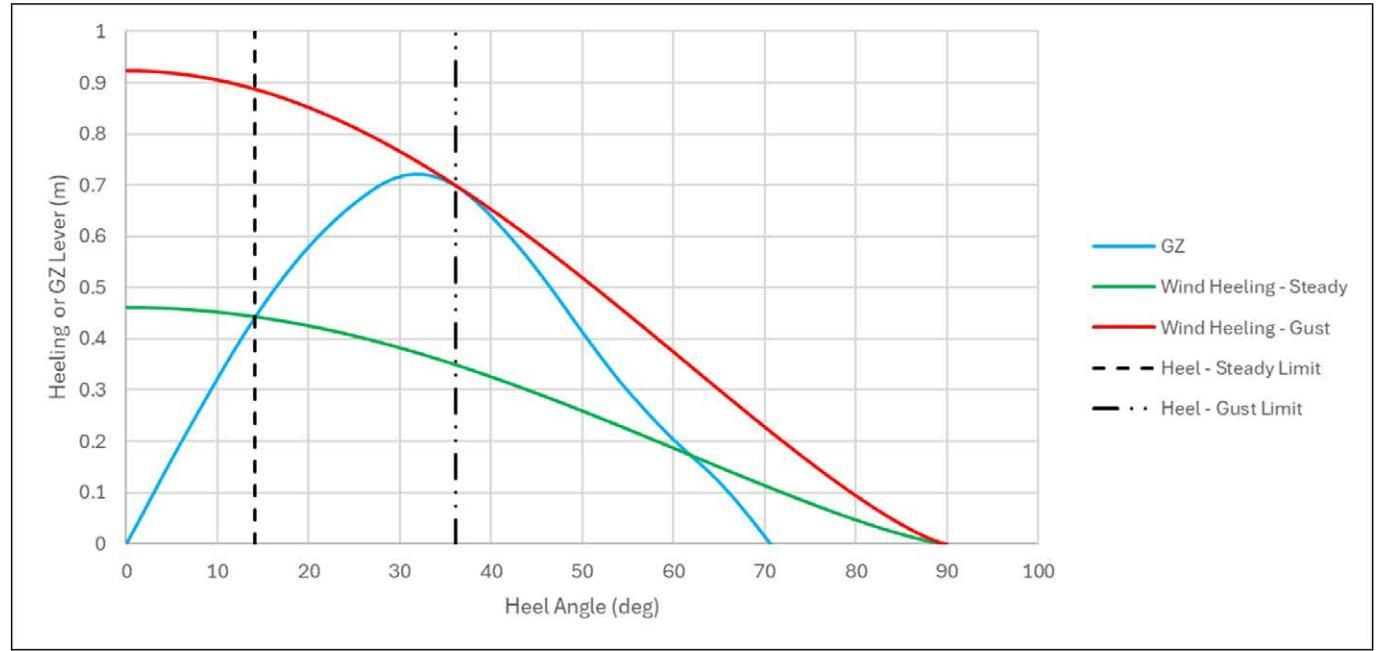
Figure 4: Derived wind heel data in assumed loss condition

Examination of a possible loss condition determined that the limiting heel angle¹⁰ for a steady wind was 14.2° and that the limiting heel angle for the associated gust was 36.3° (Figure 4). The study predicted the wind speeds that would produce those limiting heel angles for a range of apparent wind angles (AWA) relative to the bows, shown at **Table 1**. The table shows a high limit of wind speed, which included the impact of interactions and blanketing effects between different elements of the mast and rigging. The low limit describes the wind speed required to achieve the limiting heel angles if all the different elements of the mast and rigging are treated individually. More wind is required to reach that limiting heel angle when considering the blanketing effect that some of the rigging might have on the mast, for example.

The study indicated that if the wind was blowing directly onto *Bayesian*'s beam and the yacht was in the 'motoring' condition, a gusting wind speed in excess of 63.4kts would likely result in the vessel capsizing, irrespective of any interactions and blanketing effects.

Through 'desktop' assessment, the safety investigation has established that, in the assumed loss condition, once *Bayesian* heeled over to an angle greater than 70.6° (the angle of vanishing stability) there was no chance of a return to an even keel.

The investigation has also established that, in the assumed loss condition, wind speeds in excess of 63.4kts on the beam were sufficient to knock *Bayesian* over. It is possible that *Bayesian* was similarly vulnerable to winds of less than 63.4kts.
