SAFETY FLYER TO THE FISHING INDUSTRY

Capsize of the single-handed creel fishing vessel *Goodway* (FR23), with the presumed loss of one life, near Cairnbulg, Scotland, on 16 October 2021

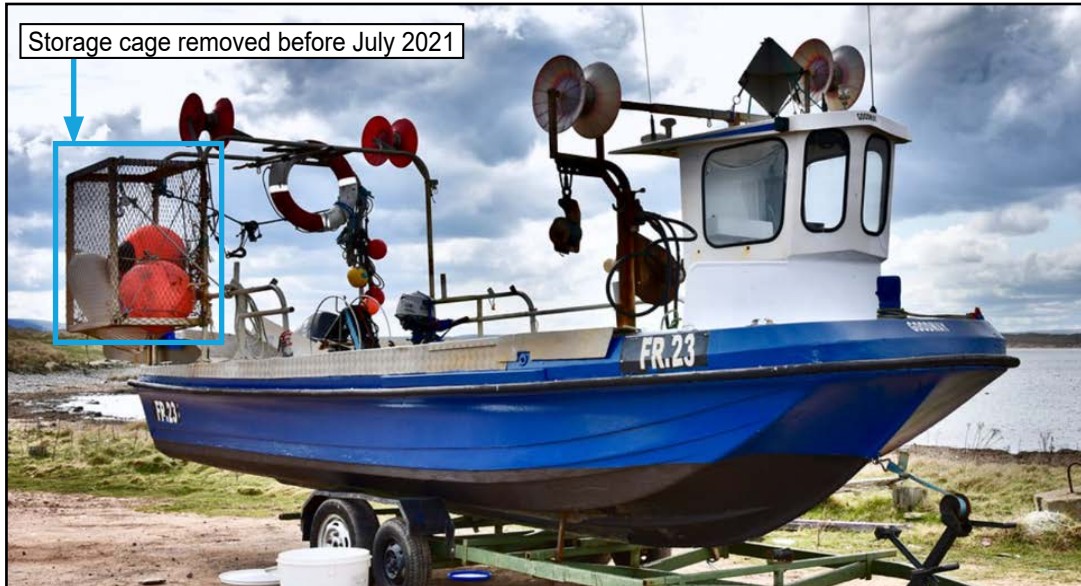
Figure 1: *Goodway*

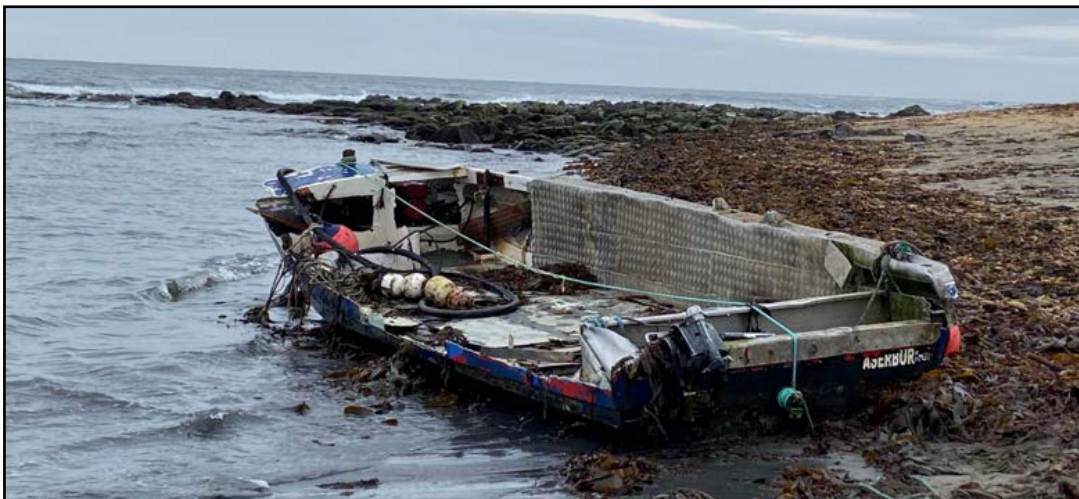
Figure 2: The wreck of *Goodway* washed ashore on Cairnbulg Point

The evidence indicated that the owner had attached the back rope of the snagged fleet of creels to the cleat on the starboard side of his vessel. It is likely that *Goodway* capsized when the owner used the outboard engine, which was offset to port, to drive the vessel forward in an attempt to free the fleet. It is presumed that the skipper fell overboard when *Goodway* capsized and he was unable to board the upturned hull or send a distress alert. It is unknown if the owner was wearing a personal flotation device (PFD) or carrying his recently purchased automatic personal locator beacon (PLB) at the time of the accident, as he has not been found and no alert was received from his PLB. *Goodway* was not fitted with a float free Emergency Position Indicating Radio Beacon (EPIRB) and the PLB purchased by the owner did not operate on the 406 megahertz (MHz) frequency required to transmit a distress alert to the coastguard.

2. There must be a means of reboarding the vessel or climbing onto an upturned hull from the water. A boarding ladder or tyres rigged down the vessel's side can improve a fisherman's chances of survival.

3. The ability to send a distress signal from the water could save a life. Many types of PLB are available on the market and fall into two distinct groups: 406MHz and AIS. A single-handed fishing vessel must carry a 406MHz PLB if it is not fitted with an EPIRB. This is the only frequency that operates on the global satellite alerting network and, when manually operated, can immediately transmit an alert. To be effective in an emergency situation, a PLB must be fit for its intended purpose. It should be attached to a PFD and its user should know how to activate it.
