Rail Accident Investigation Branch

Rail Accident Report

Near miss at Farnborough North footpath level crossing 19 May 2022

Report 04/2023
April 2023

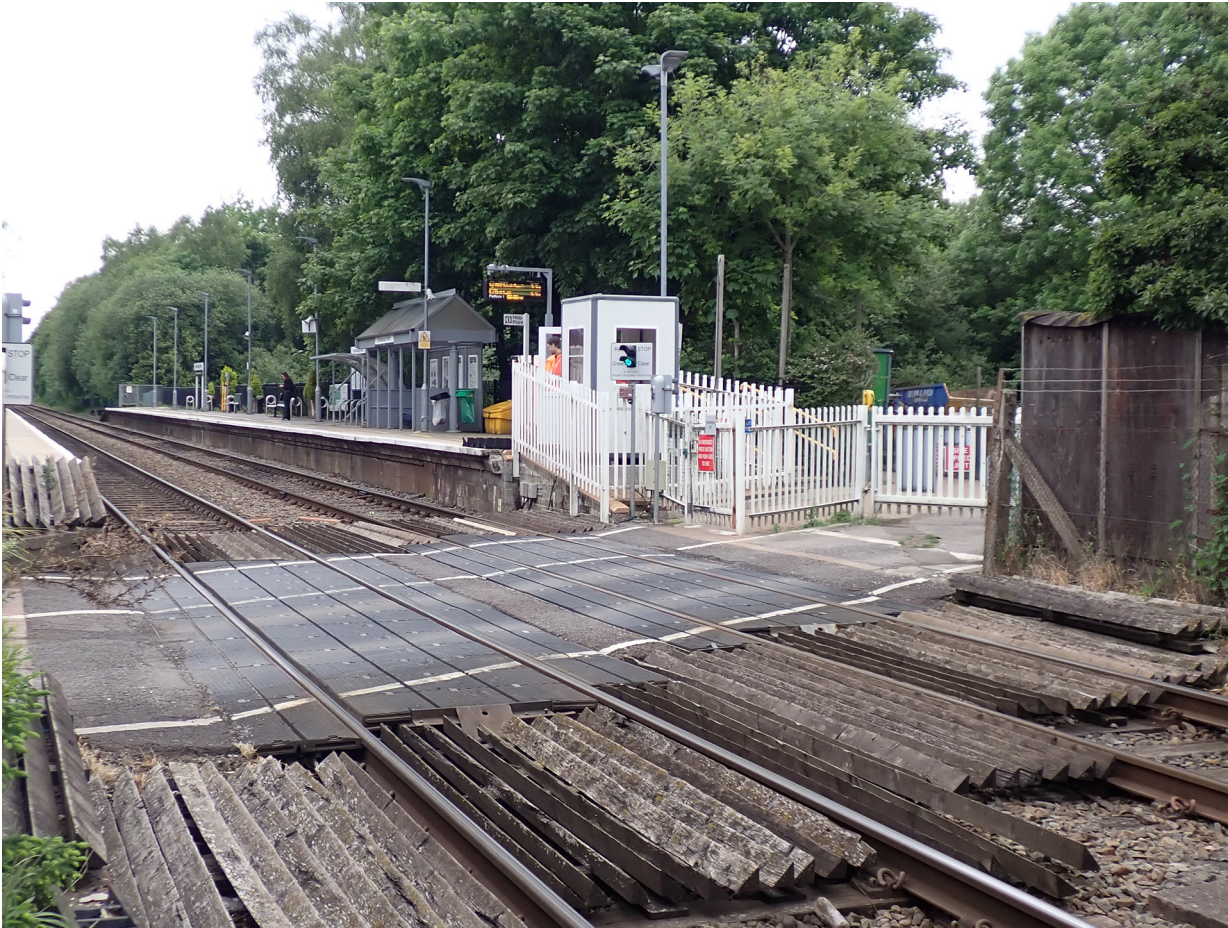
- 83 The location of the attendant's cabin was inside a fenced compound for security, but this also meant they had no direct access to the crossing gate if they needed to directly intervene as became necessary on 19 May 2022 (figure 2 and figure 12).

Figure 12: Crossing keeper's cabin within a fenced compound.

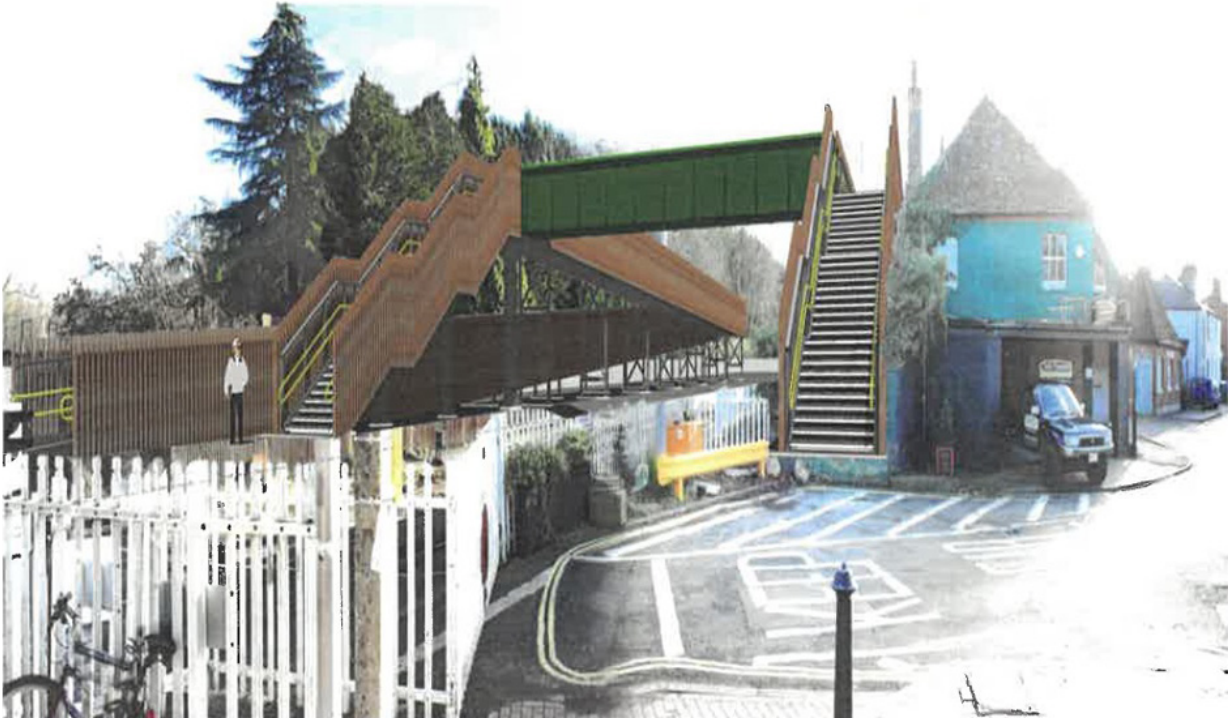
- 98 On 18 May 2018, Network Rail submitted a planning application for a stepped footbridge south of the crossing with ramps running south of the bridge (figure 13 and figure 14). The principal planning officer responded three days later stating that the application was invalid for a number of reasons. For example, the required ecological survey was not referenced in the application pack and not all the existing buildings to be demolished were shown. They requested further information before the application could be considered. However, Network Rail did not provide further information in response to the issues raised.

Figure 14: Visualisation of proposed 2018 footbridge looking south from near platform 2 (Network Rail).

- 100 Planning records show that Network Rail withdrew its planning application on 29 May 2018. The proposed scheme was therefore never formally considered by Rushmoor Borough Council.
