Report on the investigation of
the capsizing of the recreational craft

Wheelyboat 123

with the loss of two lives
on Roadford Lake, Devon, England
on 8 June 2022

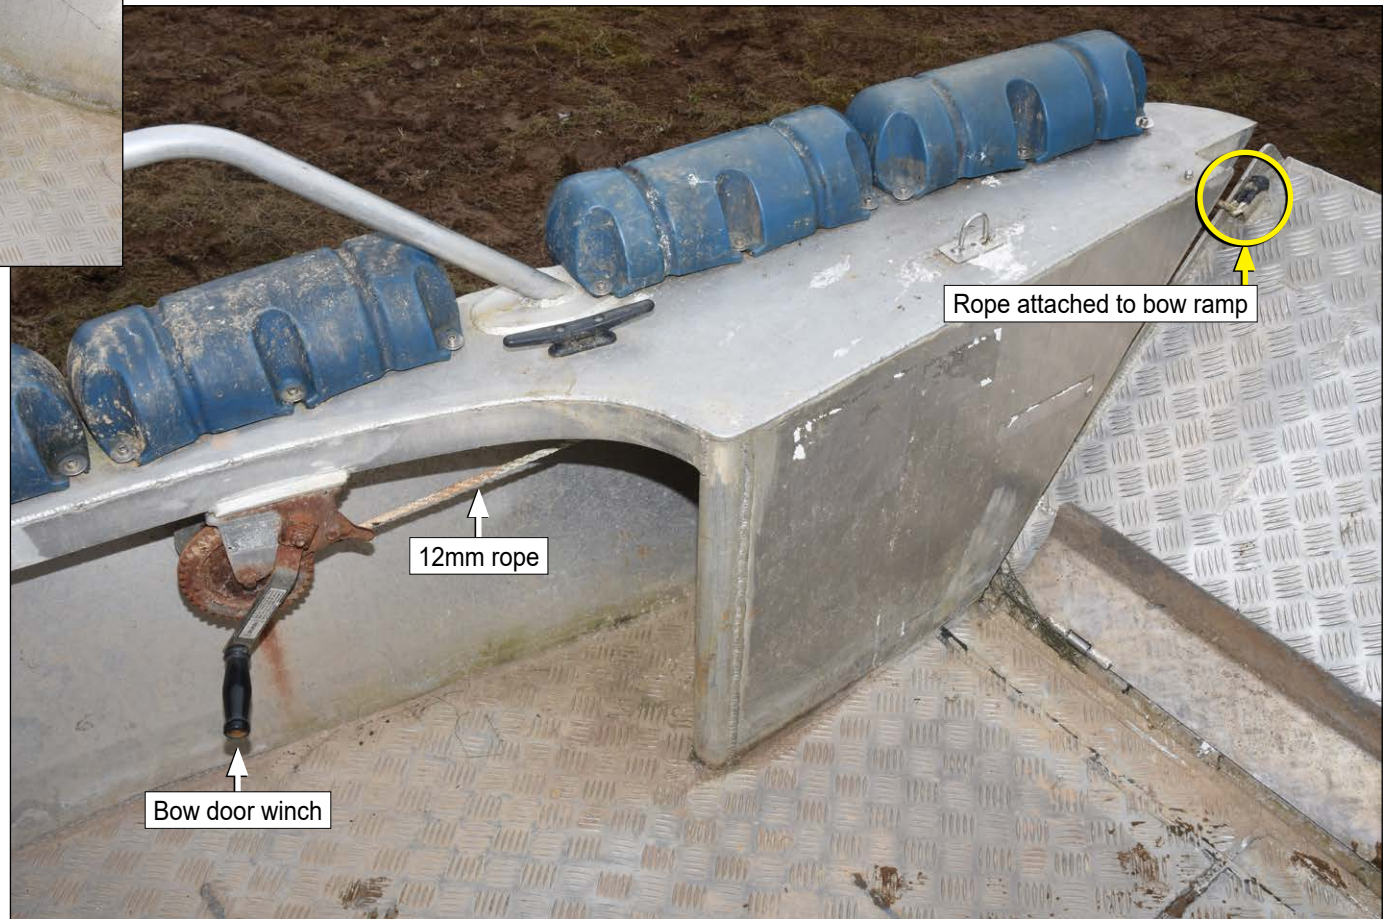
Figure 8: Bow door winch and safety clip

Observation	Figure
Safety notices and builder's plate missing from inside of bow ramp	Figure 8
Bow ramp vertical seals did not extend the full length of the bow ramp channel. A 150mm long section from the top of the channel was missing	Figure 13
Bow ramp watertight seal was degraded and deformed with small amounts of debris embedded in the seal	Annex D – E1, E2 & E3
A chalk test on the bow ramp seal indicated areas where the seal was not effective	Annex D – E3
The bow ramp seal failed a hose test allowing water to pass the seal	Annex D – E4
17 litres of water were drained from the starboard buoyancy tank	Annex D – E5
The buoyancy tanks' drain plugs were mismatched and the starboard plug was ill-fitting and lacked seals	Annex D – E6 & E7
There were small cracks in the deck	Annex D – E8
On the bow ramp, the welded hinge plate had a circumferential crack	Annex D – E9
The bow ramp hinge pins and bores were worn allowing movement of the bow ramp on the seal	Annex D – E10

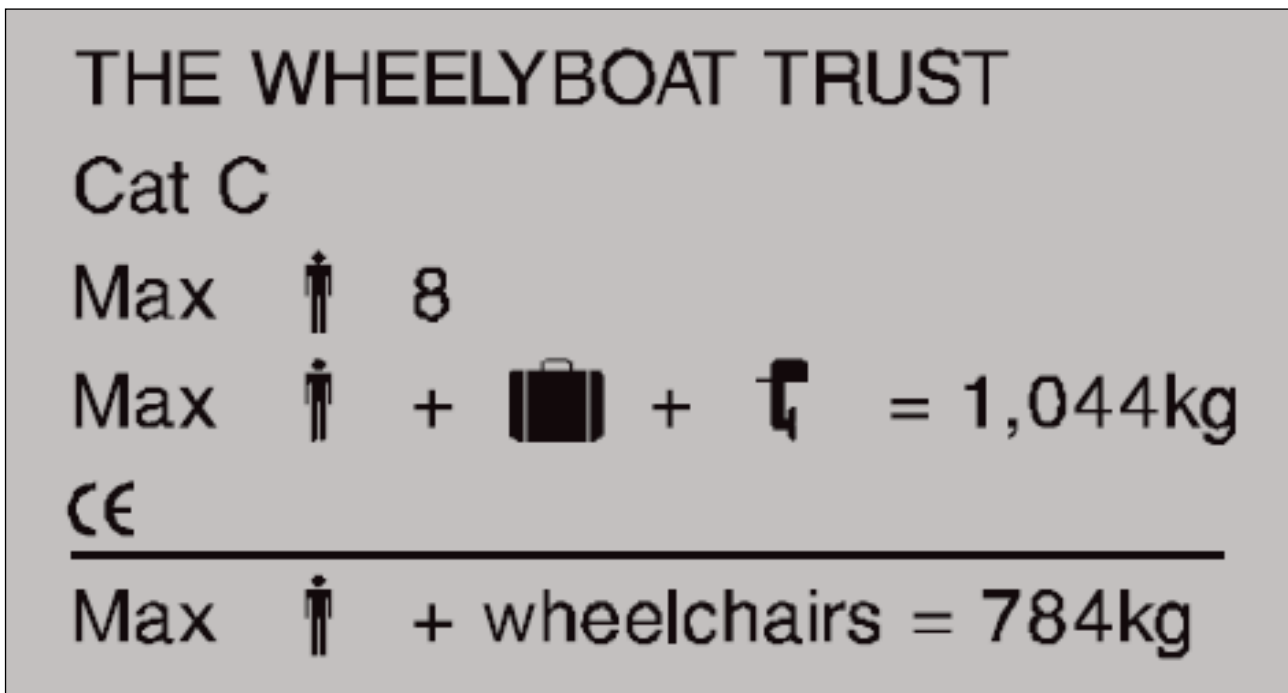
Figure 11: The 2009 modified boat builder's plate

The revised boat builder's plate (**Figure 11**) declared the maximum permitted load was eight people or a combination of wheelchairs and people up to an equivalent weight of 784kg. The total payload including engine had increased to 1,044kg. Operating with the crew limit of eight people or equivalent weight increased the boat's draught and the bow ramp threshold was just below the waterline when in use at the maximum stated crew limit of eight.

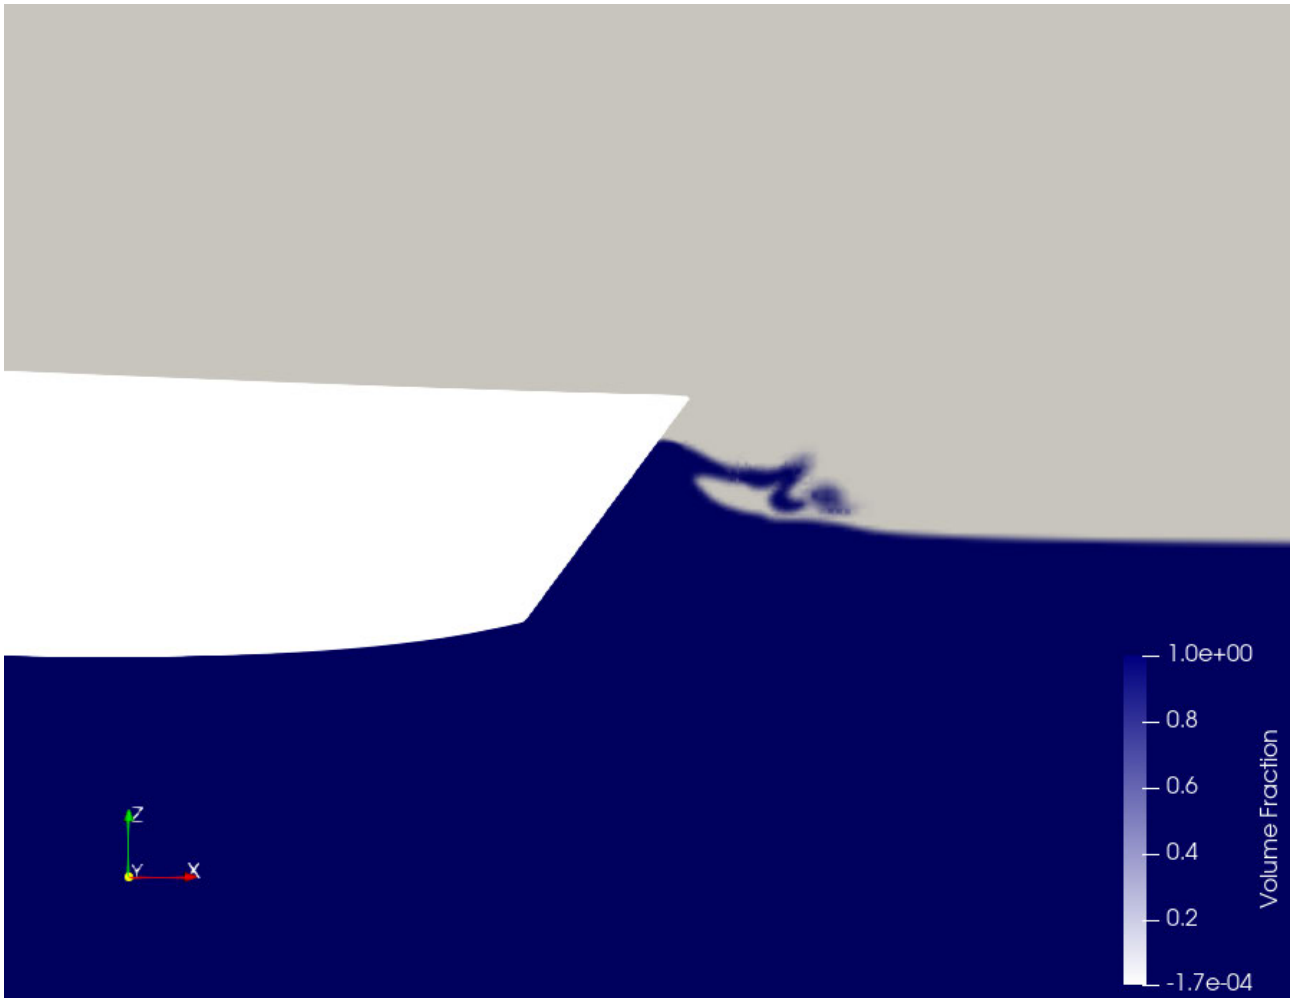
Figure 20 CFD predicted bow wave, loading condition: Pre-Turn #4, boat speed: 6 knots
2d slice through top of bow ramp seal, 475mm to port of vessel's centreline

The CFD results are presented in Table 8, renders of the wave pattern at 6 knots boat speed are shown in Figure 19 and a longitudinal contour of the bow wave in way of the port side ramp edge is shown in Figure 20.
