Report on the investigation of  
the capsizing and sinking of the tug

***Biter***

***Hebridean Princess***

off Greenock, Scotland  
on 24 February 2023

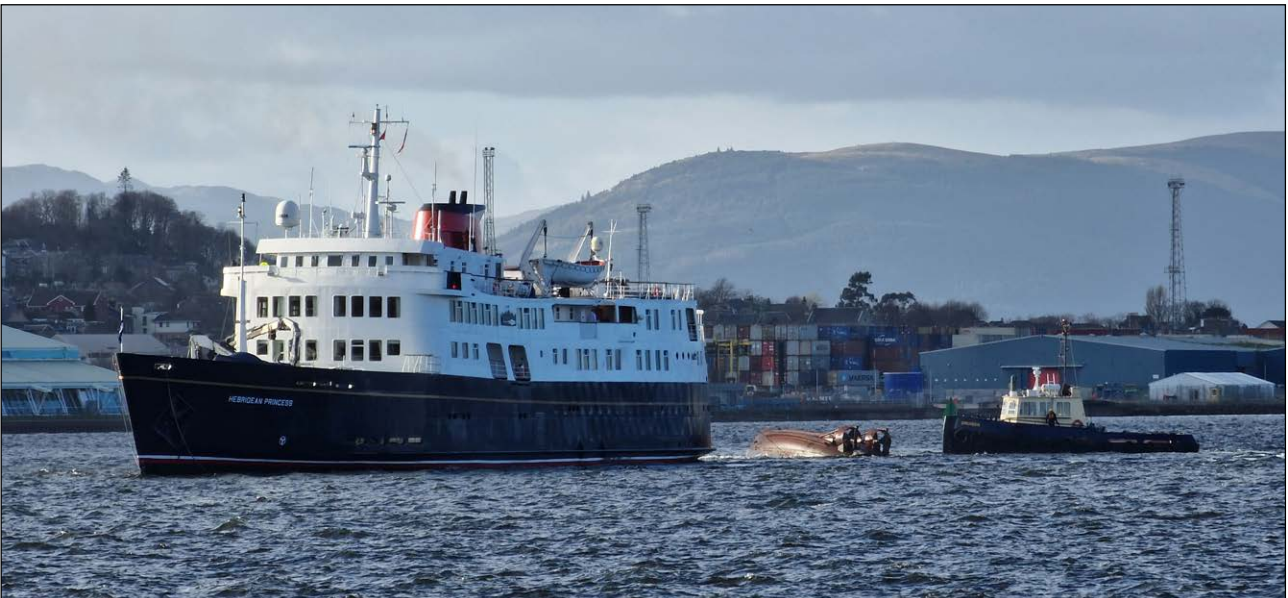
**Figure 7:** *Bruiser's* crew looking for survivors

On hearing *Hebridean Princess's* VHF report of the capsizing, *Bruiser's* master released their tug's towlines and manoeuvred close to *Biter* to look for survivors (**Figure 7**). By 1530, the crew of *Hebridean Princess* had cut the eyes of the port and starboard bridle lines connecting *Biter* to the passenger vessel.

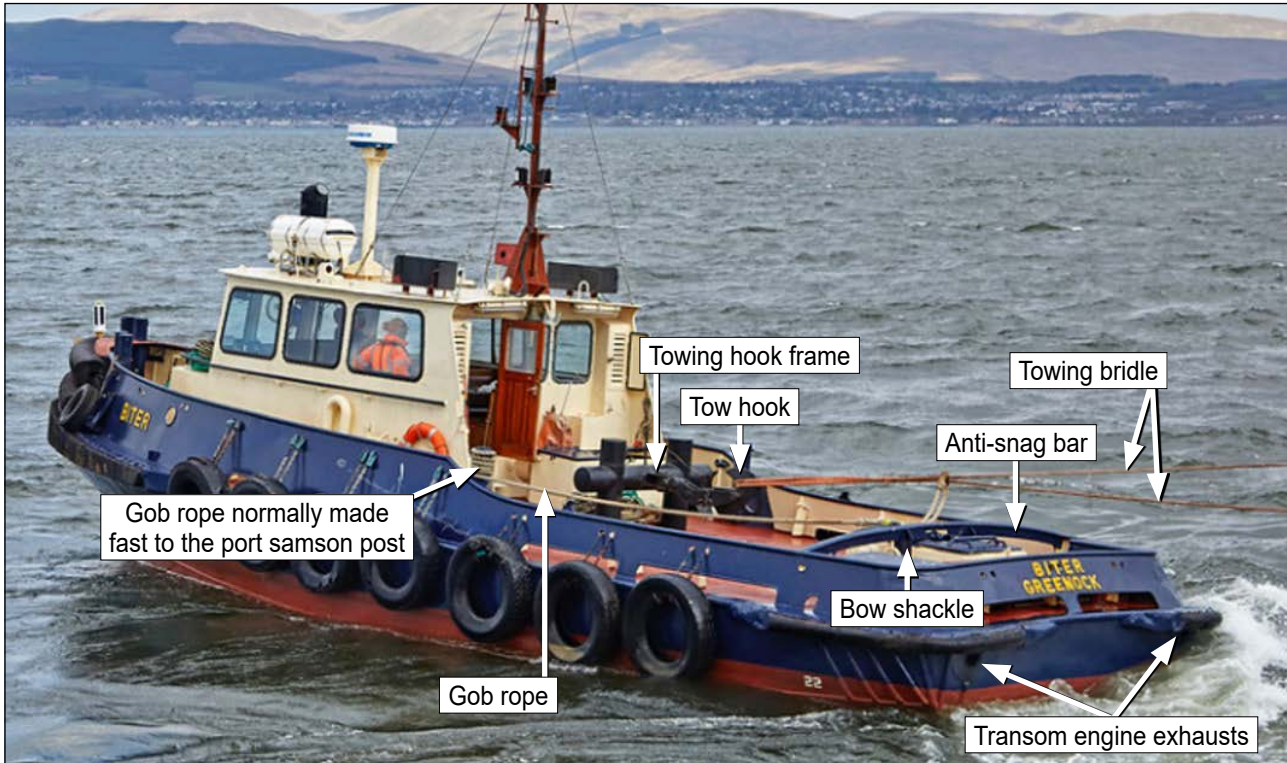
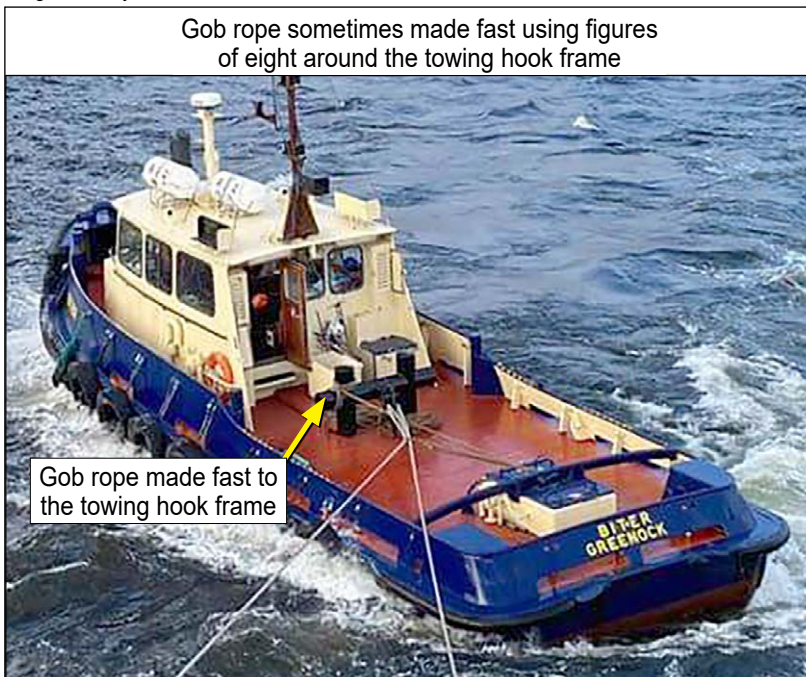
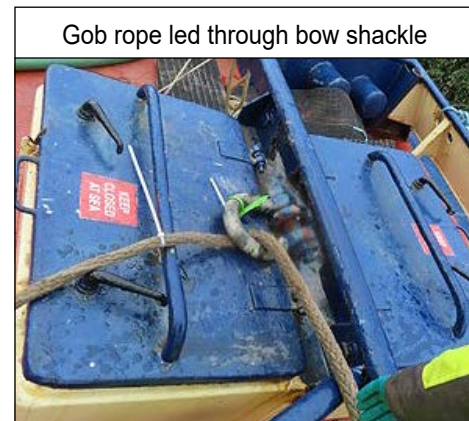
**Figure 9:** *Biter's* towing arrangements

For ship assist towage, where the vessel being assisted was not fitted with centreline fairleads, *Biter* used two 26m double-eyed tow ropes<sup>8</sup> known locally as a bridle. When made fast, one eye from each rope would be placed on the tug's tow hook, with the other eyes secured via fairleads to the assisted vessel's bollards on either side of its bow or stern. To ensure that the towing point remained at the aft end of the tug, these tow ropes were always led through the eye of the tug's gob rope (Figure 9).

*Biter's* gob rope was a 25m long, 22mm diameter, high modulus polyethylene (HMPE) fibre rope with a spliced eye at each end<sup>11</sup>. Compared to other types of rope, HMPE ropes had a relatively low coefficient of friction<sup>12</sup> and were therefore more prone to slippage. The gob rope was led through a bow shackle before being taken forward and secured to either the port side samson post or towing hook frame (see **Figure 9**).

The reason that the gob rope's securing arrangements were unable to withstand the load has not been identified. Potential causes include: the samson post securing arrangement, where the gob rope was wrapped 4 to 5 times around the post before locking turns were applied, was inadequate; or that the locking turns were inadvertently dislodged or lost during the manoeuvre. However, without guidance in the CMS SMS on gob rope securing arrangements the decision of how to secure the gob rope was left to the tug master. As a result, while most masters used the samson post, others placed figure of eights around the tug's towing hook frame (see **Figure 9**).

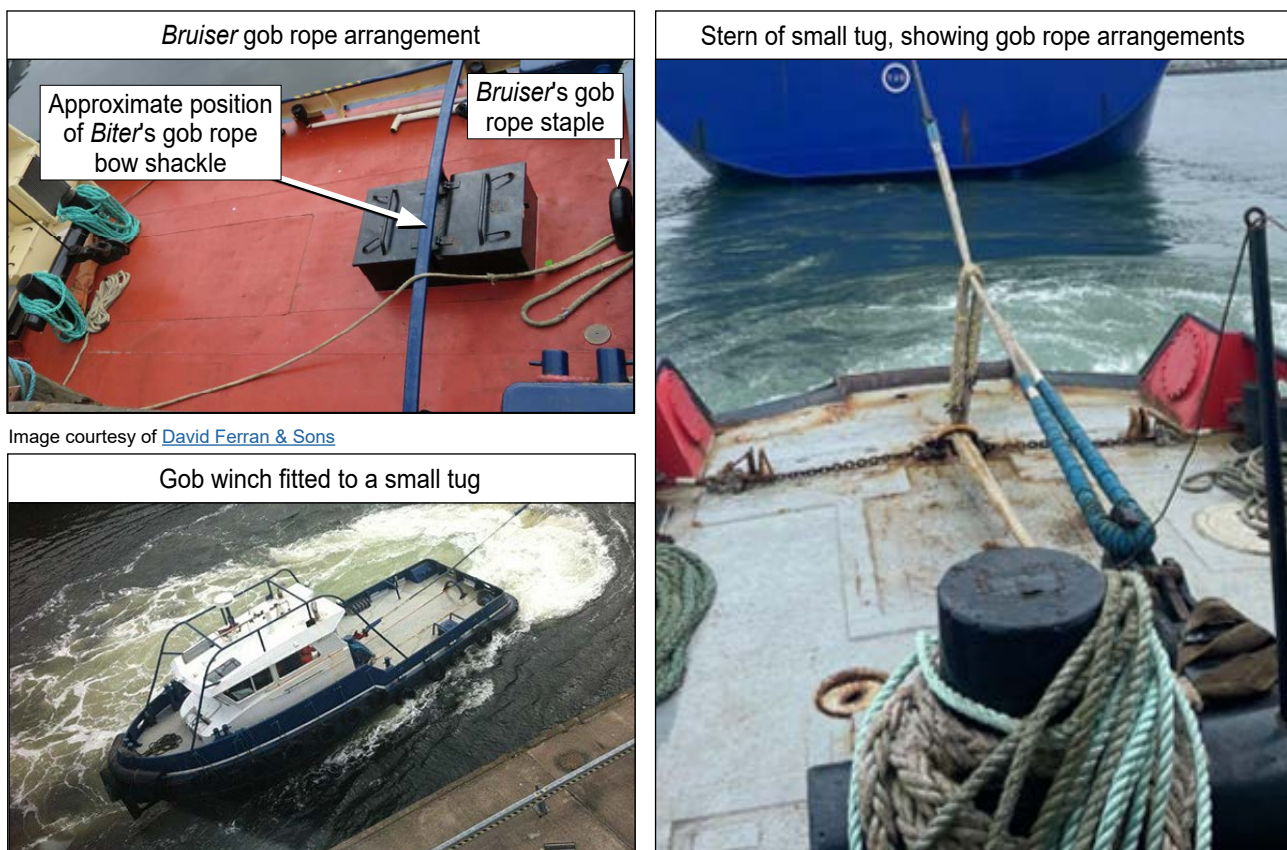
**Figure 12:** Alternative gob rope arrangements on similar conventional tugs

Some UK operators of similar small conventional tugs had adapted their vessels to move the gob rope securing point aft and fitted gob winches to allow the rope to be adjusted from the wheelhouse (**Figure 12**).

To reduce the risk of this occurring on their vessels, several operators of similar conventional tugs had modified their gob rope arrangements to lead the rope beyond the anti-snag bar, as low in the vessel as possible and as close as possible to the tug's transom. Some had also replaced the manual gob rope with a gob line winch, which could allow it to be adjusted from the tug's wheelhouse, although not while under tension (see **Figure 12**). These modifications moved the tugs' towing points as far aft as possible, increasing the effectiveness of the gob arrangements and reducing the likelihood of the tugs being towed sideways.

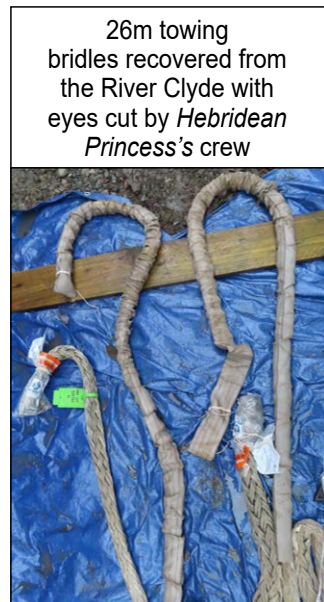
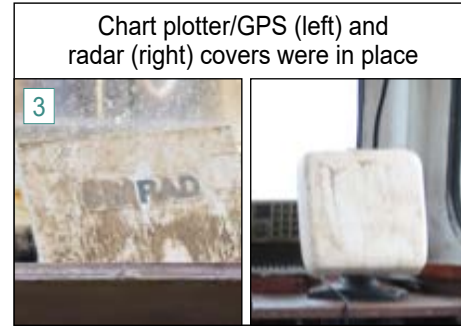
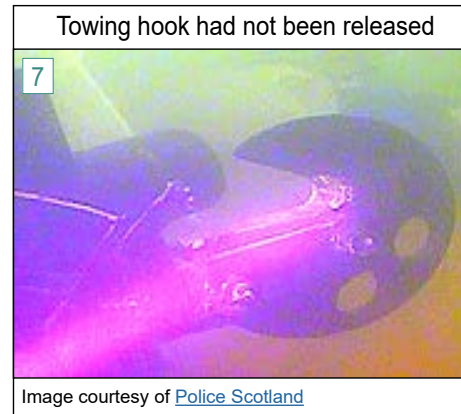
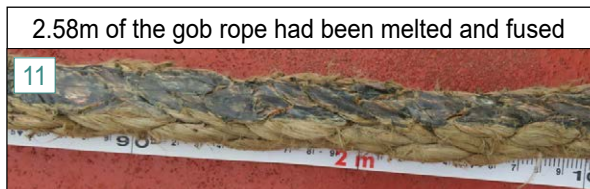
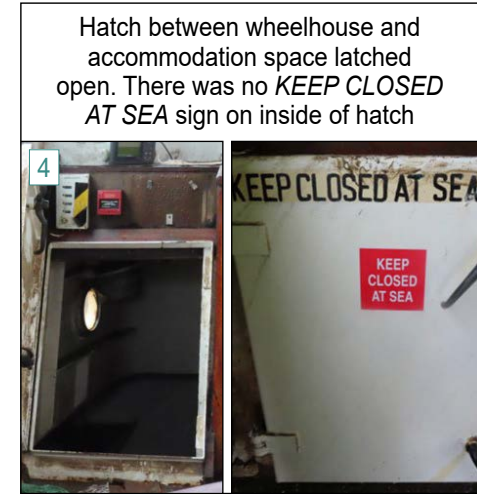
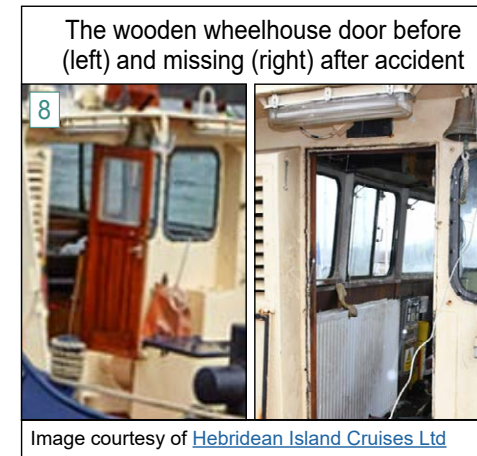
Figure 16: Biter post-accident inspection

*Biter* was inspected ashore after its salvage. The post-salvage inspection and photographs taken after the accident and during a Police Scotland dive inspection on 2 March 2023 resulted in the following observations (**Figure 16**):

- *Biter's* wooden external wheelhouse door was missing and the internal hatch between the wheelhouse and accommodation space was open. All other compartment doors and hatches were shut.
- Only one side of some of the doors and hatches was marked with *KEEP CLOSED AT SEA*. This warning sign was therefore obscured when the hatch between the wheelhouse and accommodation space was open.
- The chart plotter/GPS and radar displays in the wheelhouse were covered.

- The tow hook had not been released. When the tow hook was tested post-salvage, the local release mechanism at the hook and the emergency release wire located in the wheelhouse operated correctly.
