# ***AAIB Bulletin***

***5/2025***

<b>Aircraft Type and Registration:</b>	ATR 72-212 A, G-CMJM	
<b>No &amp; Type of Engines:</b>	2 Pratt & Whitney Canada PW127M turboprop engines	
<b>Year of Manufacture:</b>	2017 (Serial no: 1464)	
<b>Date &amp; Time (UTC):</b>	31 October 2023 at 0917 hrs	
<b>Location:</b>	On departure from Edinburgh Airport	
<b>Type of Flight:</b>	Commercial Air Transport (Passenger)	
<b>Persons on Board:</b>	Crew - 4	Passengers - 55
<b>Injuries:</b>	Crew - None	Passengers - None
<b>Nature of Damage:</b>	Fractured nose landing gear axle	
<b>Commander's Licence:</b>	Airline Transport Pilot's Licence	
<b>Commander's Age:</b>	61 years	
<b>Commander's Flying Experience:</b>	9,530 hours (of which 150 were on type) Last 90 days - 148 hours Last 28 days - 54 hours	
<b>Information Source:</b>	AAIB Field Investigation

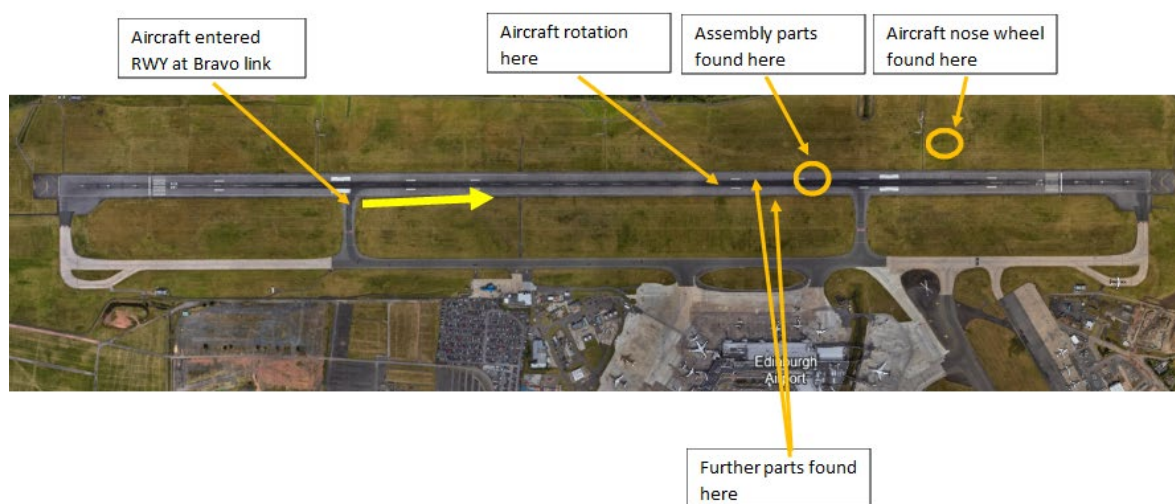
**Figure 1**

The nosewheel separated from the aircraft during takeoff from Edinburgh Runway 06 (Rwy 06) (Figure 1). It would not have been easily visible to persons in the control tower and was evident on the surface movement radar for only a couple of seconds before traversing off the side of the runway.

All components related to the detached nosewheel including the wheel axle nut were recovered. The locations at which the detached components were found at Edinburgh are as shown (Figure 1). There was no damage to the airport infrastructure reported.

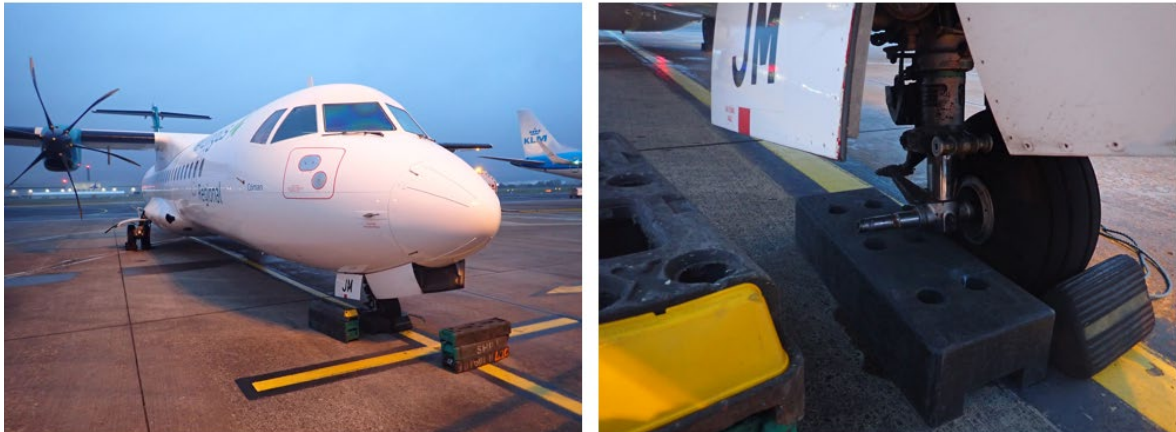
**Figure 2**

Following an ILS approach (which overflies the city of Belfast) to Rwy 04, the aircraft taxied uneventfully to its normal operational stand. Whilst the aircraft remained stable, additional support was provided to the nosewheel to provide increased support against the wind (Figure 2).

The aircraft as quarantined at Belfast City Airport

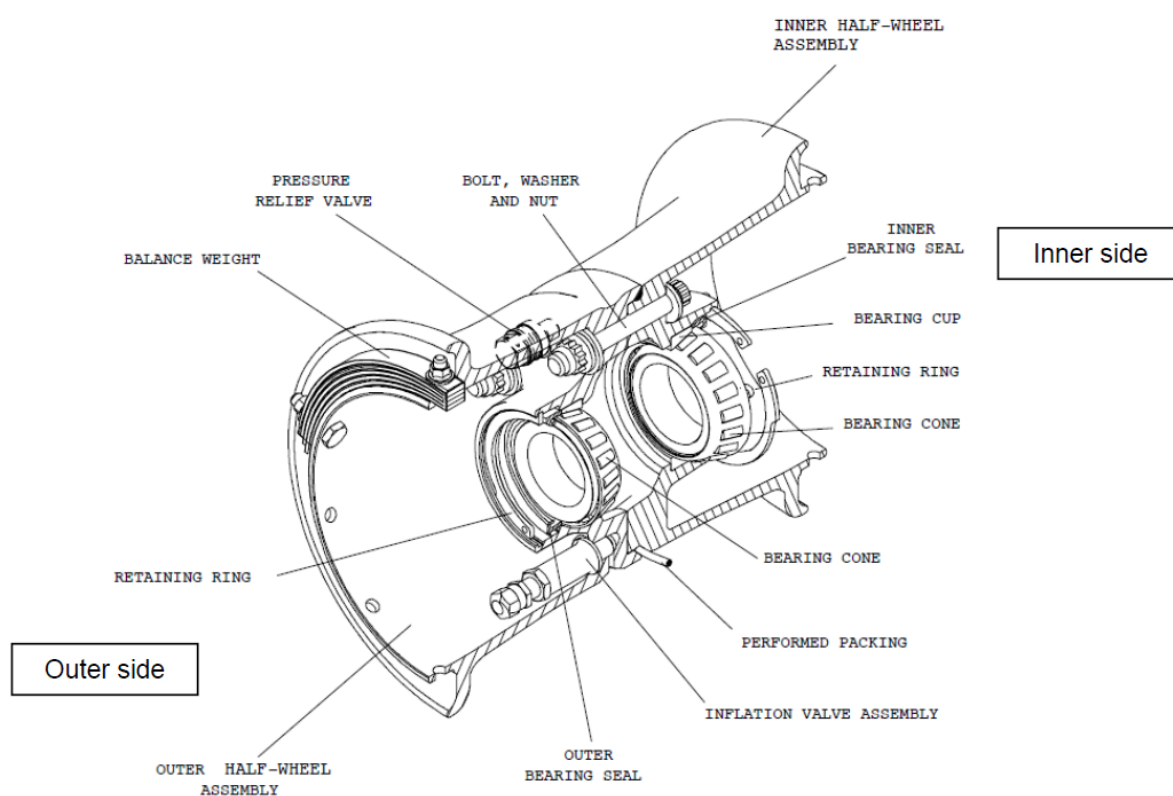
**Figure 4**

The right NLG wheel (design shown at Figure 4) was inspected and disassembled with the following main findings:

- The right NLG wheel assembly was found assembled with all tie bolts loose.
- No balancing weights were found fitted on either the outer or inner half-wheel sections<sup>1</sup>.
- The outer half wheel hub was found fractured.
- There was an interposition product found on the mating faces of the two half-wheels (Figure 5); this product is not allowed in this area<sup>2</sup> as it can lead to micro displacements of the two faces and tie-bolt loosening.
- Evidence of bearing grease indicated over-greasing of both bearings.

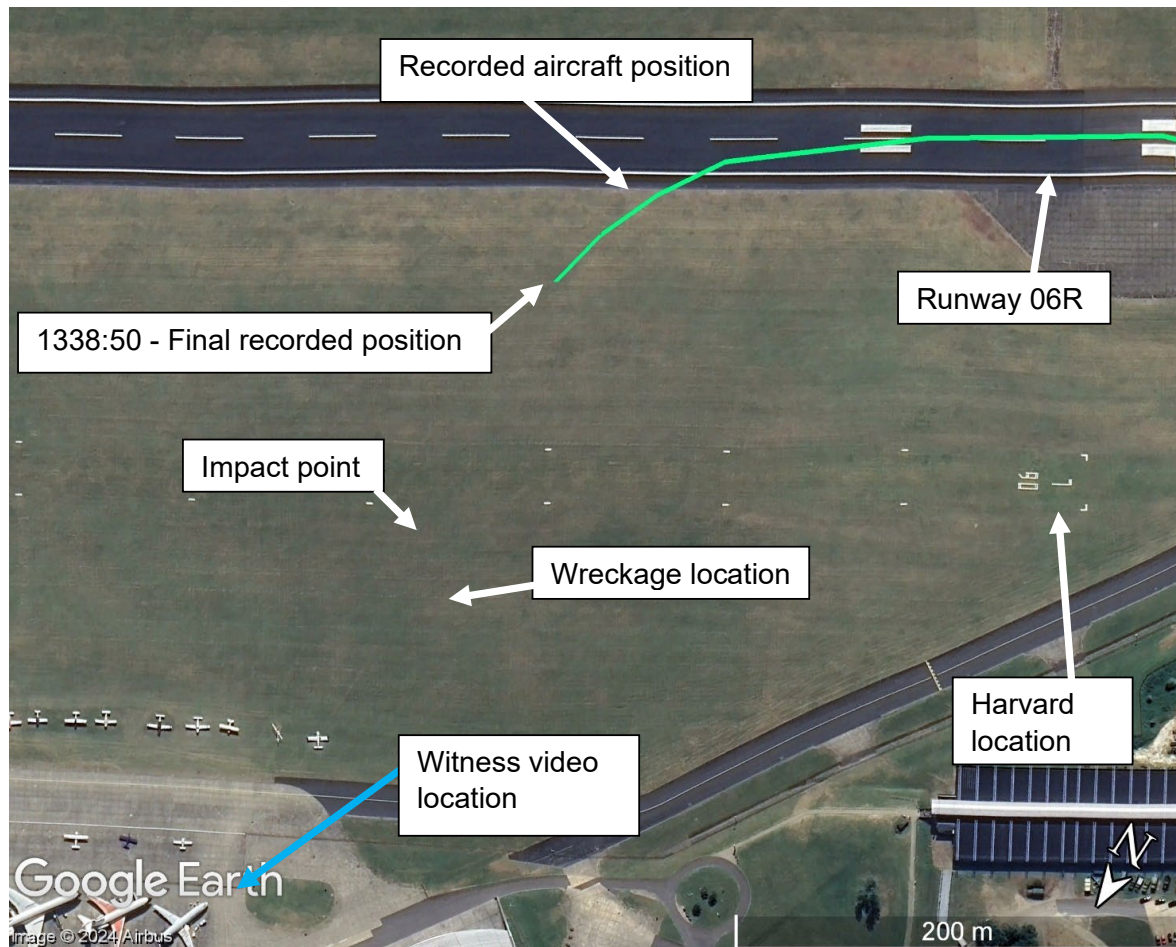
**Figure 1**

Two pilots in a Harvard T6 lined up on the parallel grass runway witnessed G-RGSK touch down. One stated that he saw the aircraft bounce about 2 ft on touchdown and that the flaps were down. The other commented that the aircraft attitude appeared higher than would be expected and that during the go-around he could “hear the propeller bite”, suggesting full power had been applied. G-RGSK passed in front of the Harvard T6 and struck the ground ahead and to the left of it. Figure 1 shows the recorded final track of the aircraft.

G-RGSK approximate accident track

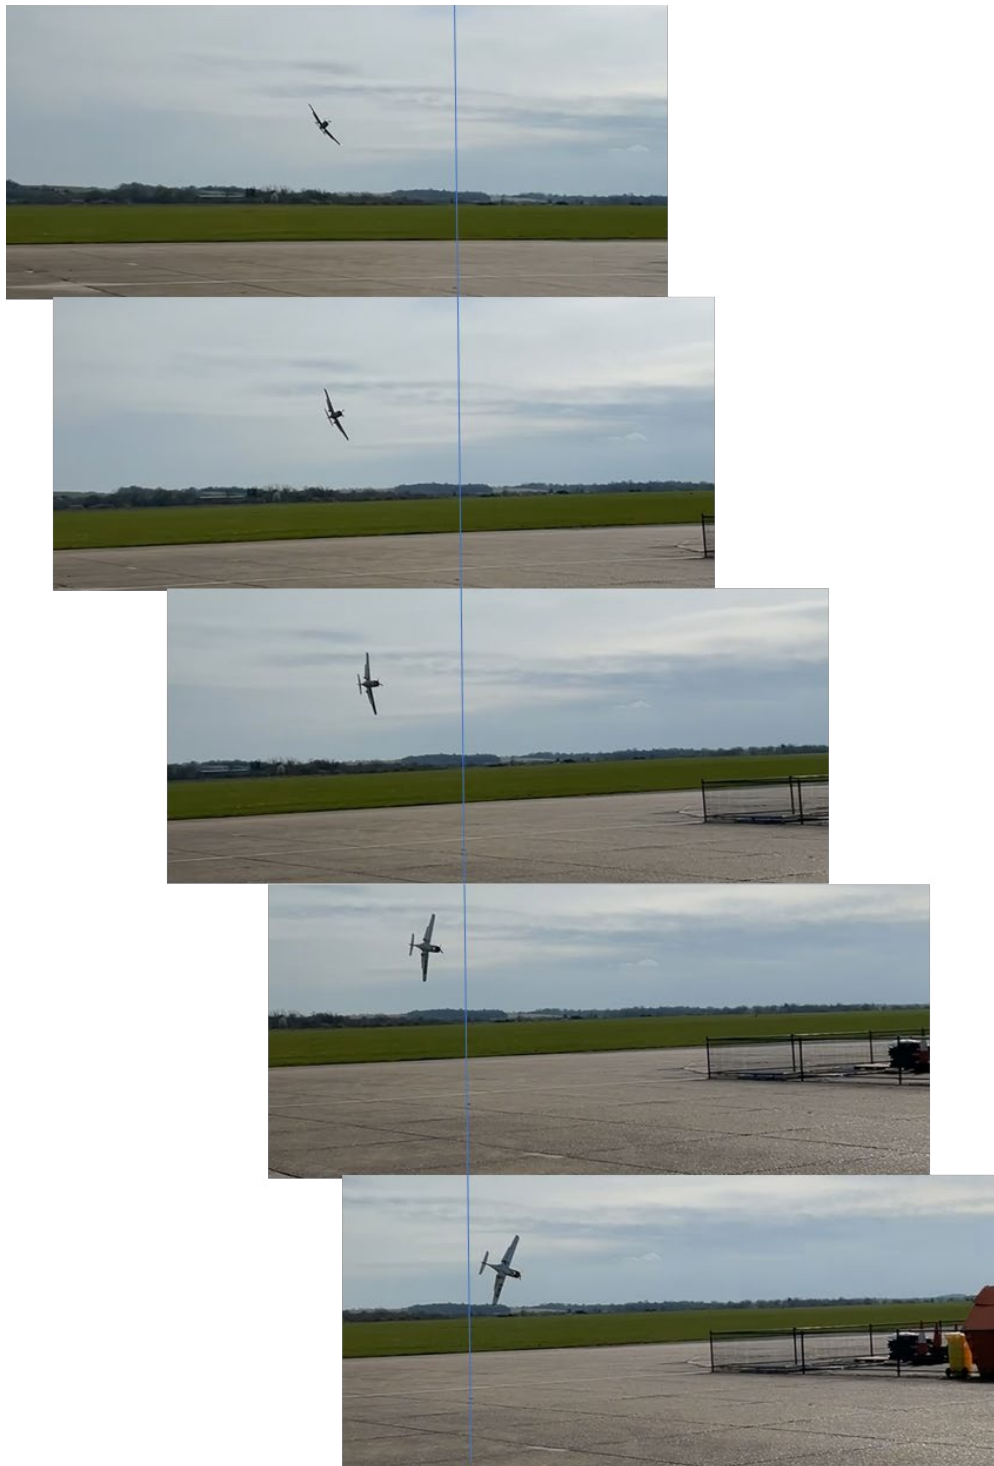
**Figure 2**

A witness standing towards the south-western end of the public western apron captured on video the aircraft shortly after it had gone around, its subsequent flight path and the impact sequence. The witness video matched the aircraft attitude in the recorded data. The video did not show the aircraft touchdown or bounce on the runway, but started after the aircraft began deviating to the left. Figure 2 shows snapshots from the video in half second intervals but excludes the impact.

Witness video frames at half second intervals just prior to impact

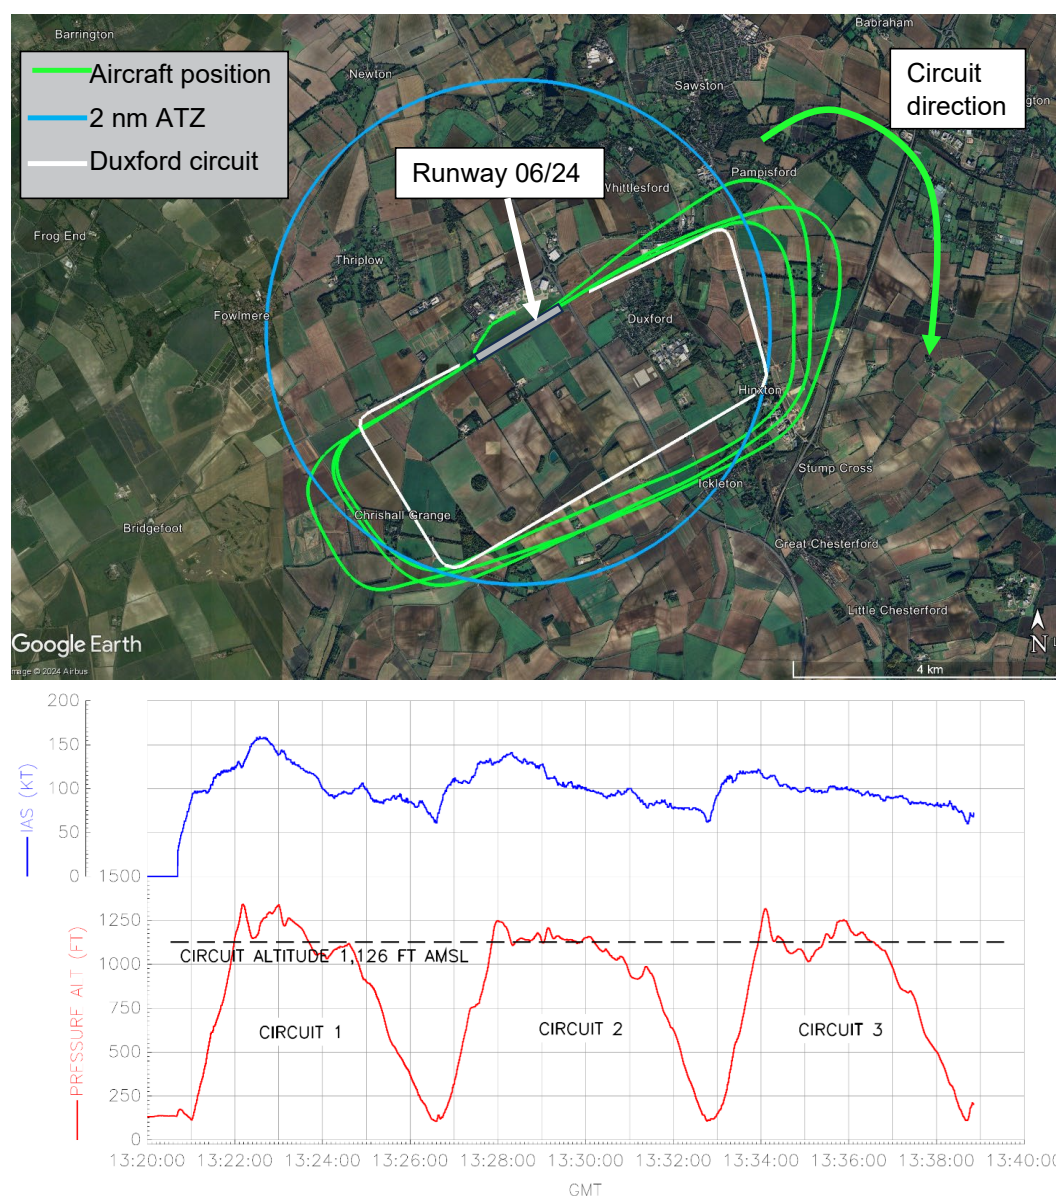
**Figure 5**

The accident flight recording commenced at 1303 hrs and the engine started just over four minutes later (Figure 5). The aircraft taxied to Runway 06R and took off at 1320:40 hrs and throughout the entire flight, the recorded data confirmed that the autopilot was not engaged. The aircraft entered a right-hand circuit, climbing initially to a recorded pressure altitude of 1,344 ft amsl<sup>4</sup>. Altitude varied between 1,344 ft and 1,033 ft<sup>5</sup> until the end of the downwind leg with recorded airspeed varying between 159 KIAS and 89 KIAS.

G-RGSK recorded position, indicated airspeed and altitude during the accident flight (circuit shape (in white) sourced from Duxford Airfield website<sup>6</sup>)

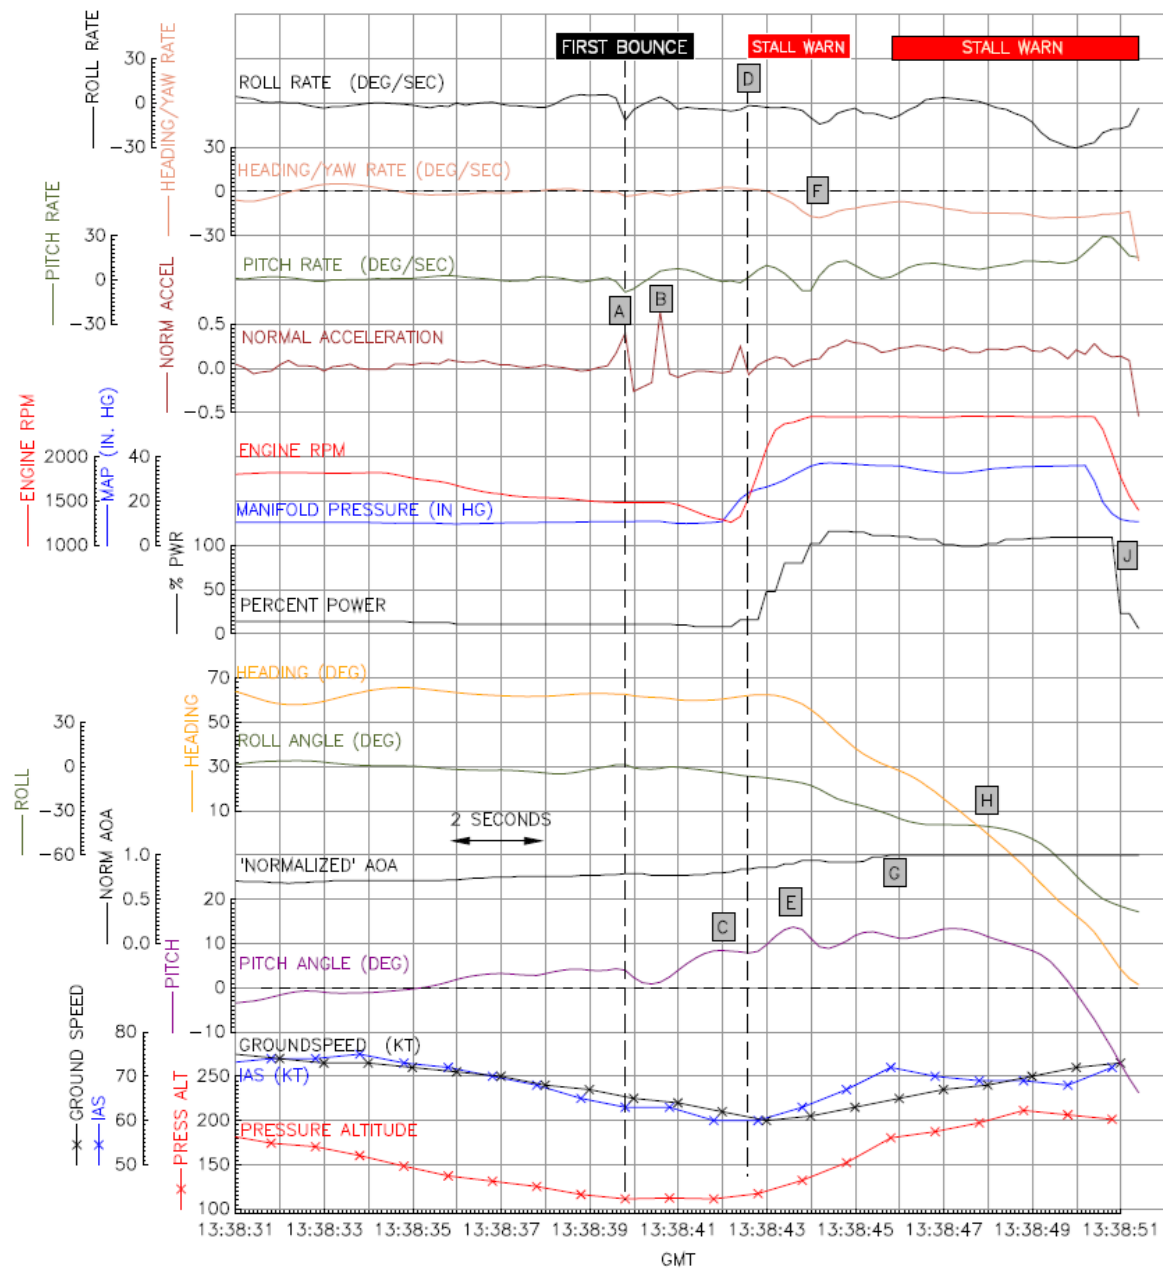
**Figure 6**  
G-RGSK RDM data

The aircraft then entered the right-hand circuit and, at 1338 hrs, turned on to the final approach at approximately 500 ft aal. The pilot made a radio call that he was on final for a touch-and-go and, at 50 ft aal, the aircraft was descending at 500 ft/min with 100% flap, 75 KIAS and 14% power. Pitch attitude then started to increase and power reduced to 11% (Figure 6).

Touchdown occurred at 1338:40 hrs at 63 kt IAS, identified by a spike in the recorded normal acceleration of 1.4g<sup>7</sup> (Figure 6, point A). A second spike in the normal acceleration was recorded 0.8 seconds later of 1.67g, suggesting that the aircraft had bounced (Figure 6, point B). A second later, the aircraft had pitched up to 8.4° and started to roll to the left (Figure 6, point C). A further second later, the recorded percent power started to increase, coincident with a recording of the stall warning activating (Figure 6, point D). Percent power increased from 8% to 116%<sup>8</sup> over 2.1 seconds (engine speed increased from 1,261 rpm to 2,500 rpm with a corresponding manifold pressure increase).

As the engine power increased, the aircraft pitched up further, continued to roll to the left and began yawing to the left (Figure 6, point E). Pitch increased to 13.7° nose-up and then fluctuated over the next five seconds while the recorded 'Normalized' AOA increased, eventually reaching and staying at 1 (indicating a stalled condition) for the remainder of the flight (Figure 6, point G). The recorded negative roll rate signified an increase in left roll from wings level to 40° left wing low over five seconds. Roll attitude held at 40° left wing low (Figure 6, point H) for a second before continuing to increase to the left until the end of the flight.

As soon as the engine power increased, the heading/yaw rate to the left increased and then remained at between 7-18 deg/sec to the left for the remainder of the recording (Figure 6, point F). This meant the aircraft was consistently yawing to the left after engine power was applied.

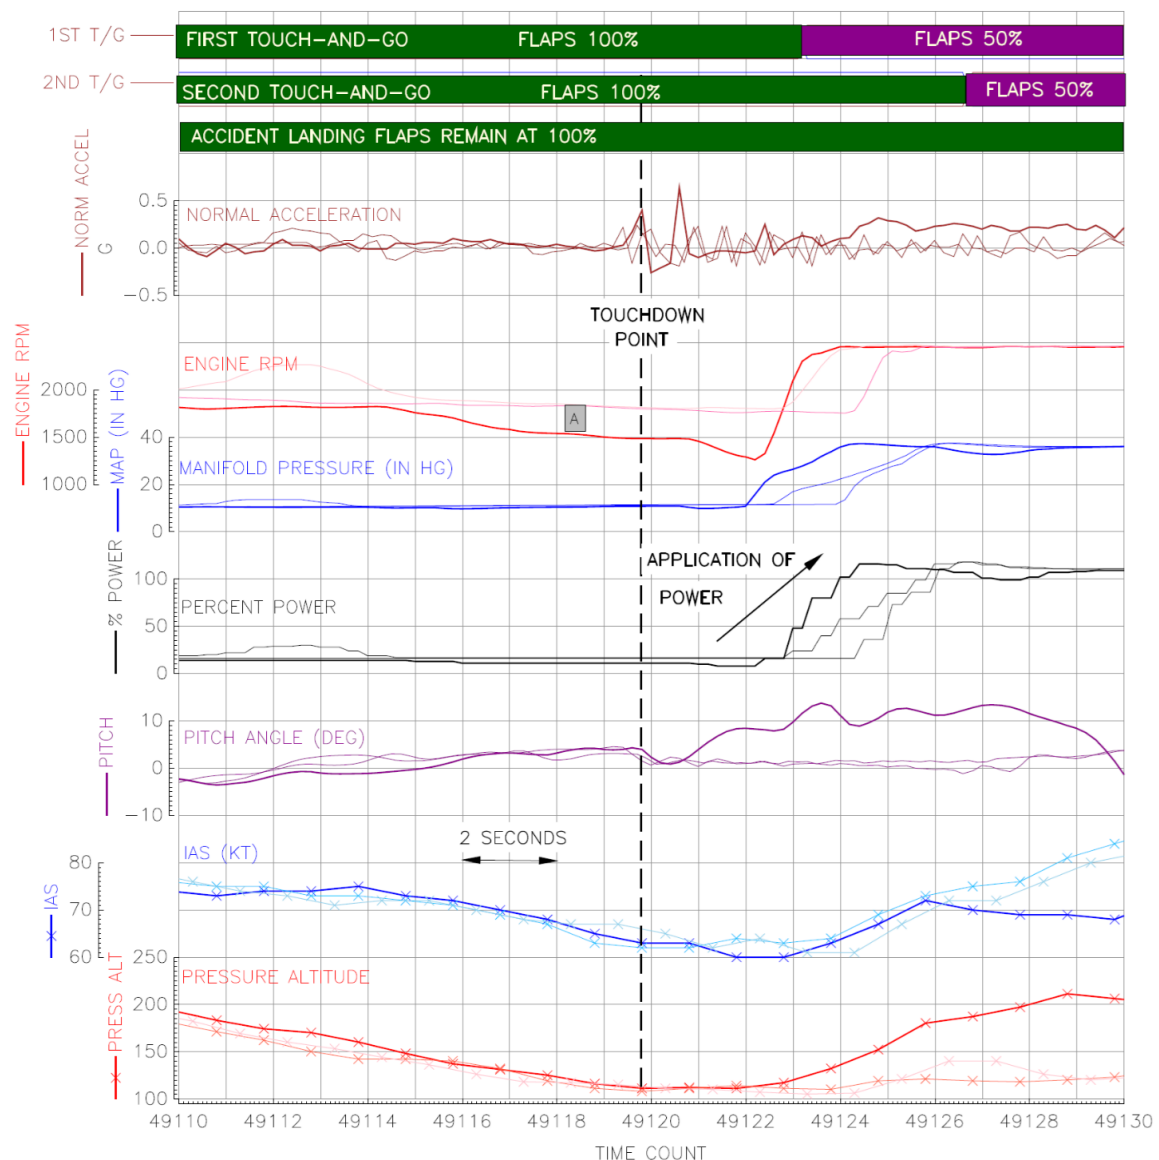
**Figure 7**

Figure 7 shows a comparison of the three approaches and landings during the accident flight. The altitude and airspeed profiles were all similar with 100% flap selected for landing.

Comparison of approaches during accident flight  
(Accident data is shown in bold colour)

Percent power on touchdown was slightly less for the accident landing than the previous two (11% vs 16% and 17% respectively) which can also be seen in a reduced engine rpm (Figure 7, point A). The rate of percent power increase was higher for the accident go-around which reached full power in 1.6 seconds (2.2 seconds and 3.2 seconds for the first and second landings respectively).

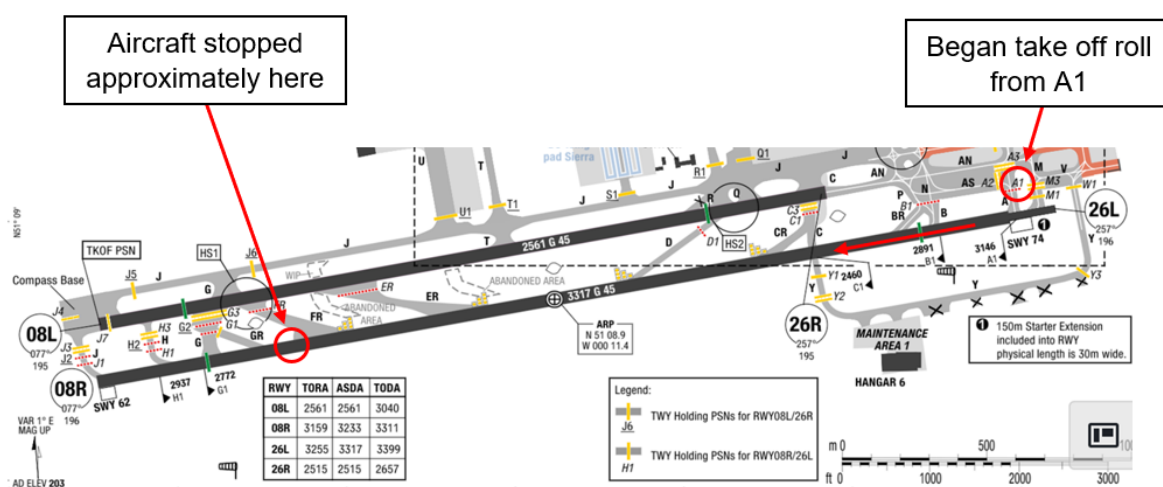
Figure 1

The aircraft stopped before intersection GR (Figure 1). The airport rescue and firefighting service attended the aircraft and extinguished a fire from hot brakes on the right main landing gear.

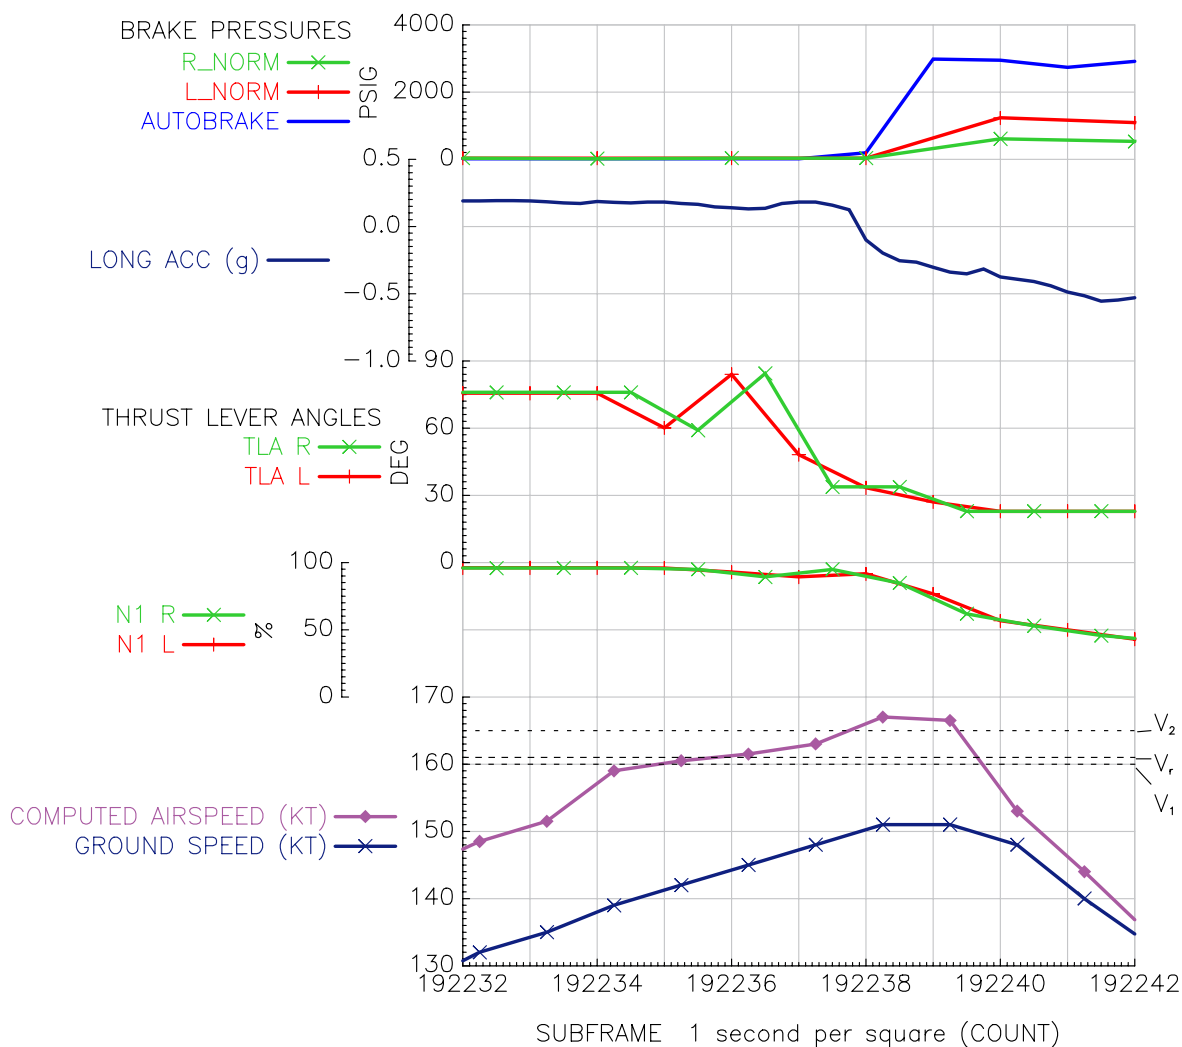
**Figure 2**

The thrust levers were retarded first at around 160 KIAS<sup>6</sup>, then again at around 162 KIAS. G-VIIT reached approximately 167 KIAS before stopping (Figure 2).

Recorded flight data
